MPC REPORT NO. 98-92

Retrofit of Existing Concrete Beam-Column
Joints Using Advanced Carbon-Fiber Composites

April 1998

A research report submitted to the
Utah Department of Transportation

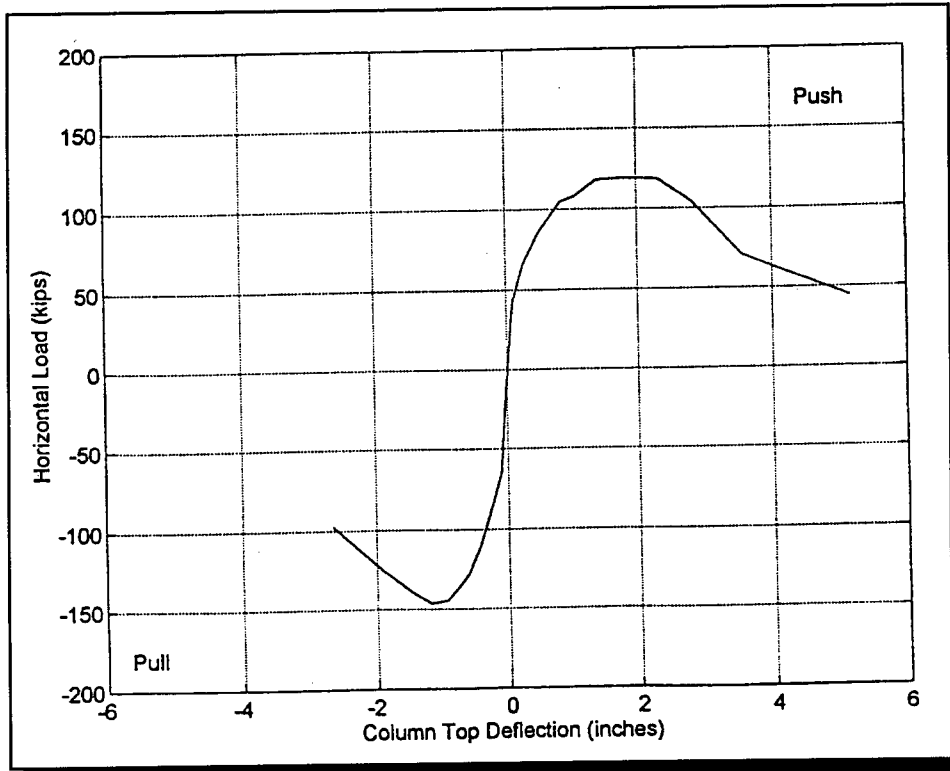
Figure 6 Test #1: Bare concrete load-deflection envelope.

To establish a basis for comparison, a bare concrete specimen was tested first. The loading history for this test is given in Figure 5. As seen from Figure 5, the maximum horizontal load, P_{ult} , carried by the as-built specimen reached 118.87 kips in the push direction and 146.58 kips in the pull direction. Figure 6 shows the load-deflection envelope for the as-built test, which reached total ductility levels, μ_1 , of 3.77 in the push direction and 3.28 in the pull direction before failure.

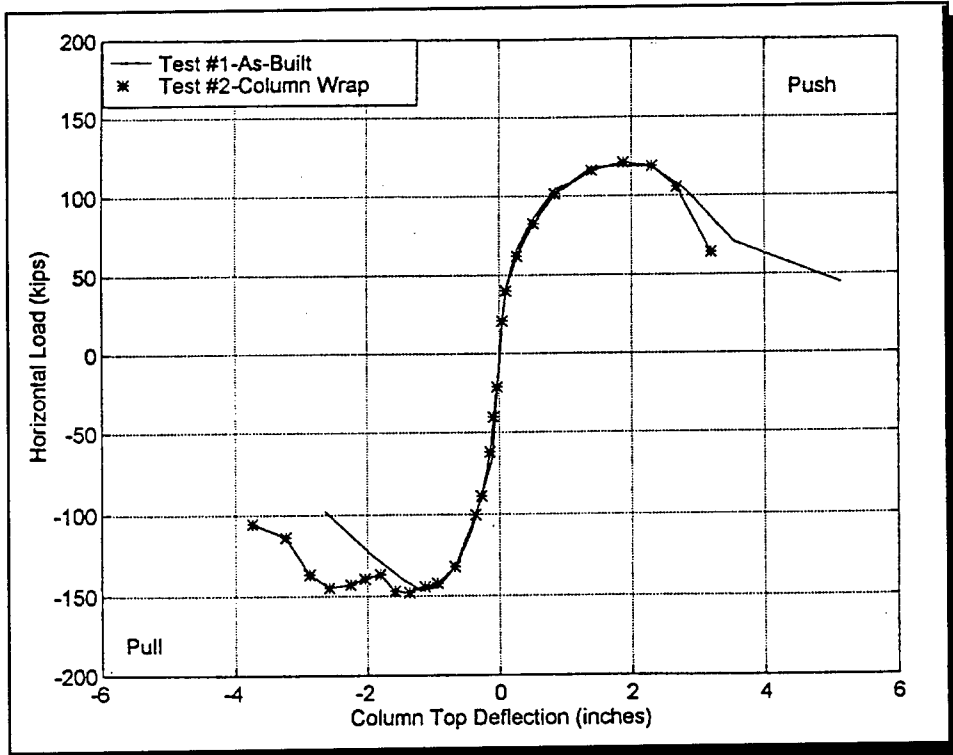
To make a direct comparison to the as-built design, the load-displacement envelope for the column wrap only test was superimposed on the load-displacement envelope for the as-built design. This comparison is given in Figure 9, which shows that an early failure developed for the wrapped column specimen in the push direction. This may be due in part to the de-bonding of the vertical column reinforcing bars in the joint area.

Figure 9 Comparison of Test #1 and Test #2 load-deflection envelopes.

The failure mechanism followed the same pattern established by the as-built column with the exception of the deterioration at the base of the column. The composite wrap proved successful in this region of the specimen. The only noticeable damage occurred in the two-inch gap between the base of the composite wrap and the cap beam where cracks appeared in the column concrete. The failure of the joint area was similar to the as-built design with shear cracks throughout the joint region.
