## **CAL/APT Goal LLPRS – Rigid Phase III:**

### **Concrete Test Section 516CT Report**

**CALIFORNIA DEPARTMENT OF TRANSPORTATION**

April 1999

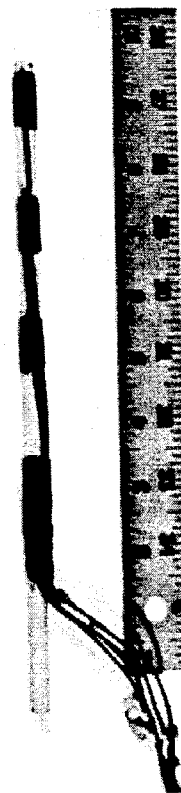
Figure 13a and 13b. Typical thermocouple setup with five thermocouple wires

depth concrete temperatures. Type K (nickel-chromium and nickel-aluminum leads) and Number 24 American Wire Gage thermocouple wires were used. The thermocouple wires are manufactured by Omega Technologies Company and have a maximum temperature capacity of 200°C. The ends of the thermocouple leads were soldered together in pairs to create the thermocouples. The soldered ends were then placed at various depths in the concrete pavement. A total of five thermocouples were used at each location with the wires taped to a 225 mm long by 7 mm diameter wooden dowel. The first thermocouple wire was placed at the surface of the concrete and the other four thermocouples were placed every 50 mm, with the bottom gage at 200 mm as shown in Figure 13.

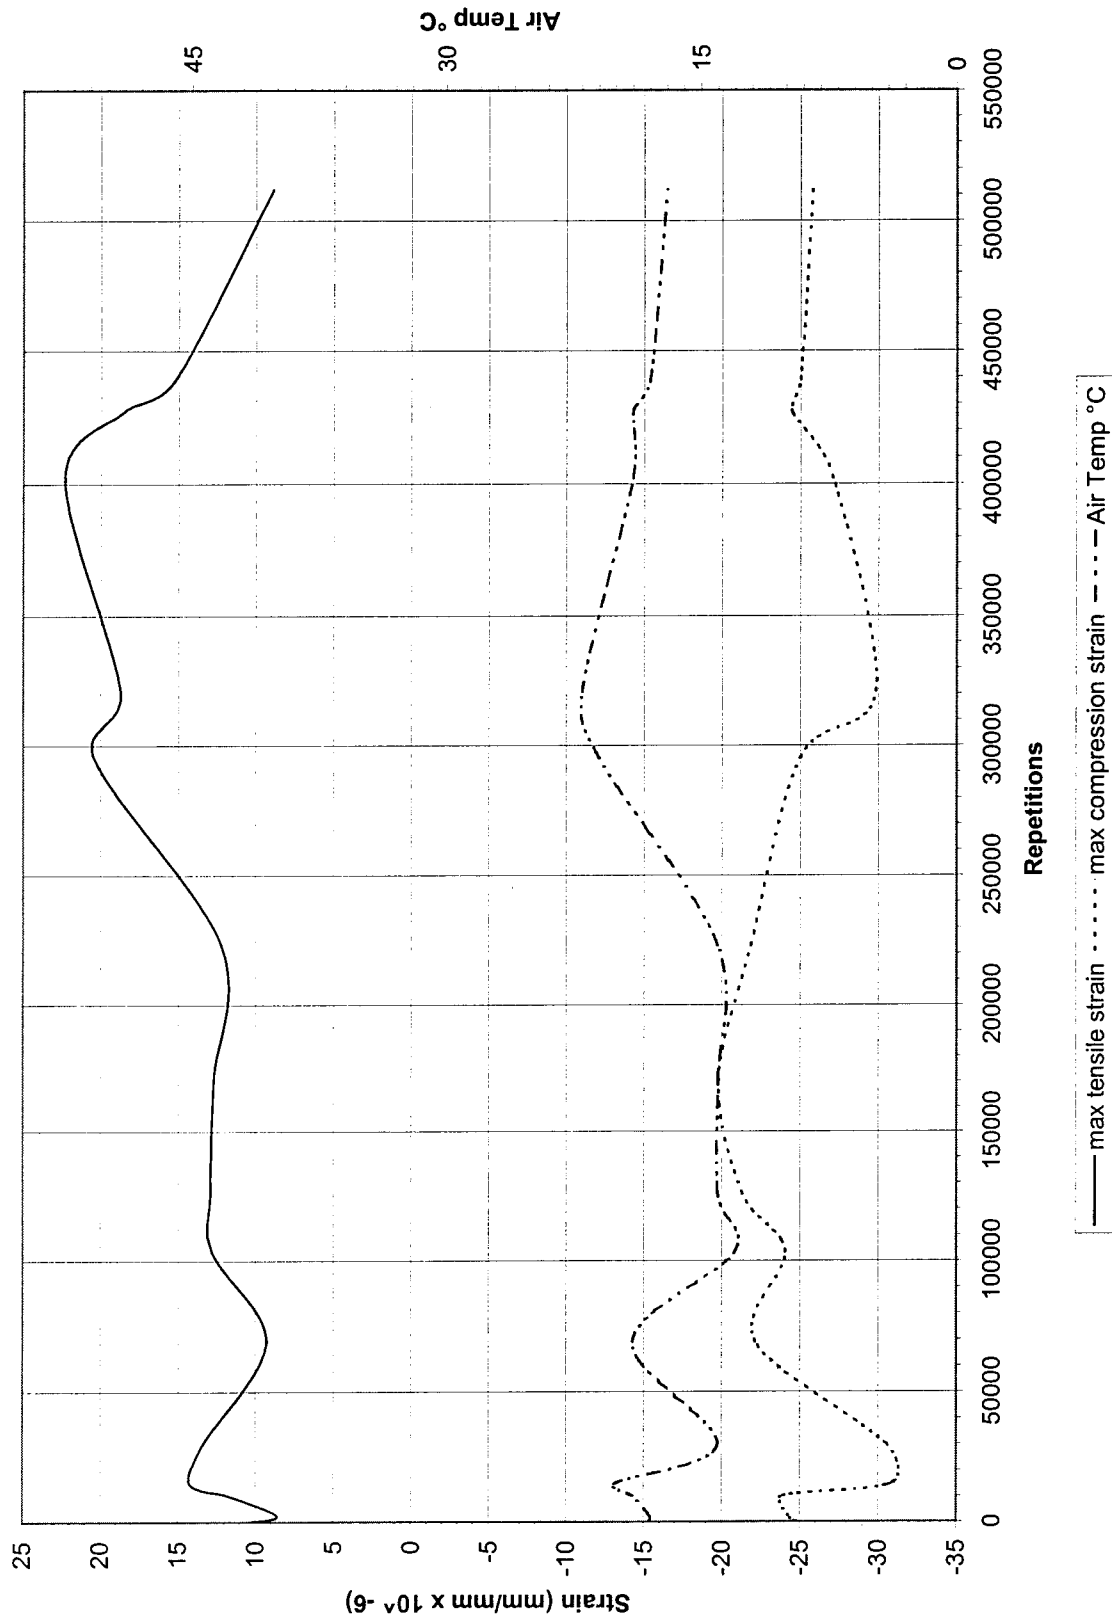
Figure 28. Dynamic strain data from Section 516CT under 60kN load. Tokyo Sokki PMR-60-6L strain gage located near the surface of the pavement near the middle slab edge, oriented parallel to slab edge.

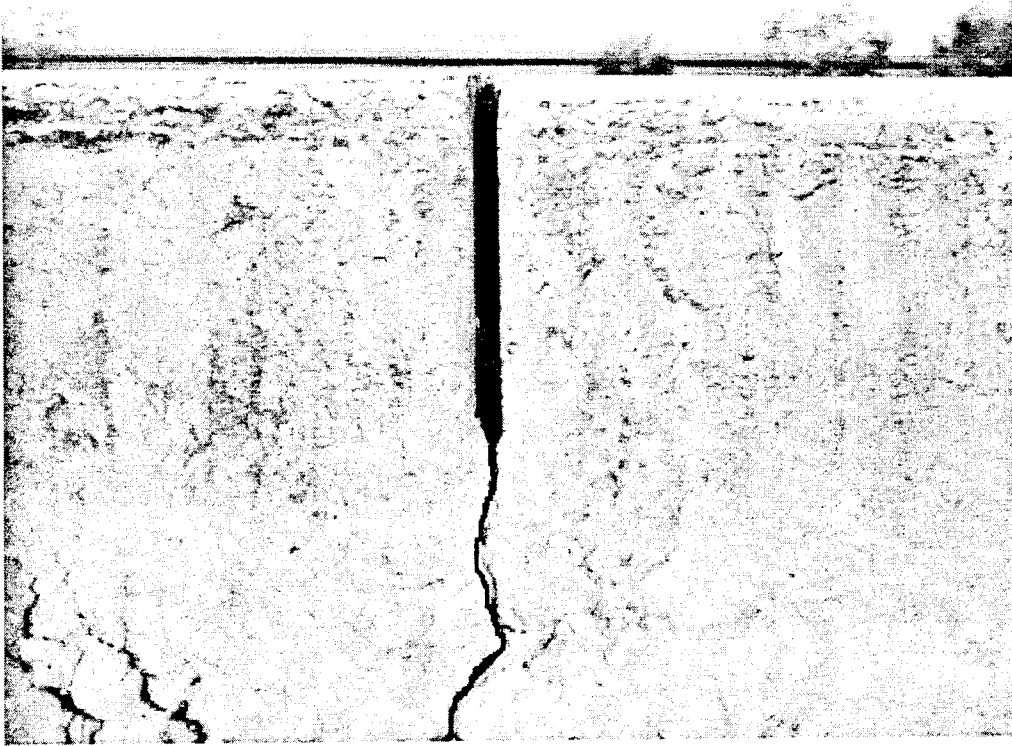
**Figure 47a: Photo of Joint 1. Joint crack is enhanced for easier viewing.**
