A CENTER OF EXCELLENCE FOR RURAL AND INTERMODAL TRANSPORTATION

MPC REPORT NO. 99-106

Assessment of Rail Flaw Inspection Data

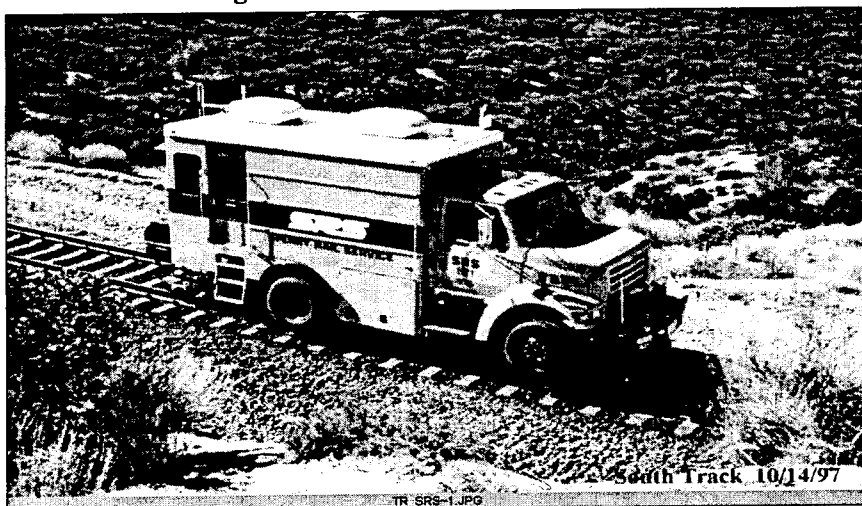
Figure 2.1: Road / Rail Ultrasonic Car

(Picture of Sperry Rail Service Car SRS #821 taken by Al Bowen.)

Ultrasonic inspection technology is the predominant rail inspection technology used in North America. Most of the major contractors rely exclusively on ultrasonic rail testing cars (see Figures 2.1 and 2.2). Some companies do employ larger rail bound units that have ultrasonic and magnetic induction technologies (see Figure 2.1). Currently, the ultrasonic rail testing cars are capable of speeds up to 30 mph in a non-stop testing mode. However, in practice the vehicle stops frequently to hand verify indications from the rail testing. With the stopping and verification rail inspection vehicles typically average 6 to 8 mph in practice.

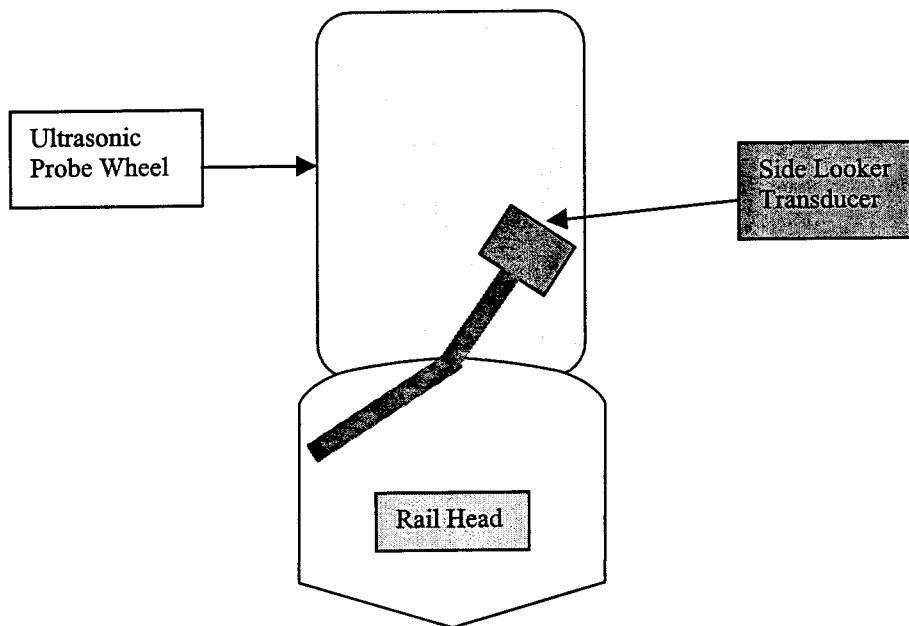
Figure 2.3: Ultrasonic Probe Wheel Transducer Arrangements

A transducer orientation in the wheel is fixed to offer different inspection capabilities. Different transducer angles are used to find different types of defects. Inside each wheel three to six transducers are mounted, usually with two wheels per rail. A total of as many as 12 transducers per rail are used. Transducers commonly have four different orientations: 0° , 45° , and 70° from the vertical, and a “side looker” transducer may be located in each wheel (see Figure 2.3). The 0° transducer is mounted, perpendicular to the track, and picks up horizontal defects. The 45° and 70° transducers are mounted in a forward and reverse position in the wheel, which allows for detection of defects in various orientations in the rail. The “side looker” transducers are sensitive to vertical and shear type defects. The angles mentioned above are not the directions of the transducer in the wheel, but the angle of the transmitted longitudinal wave in the steel rail, known as the refracted angle. The direction of the transducer in the wheel is known as the angle of incidence and can be calculated from Snells Law of Refraction:

The ultrasonic system traditionally is a pulse-echo method where standard ultrasonic piezo-electric transducers are mounted into wheels filled with fluid (Garcia, 1998). The wheels rolling along the track send signals through the rail to be received by the transducer. To transmit the ultrasonic signal from the wheel to rail, a coupling media is needed. A coupling fluid is applied between the wheel and rail contact area and usually is oil- or water-based.

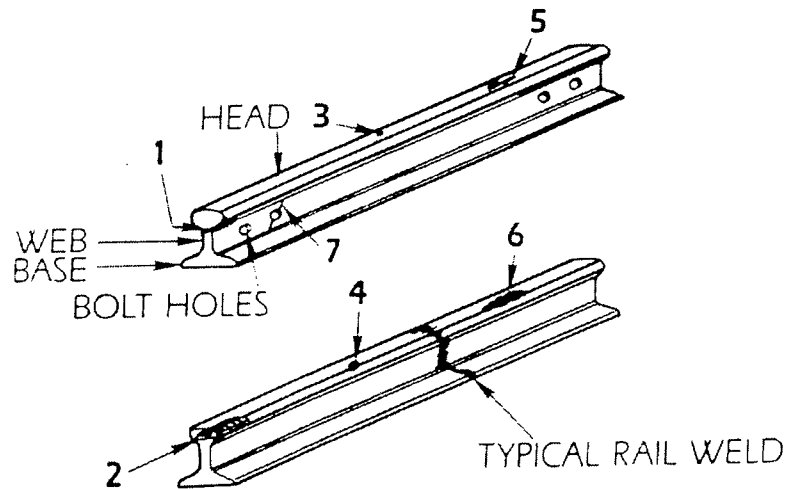
Figure 2.4: Typical Rail Defects

- Notes:**
- 1 – Head and Web Separation
 - 2 – Horizontal Split Head
 - 3 – Detail Fracture
 - 4 – Transverse Fracture
 - 5 – Engine Burns
 - 6 – Shelling
 - 7 – Bolt Hole Cracks

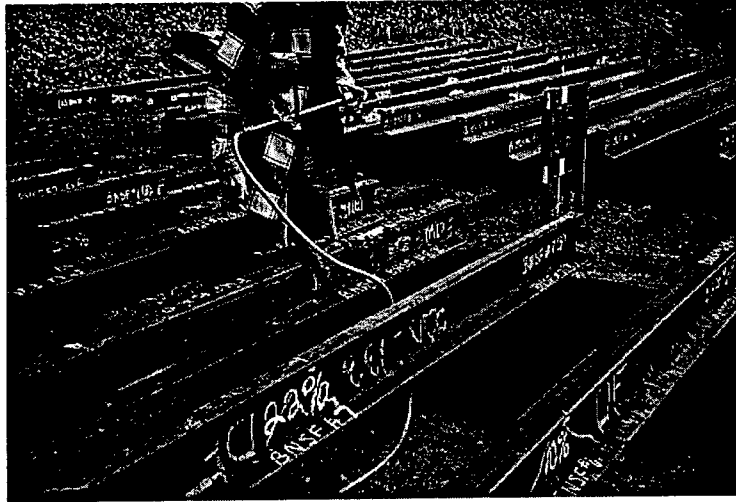
Figure 3.4: Radiography of Donated Rail Samples

(Rail samples used in RDTF located at TTC, TTCI 1998)

The rail received at TTC was inspected visually, ultrasonically and, in some cases, radiographically. The inspections were performed to document the external and internal condition of the rail. The visual inspections included identification of surface conditions such as shelling, spalling, head checks, and rail wear. The ultrasonic inspection consisted of ultrasonic hand-mapping of the head, web and base using pulse echo A-scans with 0, 45 and 70 degree transducers. Radiography of the rail was performed only on rail containing transverse defects and was performed to document the orientation of the defect when referencing the top of the rail on the gage face side (Garcia, 1998). TTCI used these methods of inspection before installing the flawed rail into the RDTF.

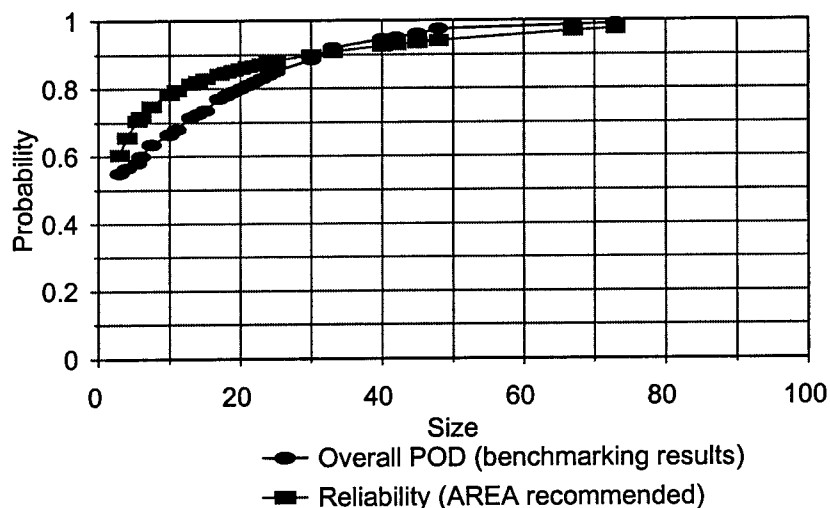
Graph 5.1: Inspection Reliability and Probability of Detection Comparison

This correlation shows the probability of detection curve and the AREA recommended inspection reliability curve for detail fractures. The reliability curve and the overall evaluation probability of detection curve increase with defect size. The inspection reliability curve supercedes the probability of detection curve for defects smaller than 30 percent. From this comparison, the overall probability of detection results for the RDTF and the minimum inspection reliability, one can conclude the ultrasonic inspection technology has a lower probability of detecting smaller defects than the expected AREA recommended industry reliability. However, the AREA manual only is a recommended guideline not a required specification.

If inspection frequency has not been adjusted to compensate for increased defect occurrence, the deterioration of rail caused by aging gradually reduces the factor of safety in an otherwise conservative design. The inspection reliability is a measure of determining the level of risk. The inspection reliability is related to defect size and the ability to detect defects. The rail industry must constantly rehabilitate and maintain the rail system to keep it safe for its customers and the public. Therefore, a reliable and accurate inspection system is necessary for finding defects in the rail. Accuracy of the inspection system refers to size of the defect that can be detected and reliability refers to probability of detecting a defect of a given size. The comparison of the overall probability of detection plot from benchmarking efforts at TTC (Graph 8) and the AREA reliability recommendations is shown in Graph 5.1 (TTCI TD 1997).

Where $n = 0.35$ for detail fractures (industry standard). The inspection reliability describes industry assumed level of performance based on previous experimental work and provides a degree of confidence with the inspection technology.
