Report No. CG-D-11-97

## **Development of Composite Components for the CCN-150-5C Transfer Pump**

Final Report  
November 1996

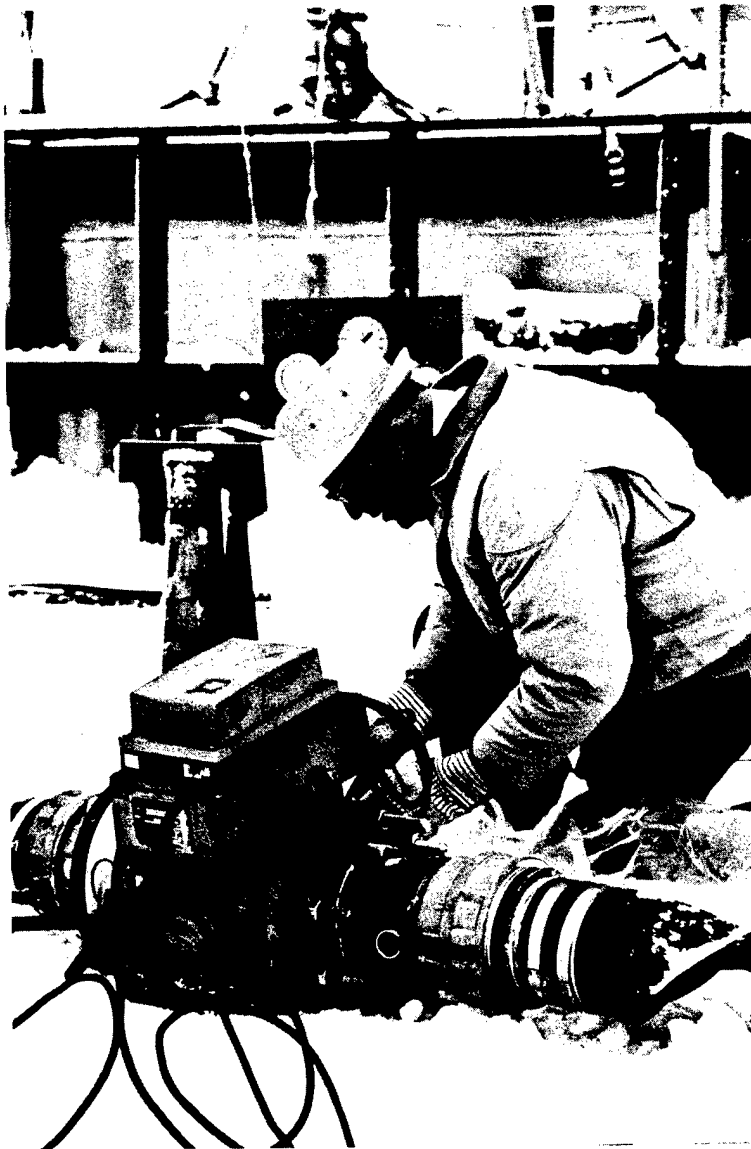
Fig. 13. Photograph of the magnetic flow meter.
