EFFECTIVENESS OF BUS BULBS FOR BUS STOPS

FINAL REPORT

September, 2004

Dr. Janice Daniel and Prof. Walter Konon
National Center for Transportation and Industrial Productivity
New Jersey Institute of Technology

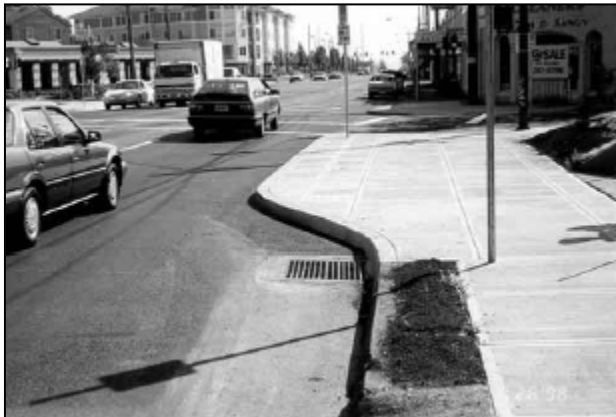
**Figure 1. Example of Bus Bulb
(Source: TCRP 65).**

Some of the advantages cited for the use of bulbs as a bus stop zone include that bus bulbs: (1) remove fewer parking spaces than the traditional curb-side bus stop; (2) decreases the walking distance for pedestrians crossing the roadway; (3) provides additional sidewalk area for bus patrons to wait; and (4) results in minimal delay for the bus. When a bus stops at a bus bulb, the bus remains in the travel lane, rather than weaving into and out of the curb lane as is typical of curbside bus stops. Removing this weaving has the potential of reducing conflicts between buses and other vehicles on the roadway as the bus does not have to merge back into the traffic stream after stopping at the bus stop.

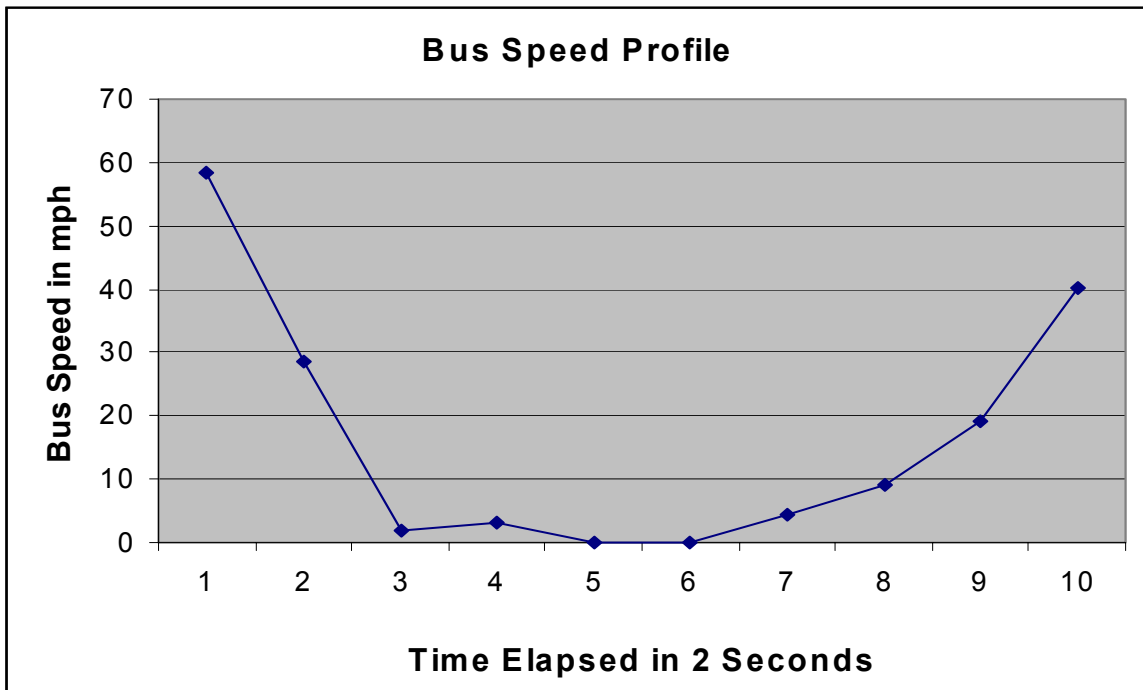
Figure 26. Bus speed Profile at Cedar Lane and Garrison Avenue.

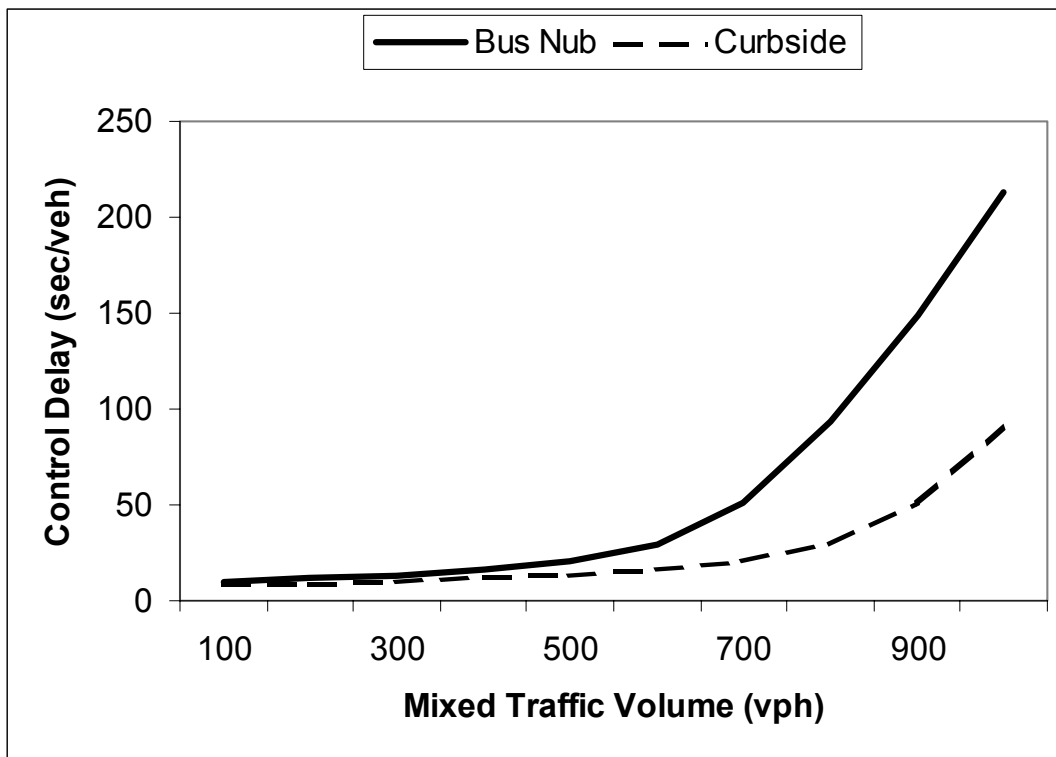
Figure 31. Intersection Control for Bus Bulb and Curbside Bus Stop.

A comparison of control delay with a curbside stop to the delay with a bus bulb was determined for a two-lane intersection approach with volumes ranging from 100 to 1000 vehicles per hour per lane (vphpl). Figure 31 shows the delays with and without the bus bulb. The figure demonstrates that for volumes below 500 vphpl, there is little difference between the delays at the intersection for a bus bulb condition or a curbside bus stop. After this volume, there are higher delays at intersections with bus bulbs when compared to curbside bus stops.

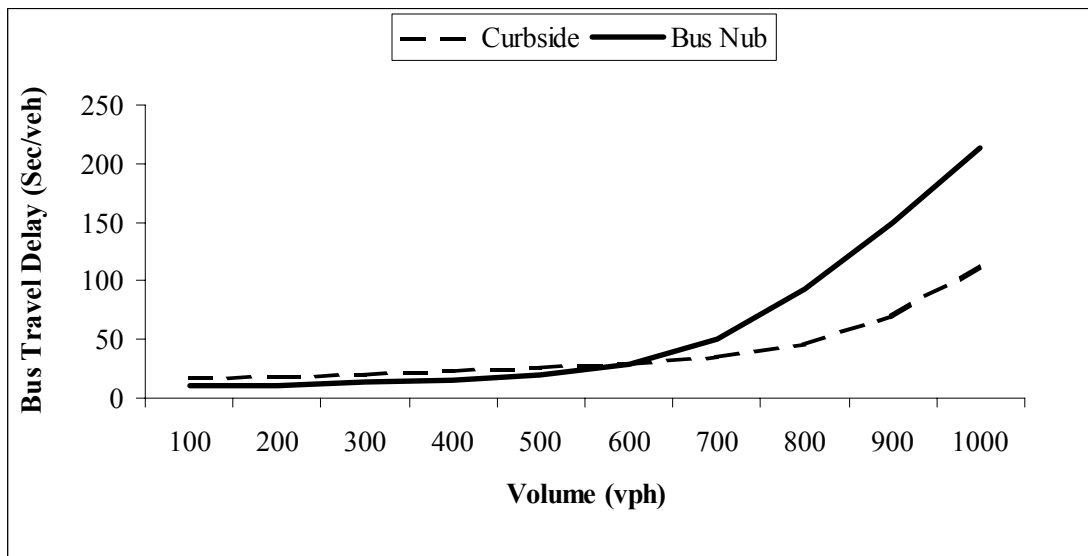
Figure 32. Bus Delays for Bus bulbs and Curbside Stops.

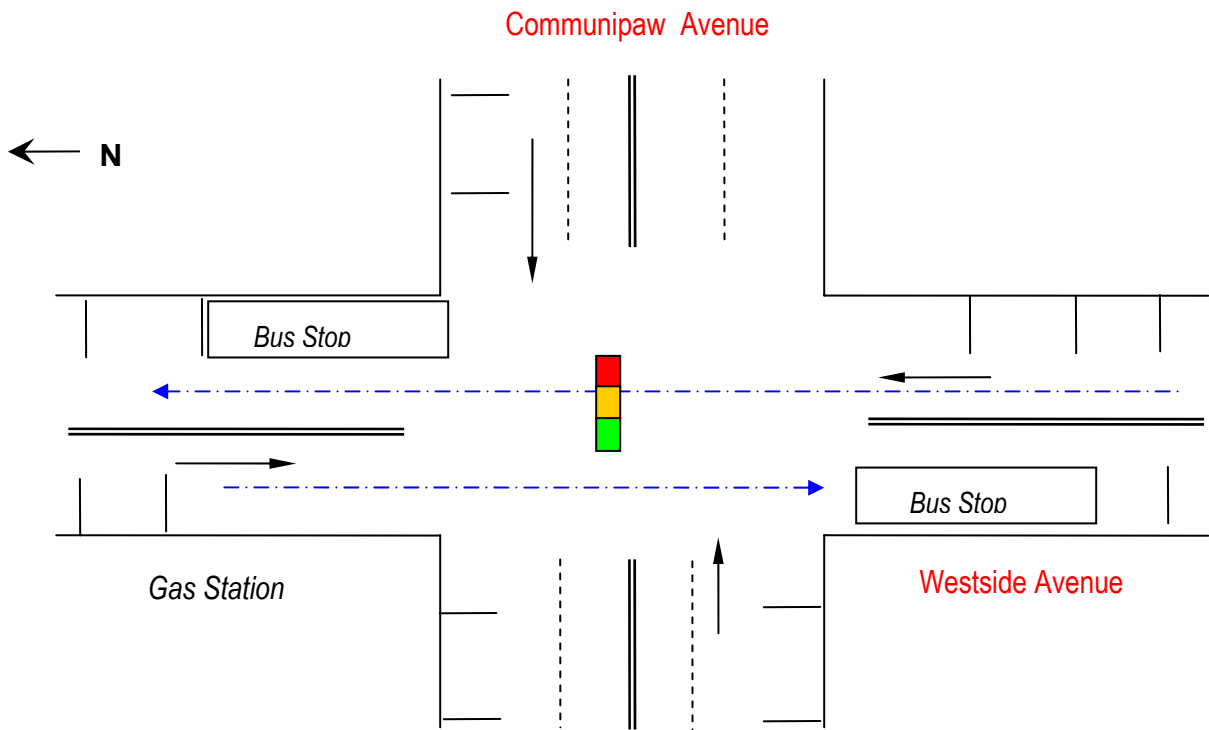
Figure 33. Westside Avenue and Communipaw Avenue.

The intersection of Westside Avenue at Communipaw Avenue is located in Jersey City. Figure 33 shows a diagram of the intersection with the adjacent bus stop. Westside Avenue is a two-way roadway with two lanes in each direction and a parking lane. The bus stop is located in a commercial district with several stores located adjacent to the intersection. Westside Avenue and Communipaw Avenue are quite congested during the evening peak period, with a high bus patronage using Route 80 which serves this location.

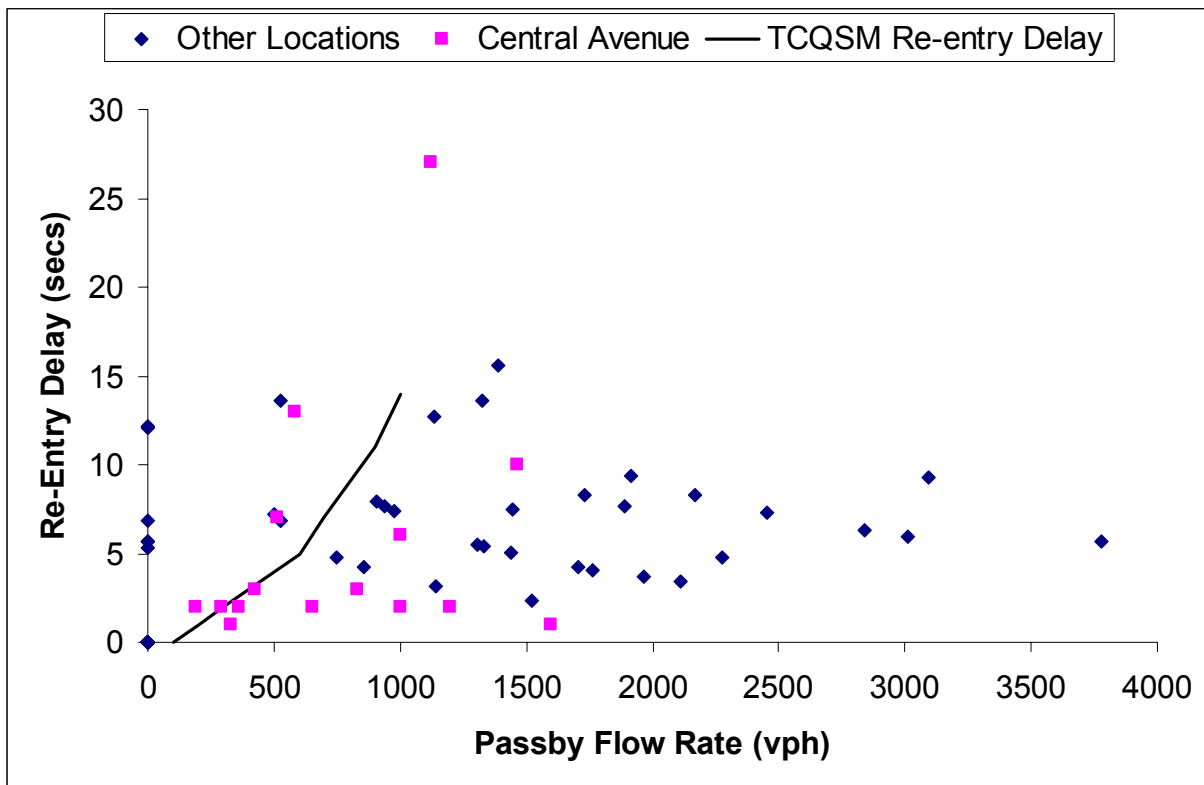
Figure 39. Re-Entry Delay vs. Passby Flow Rate.

Figure 39 shows a plot of the re-entry delay versus the passby flow rate. Included in the plot are the re-entry delays measured as well as the re-entry delays from the Transit Capacity and Quality of Service Manual (TCQSM). The plot shows that the measured re-entry delays show significant variability and spread with a minimum re-entry delay measured of 1 second and a maximum re-entry delay of 27 seconds. The plot also demonstrates that the measured re-entry differ from the delays provided in the TCQSM. The TCQSM re-entry delays increase with increasing volume. Although difficult to see a trend in the measured re-entry delays, the delays appear to not be correlated to the adjacent volume only.
