Alaska Department of Transportation & Public Facilities

Intelligent Specialty Vehicle System

Pilot Program Report

March 26, 2007

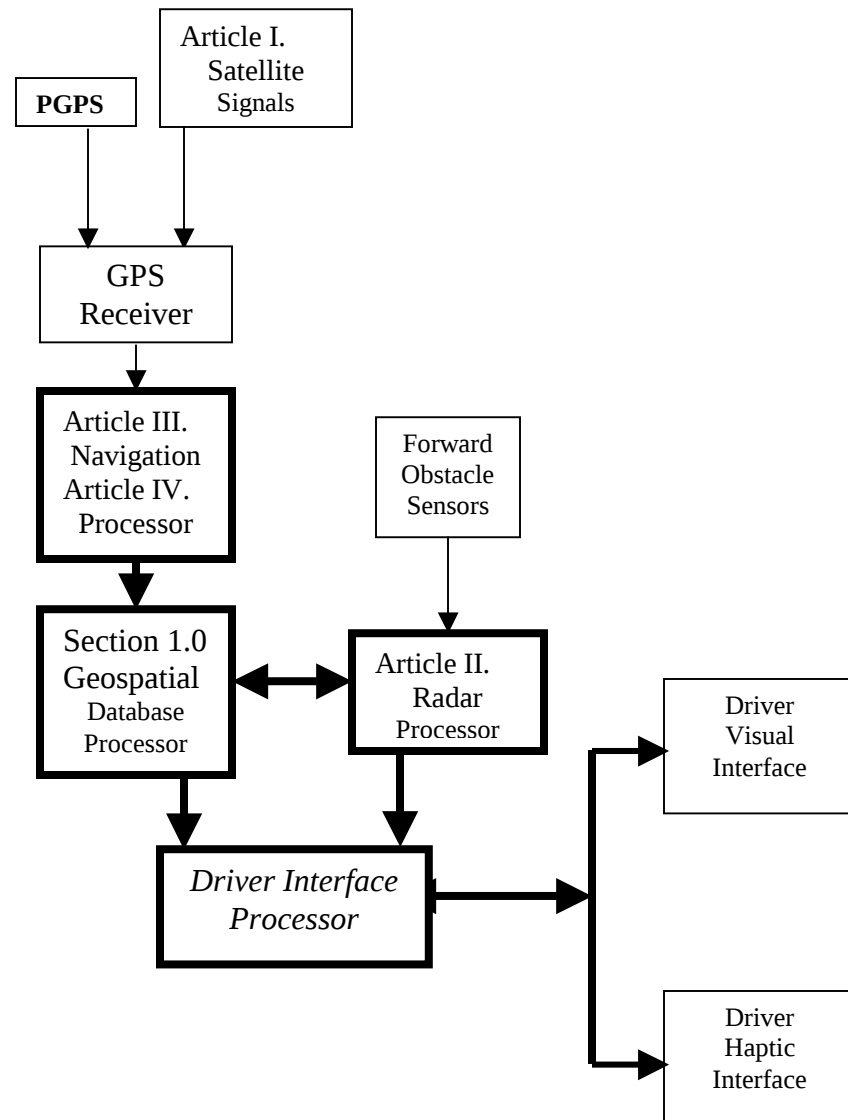
## 6. Driver Assistive System Block Diagram

Vehicle positioning, collision avoidance, and the driver interface constitute the primary components of the ISVS. Vehicle positioning is accomplished through a combination of a PGPS and a geospatial database. Collision warning and avoidance is accomplished with radar sensors and signal processing techniques, which take advantage of information returned by the vehicle positioning system. Finally, information is provided to the driver via the driver interface system, which employs graphical and tactile interfaces to provide an optimal information path to the driver. A block diagram of the driver assistive system illustrating components and signal paths is shown in 6.1. Driver Assist System Block Diagram.
