## **Occupant Protection Experiments in Support of A Full-Scale Train-to-Train Crash Energy Management Equipment Collision Test**

| 1. AGENCY USE ONLY (Leave blank) | | 2. REPORT DATE<br>July 2009 | | 3. REPORT TYPE AND DATES COVERED |
| 7. PERFORMING ORGANIZATION NAME(S) AND ADDRESS(ES)<br>Armor Holdings Aerospace & Defense Group<br>10016 S. 51st St.<br>Phoenix, AZ 85044 | | | | 8. PERFORMING ORGANIZATION<br>REPORT NUMBER<br><br>DOT-VNTSC-FRA-09-06 |
| 9. SPONSORING/MONITORING AGENCY NAME(S) AND ADDRESS(ES)<br>U.S. Department of Transportation<br>Federal Railroad Administration<br>Office of Research and Development<br>Washington, DC 20590 | | | | 10. SPONSORING/MONITORING<br>AGENCY REPORT NUMBER<br><br>DOT/FRA/ORD-09/14 |

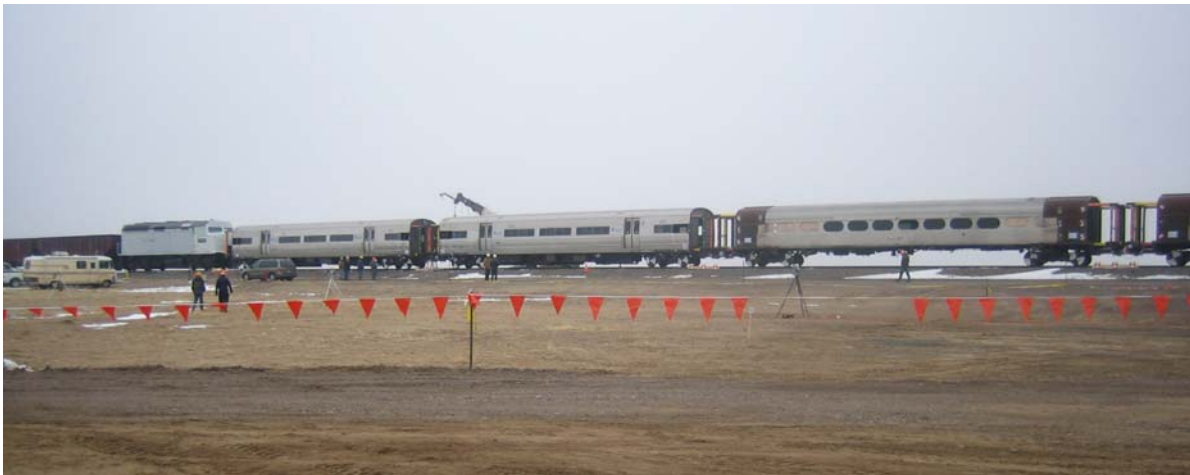
**Figure 1. Pretest Photograph of the CEM Passenger Train**

The objective of this program was to implement the five occupant protection experiments described in the test requirements document provided by the Volpe Center as part of the full-scale train-to-train CEM equipment collision test task order request (TOR) for proposals. The five experiments were conducted on the first two cars of a cab car-led consist of five cars equipped with CEM crush zones and a locomotive. This consist was subjected to a head-on collision with a stationary locomotive-led consist at a speed of 30.8 mph. Figure 1 shows a pretest photograph of the CEM equipment.

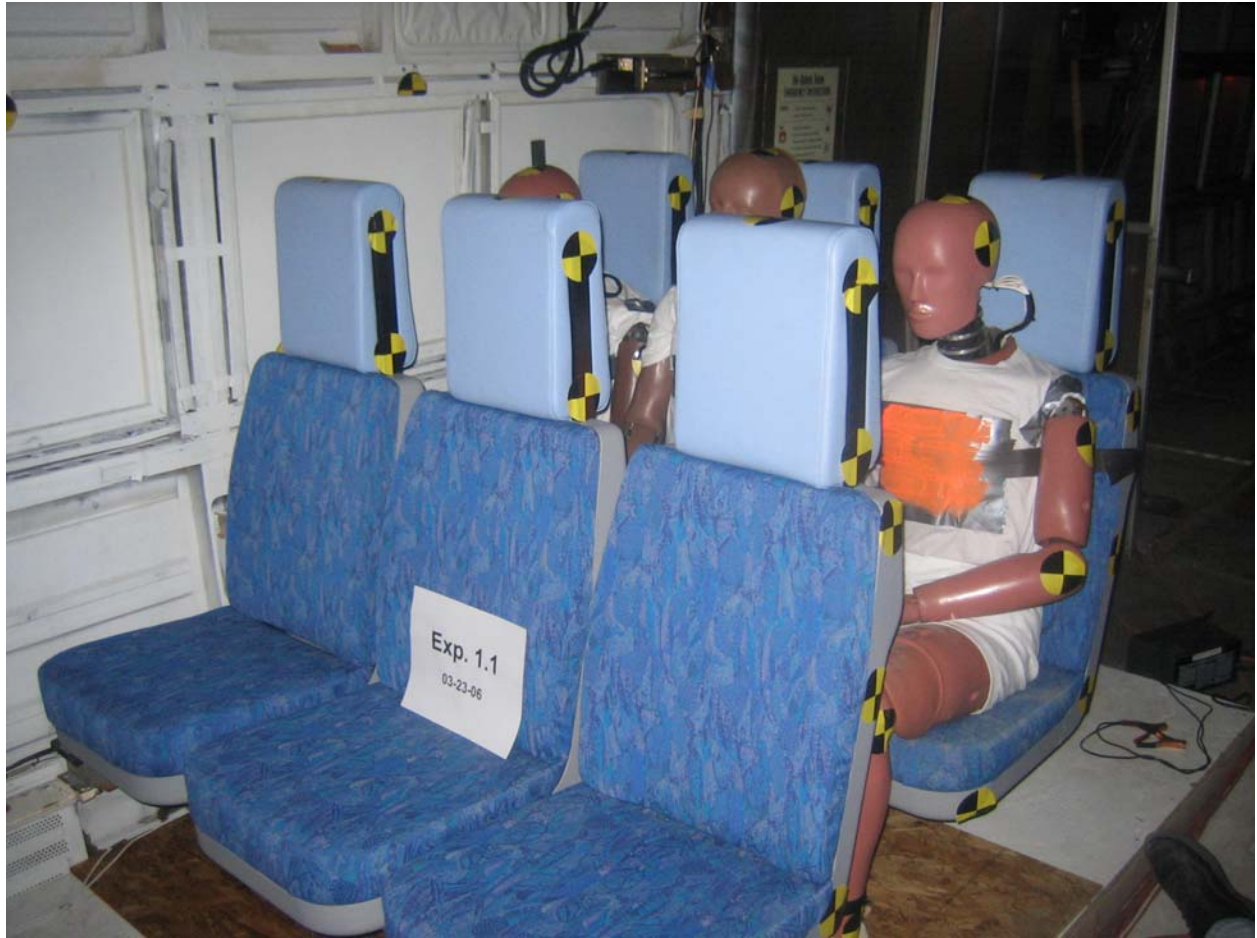
**Figure 4. Pretest Photograph of Experiment 1.1**

The interior configuration consisted of two rear-facing, newly designed, three-passenger commuter seats located in the forward left-hand-side of the lead cab car. The seats were designed with higher backs and a stiffened tubular frame to provide more energy-absorbing capability during impact. CR Safeguard™ fire-resistant cushioning was incorporated. The seat design was the same as that used in Experiment 2.2 (forward-facing, newly designed commuter passenger seats). The seat pitch was set at 32 in. Seat-mounting hardware was consistent with in-service hardware. Three ATDs were used in this experiment: two instrumented Hybrid III 50th percentile ATDs were seated in the aisle and window positions, and one uninstrumented Hybrid II 50th percentile was seated in the middle position. The ATDs were seated in the forward-most seat relative to the front (cab) end of the car. The seat located behind the occupied seat (relative to the cab end of the car) remained unoccupied. Figure 3 illustrates the location of the experiment. Figure 4 shows a pretest photograph of the experiment.

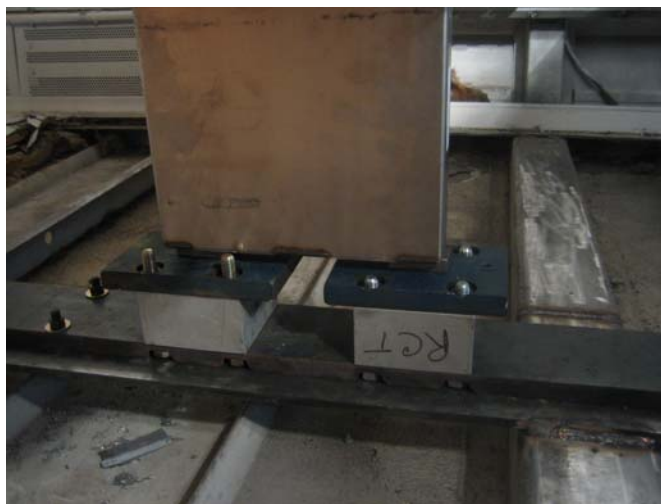
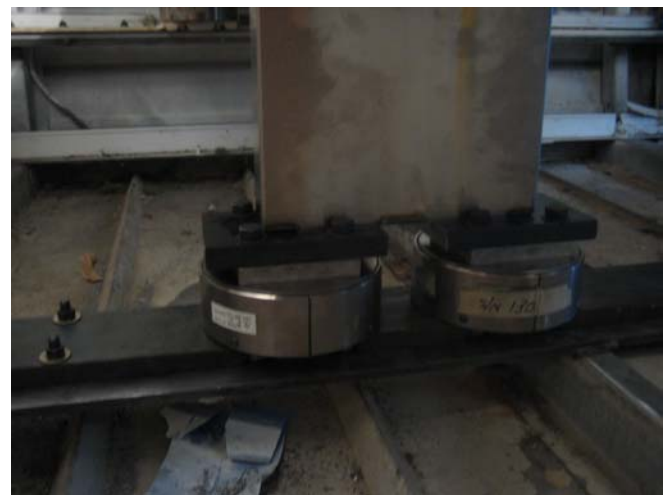
**Figure 5. Floor-Attachment Spacer Blocks for Unoccupied Rebound Seat (left) and Load Cells for Occupied Front-Row Seat (right) in Experiment 1.1**

their pedestals to the top surfaces of the load cells, and the spacer blocks were bolted through smaller attachment plates. Figure 5 shows a photograph of the load cells and the spacer blocks.

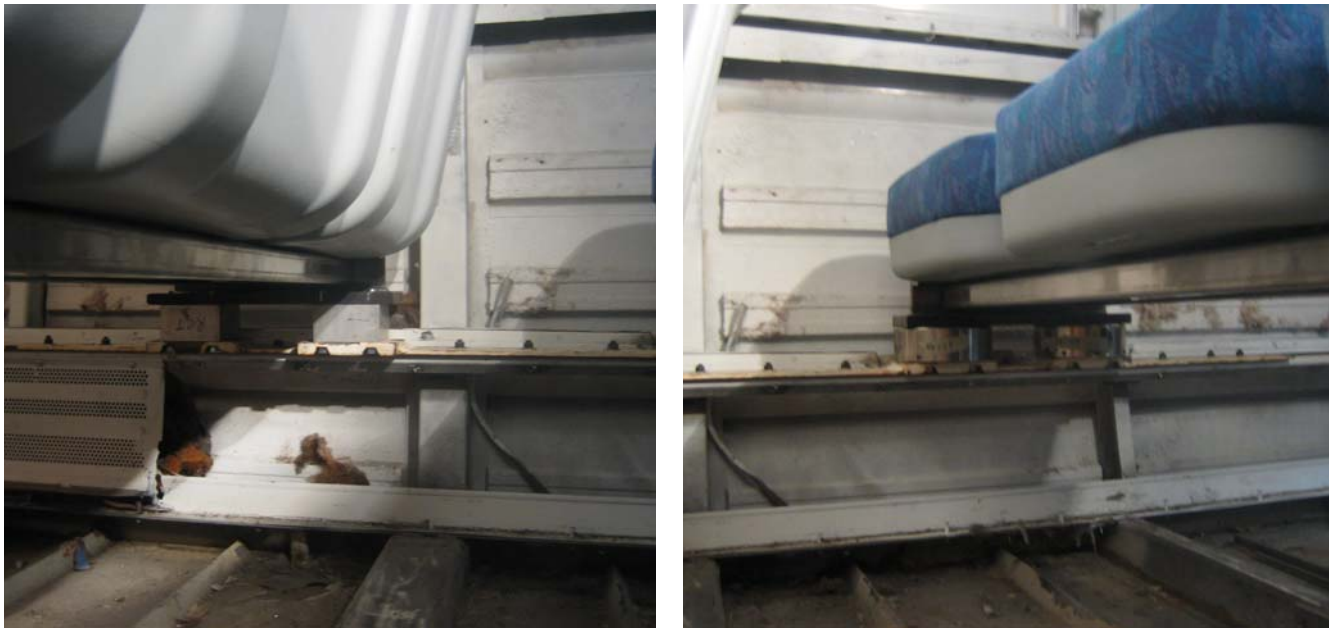
**Figure 6. Wall-Attachment Spacer Blocks for Unoccupied Seat (left) and Load Cells for Occupied Seat (right) in Experiment 1.1**

*Seat Attachment to Wall:* A steel bar measuring 78 x 3 x 0.25 in was bolted onto the heater rail along the side of the rail car. For the occupied front-row seat, two load cells were bolted onto the attachment plate. For the unoccupied aft-row seat, two spacer blocks were bolted onto the attachment plate to keep this row the same height as the occupied row. The bolt holes in the attachment plate were predrilled to provide the required 32-inch seat pitch. Figure 6 shows a photograph of the load cells and the spacer blocks. A T-shaped load-cell attachment plate was bolted to the load cells through a four-hole bolt pattern that had been drilled to the flat surface of the upside-down T. A piece of rugged angle iron was bolted to the vertical piece of the T-shaped load-cell attachment plate, which was then bolted to the C-channel that formed the base of the seat assembly, as shown in Figure 7.

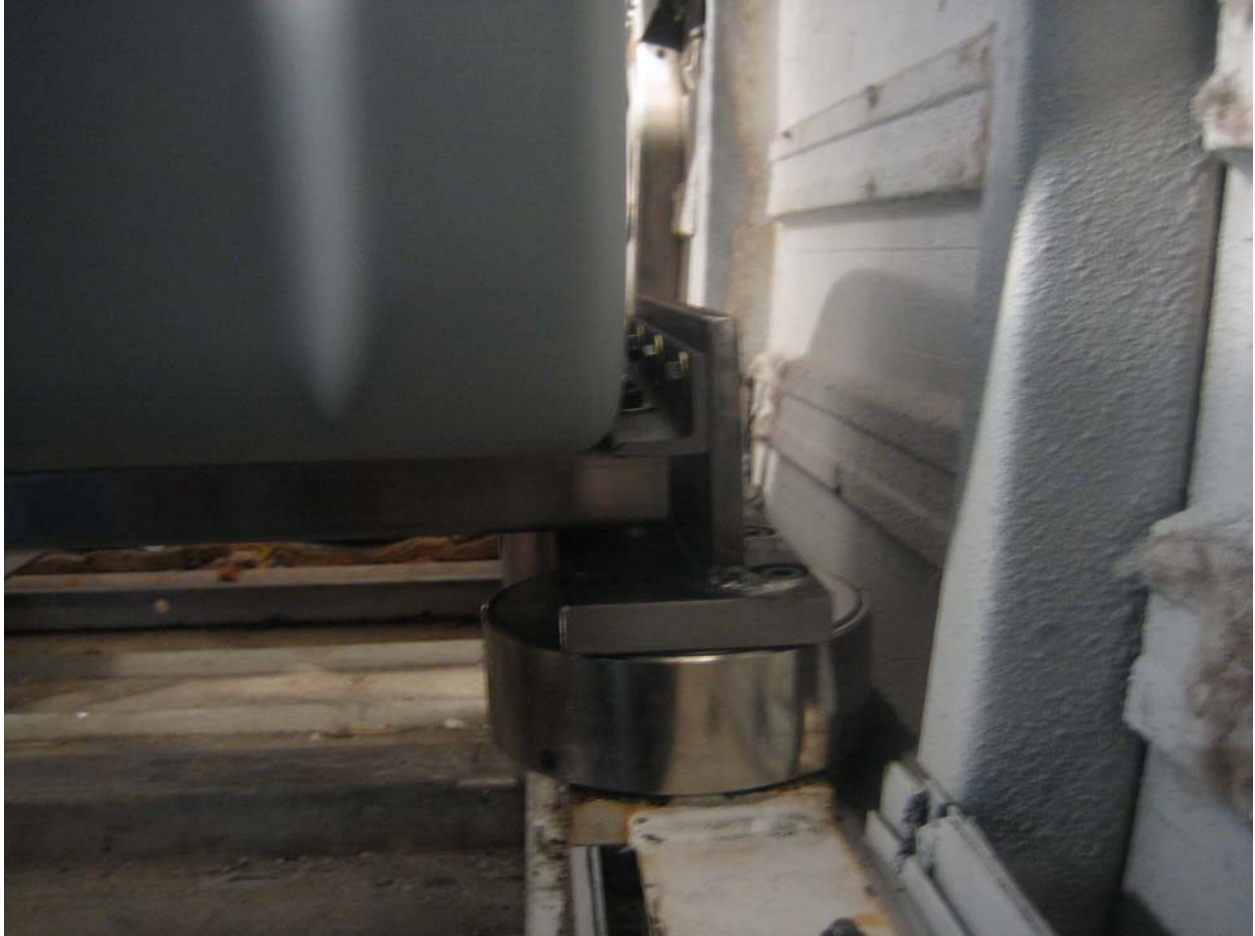
**Figure 7. Rugged Angle Iron Bolted to the Vertical Piece of the T-Shaped Load-Cell Attachment Plate and Bolted to the C-Channel That Formed the Base of the Seat Assembly**

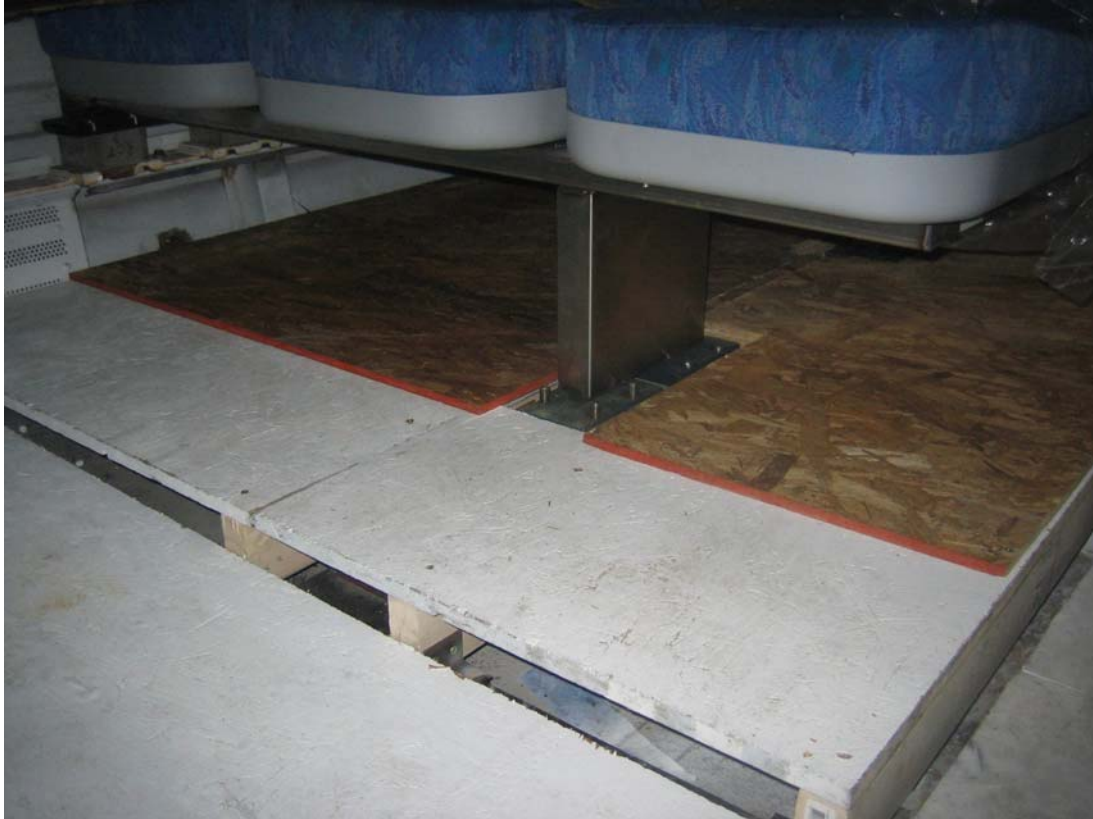
**Figure 8. Plywood Floor Installed around the Seat Installation Raising the Floor to the Level Where the Pedestal Base is Installed in Experiment 1.1**

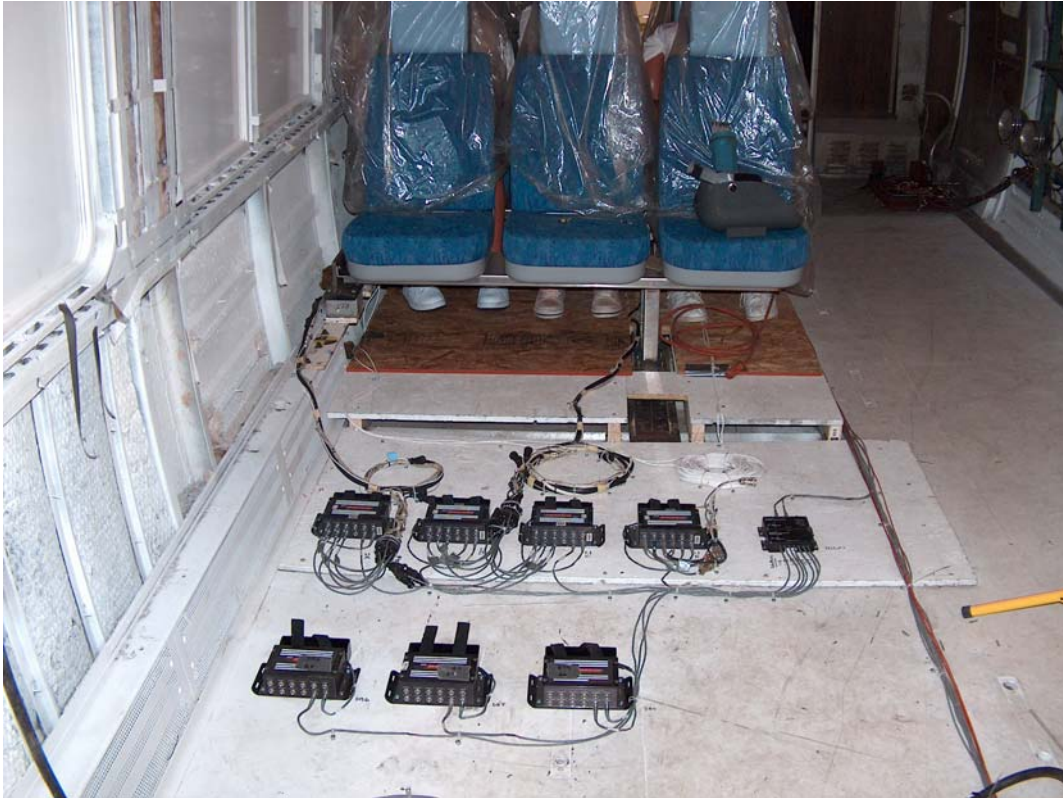
**Figure 9. Four Data Bricks Installed behind the Aft-Facing Seating Experiment to Collect 29 Channels of Data in Experiment 1.1**

Four data bricks were installed to collect 29 channels of data from five accelerometers (head, chest, and floor) and six load cells (neck, floor, and wall attachments). Table 4 lists the instrumentation requirements for Experiment 1.1. Figure 9 shows a photograph of the four data bricks installed on the floor closest to and in front of the experiment.

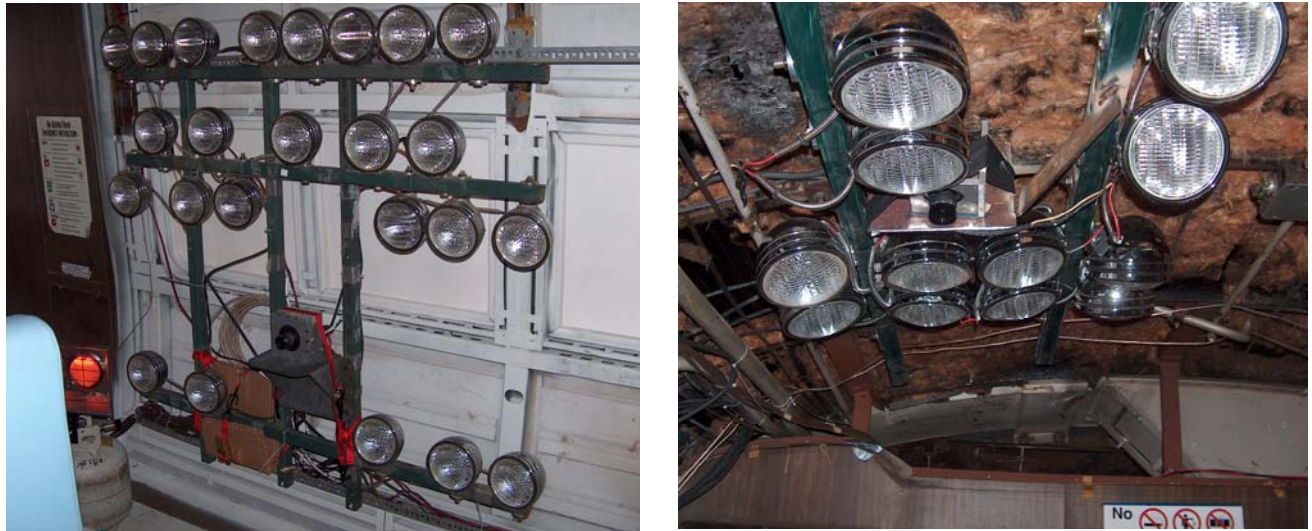
**Figure 10. Configuration of Lights and Cameras for Experiment 1.1**

experiment. The light arrays were custom-fabricated on site using a combination of unistrut and slotted-steel angle iron and were bolted and welded to hard-point structures on the walls and ceilings of the car. Figure 10 shows how the lights and cameras were configured for Experiment 1.1.

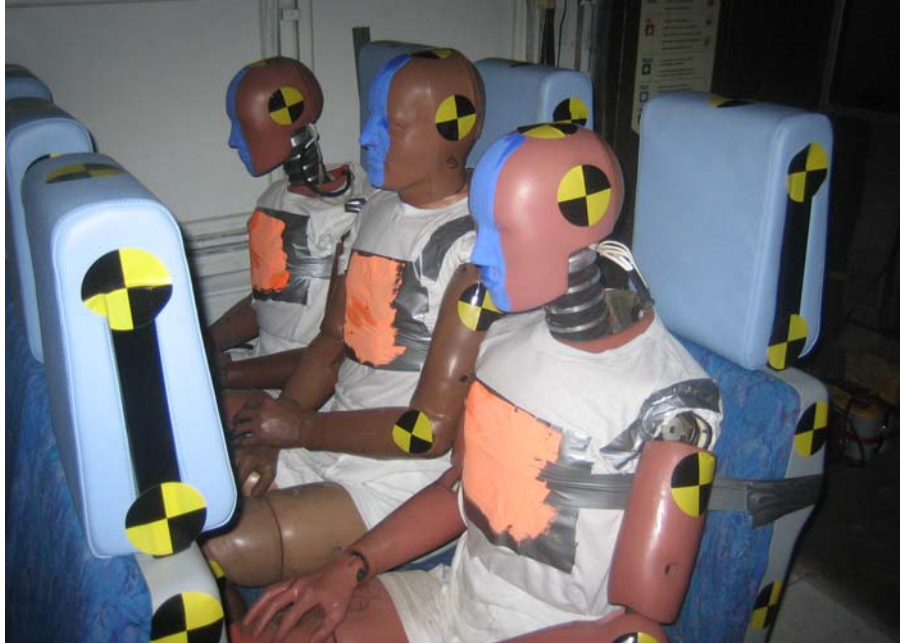
**Figure 11. Reference Targets Placed on Each ATD at the Head, Shoulder, Elbow, and Knee Locations, and on the Seats along the Edge of the Headrest and Seat Back**

Three ATDs were seated facing aft in the forward-most (relative to the cab end) commuter seat. Instrumented Hybrid III ATDs were placed in the aisle and window seats, and an uninstrumented Hybrid II ATD was placed in the middle seat. The instrumentation in the ATDs included a triaxial head accelerometer, a triaxial chest accelerometer, and a six-axis load cell in the neck that recorded  $F_x$ ,  $F_z$ , and  $M_y$ . The ATDs were seated with their feet flat on the floor and their arms on top of their legs. They were each marked with blue, orange, and red chalk on their faces, chest, and knees, respectively. Reference targets were placed on each ATD at their head, shoulder, elbow, and knee, and on the seats along the edge of the headrest and seat back, as shown in Figure 11. Appendix C illustrates the relative dimensions that were measured between the targets for Experiment 1.1 before the test.

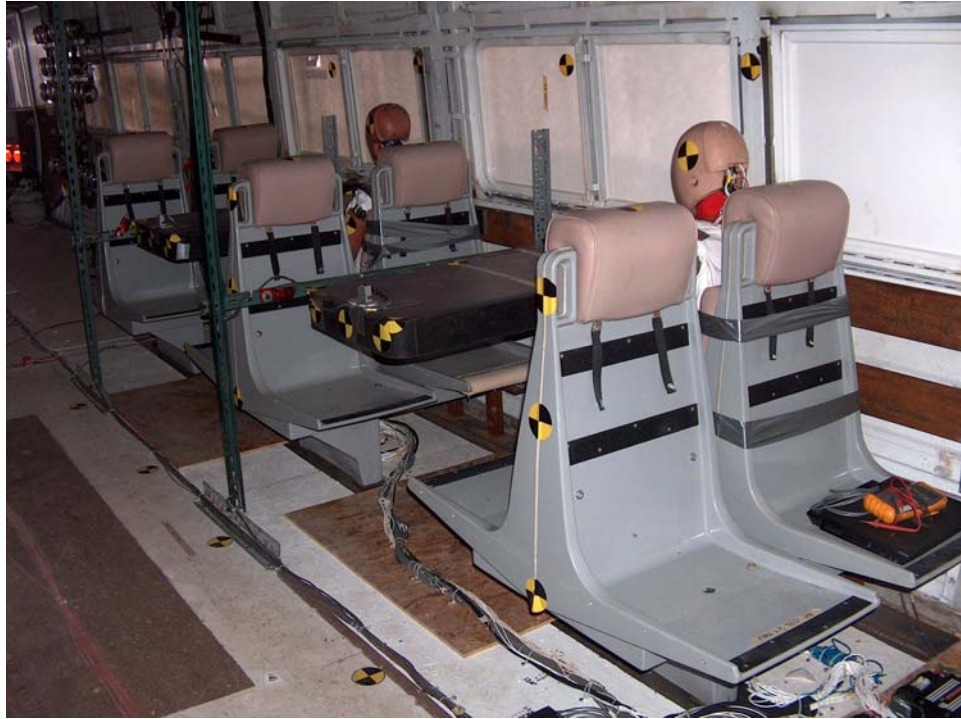
**Figure 13. Overall View of Experiment 1.2 (background) and Experiment 1.3 (foreground)**

The two experiments were located in the rear right-hand-side of the leading cab car. The launch seat of Experiment 1.2 was adjoined to the rear-facing seat of Experiment 1.3 behind it. The seat pitch was set to 65 in, with the workstation table centered between the facing seats. An ATD was positioned in the forward-facing window seat of each experiment in accordance with SAE AS8049. The seats did not incorporate occupant restraint belts. Figure 12 shows a schematic that illustrates the positioning of the workstation tables in the cab car. Figure 13 shows an overall view of both experiments. Figures 14 and 15 are pretest photographs.

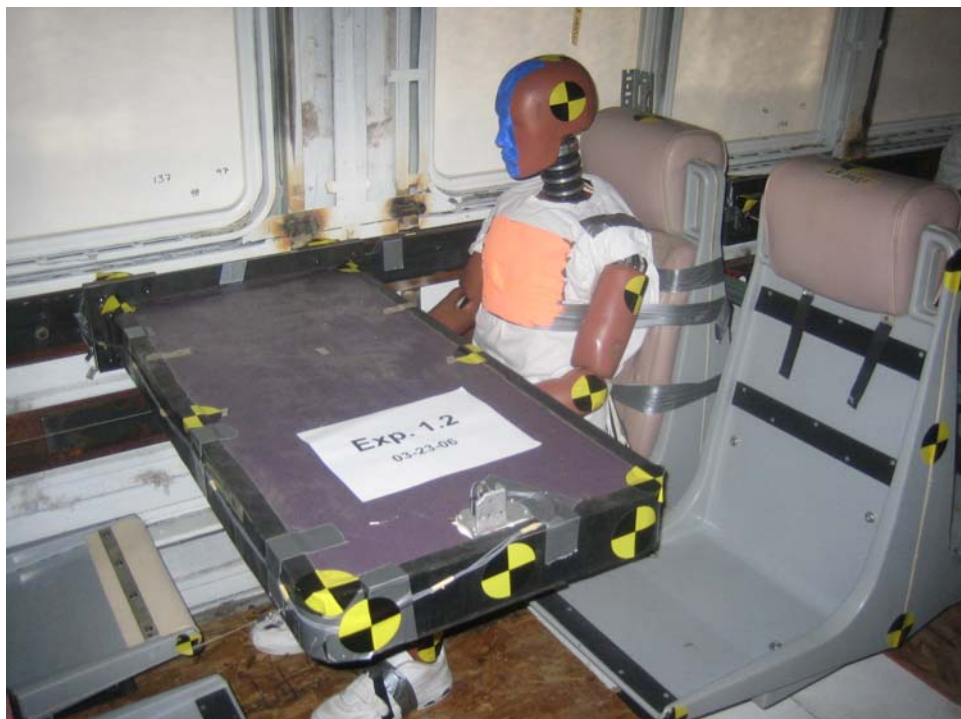
**Figure 14. Pretest Photograph of Experiment 1.2**

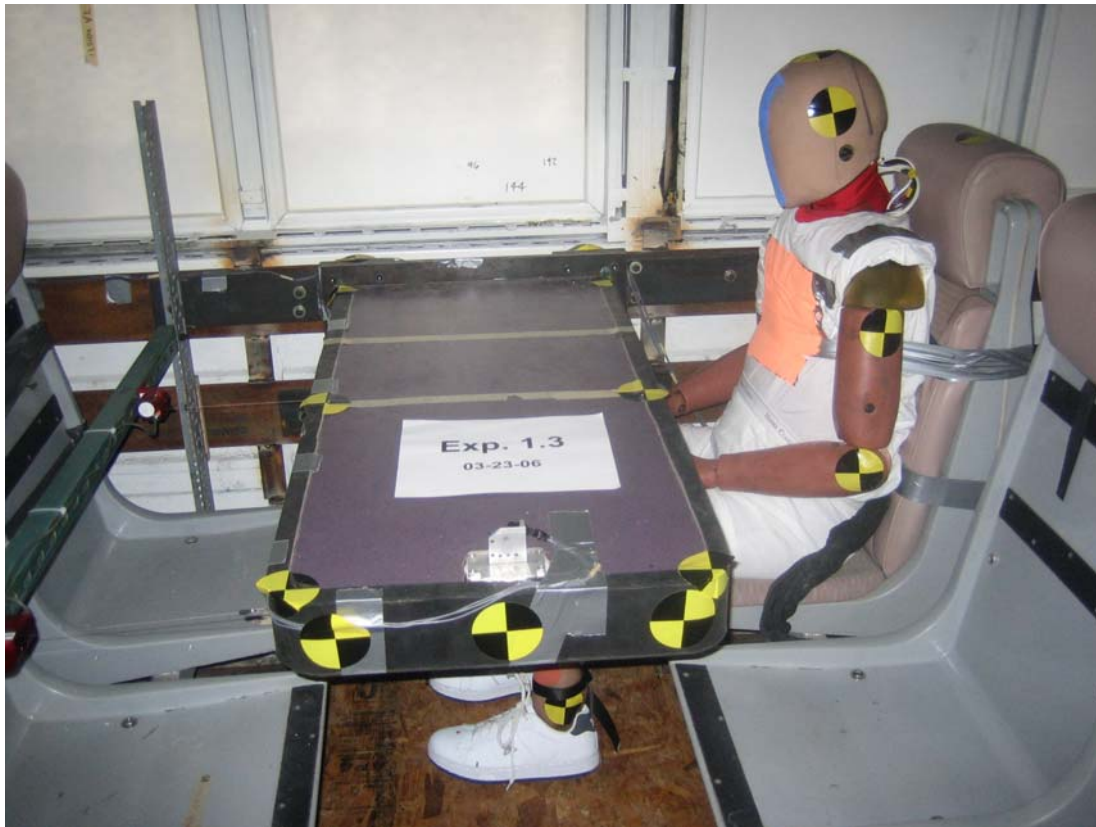
**Figure 15. Pretest Photograph of Experiment 1.3**

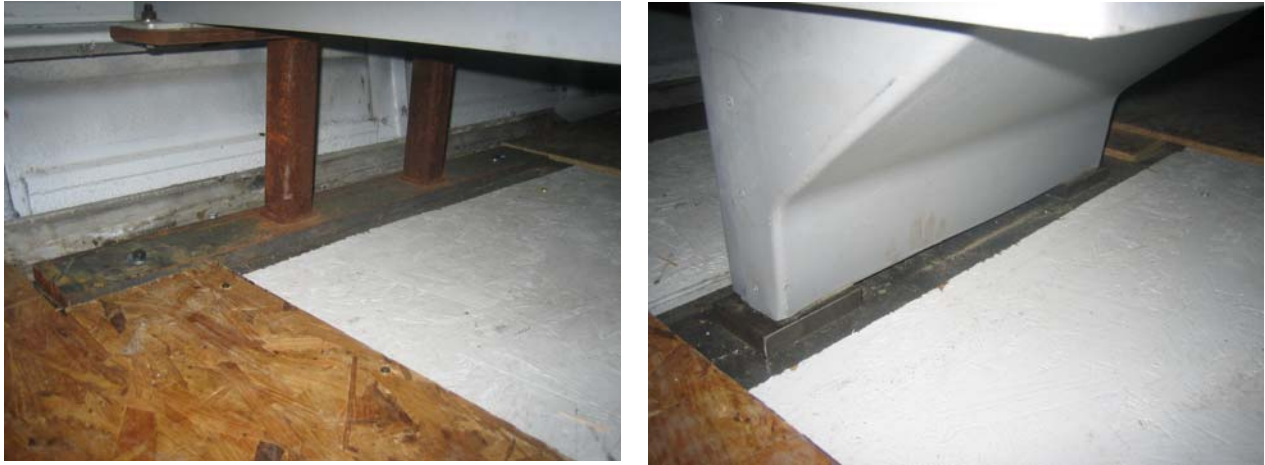
**Figure 16. Window-Side Facing Seat Installation (left), and Aisle-Side Installation (right) for Experiments 1.2 and 1.3**

*Seat Attachment to Floor:* In Experiments 1.2 and 1.3, the seats were attached only to the floor of the car. Two parallel steel bars, each measuring 15.5-foot long x 6-inches wide x 0.375-inch thick, were welded to the stringers in the floor of the car—one along the window side and one along the aisle side. These parallel bars were long enough to support the installation of three sets of back-to-back seats, as required for the two facing-seat experiments. In lieu of installing the seats directly to the wall of the rail car, three wall-side mounts were fabricated so the seats could be installed in a position that was aligned with the workstation tables, which were installed offset from the wall due to the load cells. The base of each wall-side mount was 36 x 4 x 0.75 in and the top of each mount was 27.5 x 2 x 0.75 in. The bases of these wall-side mounts were bolted to the welded bar. The metal tabs protruding from the bases of the seat pans were bolted to the tops of the wall mounts. On the aisle side, the bases of the pedestals were bolted to two smaller 2 x 3 x 0.75-inch plates that were bolted to the welded bar along the aisle. Figure 16 shows a photograph of the floor attachments.

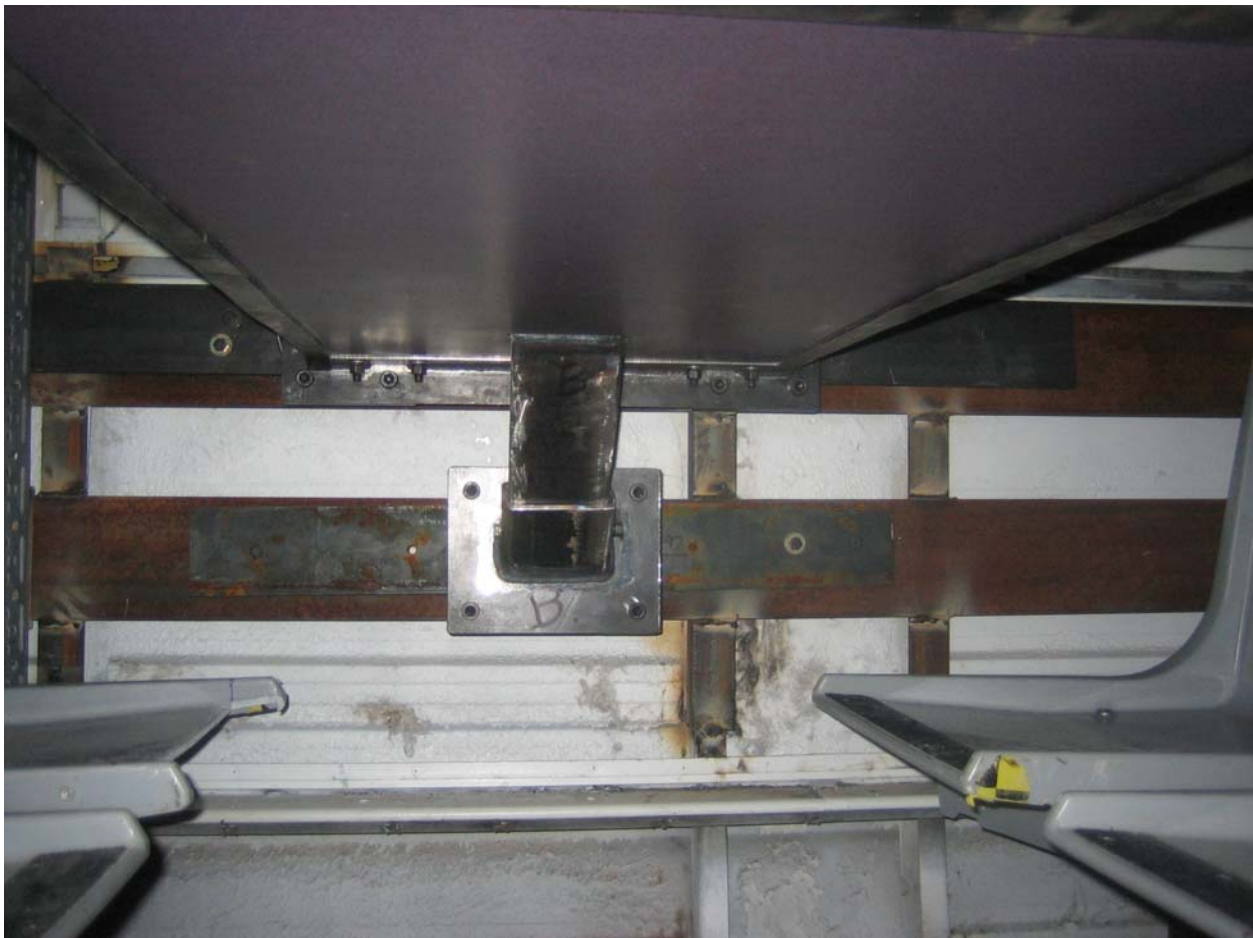
**Figure 17. Two 20-Foot Bars were Welded Four Inches Apart on Top of Vertical Bars**

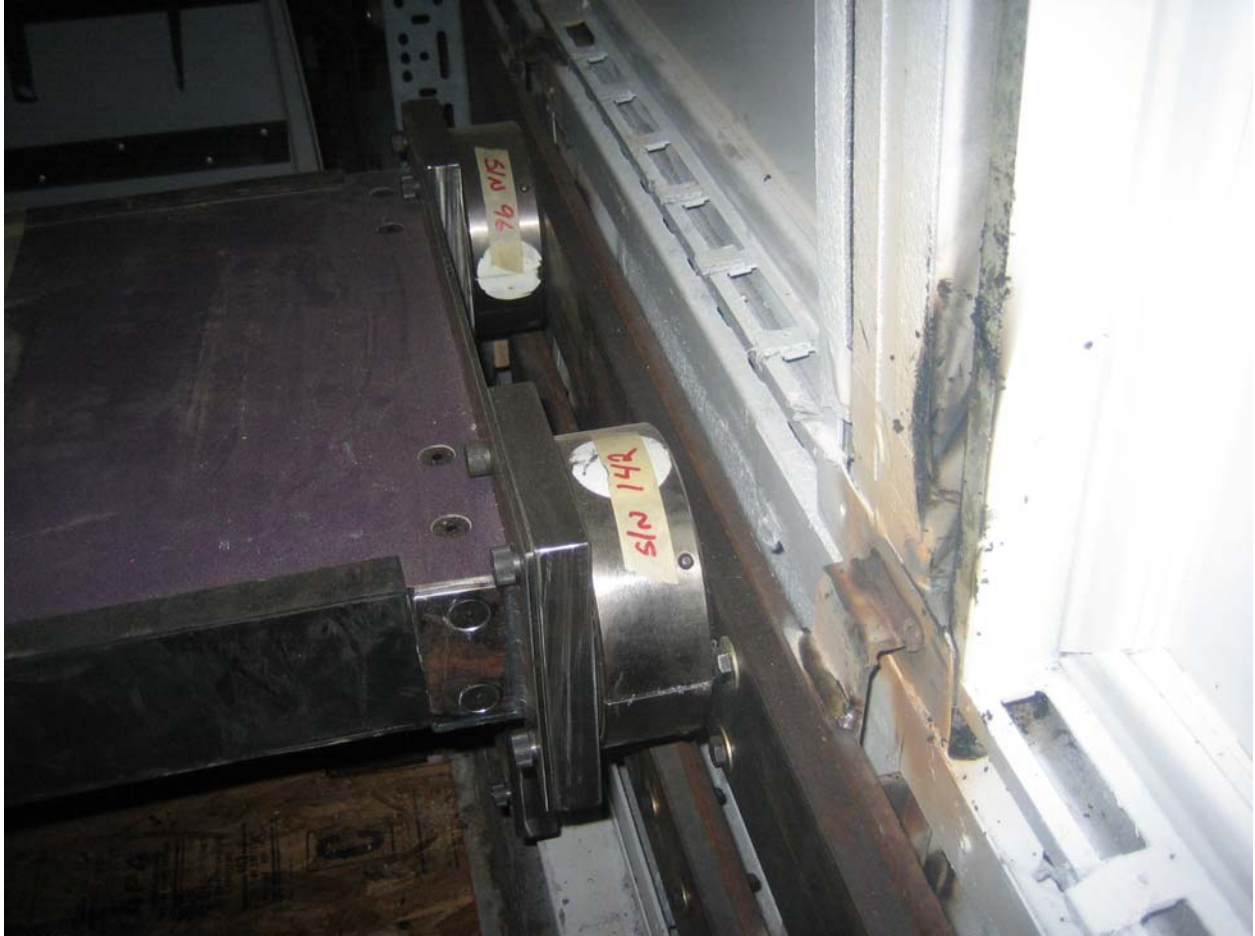
**Figure 18. Table Bolted to Three Individual Attachment Plates which were Bolted to the Load Cells**

Each table attachment included an upper attachment plate measuring 50 x 4 x 0.5 in bolted to the upper welded bar and a lower attachment plate measuring 32 x 3.75 x 0.5 in bolted to the lower welded bar. Before installation, the upper attachment plate was predrilled with two load cells bolted to it, and the lower attachment plate was predrilled with one load cell bolted to it. Together, the load cells formed a triangle that matched the bolt pattern of the cantilevered/table wall attachments. The table was then bolted to three individual attachment plates, each measuring 7 x 7 x 1 in, which were bolted to the load cells, as shown in Figure 18.

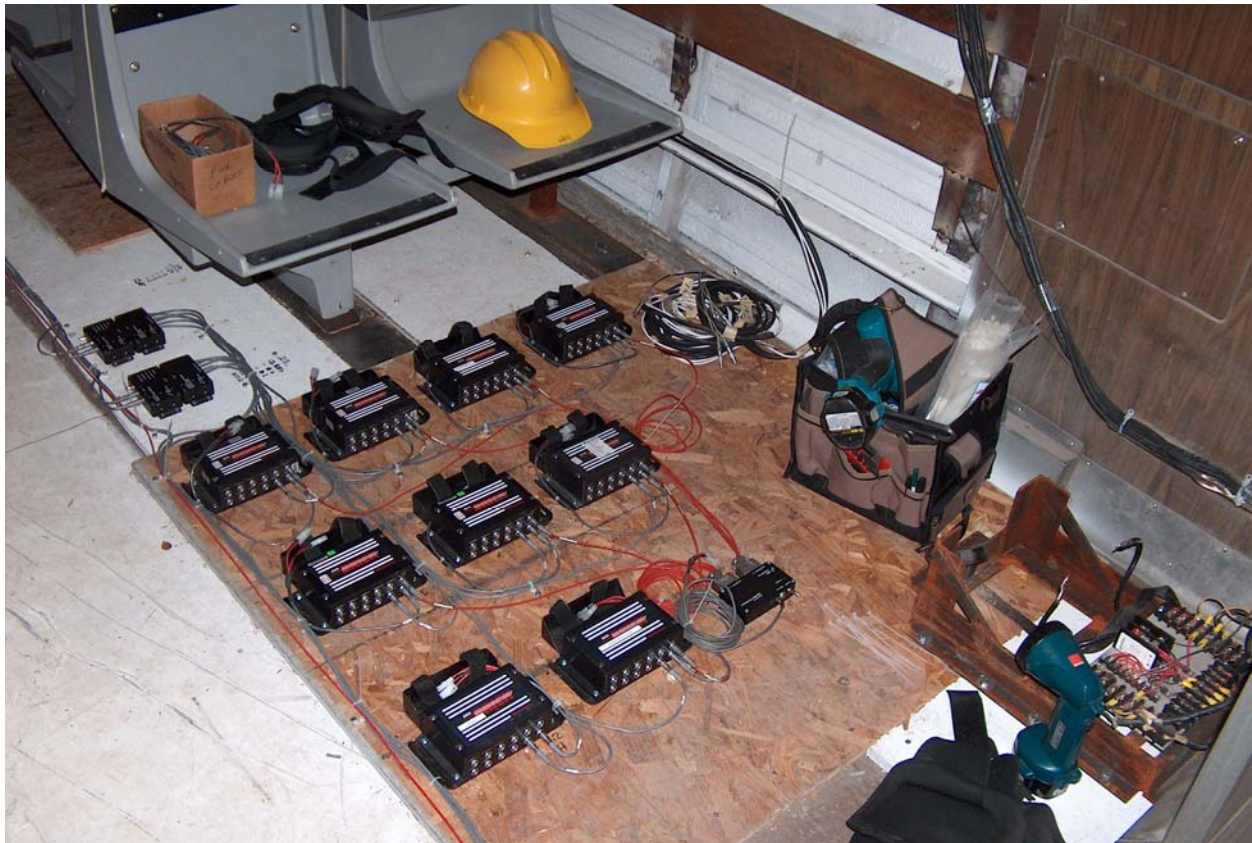
**Figure 19. Nine Data Bricks Installed to Collect Data from 70 Channels Linked to Experiments 1.2 and 1.3**

Nine data bricks were installed to collect 70 channels of data from a combined total of eight accelerometers (head, chest, upper abdomen in Experiment 1.3, floor, and table tops), 14 load cells (neck, femur, and table attachments to the wall), and 10 potentiometers (lower abdominal CRUX, upper abdomen in Experiment 1.3, occipital condyle in Experiment 1.3, and tables). Figure 19 shows a photograph of the data bricks installed on the floor behind the two experiments. Tables 6 and 7 list the instrumentation requirements for Experiments 1.2 and 1.3, respectively.

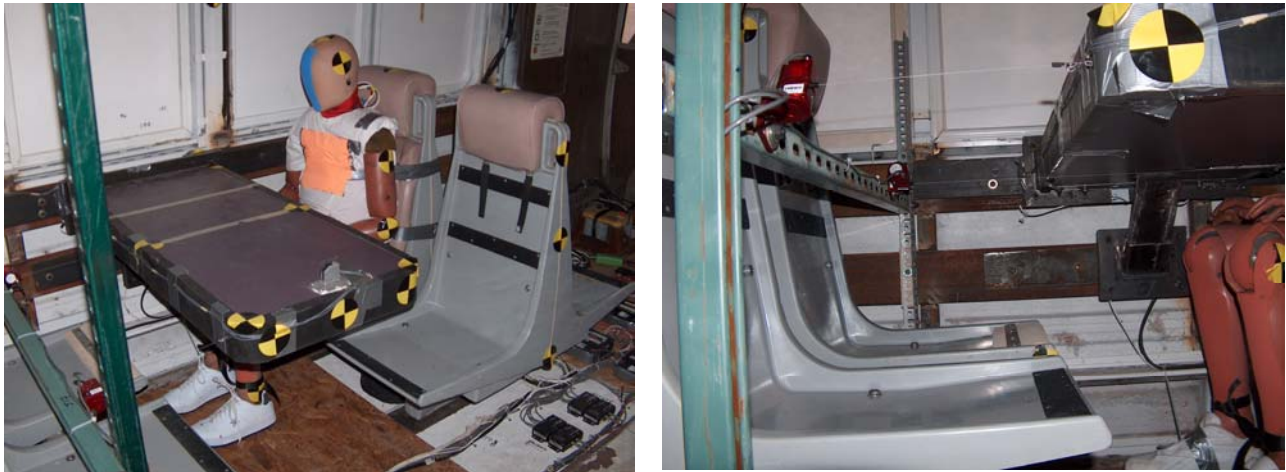
**Figure 20. Table Acceleration was Measured with an Accelerometer, and Table Crush and Displacement were Measured with Two Potentiometers**

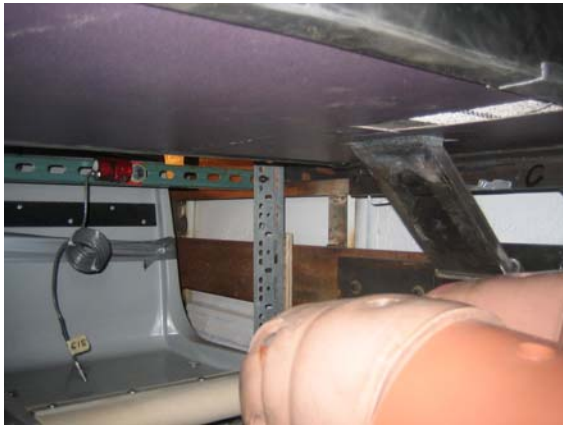
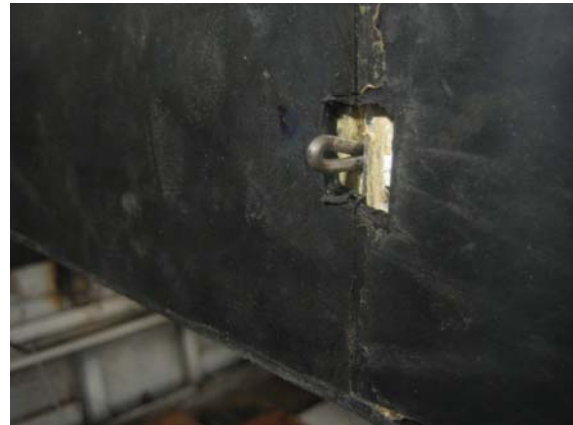
**Figure 21. Potentiometer Cord for Table Crush, Stretched under Table to a Hook Bonded into the Honeycomb Where a Melamine Strip was Removed (left). Cord for Table Displacement, Stretched from the Unistrut to a Hook Bonded into the Facing Edge of the Table (right) in Experiments 1.2 and 1.3**

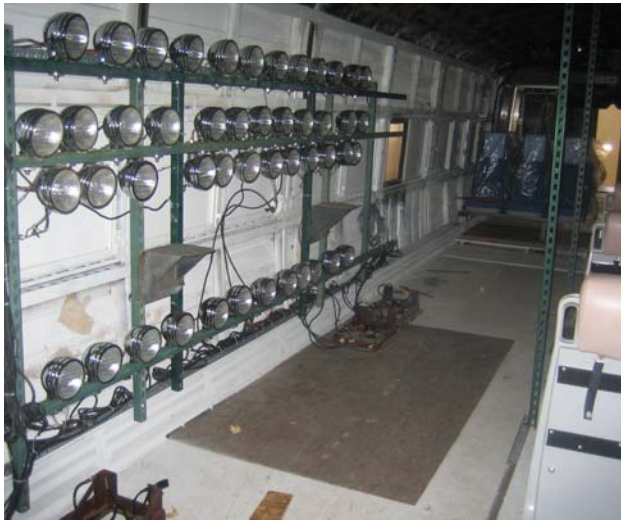
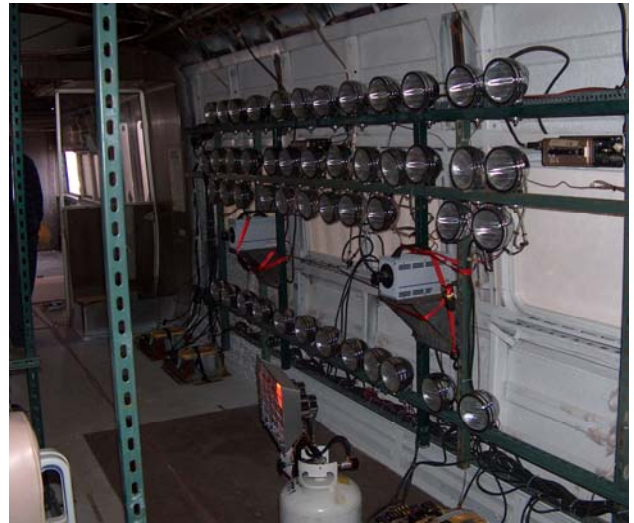
**Figure 22. Forty-Eight Flood Lights were Installed along the Wall (left), with Two RS Cameras (right) Covering Both Experiments 1.2 and 1.3**

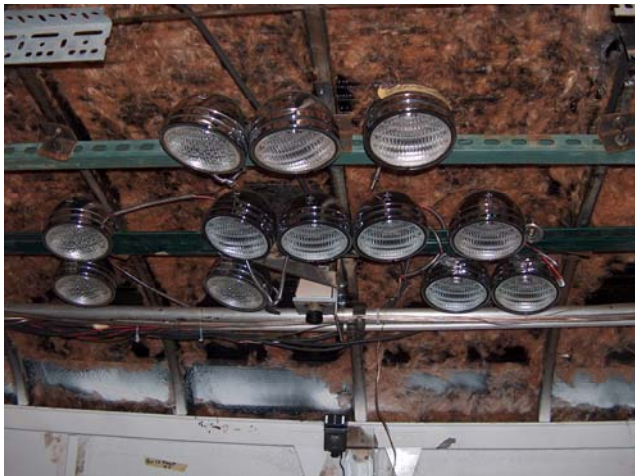
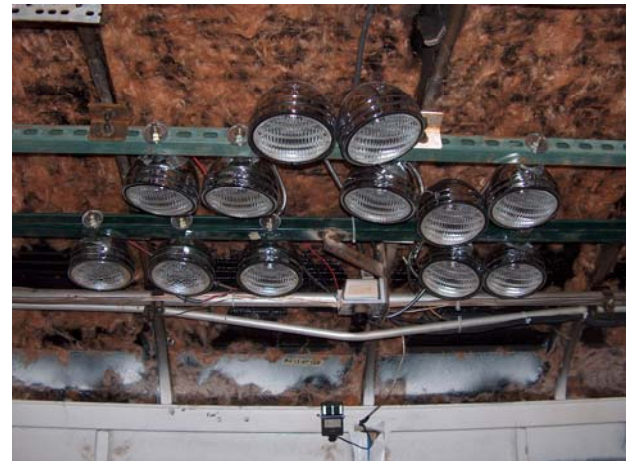
**Figure 23. Twelve Flood Lights and One U512 Camera, were Installed above for Experiment 1.2 (left) and Experiment 1.3 (right)**

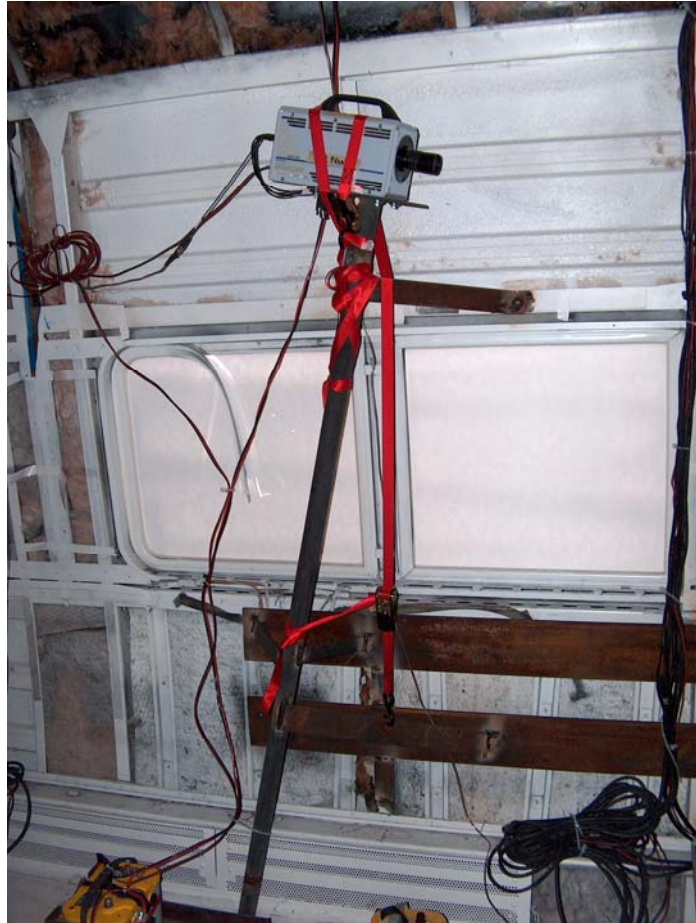
**Figure 24. One RS Front View Camera was Installed to Capture the Combined Front View of Experiments 1.2 and 1.3**

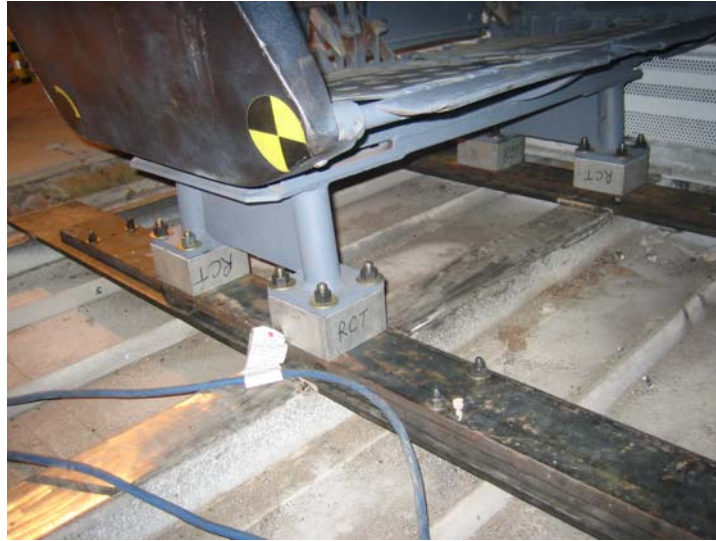
**Figure 28. Launch-Seat Installation for Experiment 2.1**

*Seat Attachment to Floor:* Two steel bars measuring 98 x 6 x 0.375 in were welded to the stringers in the floor of the car, each spanning two 4.25-inch-wide hat sections and two 1.5-inch-wide right-angle sections. An 84 x 4 x 0.75-inch attachment plate was bolted onto each welded bar with four pairs of bolts along its length. Four spacer blocks were bolted onto each attachment plate where they had been predrilled with inset holes to fit the attachment points on the spacer blocks. In previous tests, load cells were installed to raise the level of the seats. To maintain consistency with previous tests and with the other tests on board this consist, spacer blocks were installed to keep the floor level as shown in Figures 28 and 29. When installed, the spacing between the seats was 41 in. A plywood floor was built around the seats and attachment points so that the ATD feet would be at the correct height as shown in Figure 30.

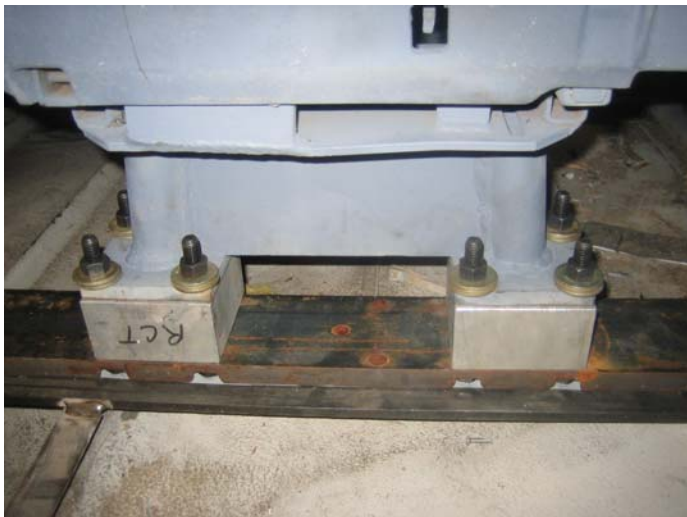
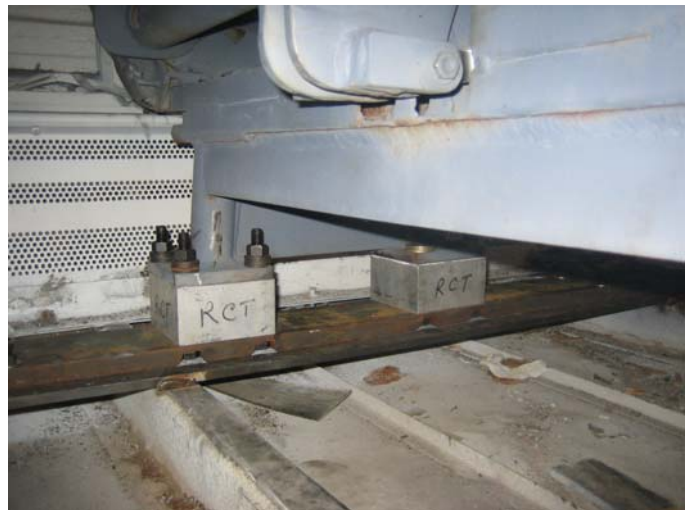
**Figure 29. Impact-Seat Installation for Experiment 2.1 Aisle Side (left) and Window Side (right)**

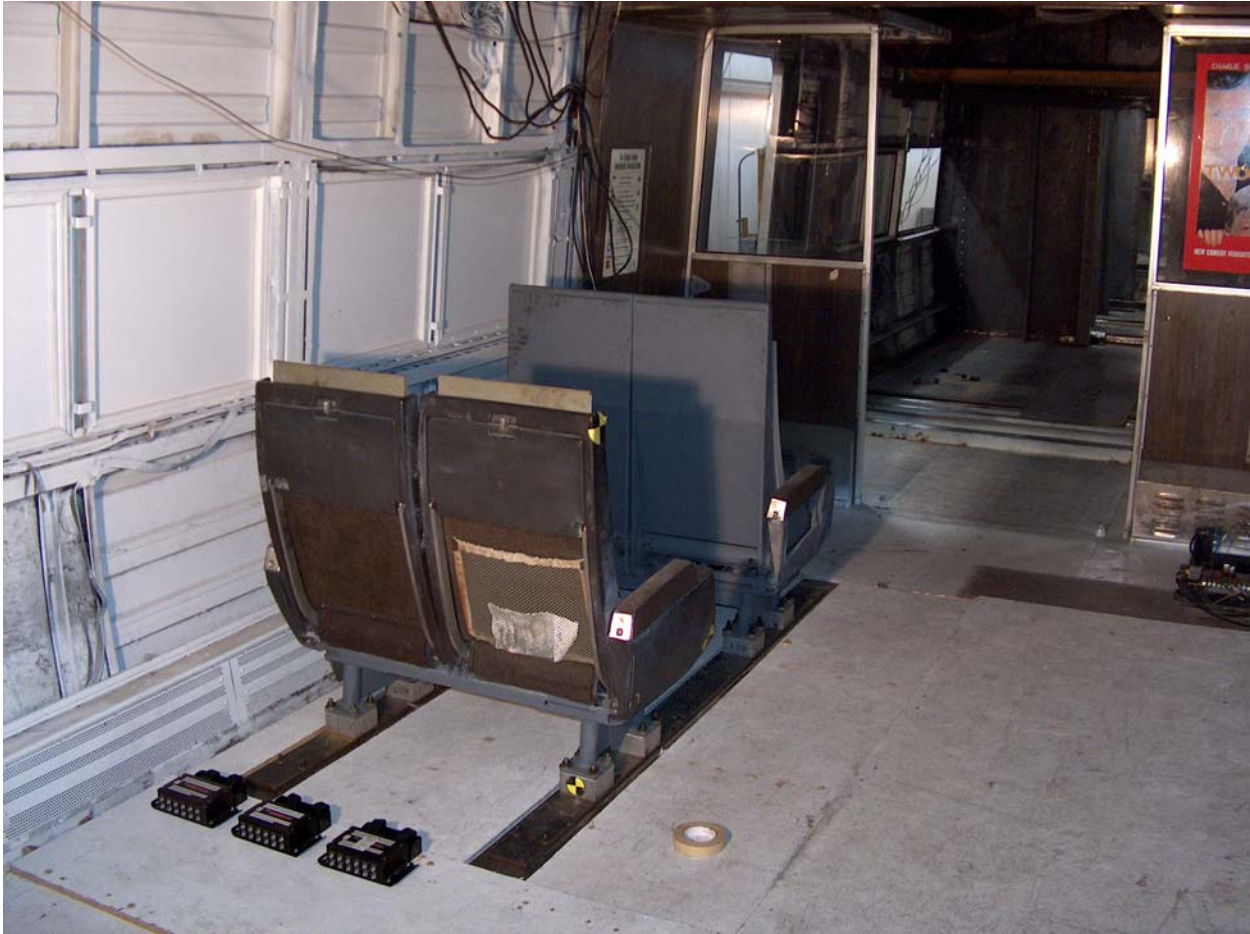
**Figure 30. Plywood Floor Installed around Experiment 2.1**

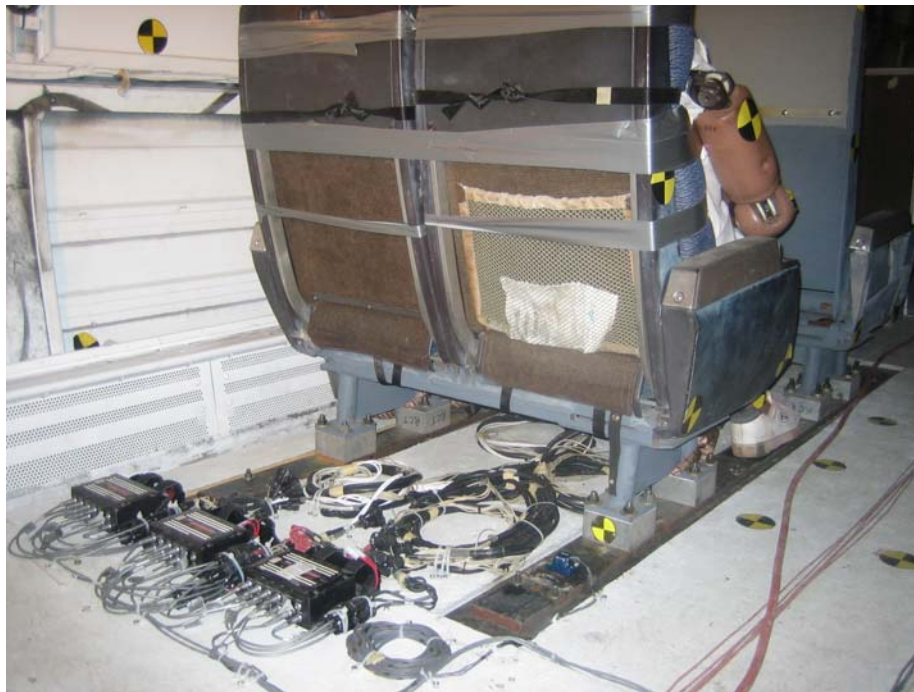
**Figure 31. Three Data Bricks and One Accelerometer, Installed behind Experiment 2.1**
