## **Occupant Protection Experiments in Support of A Full-Scale Train-to-Train Crash Energy Management Equipment Collision Test**

| 1. AGENCY USE ONLY (Leave blank) | | 2. REPORT DATE<br>July 2009 | | 3. REPORT TYPE AND DATES COVERED |
| 7. PERFORMING ORGANIZATION NAME(S) AND ADDRESS(ES)<br>Armor Holdings Aerospace & Defense Group<br>10016 S. 51st St.<br>Phoenix, AZ 85044 | | | | 8. PERFORMING ORGANIZATION<br>REPORT NUMBER<br><br>DOT-VNTSC-FRA-09-06 |
| 9. SPONSORING/MONITORING AGENCY NAME(S) AND ADDRESS(ES)<br>U.S. Department of Transportation<br>Federal Railroad Administration<br>Office of Research and Development<br>Washington, DC 20590 | | | | 10. SPONSORING/MONITORING<br>AGENCY REPORT NUMBER<br><br>DOT/FRA/ORD-09/14 |

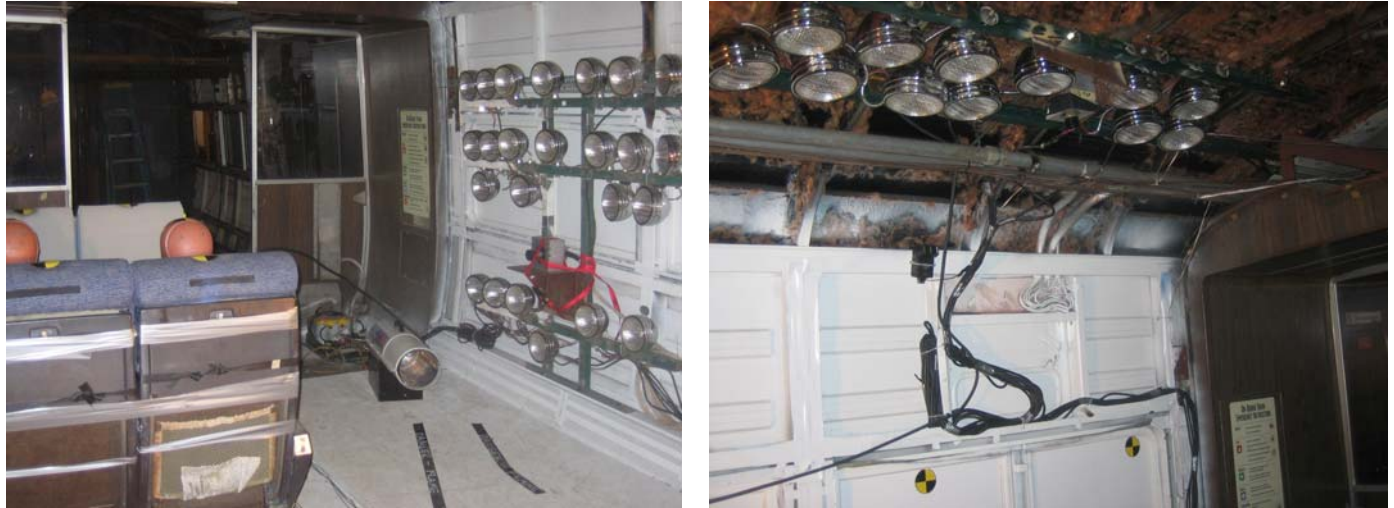
**Figure 32. One APX Camera and 24 Flood Lights were Installed along the Wall (left) and One U512 Camera and 12 Lights were Installed along the Ceiling (right) in Experiment 2.1**

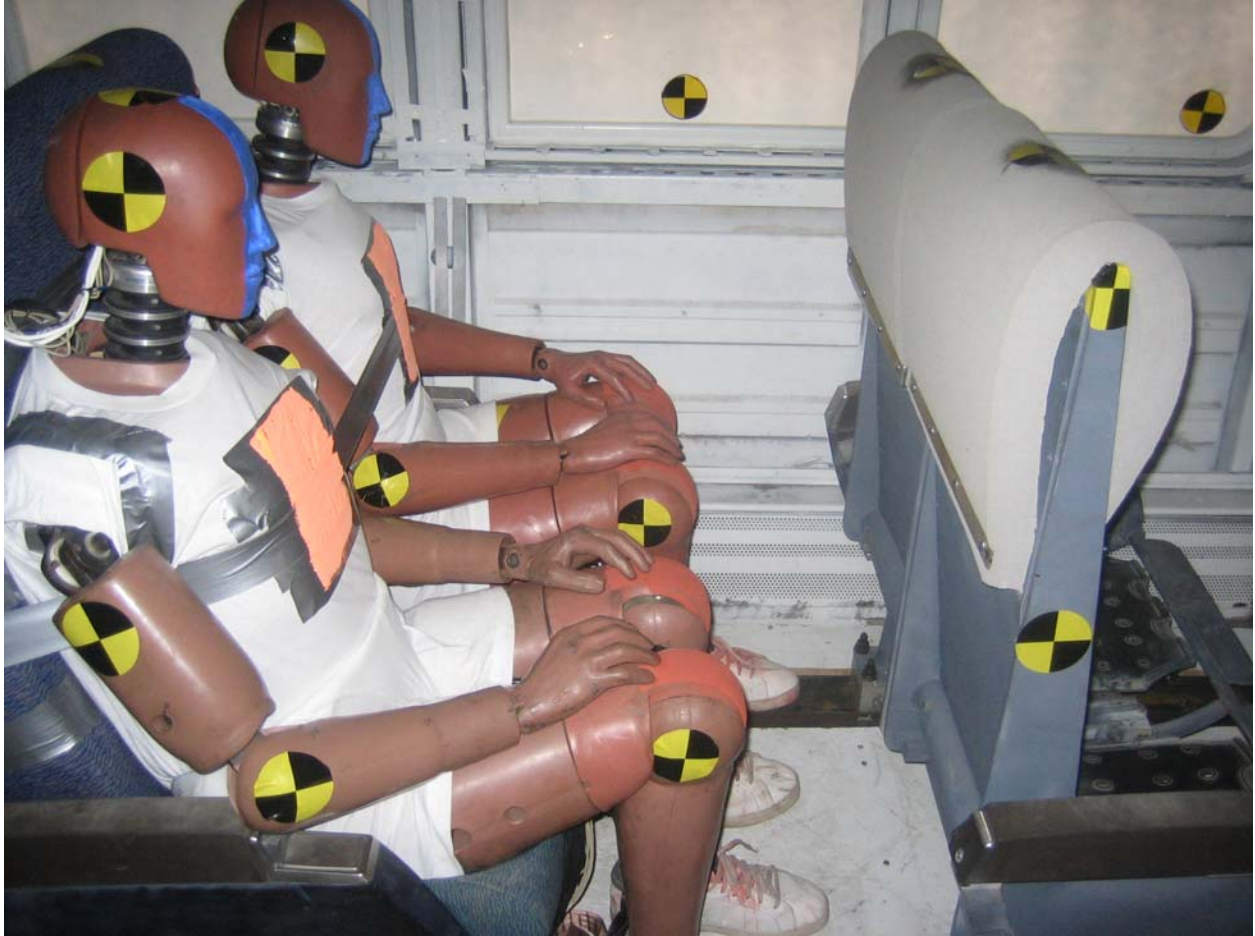
**Figure 33. Two Instrumented Hybrid III 95th Percentile ATDs Occupied the Two-Place Passenger Intercity Seat in Experiment 2.1**

Two instrumented Hybrid III 95th percentile ATDs occupied the aft row of this experiment. The instrumentation in the ATDs included a triaxial head accelerometer, a triaxial chest accelerometer, a uniaxial load cell in each femur, and a six-axis load cell in the neck that recorded  $F_x$ ,  $F_z$ , and  $M_y$ . The ATDs were seated with their feet flat on the floor and their arms on their legs. They were each marked with blue, orange, and red chalk on their faces, chest, and knees, respectively. Reference targets were placed on each ATD at their head, shoulder, elbow, and knee and on the seats along the edge of the headrest and seat back. Figure 33 shows a photograph of the experiment. Appendix C illustrates the relative dimensions between the targets that were measured before the test for Experiment 2.1.

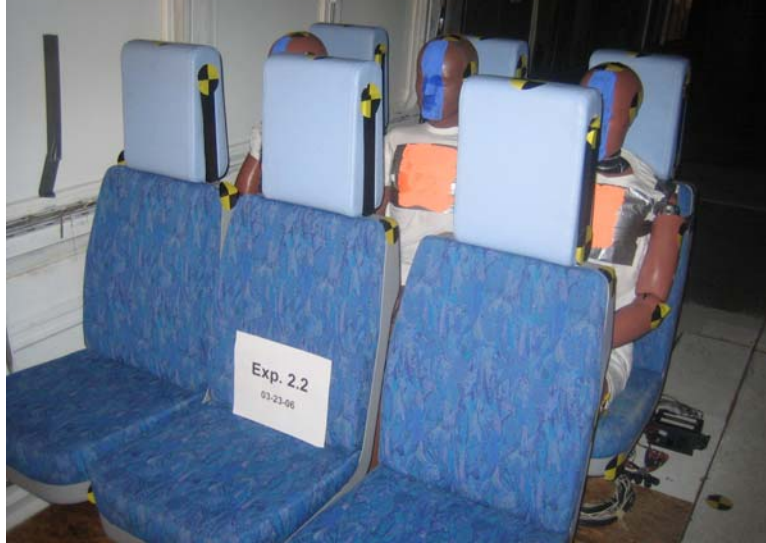
**Figure 35. Pretest Photograph of Experiment 2.2**

This interior configuration consisted of two forward-facing, newly designed, three-passenger commuter-seats located in the aft right-hand-side of the first coach car (second car in the consist). The seats tested in this experiment were identical to the seats tested in the rear-facing commuter seat experiment, Experiment 1.1. In this experiment, however, the seats faced forward. The seat pitch was set to 32 in, the same as that for the rear-facing commuter seat experiment. Seat-mounting hardware was consistent with in-service hardware. Three ATDs were used in this experiment. Instrumented Hybrid III 50th percentile ATDs were seated in the aisle and window positions, and an uninstrumented Hybrid II 50th percentile ATD was seated in the middle position. These ATDs were seated in the aft seat of the two seat rows, and the seat in front remained unoccupied. Figure 34 illustrates the positioning of the experiment in the first coach car. Figure 35 shows a pretest photograph of the experiment.

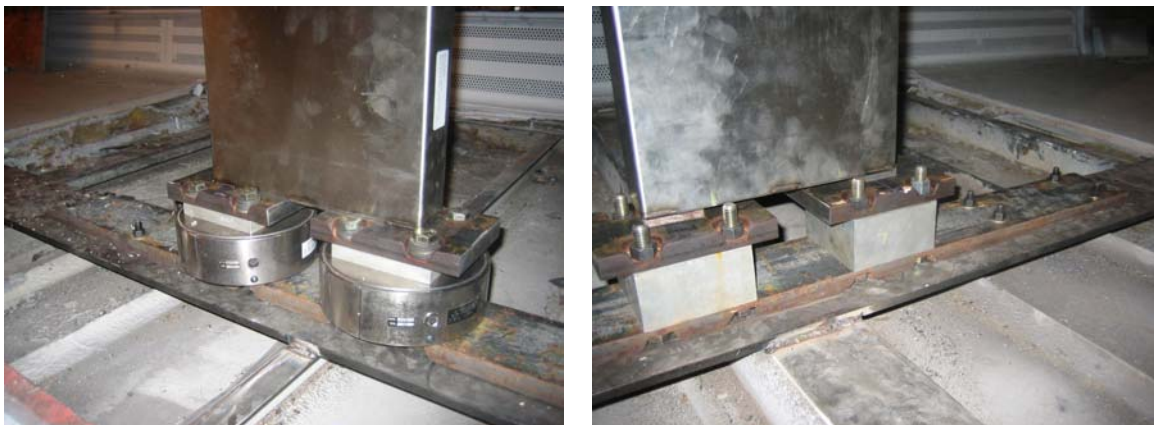
**Figure 36. Floor Attachment Load Cells for the Impact Seat (left) and Spacer Blocks for the Launch Seat (right) in Experiment 2.2**

*Seat Attachment to Floor:* A steel plate measuring 96 x 6 x 0.375 in was welded to the stringers in the floor of the car, spanning two 4.25-inch-wide hat sections and two 1.5-inch-wide right-angle sections. A 70.75 x 4 x 0.75-inch attachment plate was bolted onto the welded plate with four pairs of bolts spaced along its length. For the unoccupied front-row seat, two load cells were bolted onto the attachment plate. For the occupied aft-row seat, two spacer blocks were bolted onto the attachment plate. The spacer blocks were used to keep the aft-row seat the same height as the front-row seat. The bolt holes in the attachment plate were predrilled so that the spacing between the seats was 32 in when installed. Two rows of seats were then bolted at the bases of their pedestals to the top surfaces of the load cells and the spacer blocks through smaller attachment plates. Figure 36 shows a photograph of the load cells and the spacer blocks.

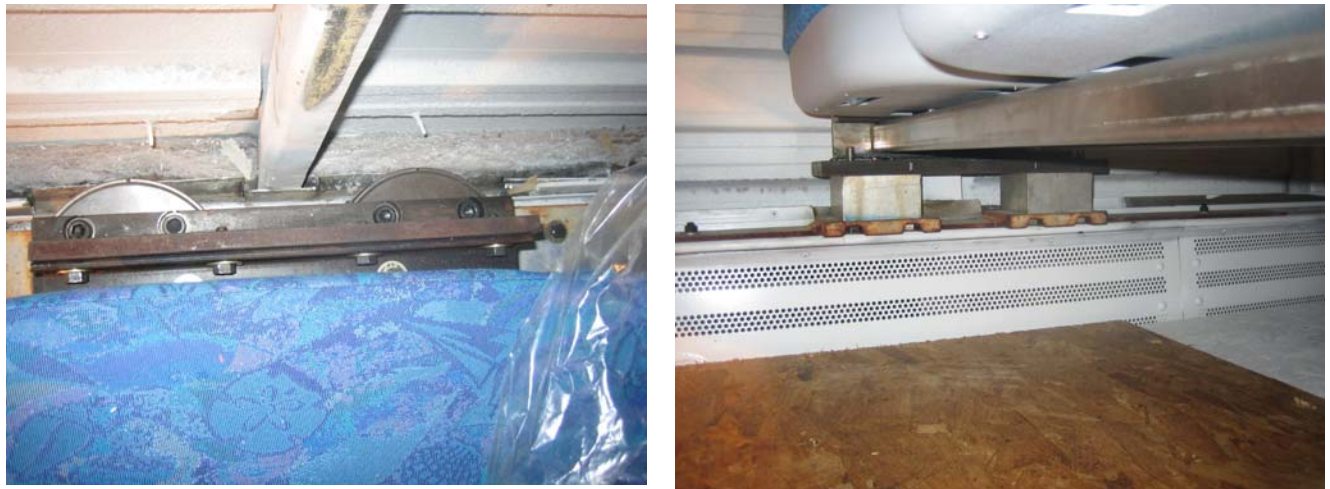
**Figure 37. Top View of the Wall-Attachment Load Cells on the Unoccupied Impact Seat (left), and Underside View of Spacer Blocks on the Launch Seat (right) in Experiment 2.2**

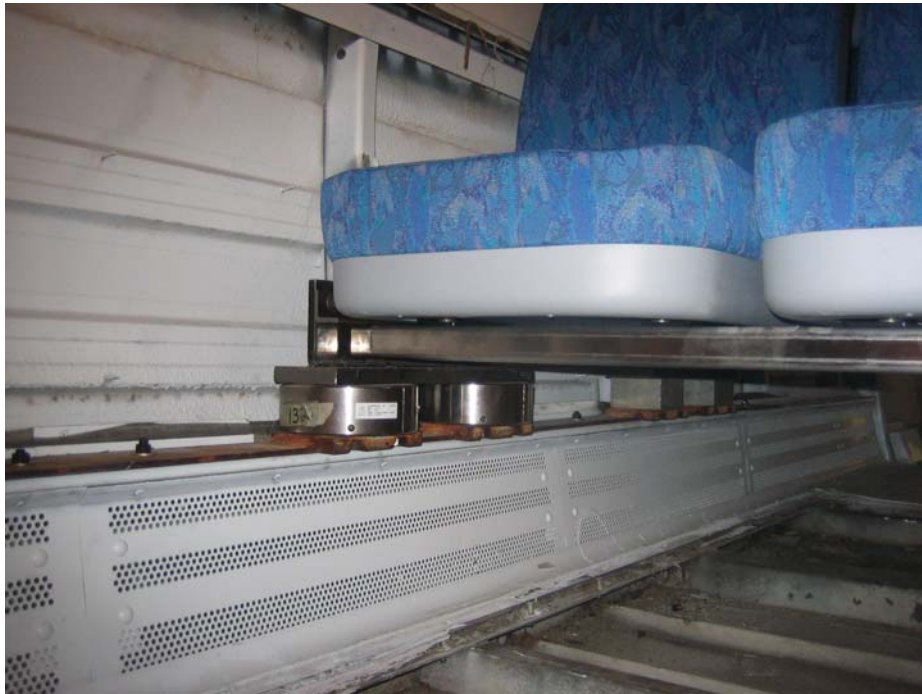
**Figure 38. Rugged Angle Iron was Bolted to the Vertical Piece of the T-Shaped Load-Cell Attachment Plate, Then Bolted to the C-Channel That Formed the Base of the Seat Assembly**

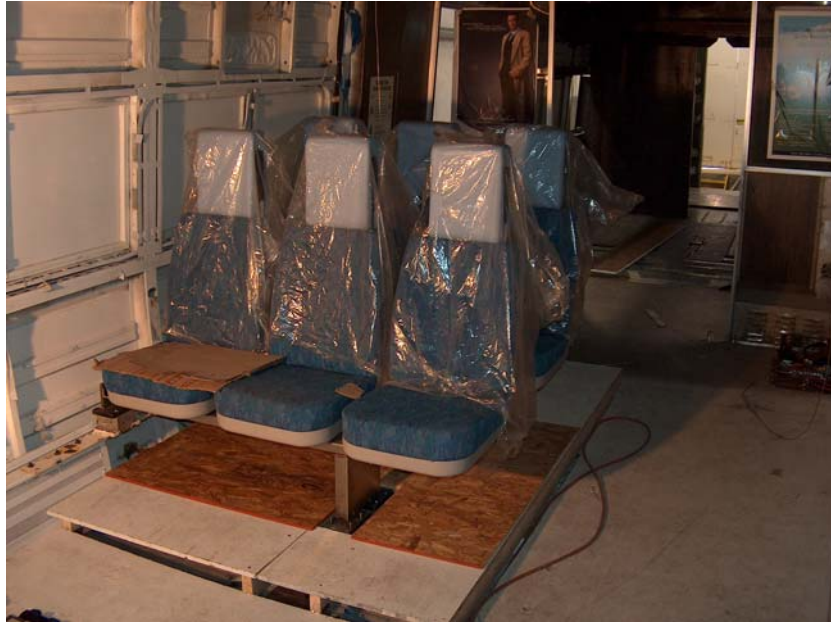
**Figure 39. Plywood Floor Built around the Seat Installation Raising the Floor to the Level Where the Pedestal Base was Installed in Experiment 2.2**

The launch seat with the three occupants was equipped with spacer blocks. The impact seat in front of the launch seat was unoccupied and was equipped with load cells. The spacer blocks were installed so that the two rows of seats were at an equal height above the floor. A plywood floor was built around the seats and attachment points so that the ATD feet would be at the correct height, as shown in Figure 39.

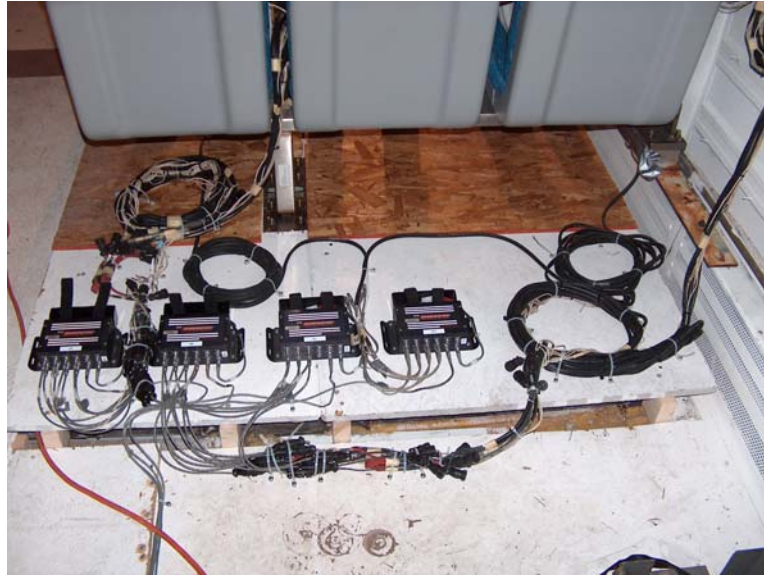
**Figure 40. Four Data Bricks Installed Behind Experiment 2.2 to Collect 32 Channels of Data**

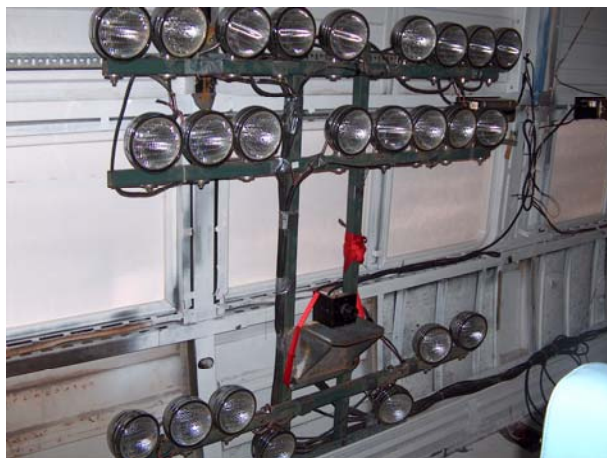
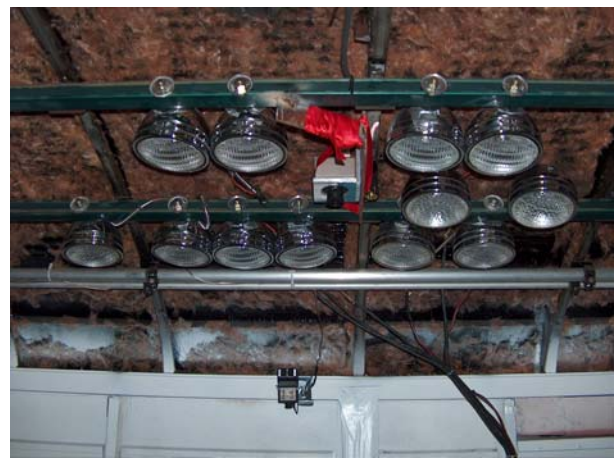
**Figure 41. One U512 Camera and 24 Flood Lights Were Installed along the Wall and One U512 Camera and 12 Lights Were Installed along the Ceiling**

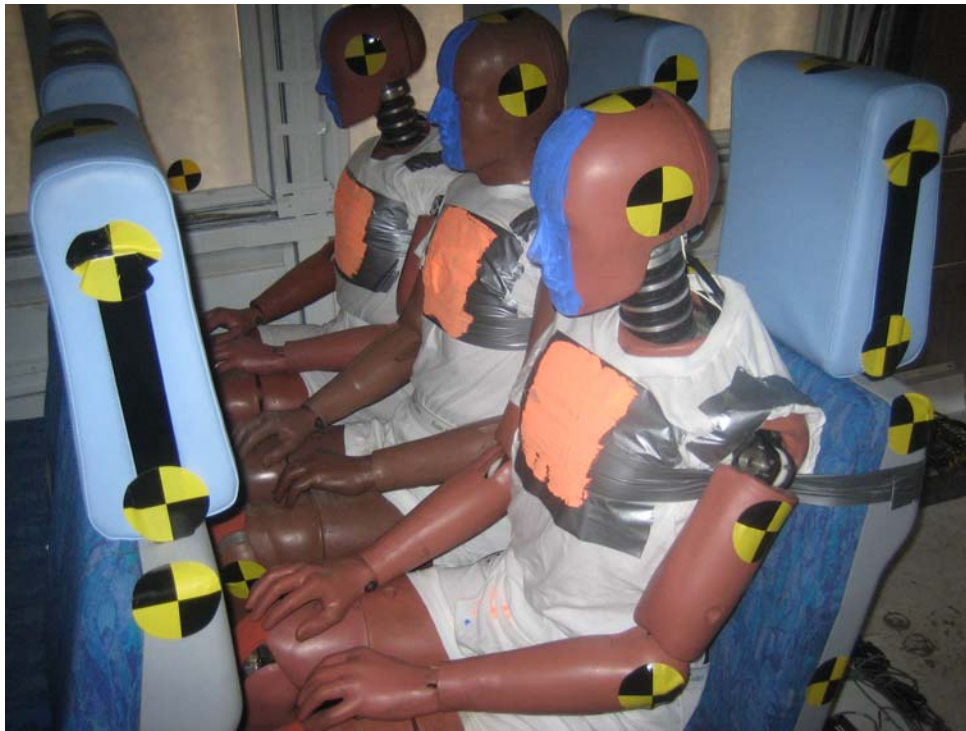
**Figure 42. Instrumented Hybrid III ATDs Occupied the Aisle and Window Seats. An Uninstrumented Hybrid II ATD Occupied the Middle Seat in Experiment 2.2**

Three ATDs were seated facing forward in the aft row of this experiment. Instrumented Hybrid III ATDs were placed in the aisle and window seats. An uninstrumented Hybrid II ATD was placed in the middle seat. The instrumentation in the ATDs included a triaxial head accelerometer, a triaxial chest accelerometer, a uniaxial load cell in each femur, and a six-axis load cell in the neck that recorded  $F_x$ ,  $F_z$ , and  $M_y$ . The ATDs were seated with their feet flat on the floor and their arms on their legs. They were each marked with blue, orange, and red chalk on their faces, chest, and knees, respectively. Reference targets were placed on each ATD at its head, shoulder, elbow, and knee and on the seats along the edge of the headrest and seat back, as shown in Figure 42. Appendix C illustrates the relative dimensions between the targets that were measured before the test for Experiment 2.2.

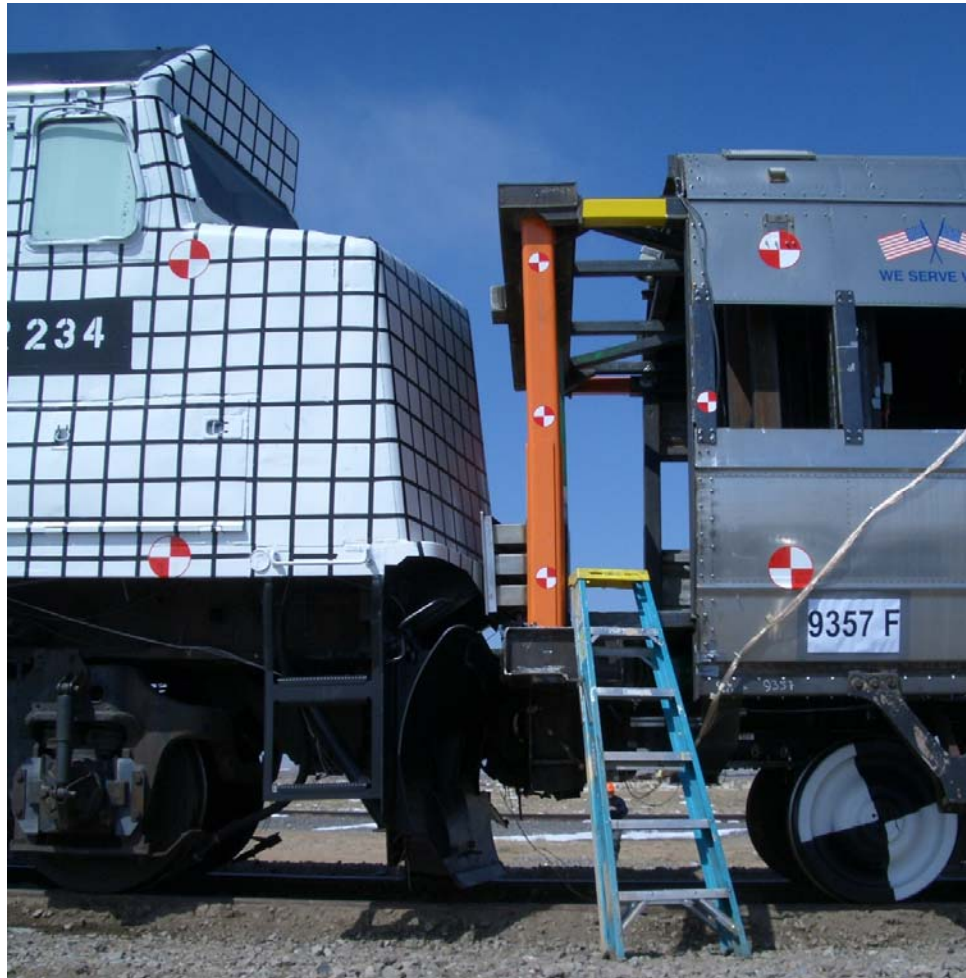
**Figure 43. Post-Test Photograph of the Impact Interface**

The five-car cab car-led passenger train impacted the stationary locomotive (coupled with two ballasted freight cars) at approximately 30.8 mph. Figure 43 shows the post-test impact interface.

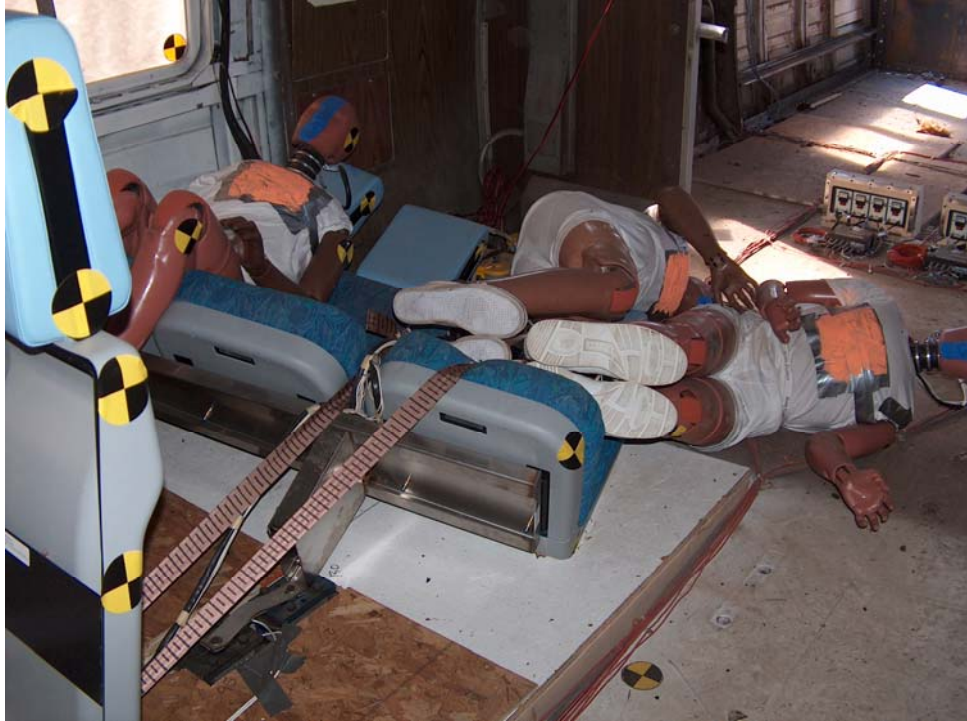
**Figure 45. Post-Test Photograph of Experiment 1.1**

This experiment consisted of two rear-facing, newly designed, three-passenger commuter seats located on the forward left-hand-side of the leading cab car. Due to a failure of the pedestal that attached the seats to the floor, which caused the seats to collapse forward as shown in Figure 45, the ATDs in this experiment were not compartmentalized.

The outcome of this experiment was a catastrophic failure of the seat-to-floor attachment and the wall, which caused the occupied seat to collapse under the inertial loading of the seats and ATDs. Specifically, the weld at the base of the pedestal failed, which caused the pedestal to separate from its base, as shown in Figure 46. Bolted attachments between the base of the seat pan and the C-channel and between the C-channel and the wall separated as shown in Figure 47. This was caused by the load that was transferred when the pedestal welds failed.

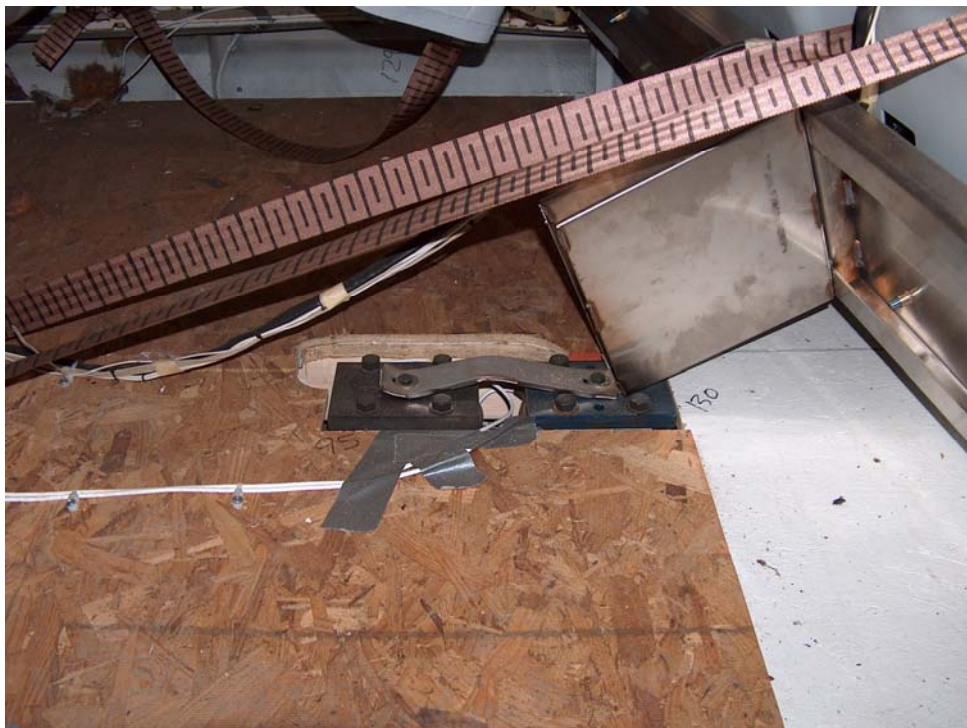
**Figure 46. Weld Failure at the Pedestal Base, which Caused the Seat to Collapse in Experiment 1.1**

The seat-attachment load data indicates that, at 0.080 s, the pedestal bottom plate peeled away from the pedestal body in tension (+6,277 lbf) from the aft side of its attachment, producing a high compressive force (-5,563 lbf) at the front end of the pedestal as shown in Table 13. On pedestal failure, the load was transmitted to the wall attachment, resulting in failure of the seat pan at both a wall attachment bolt and a seat-frame attachment bolt.

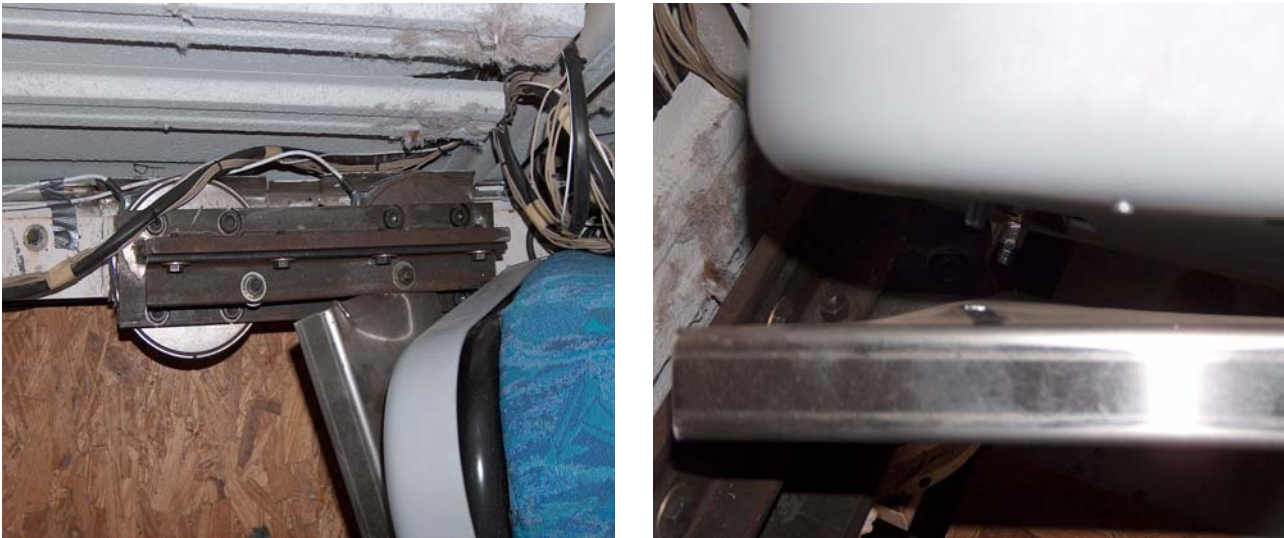
**Figure 47. The Bolt Holding Seat Base at the C-Channel Pulled through. The Connection Holding the C-Channel to the Wall also Failed**

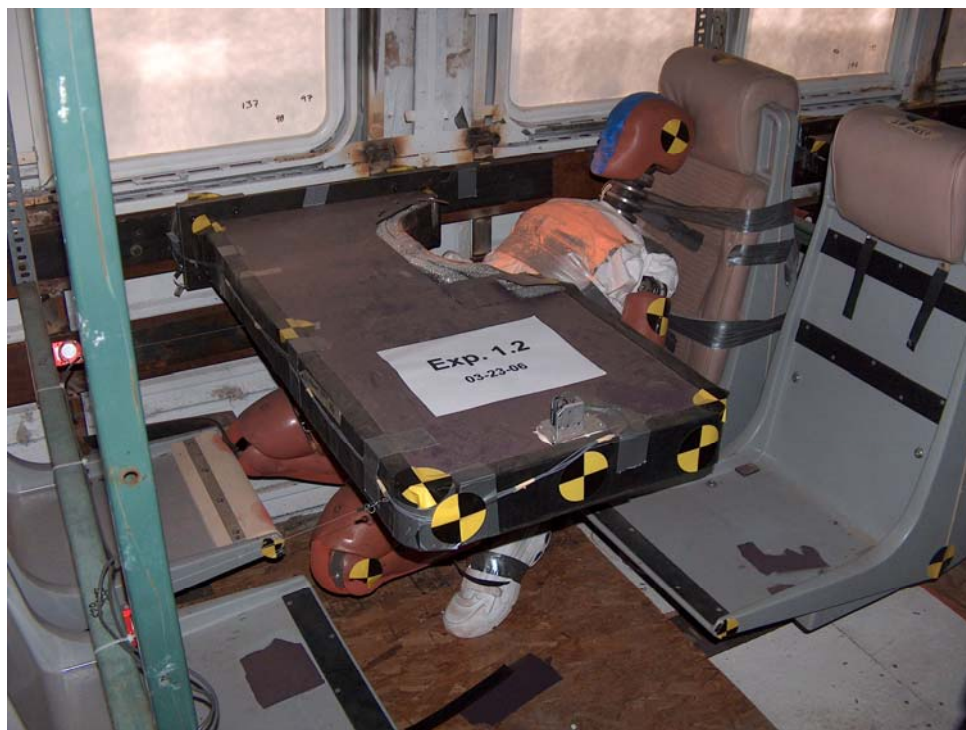
**Figure 48. Post-Test Photograph of Experiment 1.2 (with Hybrid 3RS ATD)**

This experiment was one of the two workstation table experiments located in the cab car, each with one ATD seated in the forward-facing window seat. The Hybrid 3RS ATD in this experiment successfully impacted the workstation table, which caused the table to crush as expected during the collision. Figure 48 shows a post-test photo.

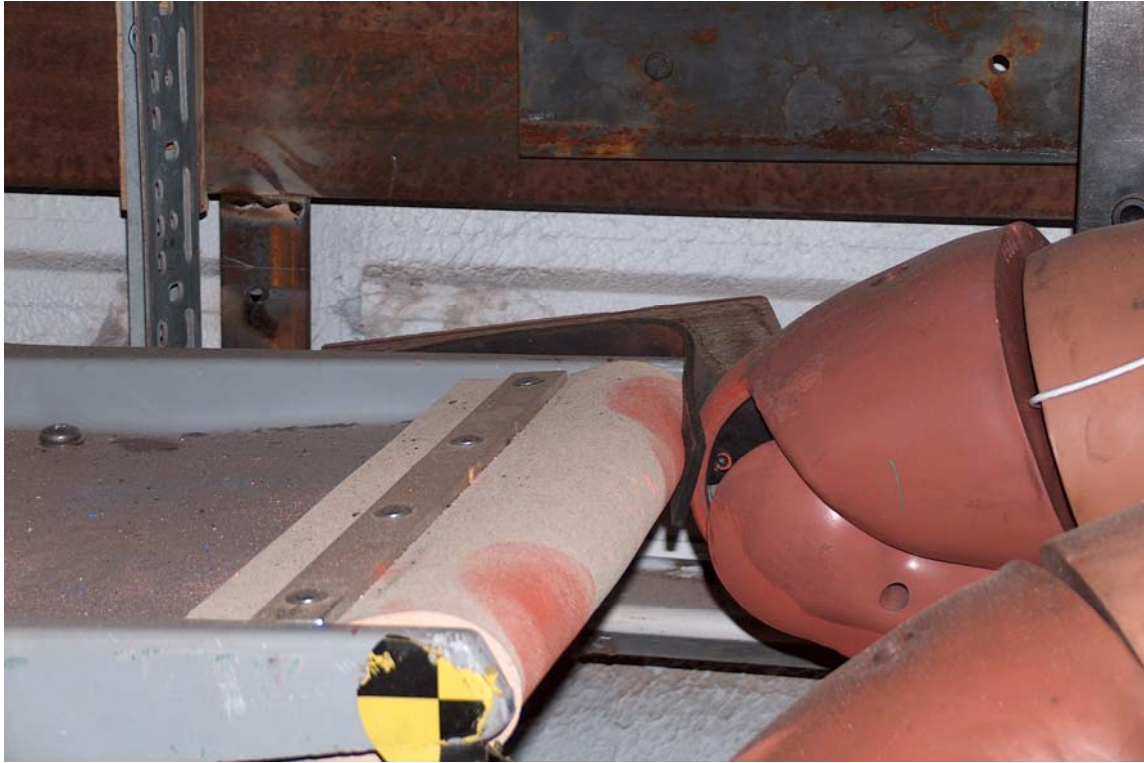
**Figure 49. Interaction of the Knees with the Facing Seat Rubber Bumper Occured in Experiment 1.2**

The Hybrid 3RS in this experiment measured a chest deceleration of 63G. No indication was found that the head impacted the top of the table. The knees of the Hybrid 3RS, however, did impact the seat pan on the other side of the table. In anticipation of this interaction between the knee/shin of the ATD and the facing seat pan, a rubber bumper was installed around the edge of the facing seat pan. This bumper was intended to mitigate the femur loads experienced by the ATD. Table 16 lists the ATD injury data. Figure 49 shows how the knees interacted with the facing-seat rubber bumper.

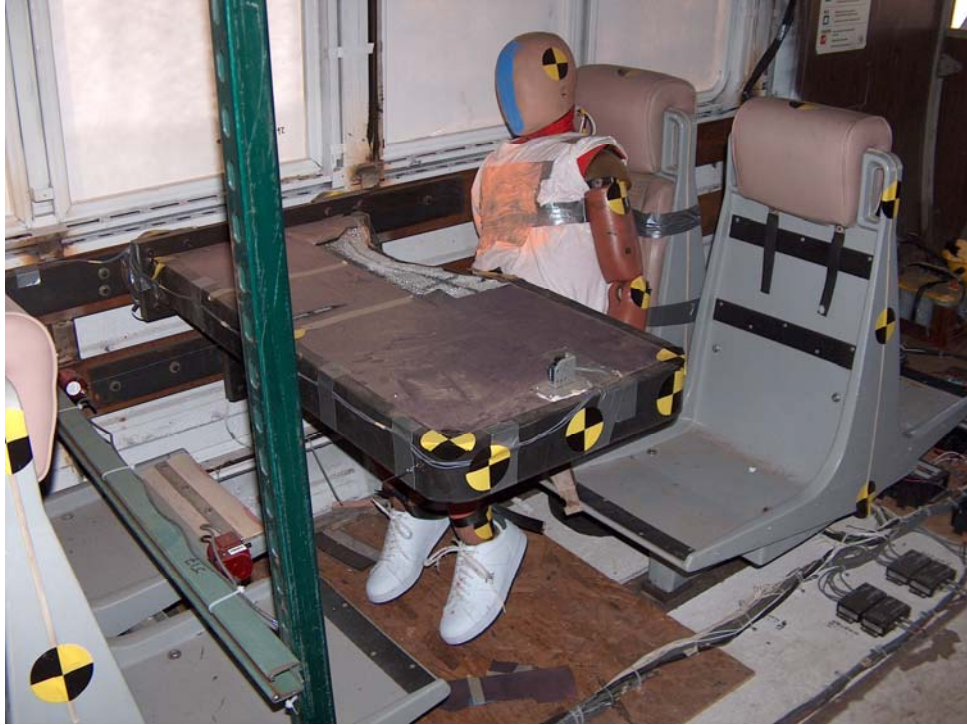
**Figure 50. Post-Test Photograph of Experiment 1.3 (with THOR ATD)**

The outcome of this experiment was a successful crushing of the table caused by the ATD impact. A maximum crush of 4.75 in was measured after the test. The wall attachment load cells measured forces that were relatively evenly distributed. Two upper attachment points carried loads that were slightly higher than loads carried by the lower wall attachment as shown in Table 17. The table remained attached to the wall and kept the ATD compartmentalized.

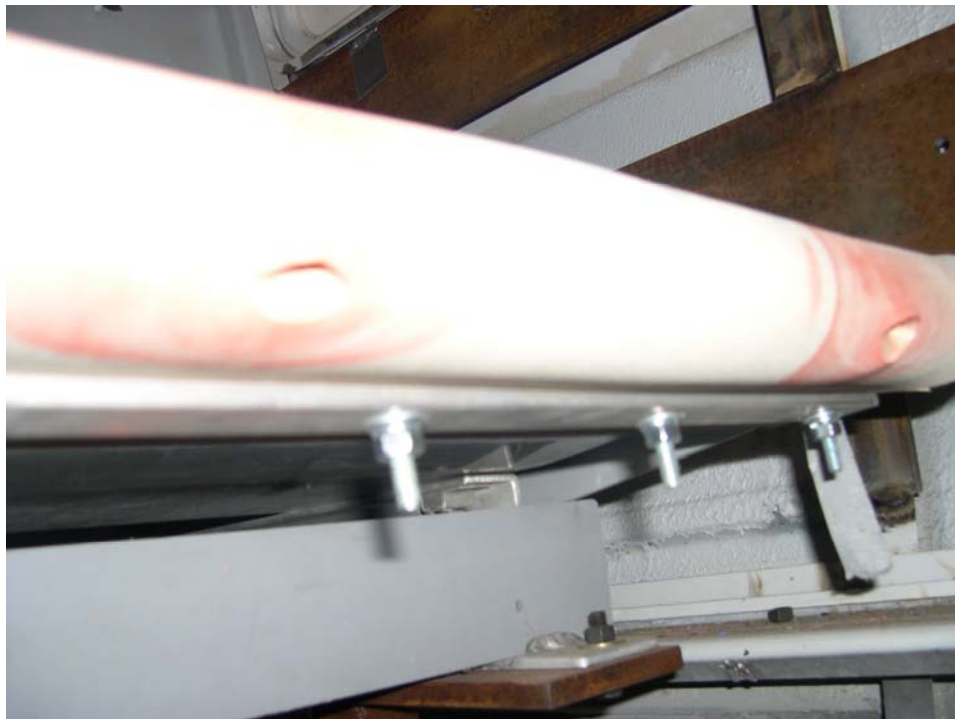
**Figure 52. Tears in the Rubber Bumper from Knee Interaction with the Facing Seat in Experiment 1.3**

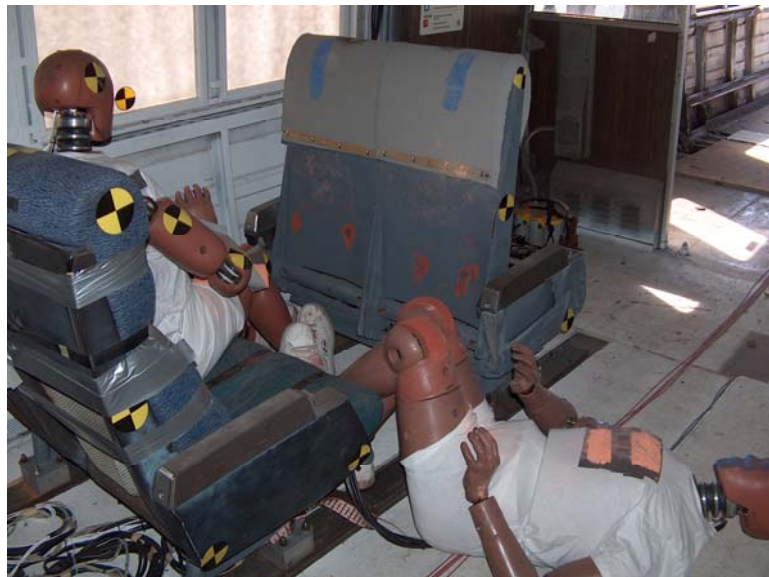
**Figure 53. Post-Test Photograph of Experiment 2.1**

This experiment consisted of two rows of modified, forward-facing, two-passenger Amtrak intercity seat pairs located in the front left-hand-side of the first coach car (second car in the consist). The ATDs in this experiment were compartmentalized as shown in the post-test photograph in Figure 53. No seat attachment loads were recorded in this experiment.

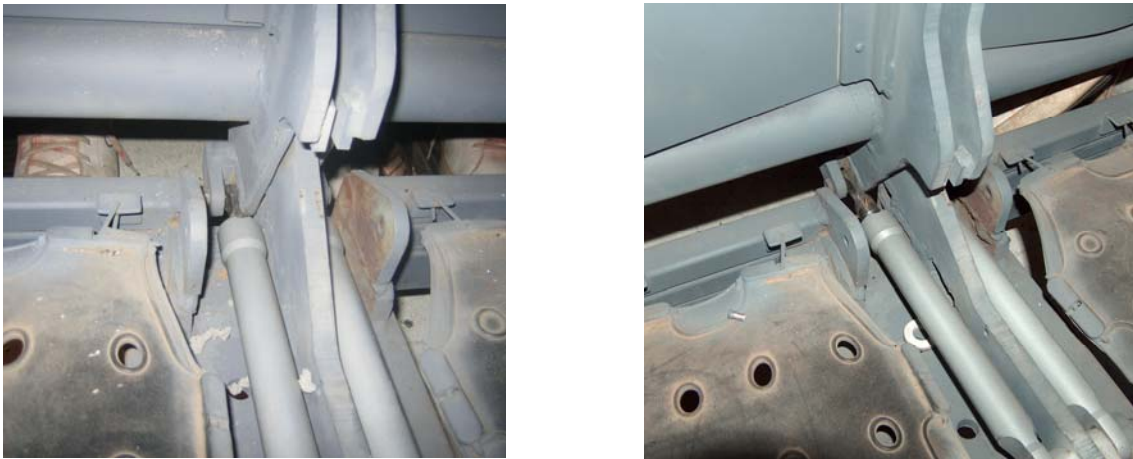
**Figure 54. Energy-Absorbing Struts Before the Test (left), Actuated Approximately 0.75 in (right) to Help Reduce the Force of the Head Impacting the Seat Back**

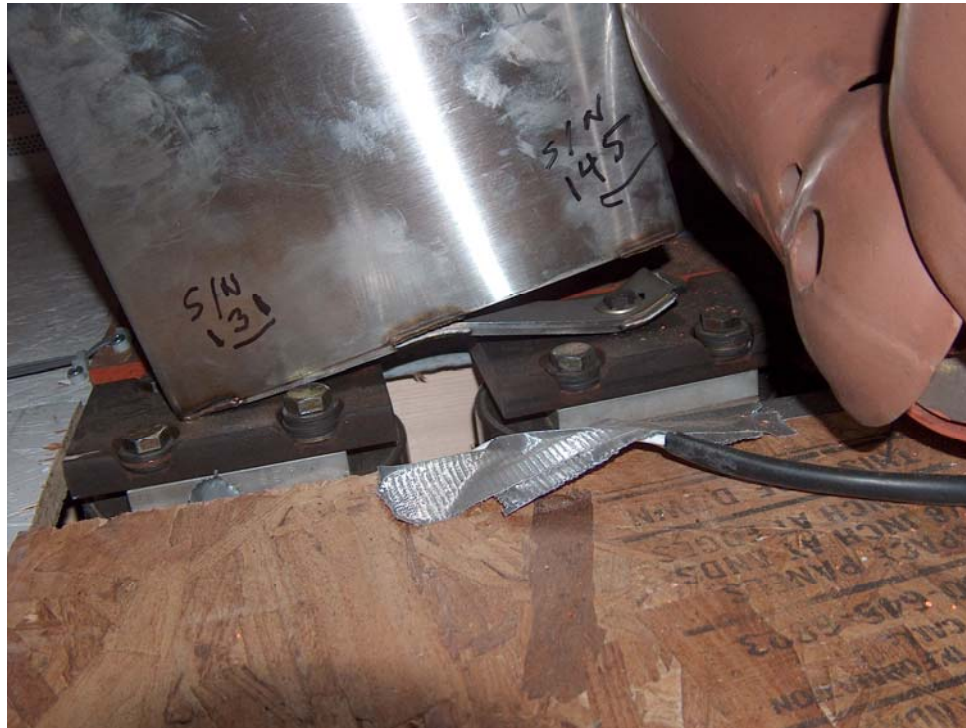
**Figure 56. Weld Failure at Pedestal Base, which Caused the Seat to Rotate Forward and Allowed the ATDs to Fall into the Aisle in Experiment 2.2**

The outcome of this experiment was a partial failure of the seat attachment to the floor, which caused the ATDs in the center and aisle seats to fall into the aisle of the car. Specifically, some of the welds at the base of the pedestal failed, which caused the pedestal to partially separate from its base as shown in Figure 56. Unlike the seat in Experiment 1.1, the bolt attachment of the seat base to the wall did not separate, which helped to keep the ATDs compartmentalized.

The seat attachment loads indicated that, at 0.214 s, some of the pedestal welds failed in tension with the vertical load at the aft attachment point reaching 6,796 lbf, while the vertical load at the forward attachment point reached -7,151 lbf, as shown in Table 21. Upon pedestal failure, the load was transmitted to the wall attachment. Unlike the seat in Experiment 1.1, however, the seat base remained attached to the side wall.
