Subject: Motorcoach Safety Research

# **Human Factors Issues in Motorcoach Emergency Egress**

## **INTERIM REPORT 1- FINAL**

August 2009

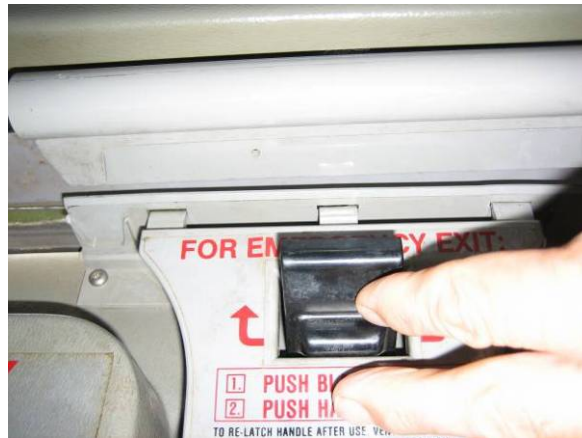
Measurements for forces applied through fingertips to roof-hatches were measured with a subminiature (button-sized) load cell (*Omega Engineering LCMKD-100N<sup>R</sup>*) placed between a finger tip and the surface to which force was applied.

**Figure 3-1. Fingertip Release – Emergency Roof Exit Hatch**

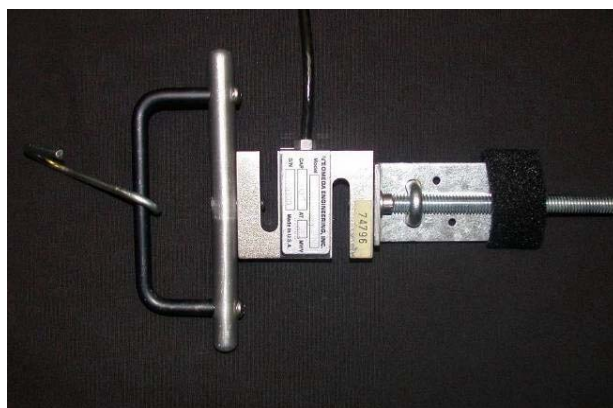
All measurements of window-release forces were made with an Omega Engineering LCCA-200 “S”-beam load cell fitted with a hook on one side and a handle on the other, as illustrated in Figure 3-2a.

**Figure 3-2. Load Cell and Free-Body Diagram of Window-Opening Forces**

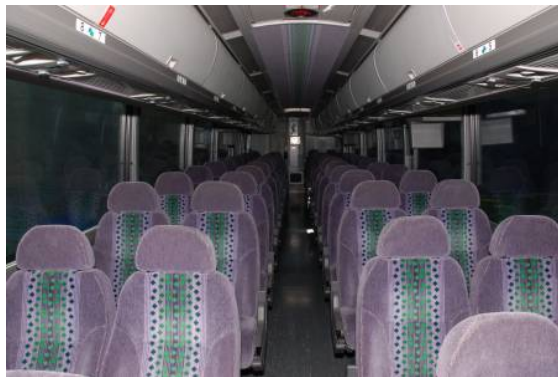
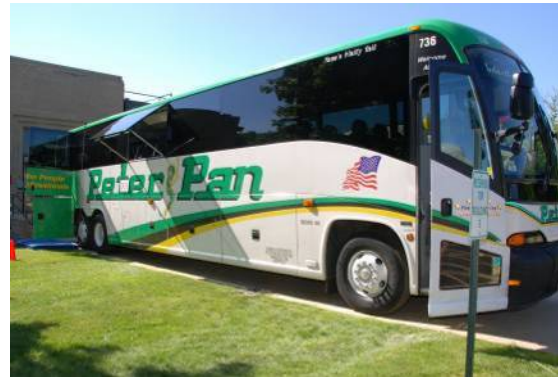
**Figure 3-7. Volpe Egress Experiment Motorcoach**

Figure 3-7 shows the motorcoach interior and the exterior, as located on the Volpe Center campus. The bus was equipped with a wheelchair door located on at the rear of the bus next to the lavatory on the right side (see the open door on the rear far left of Figure 3-7b).

a. Interior

b. Exterior

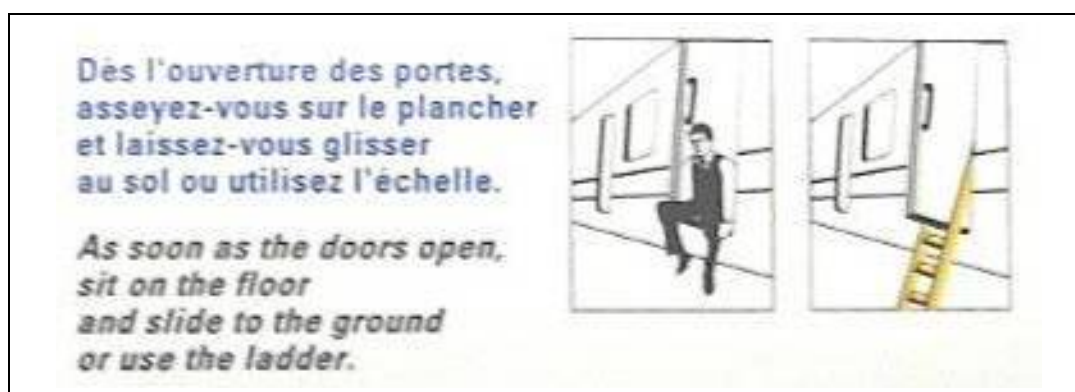
The technique used to exit the wheel chair door consisted of a “sitting jump.” Some foreign passenger railroads also include pictograms illustrating the technique in their emergency egress instructions, as shown in Figure 3-9.

**Figure 3-9. Pictogram Illustrating the Sitting Jump Egress Method**

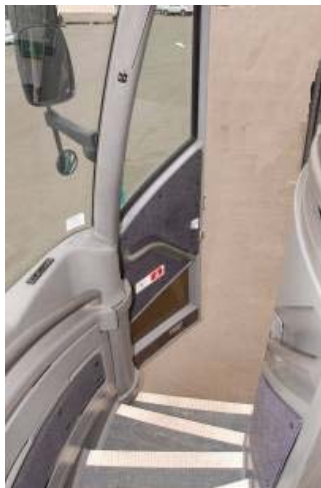
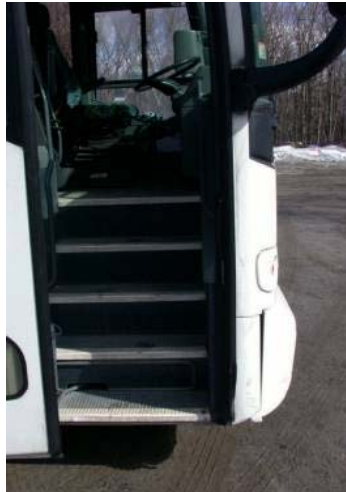
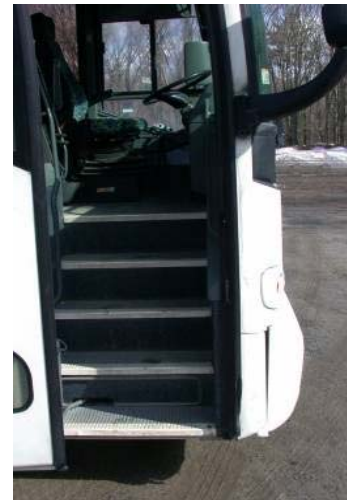
**Figure 4-1. Motorcoach Front Door and Stairs**

Figure 4-1 shows the interior and exterior views of a typical newer model motorcoach, with the front door open.

a. Interior

b. Exterior – No kneeling and Kneeling

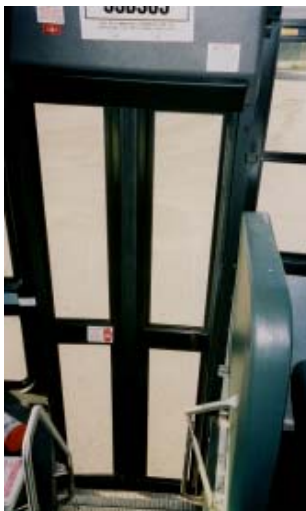
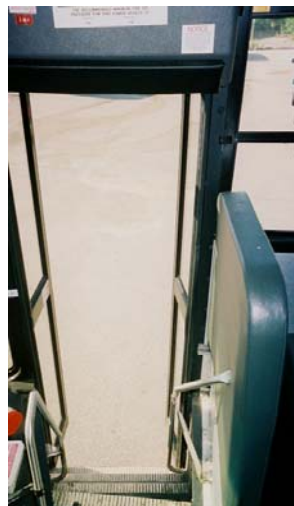
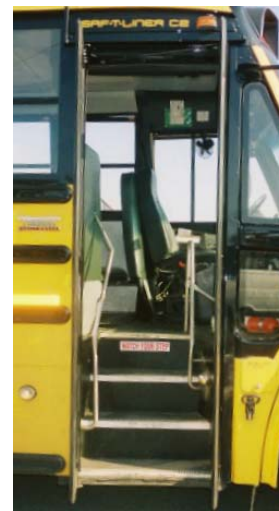
**Figure 4-2. School Bus Front Door and Stairs**

Due to their higher floor heights to accommodate under bus luggage storage, motorcoaches require passengers to use a greater number of steps to get on and off than school buses and transit buses; the latter usually have no more than three steps (see Figure 4-2 and Figure 4-3).

a. Interior – closed and open

b. Exterior – open

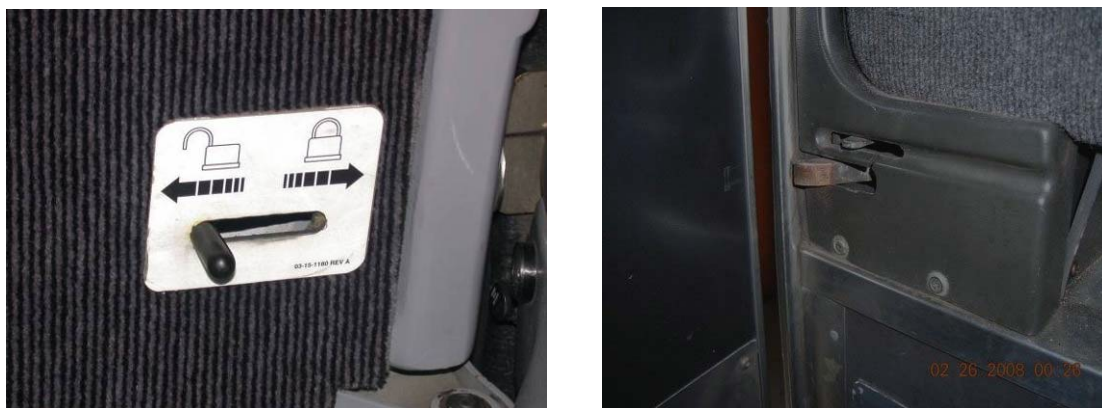
Motorcoaches of recent design have power-actuated front doors. A touch of a button or switch on the driver's console is all that is required to open or close them. When the system is functioning normally, pressing the control is the easy way to open them. With the engine off and no air pressure in the actuator, the front door can easily be pushed open, unless the mechanical lock has been set. All motorcoaches have a lock that is key-operated from outside and by some kind of lever or knob from inside (see Figure 4-4). On some motorcoaches, this lock release is labeled and is easily recognized, while on others, it is not labeled and is hard to see, particularly in dim light.

**Figure 4-4. Motorcoach Interior Latches for Front Door**

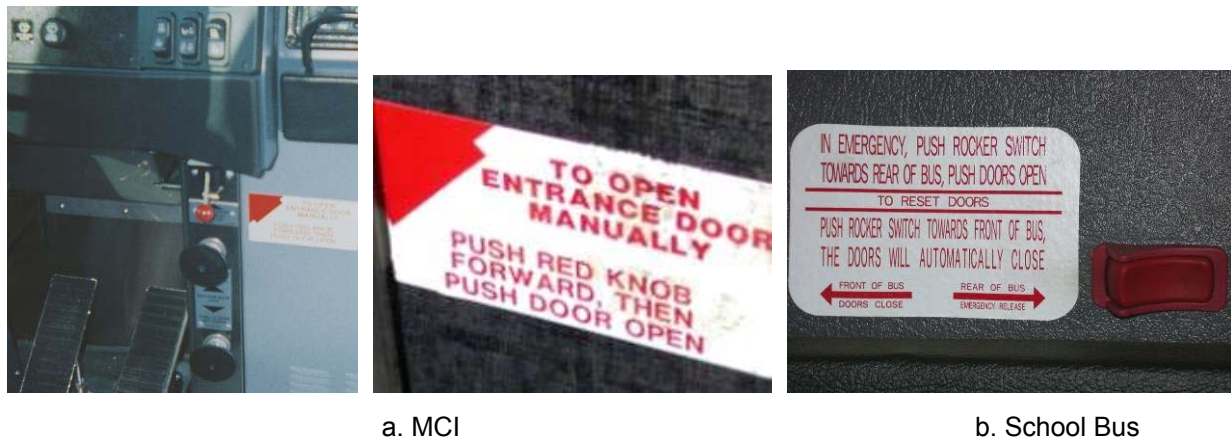
The pneumatic systems that operate the doors are designed to retain pressure for many hours after the engine is switched off. Therefore, many modern coaches include an override control to release pressure in the actuator in the event of some malfunction. This manual control is usually red in color (see Figure 4-5) and may or may not be labeled to explain its use.

**Figure 4-5. Door Pneumatic Actuator Pressure Release Knob and Instructions**

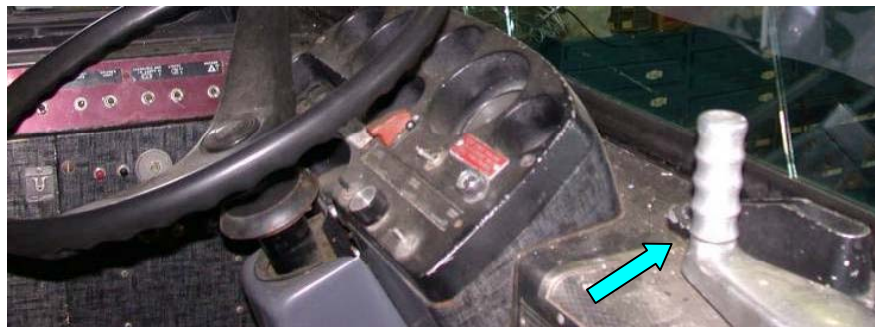
Older designs (1980s and earlier) have a mechanical arm linking the front door to a crank within the driver's reach, as shown in Figure 4-6. The front door cannot be pushed open until the crank handle is pulled out of its latched position. Bus riders who have observed drivers performing this action numerous times would presumably know what to do to operate the door; however, no instructions are provided to make the door operation explicit.

**Figure 4-6. Hand-Crank Front Door Opener**

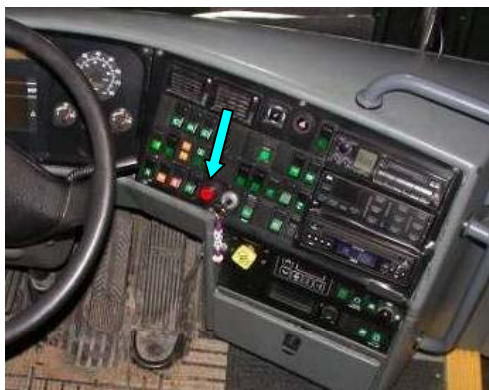
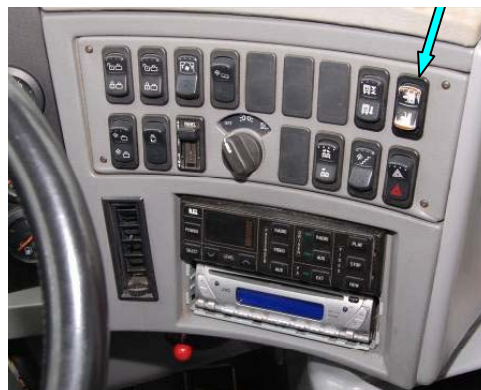
**Figure 4-7. Typical Motorcoach Driver Front Door Controls**

Since all of the front doors examined were very easy to open manually (with the actuator depressurized) and effortless under power, no force-gauge measurements were recorded. The principal issue in emergency egress via the front door is not the force required to open it, but rather whether passengers can comprehend quickly how to open the door if the driver is incapacitated. If the front door is available and the actuator is pressurized, but the driver is incapacitated, egress may be significantly delayed because passengers may not know which control operates the door. Some control panels have a switch with an icon that obviously represents the front door, while others (red button in Figure 4-7a) do not have such markings. Furthermore, even if the switch has a label or icon, it may be hard to read due to wear, as shown in the four-year-old bus (upper-right-hand switch in Figure 4-7b).

a. Van Hool door control

b. MCI door control

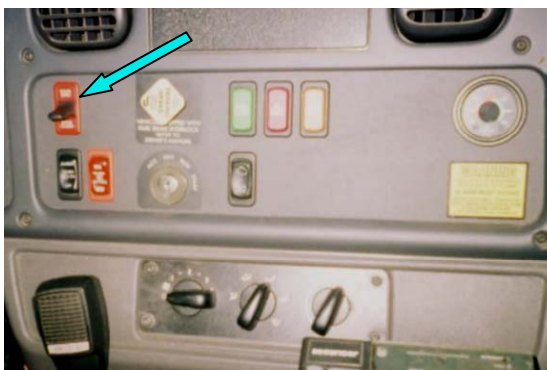
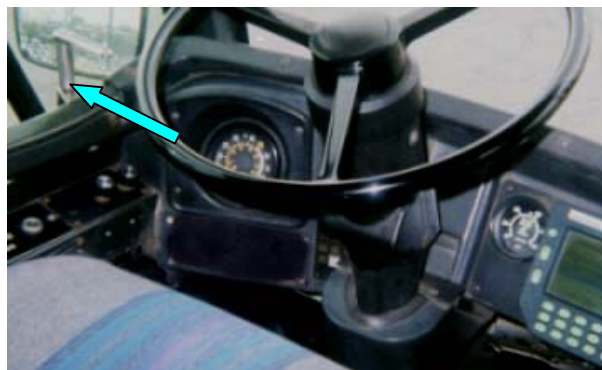
**Figure 4-8. Typical School Bus and Transit Bus Driver Front Door Controls**

Bi-fold doors are often used in school and transit operations to speed loading and unloading, but are not used for motorcoaches. Normal school bus and transit bus front door controls are illustrated in Figure 4-8. (The transit bus front door shown is operated with a hand crank handle, to the left of the steering wheel; some newer buses use a door switch in a similar location.)

a. School bus

b. Transit bus

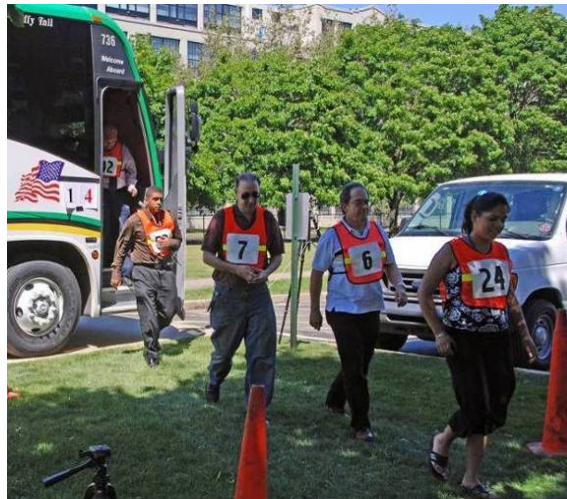
As described in Chapter 3, Volpe Center staff conducted a front door motorcoach egress experiment (see Figure 4-9). The experiment objective was to collect “baseline” exit times under controlled best-case conditions. The experiment included four trials: two in which the bus was in the kneeling condition, and two in which it was not. The subject group was comprised of Volpe Center federal employees, including a balanced mix of genders and age groups.

**Figure 4-9. Volpe Center Motorcoach Experiment to Determine Front Door Egress Rate – Best-Case**

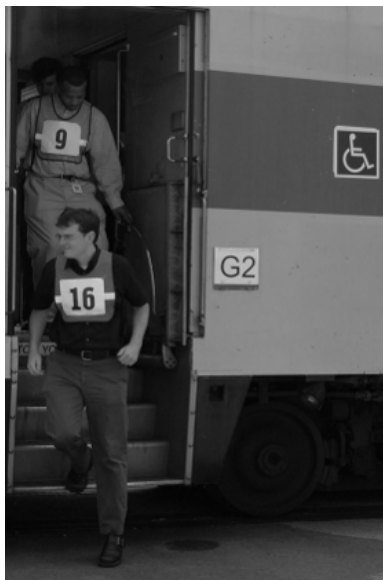
In 2006, Volpe Center staff conducted several commuter rail car egress flow rate tests using the side steps to a low-level platform.<sup>55</sup> The average flow rate for unencumbered, able-bodied subjects was 41 passengers per minute. Five trials were conducted using 17 Volpe Center employees and the commuter rail cars illustrated in Figure 4-10. The distance from the bottom step to the ground was 39 cm (15.5 in), and the rise of the other four steps was 22 cm (8.5 in).

**Figure 4-10. Volpe Center Commuter Rail Experiment to Measure Normal Egress Rate**

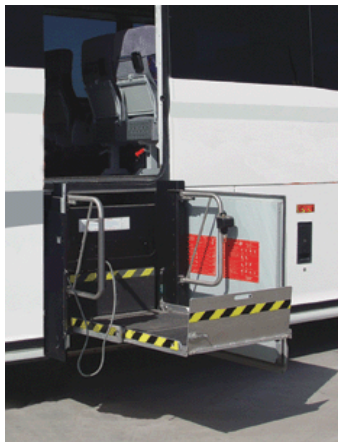
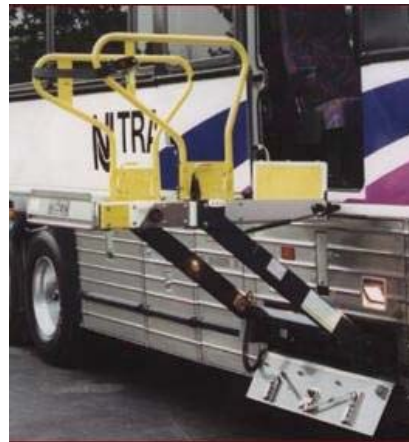
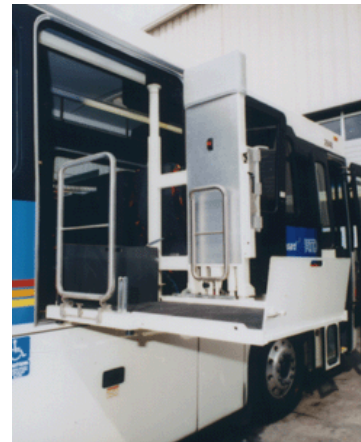
**Figure 5-4. Motorcoach Wheelchair-Access Door / Lift Exterior View – Examples**

Figure 5-4 shows the exterior of several motorcoach wheelchair-access doors with the lifts in the open position.

a. Ricon (Wabtec) Bay

b. Ricon (Wabtec) Mirage

c. Stewart & Stevenson

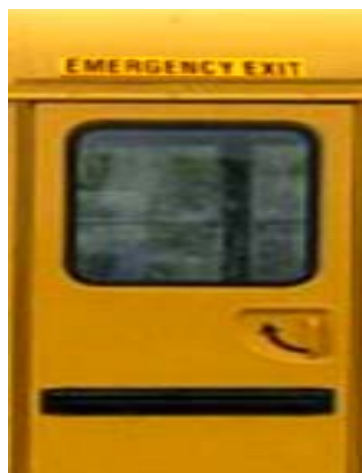
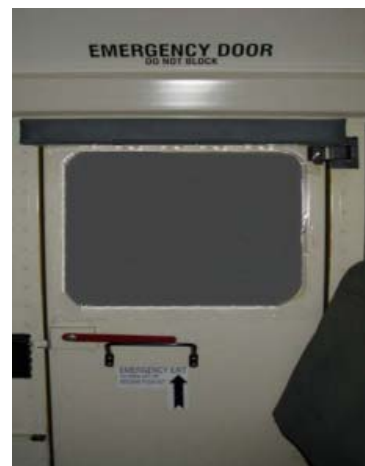
**Figure 5-5. School Bus Wheelchair-Access Door Emergency Exit – Closed Position**

Figure 5-5 shows the interior and exterior of a school bus wheelchair-access door with the door and the lift in the closed position that complies with FMVSS 217. Figure 5-6 shows the interior and exterior of another school bus wheelchair-access door. However, this type of wheelchair-access door does not comply with FMVSS 217 emergency exit door requirements.

a. Exterior

b. Interior

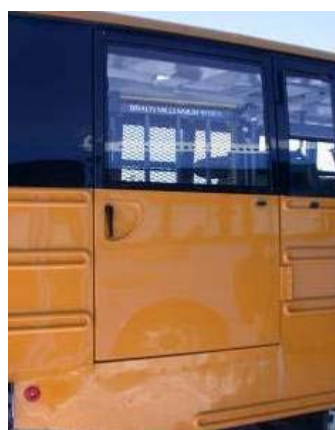
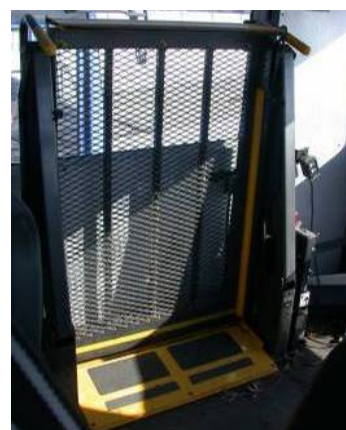
**Figure 5-6. School Bus Wheelchair-Access Door – Closed Position**

a. Exterior

b. Interior

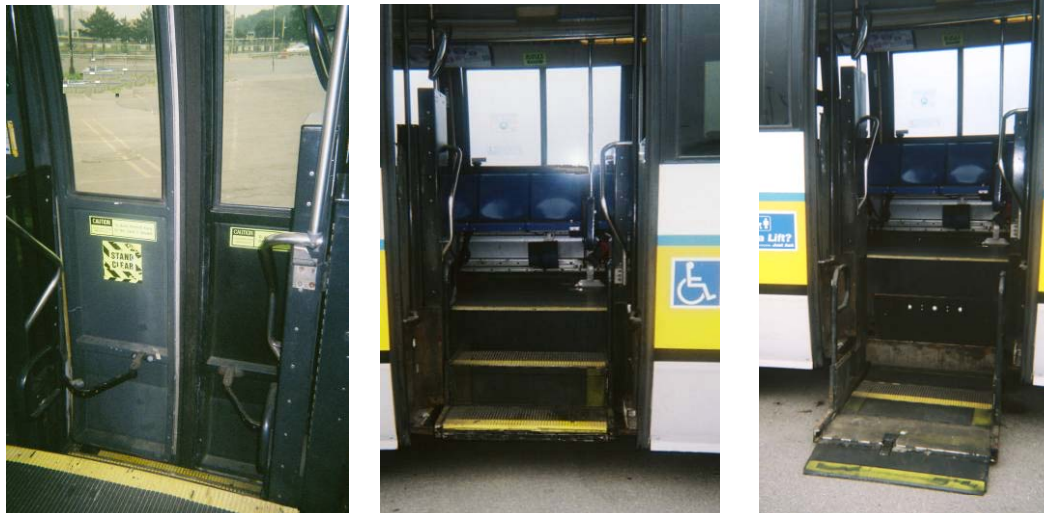
**Figure 5-7. Transit Bus Rear Side Wheelchair-Access Door Location – Example**

Figure 5-7 shows an example of a transit bus wheelchair-access side door and ramp located at the rear side door of the bus. The three steps are used by able-bodied passengers; newer “low floor” buses have the wheelchair access function integrated into the bus front door steps. (There is an emergency release provided for the rear side door (not shown); however, the release is accessed by the use of a small hammer to break the protective glass cover.

a. Interior – Door Closed

b. Exterior – not deployed and deployed

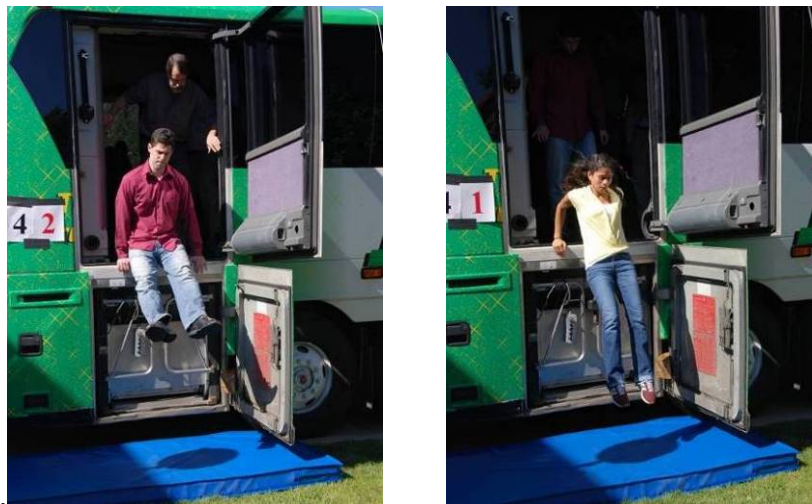
The sitting jump method of egress used by the subjects is illustrated in Figure 5-9. In the first photo, the subject sits on the door sill and uses both hands to slide forward. Hands are kept on the door sill as long as possible into the fall to retard acceleration and minimize free-fall drop, as shown in the second photo. In both egress trials, egress time for all five subjects totaled 12 seconds, equivalent to a flow rate of 25 ppm.

**Figure 5-9. Volpe Center Subjects – Sitting Jump Using Wheelchair-Access Door**

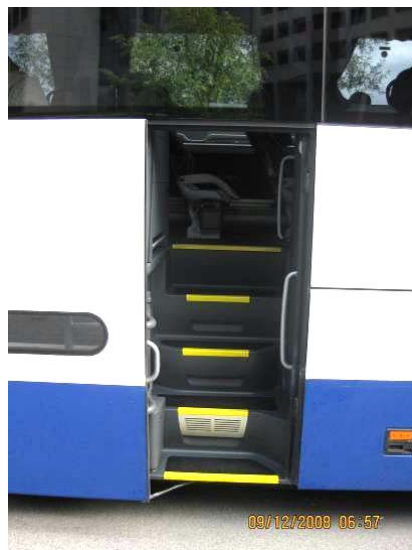
ECE 36<sup>38</sup> does not specifically address wheelchair-access doors, but requires that buses have two doors, one of which must be a service door. One of the doors is normally placed in the rear half of the coach (with 4 steps and 5 risers) on the same side as the front service door, and is generally used as a service door to speed loading and unloading. (See Figure 5-10.)

**Figure 5-10. MAN Motorcoach — Middle Side Service Door**

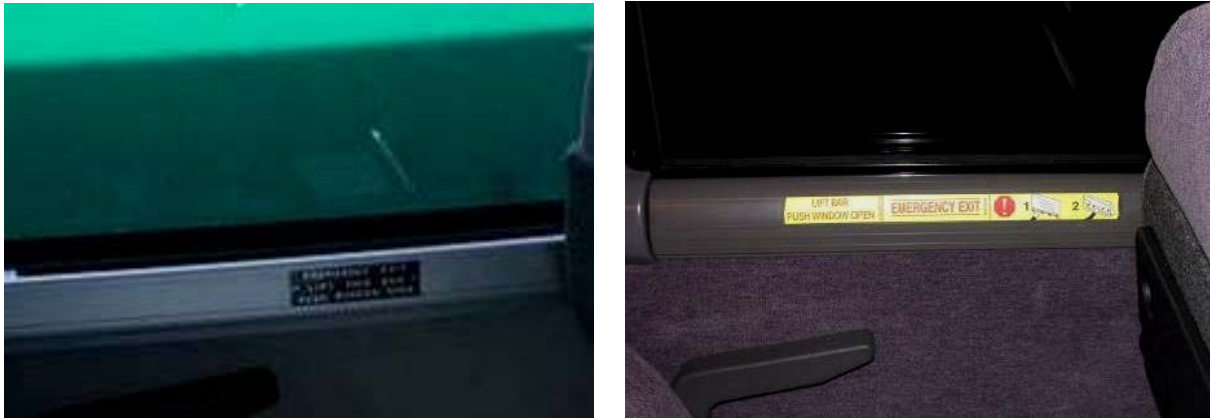
All of the MCI designs observed have a release bar at the sill that runs the full width of the window (Figure 6-3).

**Figure 6-3. MCI Emergency Exit Window Release Bars**

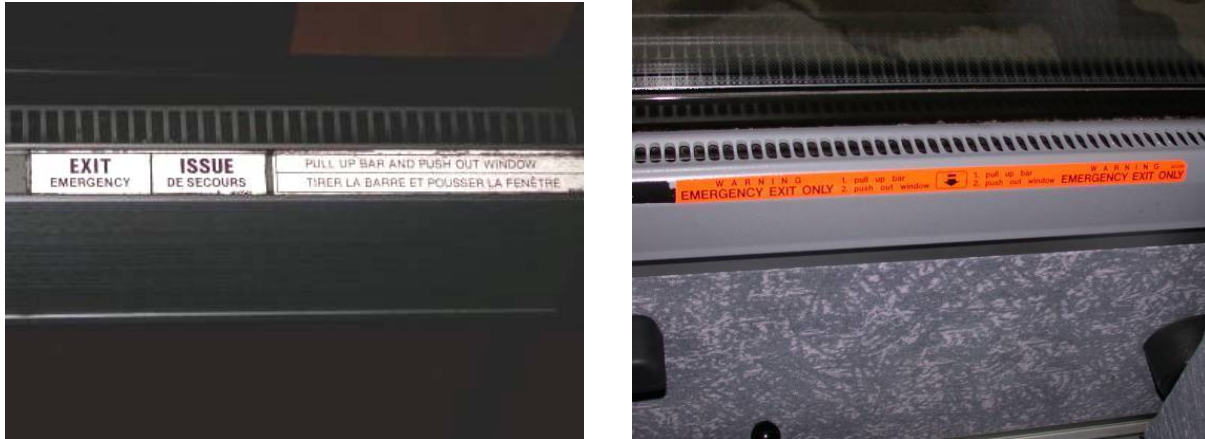
*Prevost* (a Division of *Volvo-Canada*) has also used a long-bar release design in all of its coaches for the past two decades (see Figure 6-5). Like the newer *MCI* design, the lift bar is attached to the sash, which means that the bar protrudes into the open space between the emergency exit

**Figure 6-5. Prevost Sash-Mounted Emergency Exit Window Release Bars**

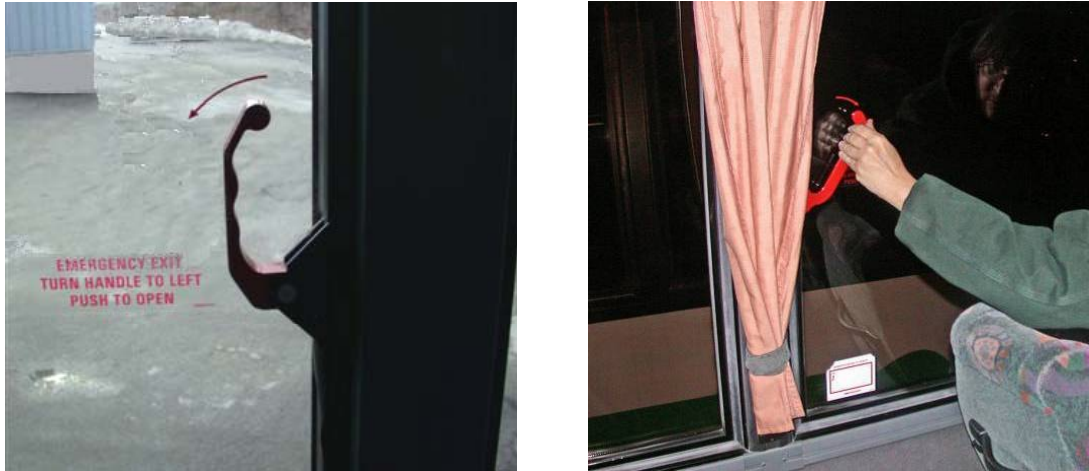
The *Van Hool* window release mechanism is entirely different (Figure 6-7) from the other types of exit windows, as it is contained almost entirely within the sash frame, with the result that the latch components on the sill are much smaller than those on *MCI* or *Prevost* windows. A red handle, located one side of each exit window, operates the release. The only evident changes between models are slight differences in the shape of the release handle and whether the handle is on the left or the right side of the window.

**Figure 6-7. *Van Hool* Sash-Mounted Emergency Exit Window Release Mechanism**

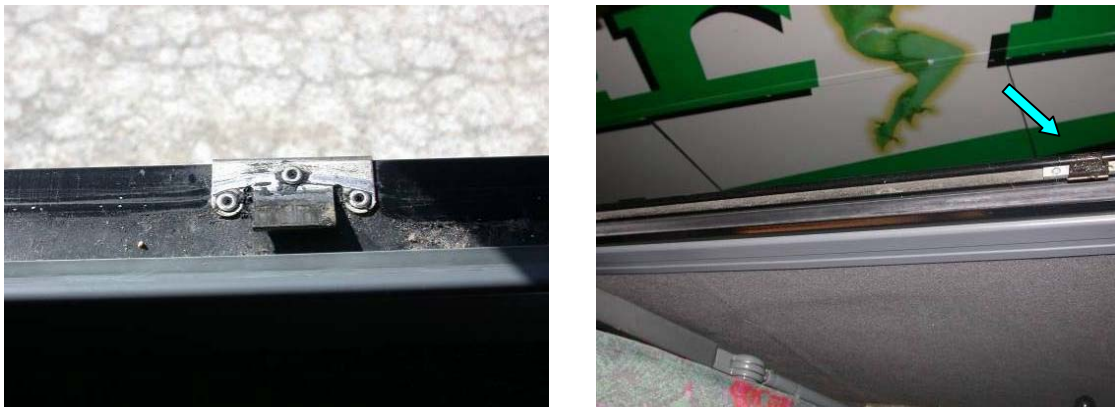
The small strikes located on the sill near each side of the *Van Hool* window (Figure 6-8), present much less interference with window egress than the sill-mounted mechanisms of the other manufacturers.

**Figure 6-8. *Van Hool* Emergency Exit Window Sill-Mounted Release Components**

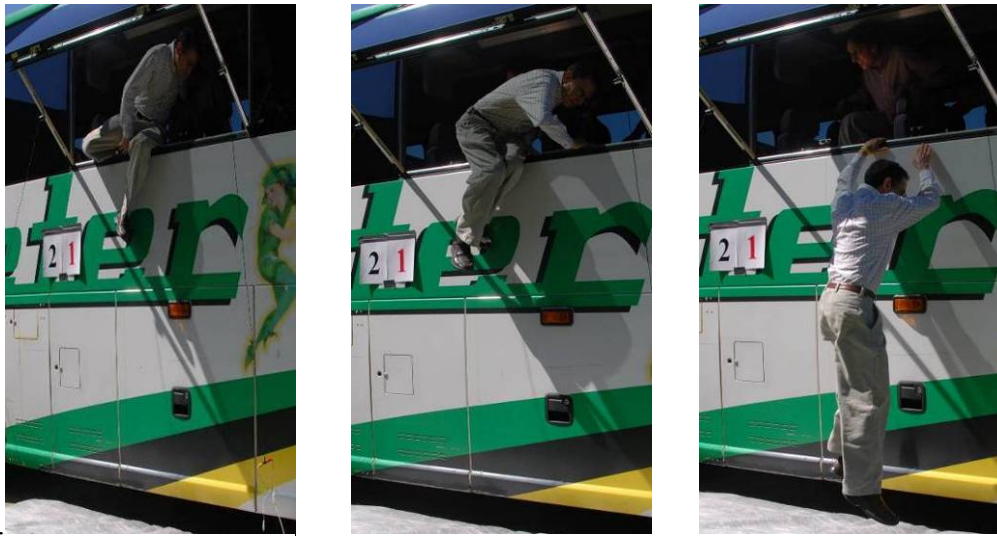
**Figure 6-10. Subject Performing Motorcoach Emergency Exit Window Egress**

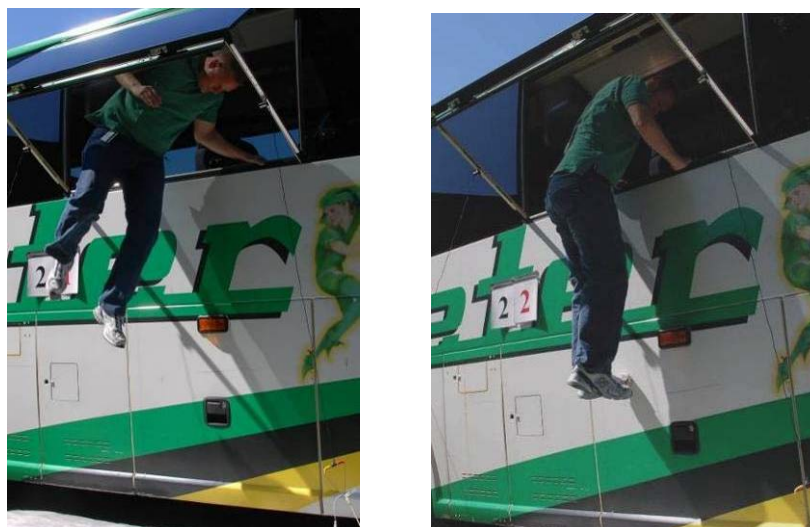
a. Left – Jumping

The last subject (the +95<sup>th</sup> height-percentile male) elected to jump from the sill, as shown in Figure 6-11. This method made his egress the fastest observed. However, in jumping, he almost struck the window sash, despite the 91-cm (36-in) opening, as shown in the left-hand photo.

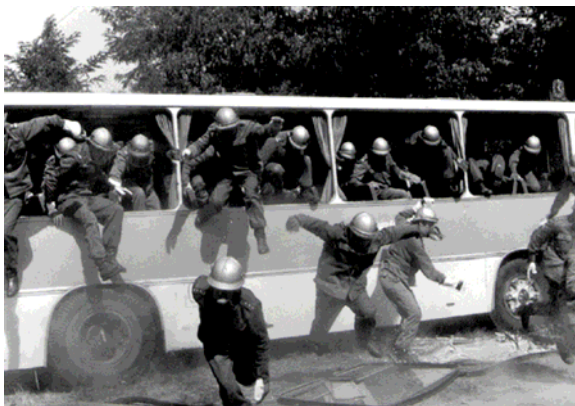
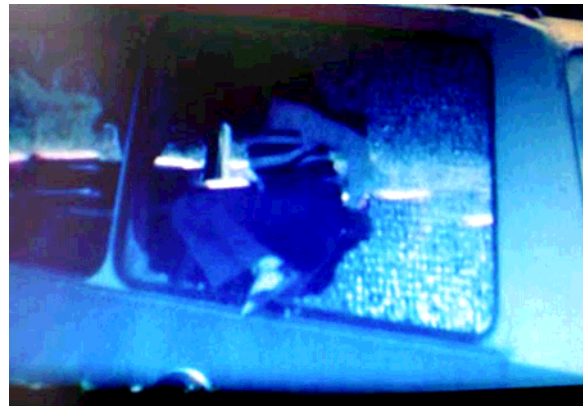
**Figure 6-13. 1984 Hungarian Bus Window Egress Tests**

A more recent study performed in 1984 by the Hungarian bus manufacturer, *IKARUS*, used a group of 45 male firefighters, aged 20 to 40 years, as subjects in a window-evacuation test.<sup>56</sup> They were instructed to kick out all of the windows on both sides and exit as rapidly as possible, which they accomplished in only 10 seconds; equivalent to an egress rate of 34 ppm per window (see Figure 6-13a).

a. Firefighters

b. Civilian female

as, “afraid of jumping through the window, which had glass fragments in the “waistrail” (i.e., windowsill).” Thus, she needed help from outside to jump out, as illustrated in Figure 6-13b and required an additional 50 seconds to complete her egress, with assistance by the firefighters outside the bus.

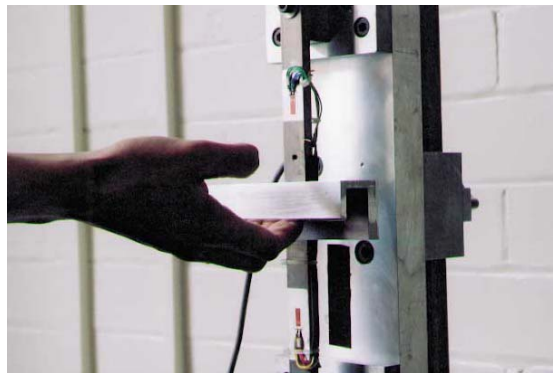
**Figure 6-14. Test Apparatus for Measuring Finger-Tip Pulling Strength**

A recent study conducted for the British (UK) Department of Trade and Industry<sup>47</sup> raises questions about the 268-N force limits currently permitted by FMVSS 217 criteria for releasing and opening any of the means of egress on a motorcoach. Subjects in this UK study were tested to determine the maximum force they could exert on the apparatus shown in Figure 6-14).

This UK strength-measurement test is similar to the task that must be performed to pull the release bar on the majority of bus emergency exit windows. The distribution of maximum forces exerted by 152 subjects is shown in Figure 6-15. The data in Figure 6-15 show that that most of the subjects in these tests were not able to exert forces of 268 Newtons, which is the current allowable FMVSS 217 maximum limit.

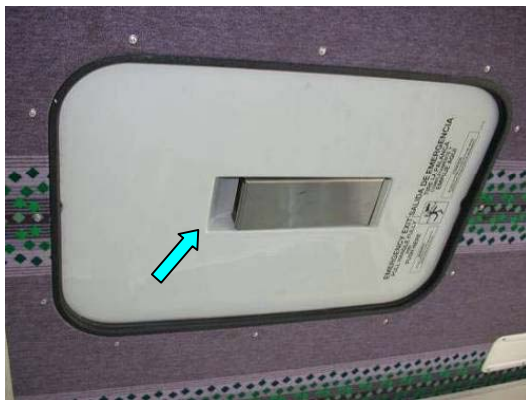
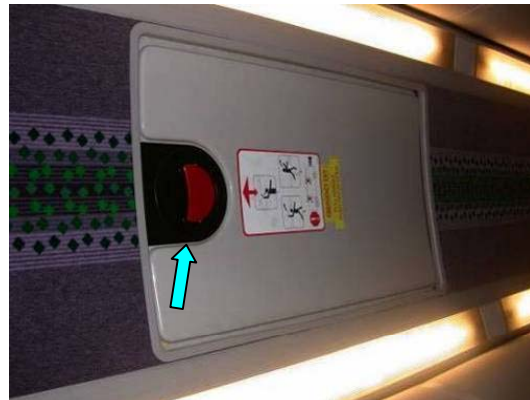
**Figure 7-1. MCI Emergency Roof Exit Hatches – Interior**

There is much less variety in emergency roof exit hatch design than is the case for emergency exit windows. All of the *MCI* motorcoaches observed were fitted with oblong exit hatches (measuring about 87 by 52 cm (20.5 by 34.5 in), as shown in Figure 7-1. The hatch mechanism has changed over time from the stainless steel handle shown on the left to the red plastic one on the right. However, the required action is the same – pull the handle down as far as possible to release and push the roof hatch open with the other hand. Moving the handle to this position and the addition of the pictogram likely helps to guide users to apply the opening force more effectively, as far from the hinge as possible. These emergency roof exit hatches weigh about 18 kg (40 lbs), which means they are somewhat difficult to open when the motorcoach is upright. However, when the motorcoach is on its side, the hatches swing open freely.

a. Older

b. Newer

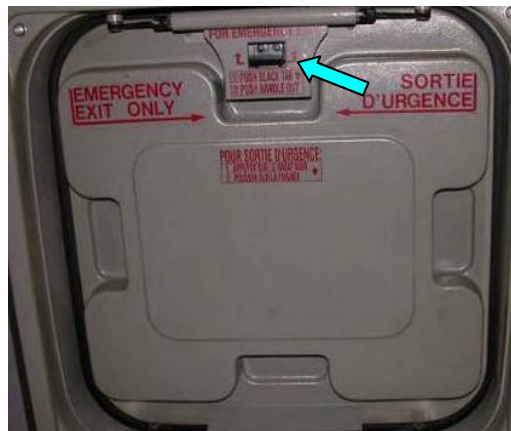
**Figure 7-2. Prevost and Van Hool Emergency Roof Exit Hatch**

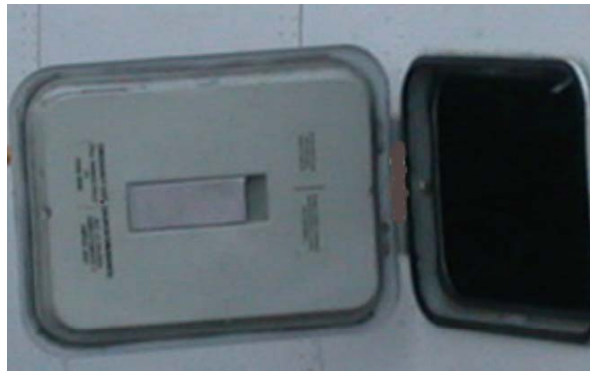
**Figure 7-3. MCI Open Emergency Roof Exit Hatch – Exterior**

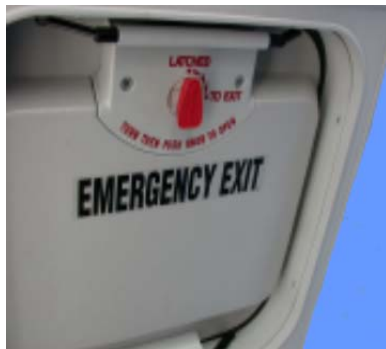
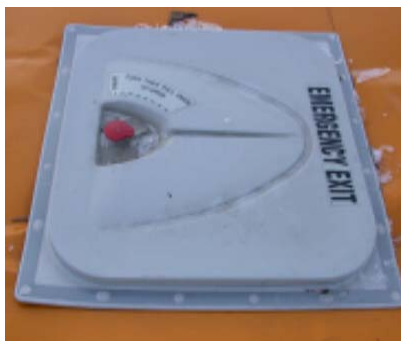
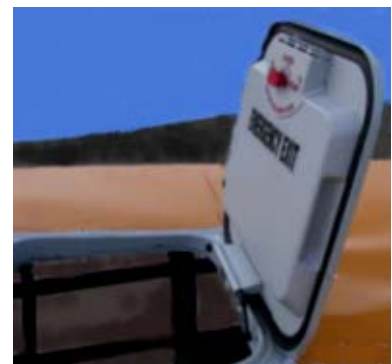
**Figure 7-4. School Bus Emergency Roof Exit Hatch**

Similar emergency roof exit hatches are used on school buses; however, those hatches are required to be marked on the exterior with “Emergency Exit” signs and have an exterior release handle. Figure 7-4 shows a typical emergency roof exit hatch from the interior and the exterior of the school bus.

a. Interior

b. Exterior – closed

c. Exterior – open

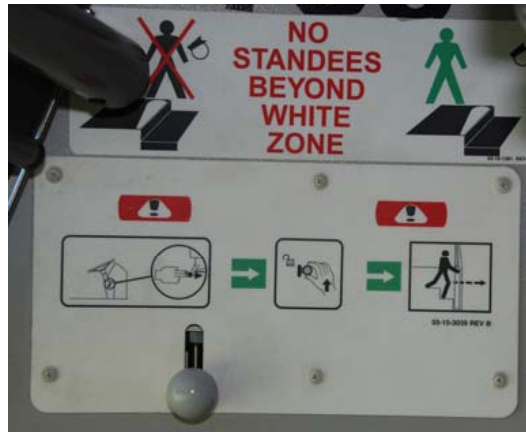
**Figure 8-1. Motorcoach Front-Door Operation Instructional Signage Example – Interior**

Figure 8-1 shows an example of motorcoach front-door operation instructional interior signage.

This sign is located above the door of the motorcoach, where it is out of view of a person standing in the step well and attempting to open the door. Moreover, during field testing and setup for the 2008 Volpe Center-conducted human-subject experiments, various staff members had initial difficulty in interpreting its meaning, and sometimes took more than one minute to determine how to open the door. (The knob is not red in color as most emergency exit release controls are.)

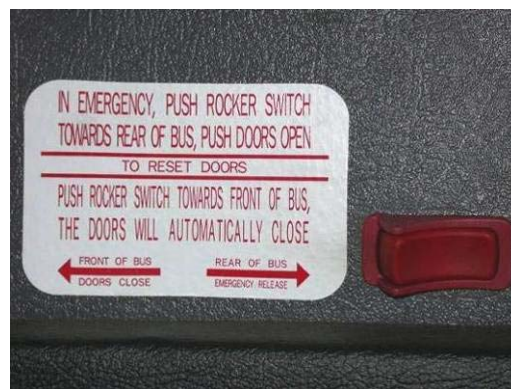
**Figure 8-2. School Bus Front-Door Instructional Signage Example – Interior**

Figure 8-2 shows an example of the clearer interior school bus front-door-opening emergency exit instructions, located next to the red switch at the right top of the door.

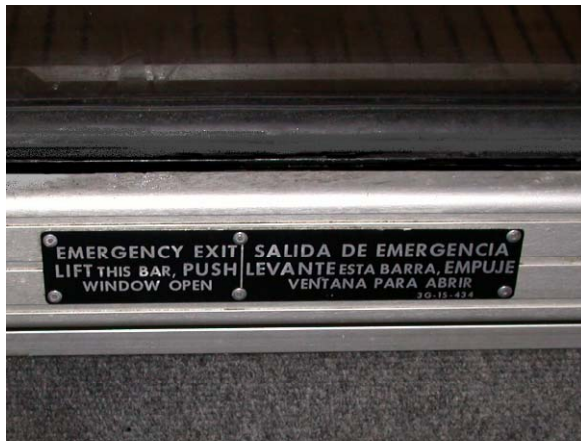
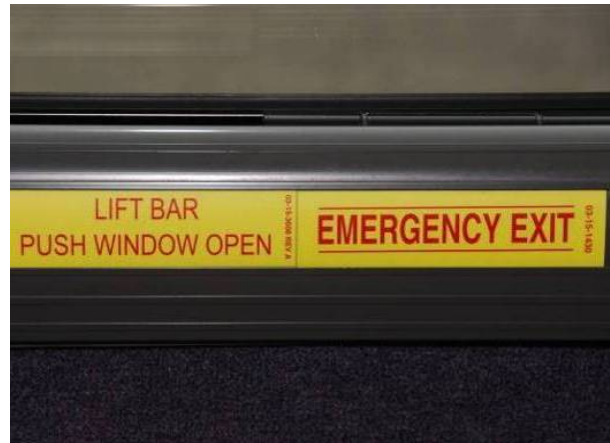
**Figure 8-3. Motorcoach Emergency Exit Window Marking and Instructions (1)**

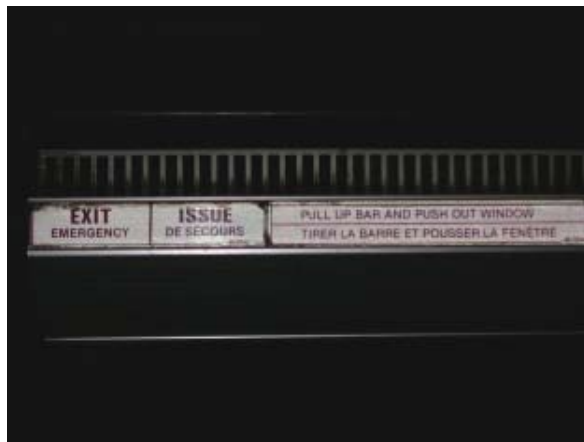
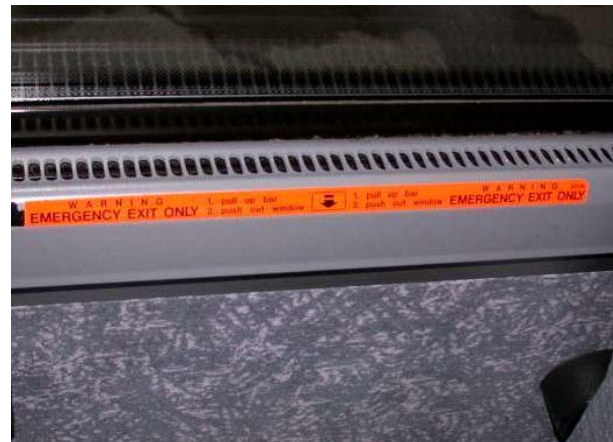
**Figure 8-4. Motorcoach Emergency Exit Window Marking and Instructions (2)**

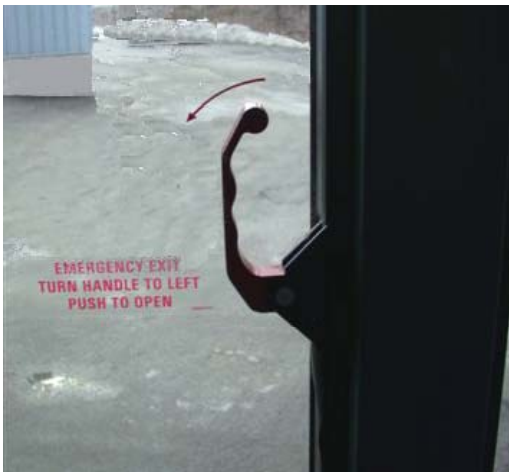
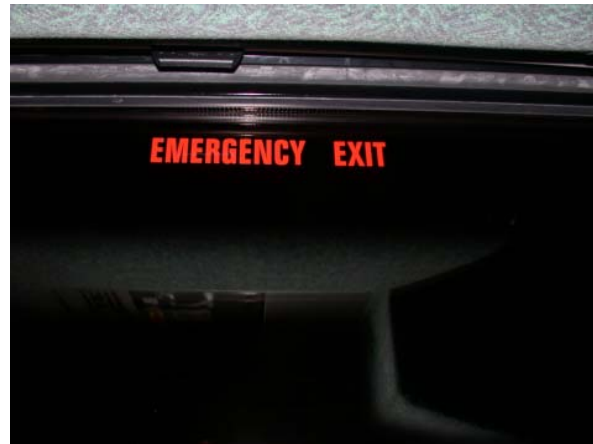
**Figure 8-5. Motorcoach Emergency Exit Window Signage and Instructions**

In addition, *Van Hool* motorcoach emergency window exits observed by Volpe Center staff had emergency exit signs, comprised of red letters, installed on the window surface (see Figure 8-5). However, the larger sign located on the window, just under the luggage rack, in Figure 8-5b, is not required by FMVSS 217.

a. Marking and Instructions

b. Sign

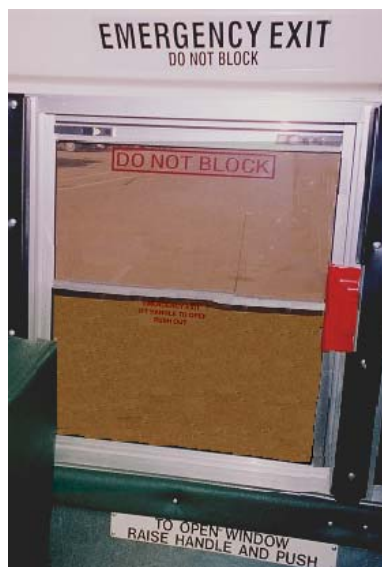
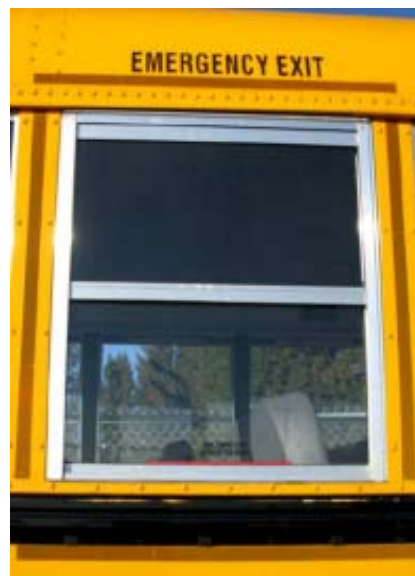
**Figure 8-6. School Bus Window Emergency Exit Signage**

Figure 8-6 shows school bus side window emergency exit marking that complies with FMVSS 217 requirements for signs and instructions.

a. Interior

b. Exterior

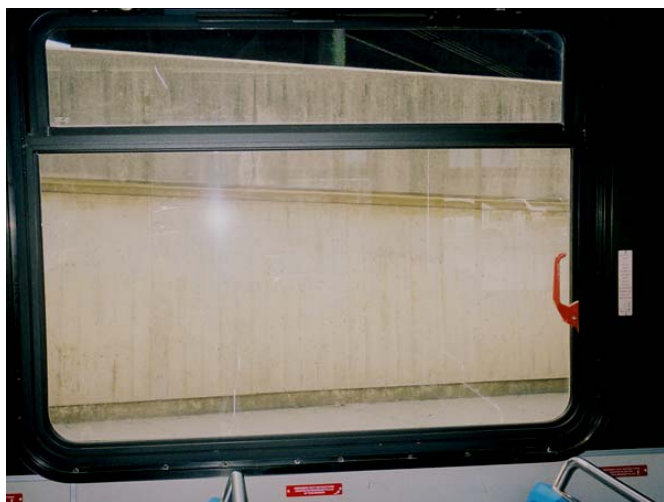
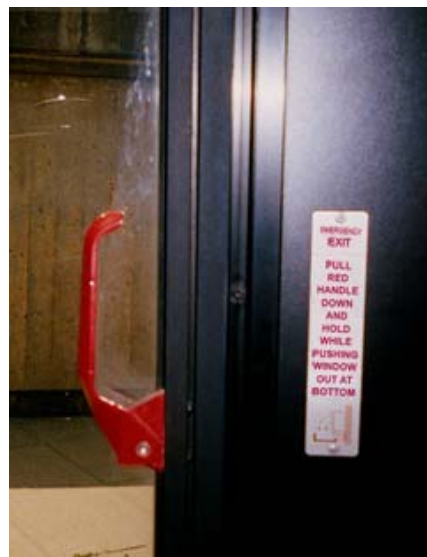
**Figure 8-7. Transit Bus Door and Window Emergency Exit Signage – Interior**

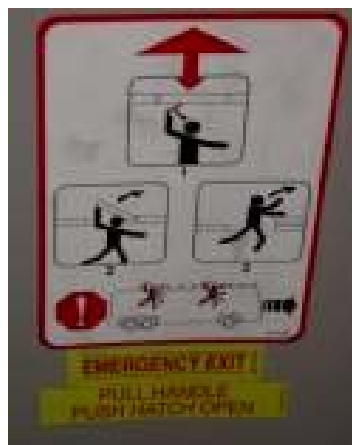
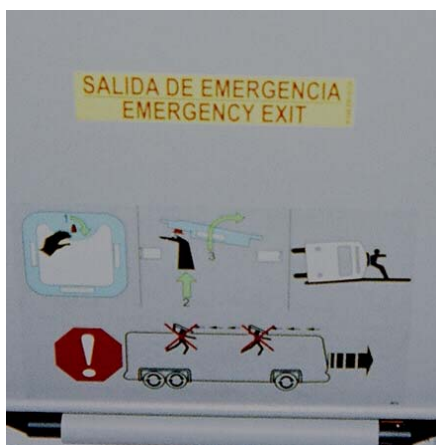
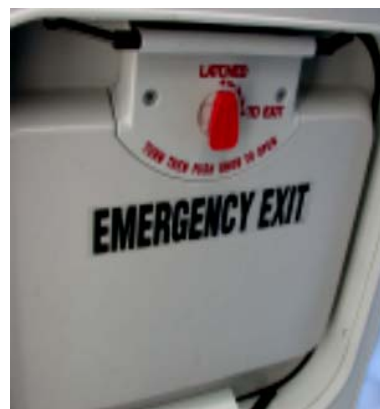
**Figure 8-8. Motorcoach and School Bus Emergency Roof Exit Hatch – Interior Signage and Instructions**

Motorcoach and school bus interior emergency roof exit emergency signage and instructions are shown in Figure 8-8. Emergency roof exit emergency signage and instructions can be unclear as shown in Figure 8-8a, which illustrates how a person might use the exit hatch to escape from an upright motorcoach. However, the hatch is needed primarily for egress from overturned coaches. Figure 8-8b has pictograms on the lower part of the roof exit hatch showing the bus on its side and how to use the hatch in that condition. Figure 8-8c shows the school bus roof hatch marked with the 5 cm-high (2 in) letters, as required by FMVSS 217.

a. MCI – older

b. MCI – newer

c. School bus

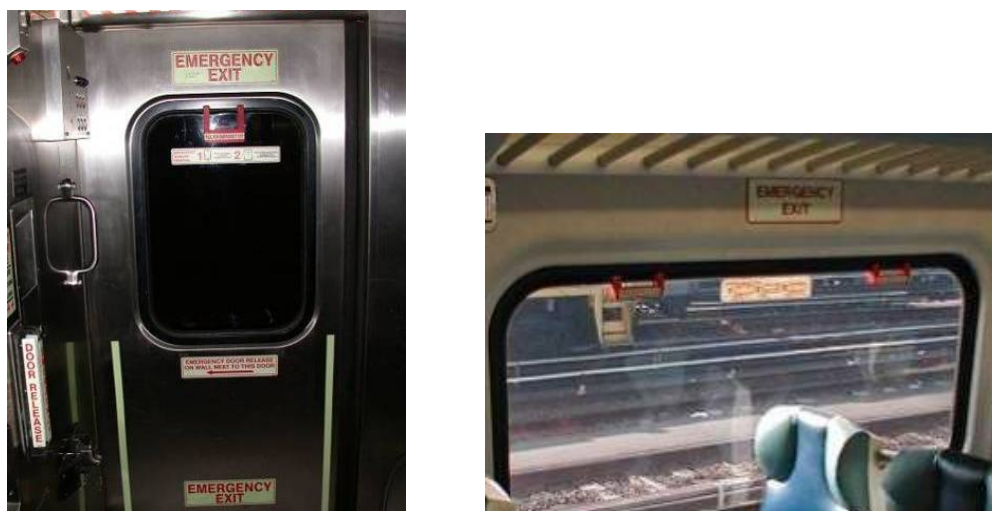
**Figure 8-10. Passenger Rail Car – Photoluminescent Emergency Exit Signage**

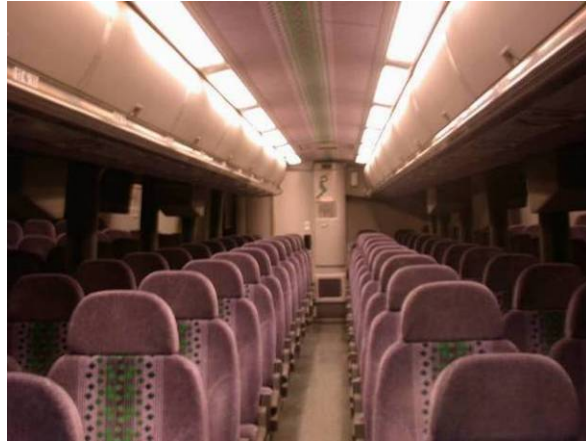
**Figure 9-1. Typical Motorcoach – Bright Fluorescent Lighting**

The two motorcoach models tested have two rows of fluorescent lamps arrayed on the ceiling that are used during loading and unloading (see Figure 9-1) to provide a relatively high level of illumination. Illuminance measured on the floor at the center of the aisle ranged from 140 to 320 lux (13 to 30 foot-candles) and from 53 to 90 lux (5 to 8.4 foot-candles) at the release mechanisms of the windows.

These levels of illumination provided by the overhead fluorescents and the reading lights where used are sufficient to make all of the emergency exit signage readable and to charge photoluminescent emergency exit signage, installed at armrest level. However, the reading lights direct their output downward, so that they do not provide sufficient charging light for signs

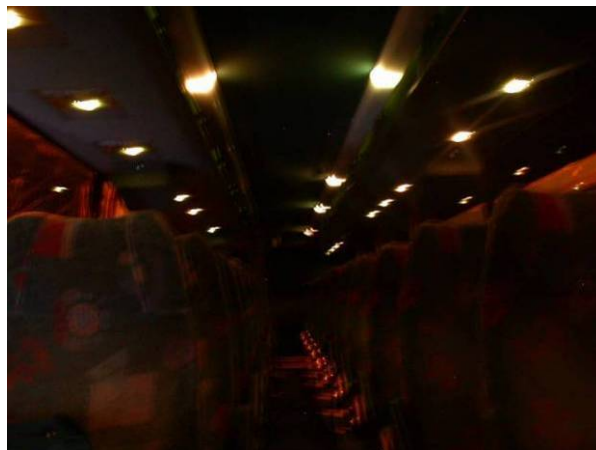
**Figure 9-2. Typical Motorcoach – Reading Lights On**

The reading lights located above every seat produced an illuminance of 75 to 100 lux (7 to 9 foot-candles) directly below the lamp (see Figure 9-2). Stray light from these lights yielded readings of a few lux (~0.5 foot-candle) in the aisle or on the emergency exit window releases near seats where the reading lamp was switched on. Under these conditions, the signage on the window sill or midway up the emergency exit window was readable, but the “Emergency Exit” sign located on the emergency window exit surface near the top was nearly invisible. (However, FMVSS 217 does not require that additional emergency sign.) Typically, many reading lights are in use by motorcoach passengers in the early part of the night, but all or nearly all are switched off after midnight. Figure 9-2 shows the presence of a few small ceiling lights above the aisle, which are also on this circuit.

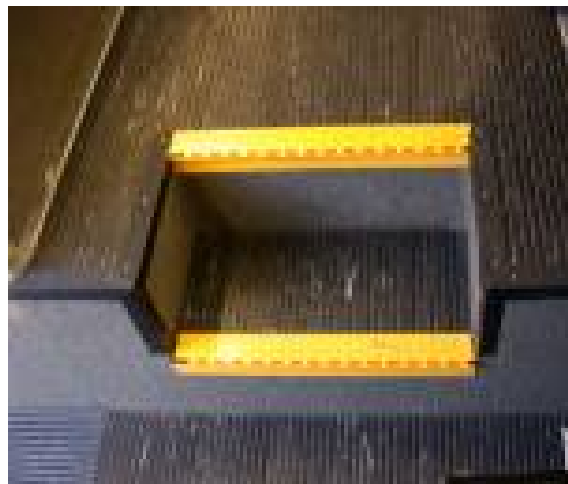
**Figure 9-3. Outline Lighting on Bus Step**

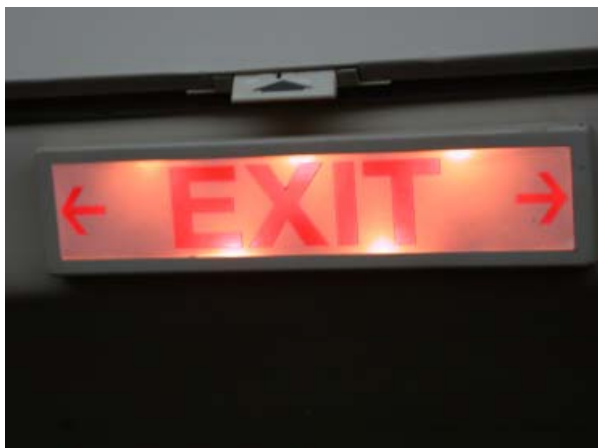
**Figure 9-4. Aircraft Electrically-Illuminated Emergency Exit Sign**

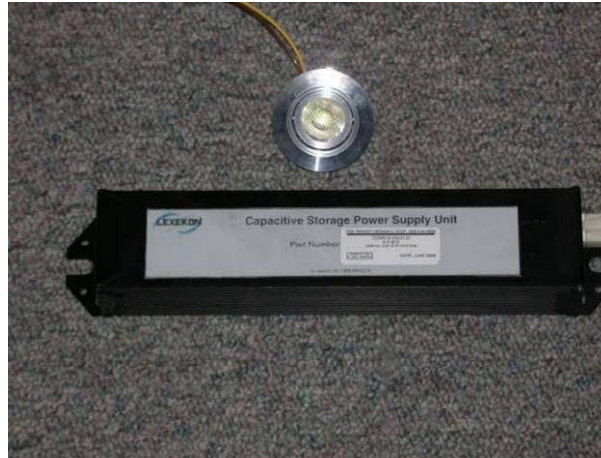
### Figure 9-7. LED Emergency Light with Capacitive Energy Storage
