Subject: Motorcoach Safety Research

# **Human Factors Issues in Motorcoach Emergency Egress**

## **INTERIM REPORT 1- FINAL**

August 2009

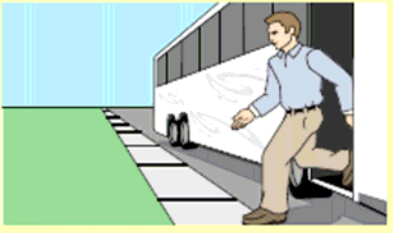
### Lift Window Instructions

| EMERGENCY EXIT LOCATIONS/OPERATION | | EMERGENCY CONTACT |
|---|---|---|
| | The primary exit is the door at the front of the vehicle through which you entered. | <ul style="list-style-type: none"><li>■ If necessary, notify authorities of an emergency situation by calling <b>911</b>.</li></ul> |

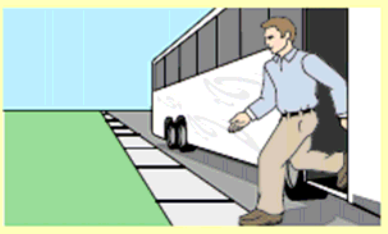
### Pull Window Instructions

| EMERGENCY EXIT LOCATIONS/OPERATION | | EMERGENCY CONTACT |
|---|--|---|
| <p>The primary exit is the door at the front of the vehicle through which you entered.</p> | | <ul style="list-style-type: none"><li>■ If necessary, notify authorities of an emergency situation by calling 911.</li></ul> |

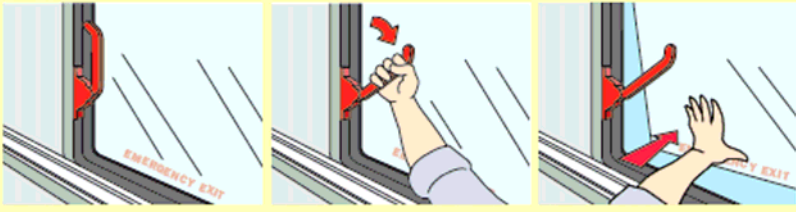
| EMERGENCY EXIT LOCATIONS/OPERATION | | EMERGENCY CONTACT |
|---|--|---|
| <p>Designated windows are marked as emergency exits and push out to open. Follow the marked instructions to release the lock and open the window.</p> | | <p><b>DRIVER DIRECTIONS</b></p> <ul style="list-style-type: none"><li>■ In the event of an emergency, remain calm and follow the driver's instructions.</li><li>■ If you are able, assist the driver with evacuating passengers with disabilities.</li></ul> |

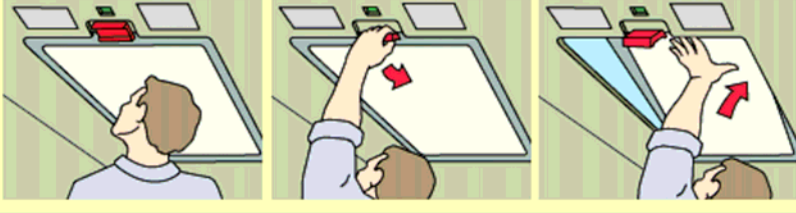
| EMERGENCY EXIT LOCATIONS/OPERATION | | EMERGENCY CONTACT |
|---|--|---|
| <p>At least one roof hatch, located above the aisle, is also available as an emergency exit. Follow the marked instructions to open the roof hatch.</p> | | <p><b>LOCATION OF FIRE EXTINGUISHER</b></p> <ul style="list-style-type: none"><li>■ A fire extinguisher is on-board. It is usually located toward the front of the vehicle behind the driver's seat, underneath a passenger seat on the right hand side, or in an overhead compartment.</li></ul> <p><b>RESTROOM EMERGENCY BUTTON OR SWITCH</b></p> <ul style="list-style-type: none"><li>■ If you are in the restroom and need assistance, use the emergency button or switch to alert the driver.</li></ul> |
