TECHNICAL NOTE

FRA/ORD/95-67

TRIAL LOW TRACK MODULUS TESTS AT FAST

W. Ebersöhn, E. T. Selig, and M.C. Trevizo

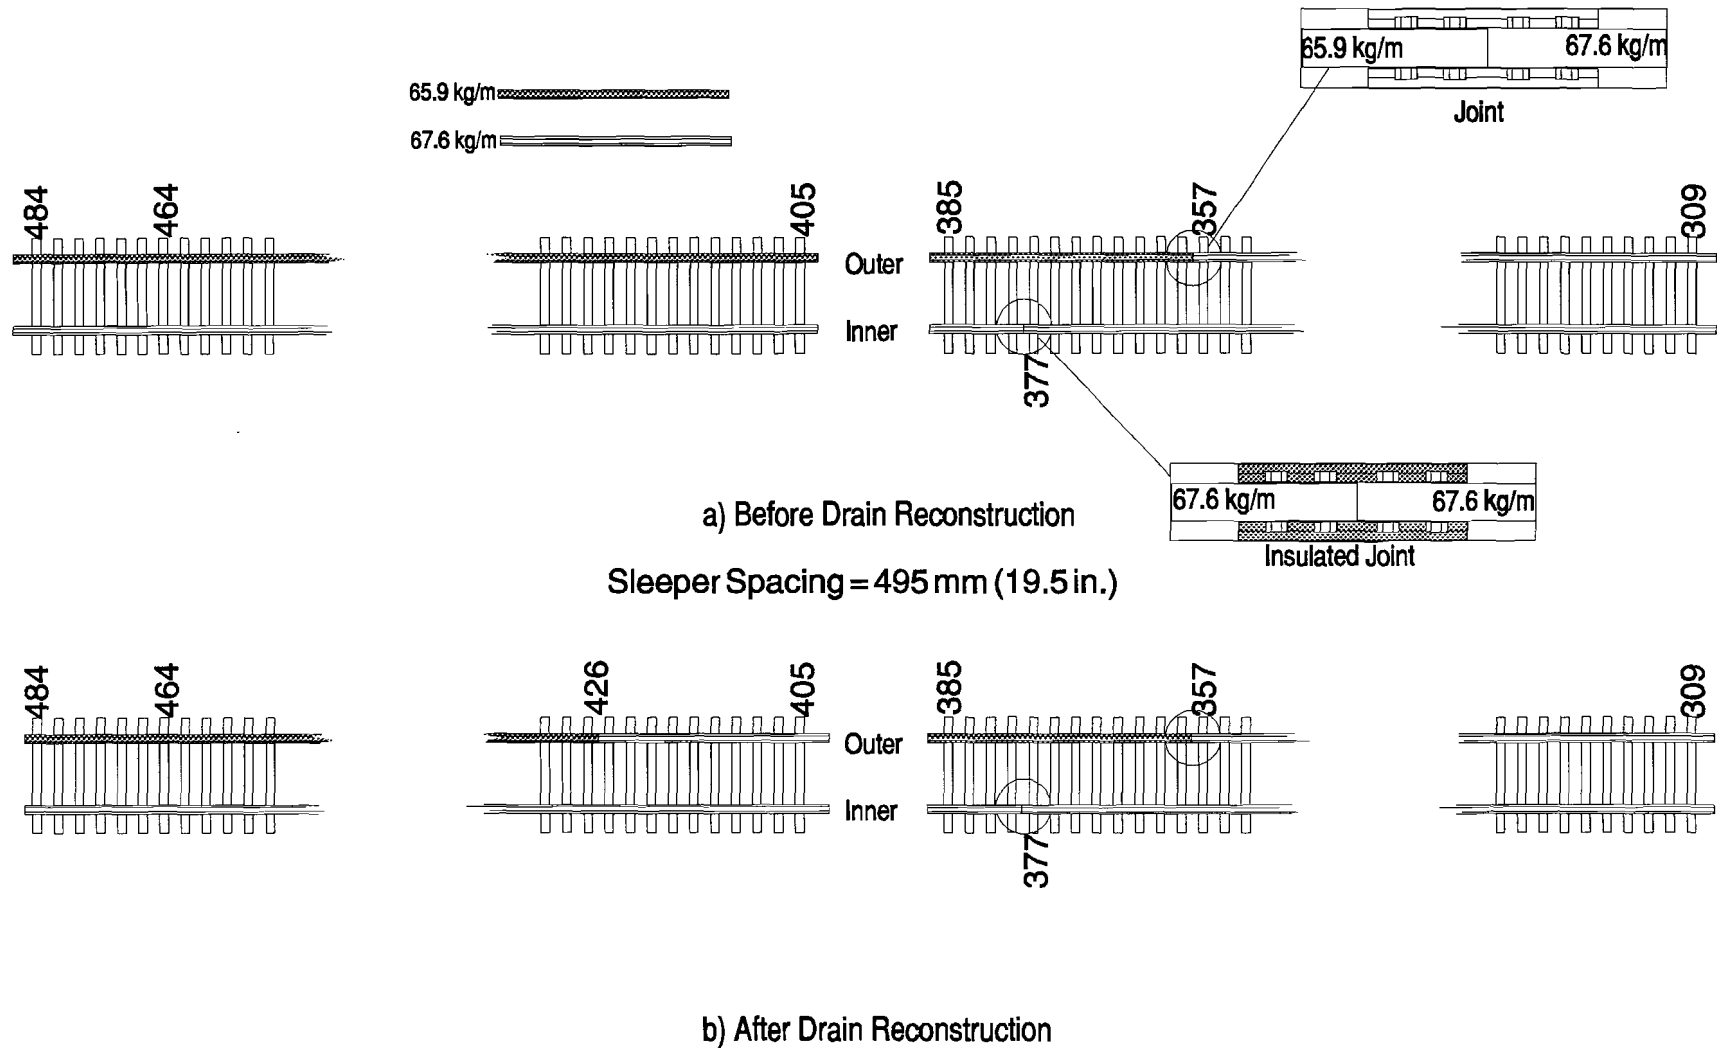
Figure 5: Tie Numbering and Joint Positions

At 39.15 MGT (May 28, 1991), a track panel was removed from tie 426 to tie 405 to construct a cross drain in the clay test section. The track panel was replaced with only 67.6 kg/m (136 lb/yd) rails. Figure 5 shows the rail weights and joint positions for each test section as well as the change in superstructure after the drain construction.

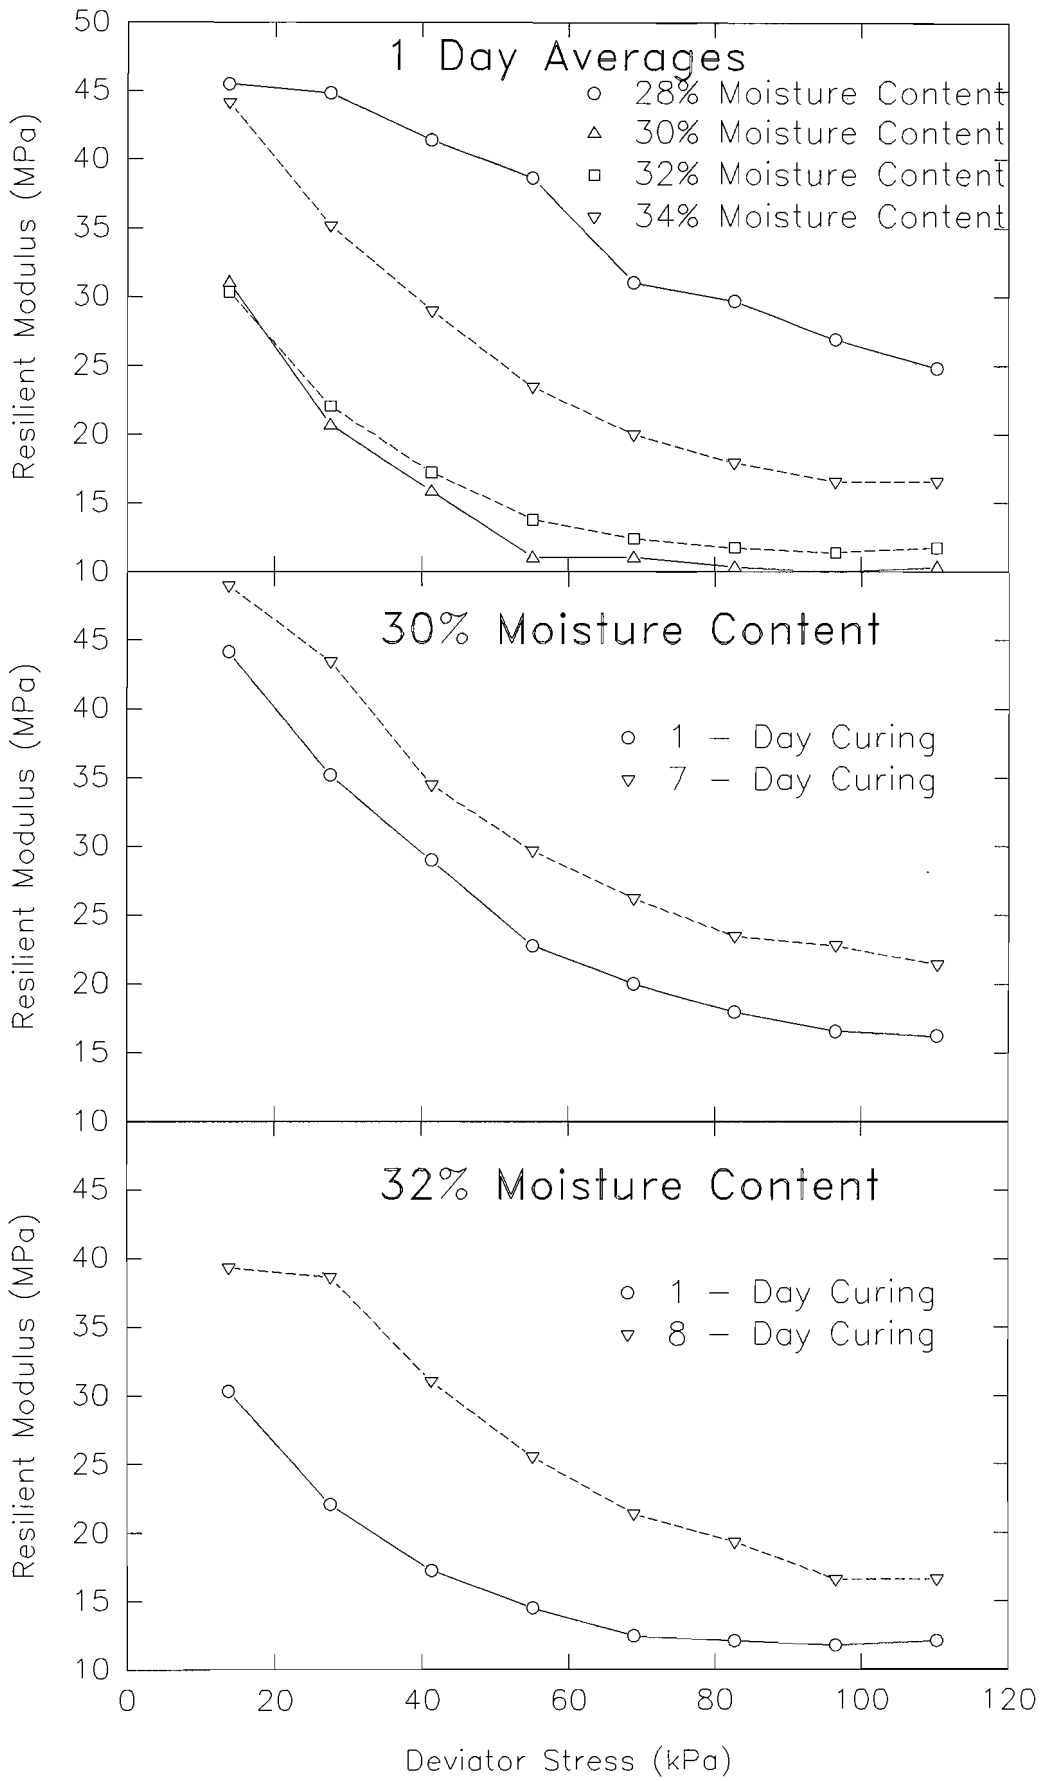
Figure 11: Clay Resilient Modulus

Figure 11 presents the resilient modulus test results obtained by Thompson⁷ on the subgrade clay. The shape of the curves changes with the moisture content, compaction and loading condition, as described by Selig.⁸

Table 8: Clay Subgrade Material Properties		
Property	Coleman⁶	Thompson⁷
ASTM Identification	Very plastic clay	
Unified Classification	CH	
PI	45	
LL	67	
Natural Moisture Content (%)	35	
Specific Gravity	2.7	
Resilient Modulus		Refer to Figure 11
Optimum Moisture Content (%)	22.8	
Maximum Dry Density, kg/m ³ (pcf)	1,472 (91.9)

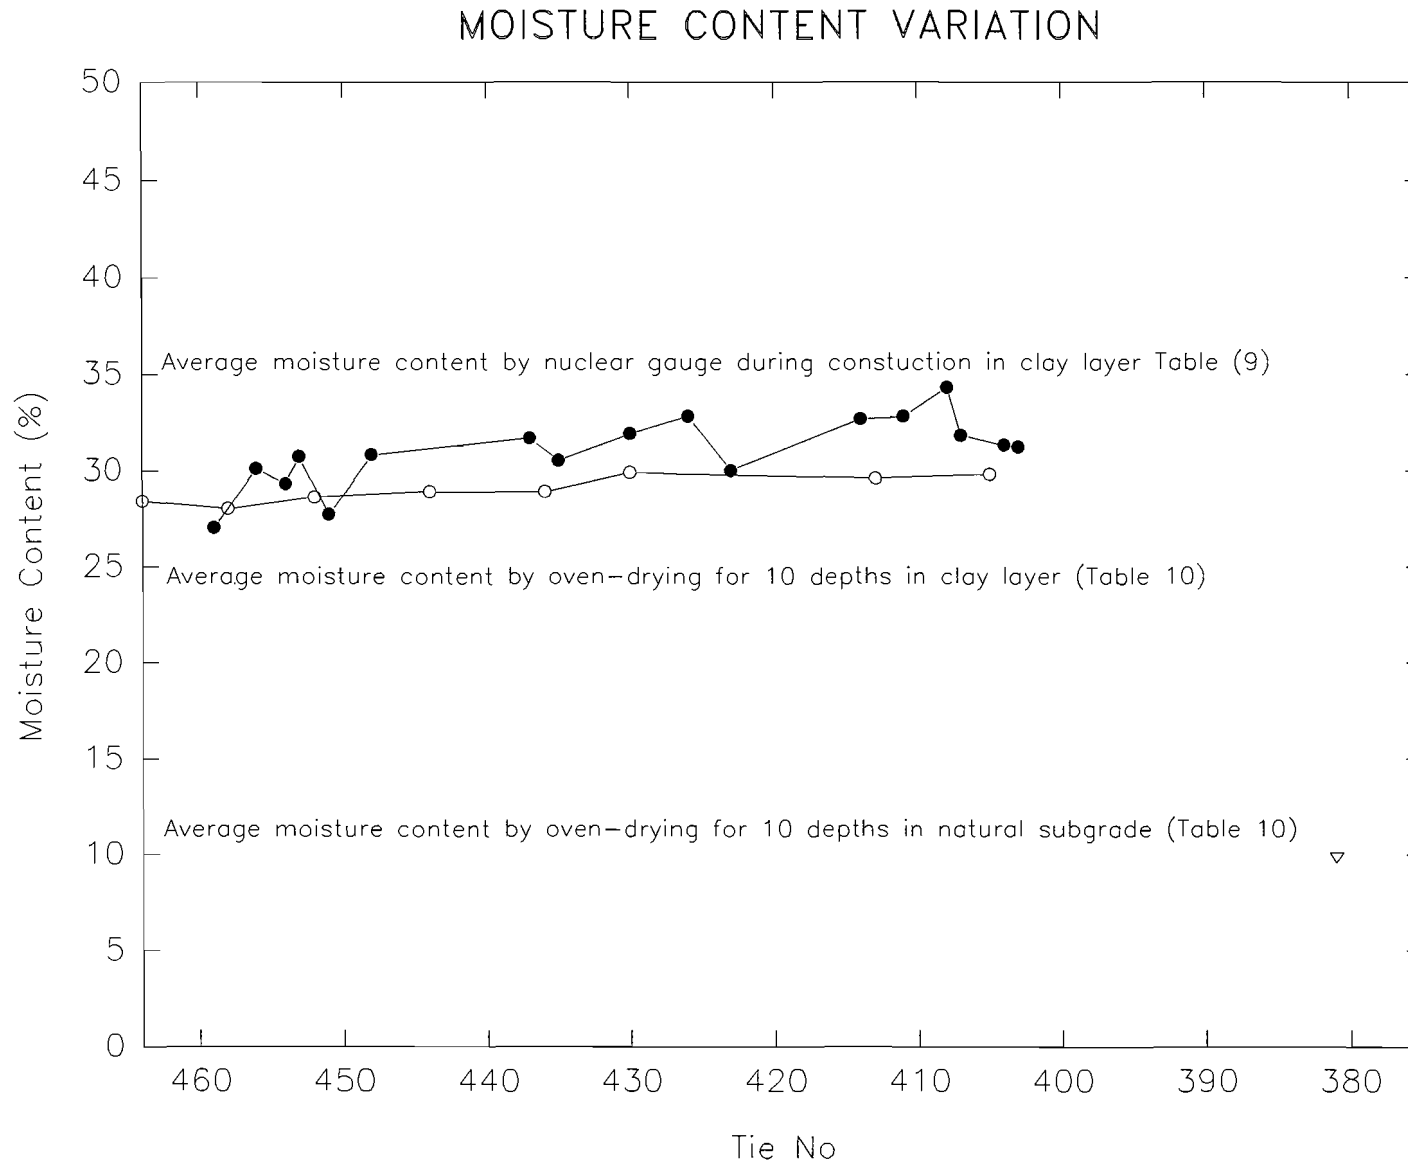
Figure 14: Moisture Distribution in Subgrade

The moisture contents, after TLTM experiment, were measured by taking 25 mm (1 in.) hand auger samples at selected tie locations every 150 mm (6 in.) in depth. Table 10 lists the average and range of moisture readings for each tie location. Figure 14 gives an indication of the moisture content distributions along the length of the sections based on Tables 9 and 10.
