JRC2010-3602

UPDATE ON ALTERNATIVE OCCUPANT VOLUME TESTING

Michael Carolan
Michelle Priante Muhlander
Volpe National Transportation Systems Center
US Department of Transportation
Cambridge, MA 02142

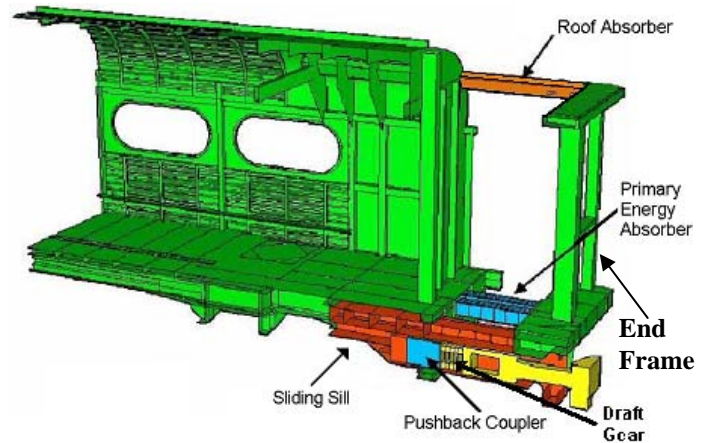
Figure 2 is a schematic figure of the CEM system on the Pioneer car in its undeformed state. During a collision, loads travel through the pushback coupler and its energy absorber to load a set of shear bolts between the fixed and sliding sills at the floor level and into a set of shear rivets at the roof level. The fixed sill is integrated into the underframe of the car, transmitting loads into the body bolster and center sill of the car. For this quasi-static test, the coupler and all energy-absorbing elements can be removed. However, the end frame,

sliding sill, and roof absorber tubes must still be attached to the floor and the roof of the car to ensure a complete structure.

Figure 2 - Schematic View of CEM System

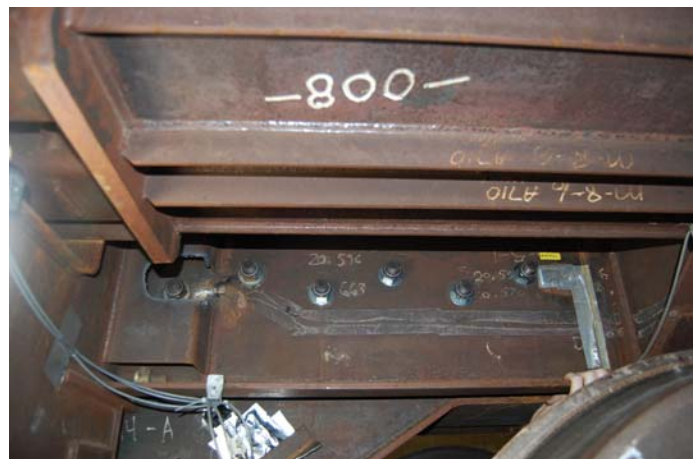
At each end of the car, the fixed sill and sliding sill are connected to each other by 12 bolts. As a trigger to the CEM system, these bolts are designed to fail at a prescribed load. The bolt pattern is shown below in Figure 3 for one side of one fixed sill. The replacement bolts used in the repair of the sliding sill are 1-inch (in) A490 bolts. These bolts have an approximate shear load of 80,000 lb. This gives a shear strength of approximately 960,000 lb to the connection between fixed and sliding sills at each end of the car.

Figure 3 - Shear Bolt Pattern on Fixed/Sliding Sill Connection

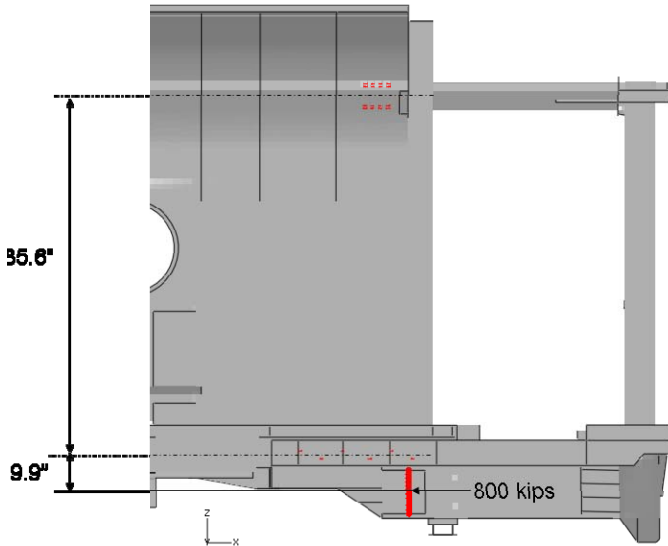
For the compressive strength test, the load of 800,000 lb is to be placed at the buff lugs, within the draft sill. This places the load approximately 9.9 in below the centerline of the shear bolts. The centerline of the shear bolts is approximately 85.6 in below the centerline of the Huck rivet arrangement. This cross-section of the car is shown below, in Figure 4.

Figure 4 - Static Load Diagram

Because of the moments generated by the 800,000-lb load, the end frame will tend to pull out of the roof tube. This causes a tensile load in the shear rivets. Accordingly, the shear bolts at the fixed-sliding sill connection will experience a compressive load magnitude of greater than 800,000 lb. On the basis of the geometry of the Pioneer car, the roof experiences a tensile load of approximately 92,500 lb and the floor compressive load is approximately 892,500 lb.

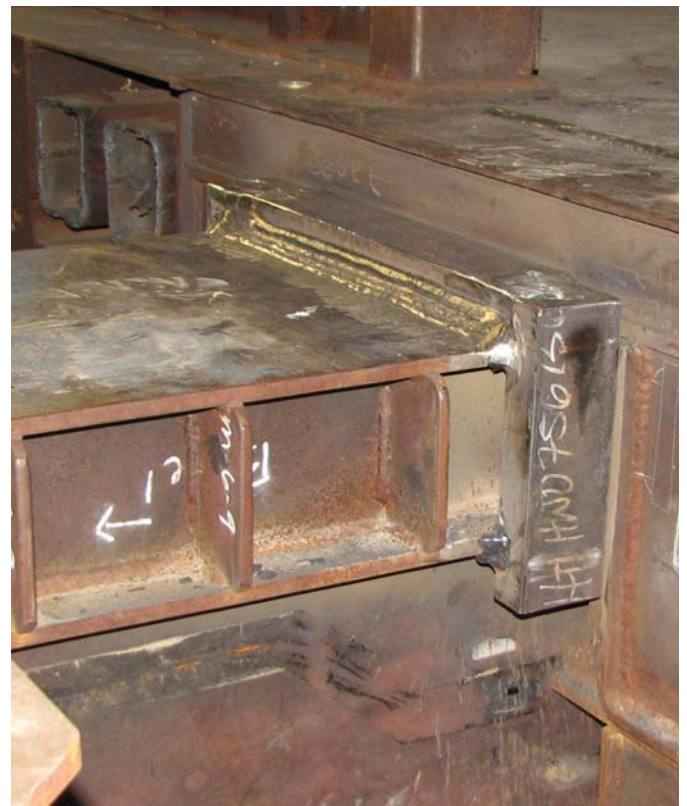
Another solution is to slightly alter the load path between the sliding sill and fixed sill, providing some relief to the amount of load traveling through the bolts. After reviewing various arrangements of increasing the load path between the fixed and sliding sills, the final configuration of interference blocks was chosen. This pattern features a steel block welded across the top of the sliding sill and two vertical blocks welded to the sides of the sliding sill. When the shear bolts are loaded, the interference blocks come into contact with the outboard cross-member of the underframe. This allows the load to be shared between the shear bolts and interference blocks. The blocks can be seen in Figure 5.

Figure 5 - B-end Interference Blocks

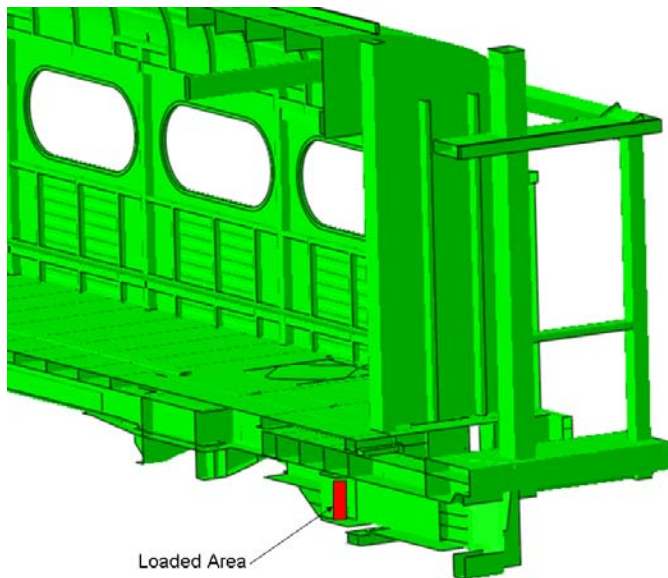
The commercial FE software Abaqus/CAE was used to modify the existing model [11]. The analyses that were performed were quasi-static and executed in Abaqus/Explicit. Loading was implemented by placing a pressure on the structure within the sliding sill of the car. This pressure was gradually increased with time such that the total force increased to 800,000 lb. The loaded area is shown in Figure 6.

Figure 6 - Loaded Area on Sliding Sill

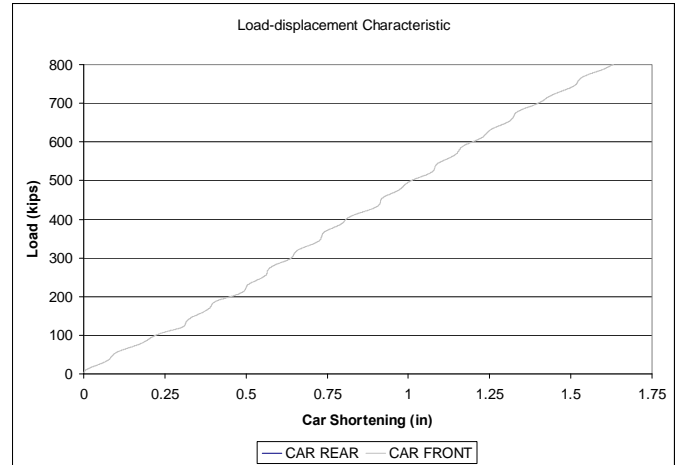
Force-displacement data were obtained during the simulated loading. Displacement data were recorded at the nodes making up the loaded area, whereas reaction force data were obtained at the midplane of symmetry. The applied force was calculated based on the applied pressure as a function of time. For quasi-static simulation, it is expected that the reaction forces at the front and rear of the car should be the same. The load-displacement characteristic obtained by the pretest FE analysis is shown in Figure 7.

Figure 7 - Pretest FE Load-Displacement Prediction

On the basis of the pretest FE analyses, the overall decrease in carbody length is estimated at approximately 1.6 in when a load of 800,000 lb is applied. In addition to this longitudinal shortening of the car, the analysis is predicting a deformation mode where the center of the car lifts upward relative to the end of the car. At 800,000 lb, the maximum uplift of the center sill is predicted to be approximately 2 in. Additionally, the two ends of the car are expected to shift vertically downward toward the ground. The deformed mode shape is shown in Figure 8, with the vertical scale of the image exaggerated by a factor of 10 for emphasis and a dashed line indicating the nominal starting level of the underframe.

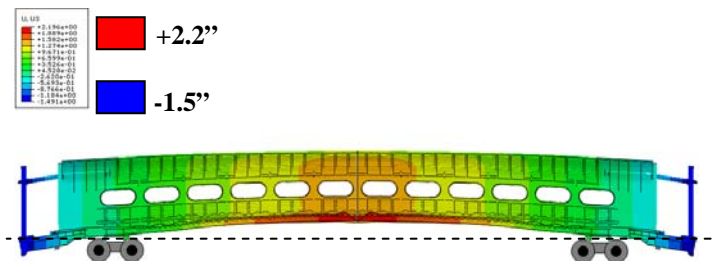
Figure 8 - Predicted Vertical Deflection (exaggerated 10x)

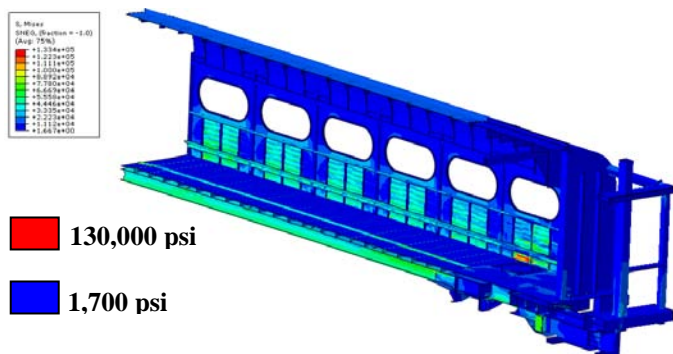
In addition to providing an estimated load-displacement behavior for the Budd Pioneer car, the pretest FE analysis was used to assist in placing instrumentation on the car. The FE analysis indicated potential areas of high strain where instrumentation placement would be critical. Figure 9 shows a contour plot of von Mises stress in the carbody under the 800,000-lb load.

Figure 9 - Contour Plot of von Mises Stress, 800,000 lb

As seen in the previous figure, the model is predicting an increase of stress in the sidewall at the location of the body bolster. In addition to featuring the body bolster in the underframe, the side sill undergoes a change in cross-section in this area. In response to this prediction of high stress, strain gages were placed accordingly on the structure.

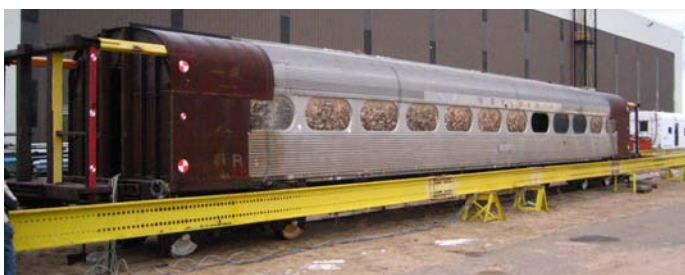
Longitudinal restraint is provided through the test frame. The frame consists of two W-sections running the length of the car. At the A-end, a crosshead with hydraulic ram is fixed to ground. At the B-end of the car, a crosshead is attached between the two parallel beams. This crosshead has a block attached to it, which contacts the buff stops within the B-end sliding sill of the car.

Figure 10 - Budd Pioneer Car in Test Frame

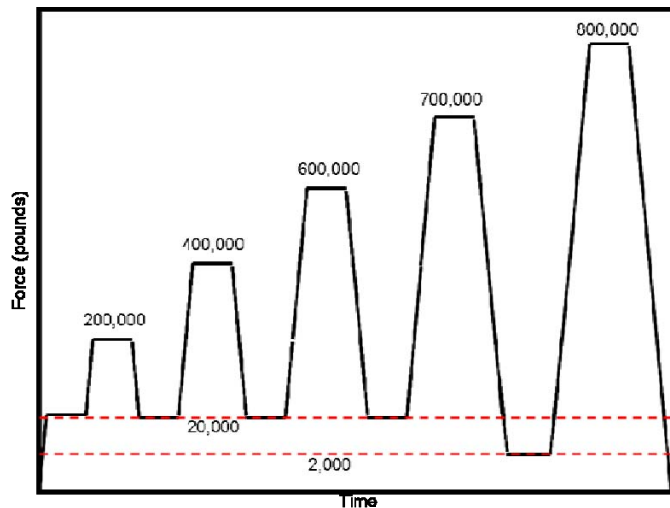
The 800,000-lb test is designed to be a quasi-static test of the occupant volume strength of the car. During the test, load is applied to the buff stops at the A-end of the car by a hydraulic ram. The ram was displacement controlled with a target load rate of less than 1 in per minute (min). In accordance with APTA SS-C&S-034-99 rev 2, the load magnitude was increased in a number of steps. The load was held at each target value for at least 1 min before being decreased to allow for safe inspection of the vehicle structure. The target load versus time diagram is shown schematically in Figure 11.

Figure 11 - Target Force-Time History

Once the carbody had been loaded to 700,000 lb, the load was decreased to a value no greater than 2,000 lb, in accordance with APTA procedures. After the target load of 800,000 lb had been reached, the load was completely removed from the carbody. At that point, residual deformation of the unloaded carbody could be measured.

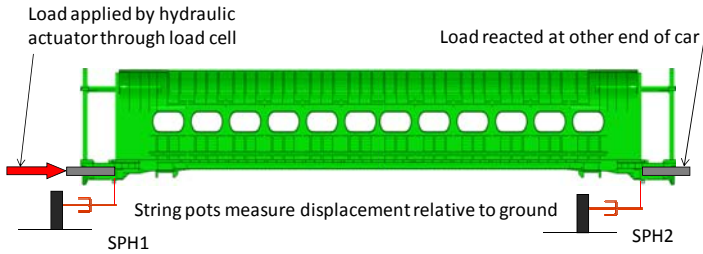
Instrumentation was placed on the carbody to record global structural response to the applied load as well as strain behavior in selected areas of the structure. The global behavior of greatest interest is the force-displacement characteristic. The applied force was measured by a 1,000,000-lb capacity load cell placed between the hydraulic ram and the buff stops on the live end of the car. Displacement was recorded as total decrease in car length. This was measured by string potentiometers placed at both ends of the car, as shown in Figure 12. The difference between these two measurements provides overall change in length of the car.

Figure 12 - Longitudinal String Potentiometers

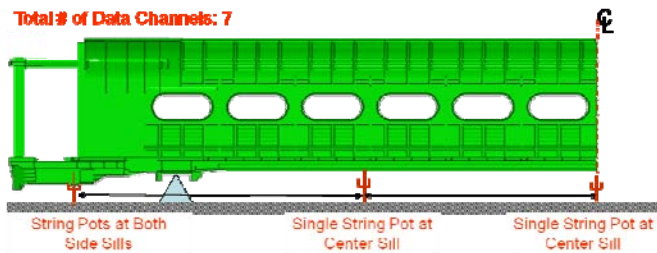
Another key global output for the carbody response is the bending mode of the structure. This value was measured by recording the vertical deflection of the underframe with respect to the ground at different cross-sections along the length of the car. A series of string potentiometers were attached between the underside of the car and the ground, as shown in Figure 13. This figure shows one-half the length of the car; a similar string potentiometer arrangement was used on the other half of the carbody for a total of seven vertically-mounted string potentiometers.

Figure 13 - Vertical String Potentiometers

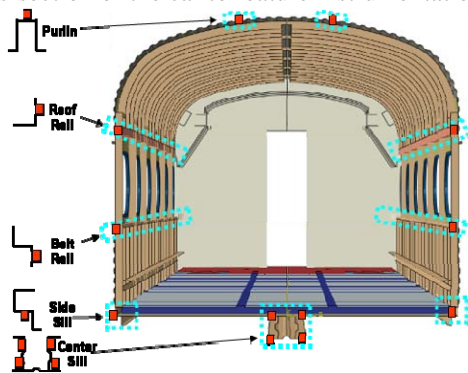
In addition to the global behavior of the car, strains at specific cross-sections of the occupant volume were recorded. Uniaxial strain gages were placed on the center sill, side sills, belt rails, roof rails, and purlins of the car. These members are shown schematically in Figure 14. This figure also indicates the location of the strain gage on each cross-section with a rectangle. Strain results at these members give an overall indication of the state of stress within the occupant volume at each cross-section of the car to feature instrumentation.

Figure 14 - Cross-Section Showing Longitudinal Members

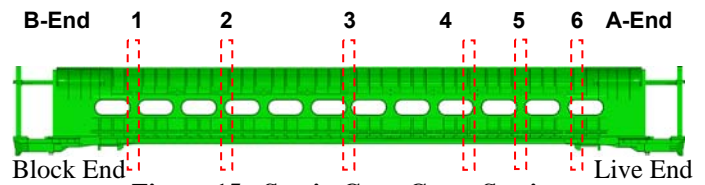
Strain gages were placed on the occupant volume at six different cross-sections of the car so that the state of stress along the length of each member could be evaluated. These locations are shown in Figure 15. At cross-section 6, instrumentation was placed only at the belt rail and side sill. Pretest FE analysis indicated a likely high stress in the sidewall of the car in this area, warranting additional instrumentation.

Figure 15 - Strain Gage Cross-Sections

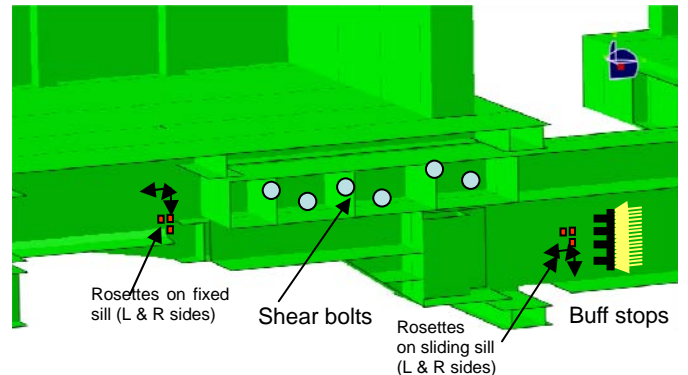
In addition to longitudinal uniaxial strain gages, three-axis strain rosettes were placed at locations on the fixed and sliding sills. These locations were expected to have high levels of strain based upon pretest FE analysis predictions. A total of eight rosettes were used on the car, one each at the left and right fixed and sliding sills on both ends of the car. The rosette placement is shown schematically in Figure 16 for one end of the car. This image shows a one-quarter symmetric view of the car taken from the FE model.

Figure 16 - Strain Rosette Locations

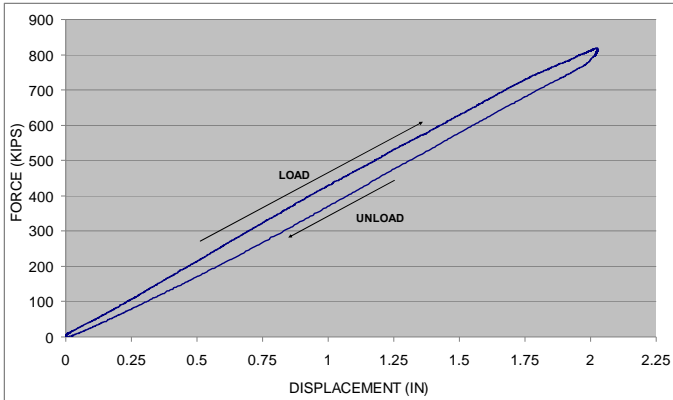
Globally, the car behaved as predicted by the pretest FE analysis. At a load of 800,000 lb, the carbody shortened by approximately 2 in, while the pretest analysis estimated a shortening of 1.6 in. The 800,000-lb test load-displacement characteristics are shown in Figure 17 for the load and unload cycle.

Figure 17 - Test Data, 800,000-lb Load Cycle

The top portion of this characteristic is the loading of the car and the lower portion of the characteristic is the unloading. The slope remained approximately linear until about 700,000 lb. From 700,000 to 800,000 lb, the slope softens slightly. An unexpected result of this test is the unloading characteristic of the car. For an elastic beam, the unloading characteristic is expected to overlay the loading characteristic. Also, the displacement measurement returns to zero at the end of the test, which is indicative of an elastic beam. Further analysis of the force-displacement data is required to better understand the car's behavior.

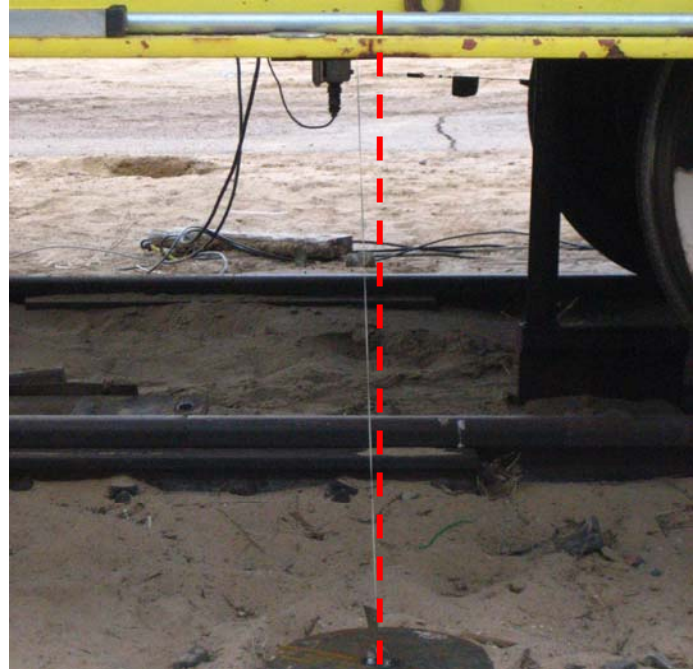
During the test, the vertically mounted string potentiometers were observed to be measuring deflection in both the vertical and longitudinal directions because of longitudinal motion of the car at the points of attachment. Additionally, lateral motion of the carbody is likely to have occurred at higher load magnitudes. Although the shortening of the car was initially assumed to be an insignificant source of error, analysis has been conducted to resolve each string potentiometer's data into longitudinal and vertical components. Figure 18 shows one vertical string potentiometer while the carbody is loaded. The dashed line was added to indicate the vertical condition.

Figure 18 - String Potentiometer Showing Offset

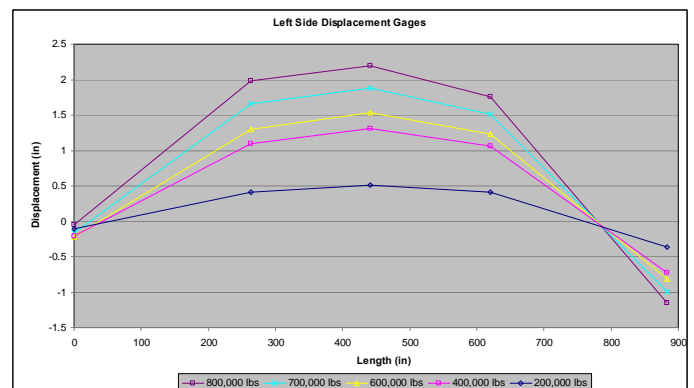
A key measure in observing the mode of deformation during the test is the vertical displacements of the carbody along its length. Figure 19 shows the vertical displacement measurement along the length of the car, recorded during the 800,000-lb load cycle. The horizontal axis has its origin at the vertical string potentiometer at the blocked end of the car. As predicted in the pretest model, the ends of the car slightly dip downward. The center of the car progressively rises during the test.

Figure 19. Vertical Displacement Measurements

On the basis of the posttest analysis of the displacement transducer data, the values shown in this figure have been adjusted to remove effects associated with longitudinal motion of the carbody at the string potentiometer attachment points. These data are undergoing further analysis and may require additional adjustment to account for lateral displacement effects.

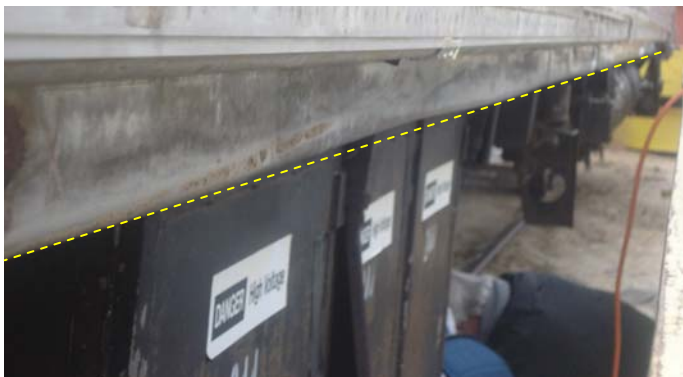
Before the test, a dent was observed in one of the side sills. The damage was to the lower part of the sill, shown in Figure 20. At the maximum static load of 800,000 lb, the dent in the side sill was observed to be visibly larger. After the load was reduced, the dent was observed in the side sill in greater detail. There was no other side sill damage observed as a result of the 800,000-lb test. Figure 21 shows a posttest photos of the side sill damage taken from the side. Figure 22 shows the same side sill viewed from underneath the car. In all photos, the dashed line has been added for clarification.

Figure 20 - Pretest Photo of Side Sill Damage

On the basis of the observations made during the test and a preliminary analysis of the test data, the car appears to have sustained permanent deformation to an area of the side sill where damage was known to exist. This test was run to evaluate the fitness of this car for additional testing and demonstrate a stable mode of deformation under 800,000 lb of applied load. This car will be used in the next two tests of occupant volume integrity as an example of an 800,000-lb compliant car subject to loading along the collision load path.

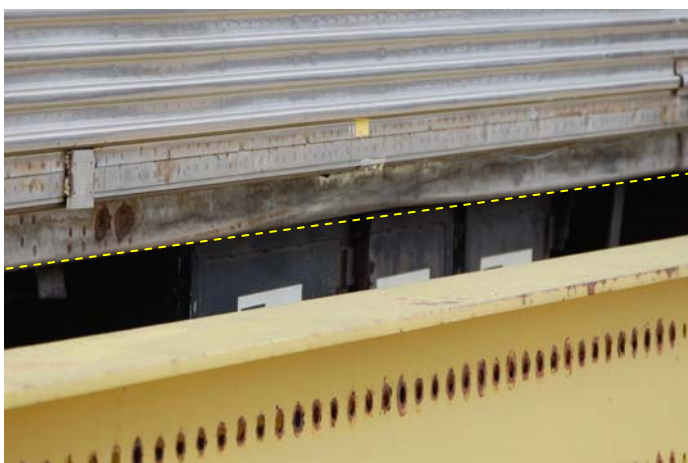
Figure 21 - Posttest Photo of Side Sill Damage

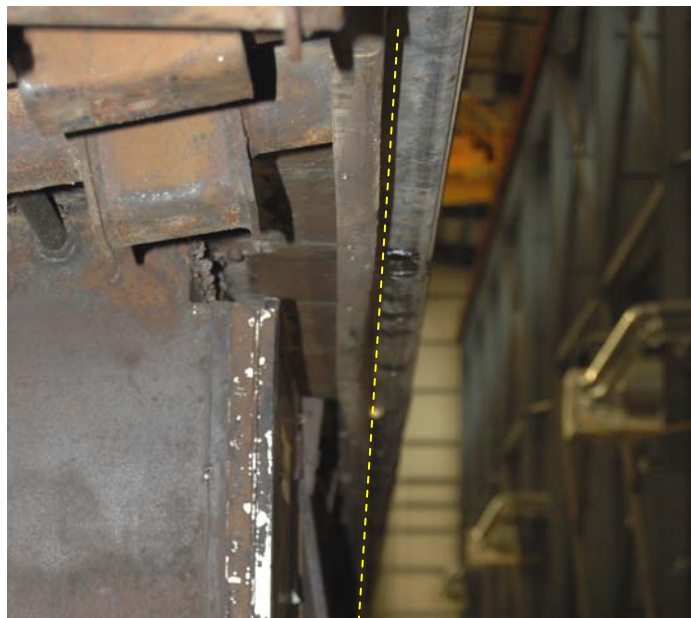
Figure 22 – Posttest Photo of Side Sill Damage from Below
