JRC2013-2546

FINITE ELEMENT ANALYSIS AND FULL-SCALE TESTING OF LOCOMOTIVE CRASHWORTHY COMPONENTS

ABSTRACT

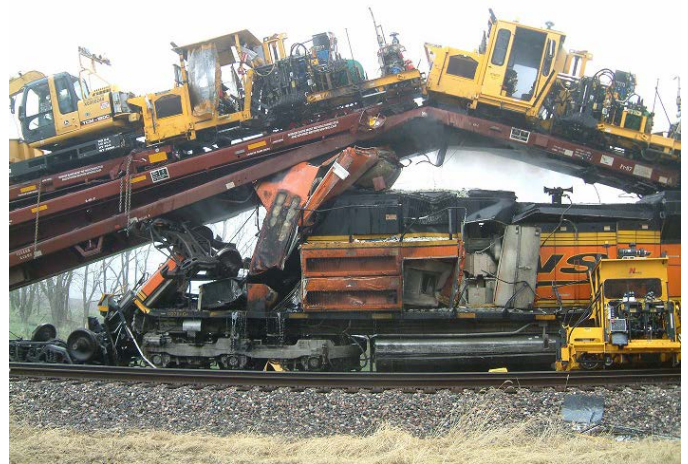
Figure 1. Red Oak, Iowa Collision, April 17, 2011

As seen in Figure 1, the accident resulted in several maintenance-of-way equipment cars overriding the impacting locomotive. The photograph shows the impacting locomotive's modular crew cab was detached and partially crushed as a result of being overridden, resulting in two fatalities. In order to be effective, an anti-climber must engage the end structures of opposing equipment and provide sufficient vertical load carrying capacity to prevent such override.

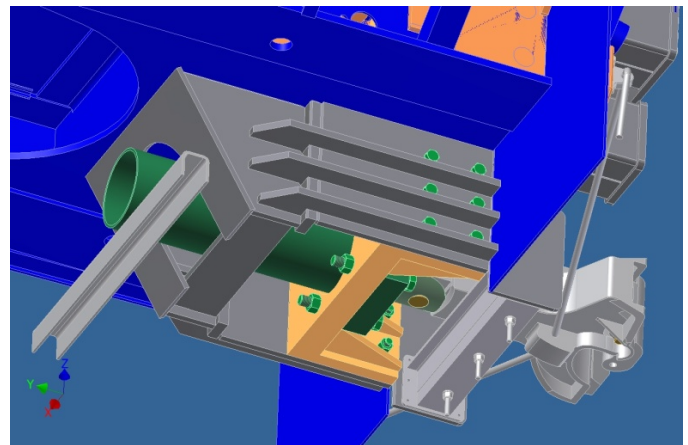
Figure 2. View of the shear bolts (green) that attach the push-back coupler to the sides of the draft gear pocket

The draft gear pocket has been redesigned to provide more than 10 inches of additional stroke. The push-back coupler is attached to the draft gear pocket by the coupler support assembly (shown in yellow in Figure 2) with 12 shear bolts, six on each side. The six shear bolts on the right side are shown in Figure 2 in green. These bolts are designed to fail at a total load of approximately 1,000,000 lbf once the energy-absorbing stroke of the push-back coupler has been exhausted, thereby shifting the load path from the push-back coupler to the deformable anti-climber.

After the shear bolts fail, the entire coupler support assembly, or 'sliding lug', slides back, so that the load through the coupler is effectively zero. As is shown in Figure 2, the back of the draft pocket has structure built into it that will capture the sliding lug after 10 additional inches of push-back.

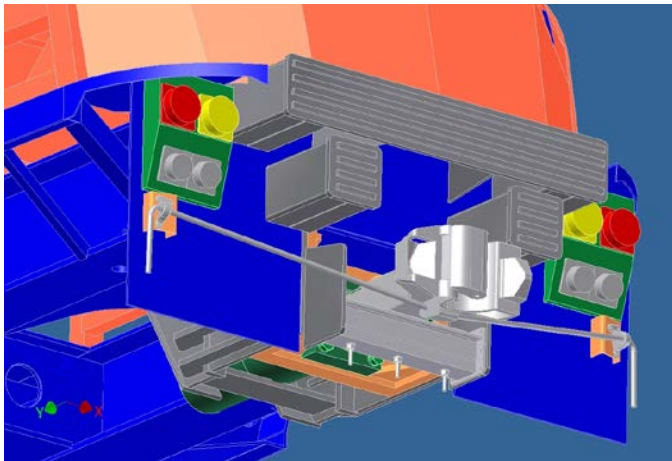
The design for the deformable anti-climber employs four progressive buckling tubes (crush tubes) welded onto the front plate of the locomotive: two tubes located at the base of the short hood, and two tubes located beneath them. Figure 3 shows a detailed view of the deformable anti-climber/pushback coupler system.

Figure 3. Detailed view of the deformable anti-climber/push-back coupler system

In a collision with a conventional locomotive, the upper crush tubes are designed to interact with heavy gussets that are welded to the front plate of the locomotive as part of the conventional anti-climber. The upper crush tubes are connected laterally by a ribbed front plate. This plate is designed to resist the upward motion of the coupler of a colliding vehicle to help prevent override. Together with the upper set of crush tubes, it is designed to withstand a 100,000 lbf vertical load at any time during the crush process. In the event of a collision with a cab car, this plate also interacts with the collision posts at the end of the cab car, allowing the upper crush tubes to absorb energy. The lower set of crush tubes is designed to interact with the buffer beam of a colliding cab car. In a collision with a conventional locomotive, these tubes do not participate in the

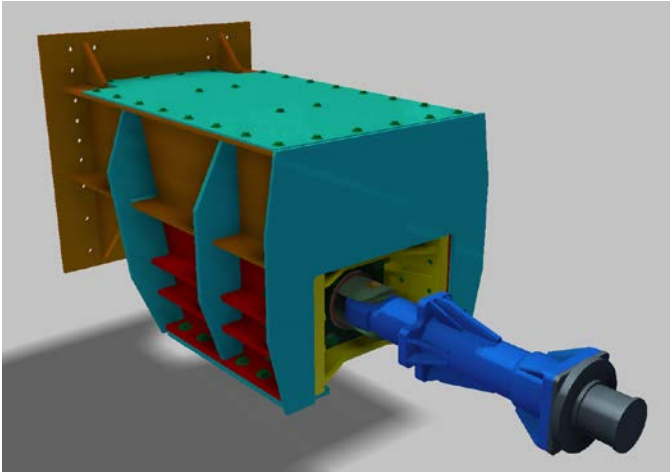
The push-back coupler test article model is pictured in Figure 4. It comprises a support assembly that features two I-beams that are welded to a large back plate and reinforced with triangular gussets. A top plate is bolted across the top flanges of the I-beams and a bottom plate is welded between the bottom flanges. Side plates are welded to the bottoms of the I-beams and reinforced with horizontal stiffener plates. A front plate and two sets of gussets (one vertical and one angled back) provide further stiffness to the support assembly.

Figure 4. The push-back coupler test article

The push-back coupler is mounted to a sliding lug assembly (indicated in yellow in Figure 4), that is in turn bolted to the side plates using 12 specially-designed shear bolts. A coupler extension (shown in blue) is connected to the coupler through use of a standard coupler pin arrangement. A feature has been added to the coupler extension so that, when the total stroke of the coupler reaches 18" (457 mm), the back surface of the feature will impact the front surface of the sliding lug mounting block, thereby causing the load to spike and shear off the bolts. Once the bolts have broken, there is no further mechanism of energy absorption, and the force drops to zero.

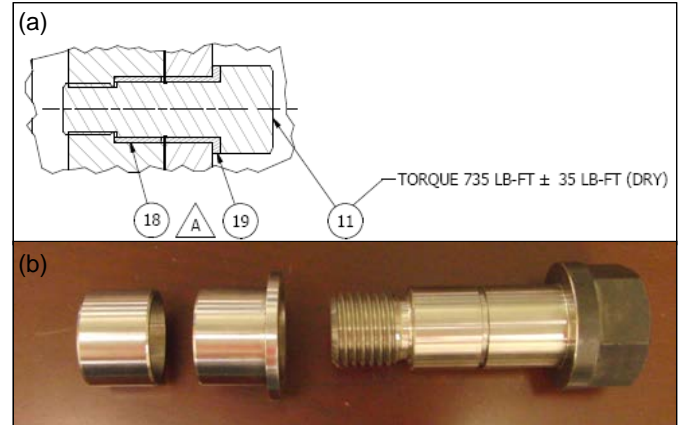
The shear bolts have been designed so that they break at a design load of $12 \times 88 \text{ kips} = 1,056 \text{ kips}$ (4,700 kN). A detail from a drawing that shows the shear bolt connection arrangement is pictured in Figure 5(a). A shear bolt is pictured in Figure 5(b) together with its two bushings. The front of the extension is bolted to a 'tup' — a 6-inch round cylindrical impactor that is slightly rounded at its forward end and includes a 5,000 kN (1,125 kips) load cell. The push-back coupler test article weighs approximately 6,600 lbs.

Figure 5. (a) a drawing detail showing the shear bolts installed through the walls of the side plate assembly and the sliding lug assembly; (b) a photograph of a shear bolt and its two bushings. (Shear bolts were designed and manufactured by Voith Turbo.)

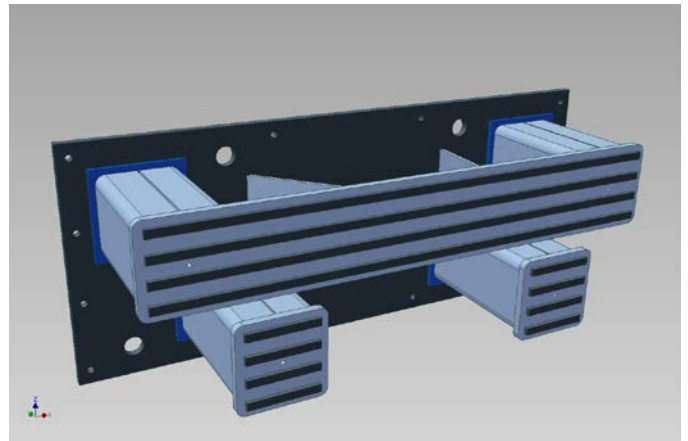
The deformable anti-climber test article model, pictured in Figure 6, consists of four crush tubes mounted onto a large, thick back plate that is designed, in turn, to be mounted directly to an instrumented test wall. The two upper crush tubes are positioned 12.5 inches above the lower crush tubes. They are connected by a 68-inch wide \times 11-inch high \times 1.0-inch thick front plate that has four 0.5-inch thick \times 1.0-inch high \times 66-inch long bars, centered vertically 2.5 inches apart from one another, welded to its front surface. The two lower crush tubes are two inches longer than the two upper crush tubes, and

spaced closer together laterally (38.5 inches center-to-center vs. 57 inches center-to-center for the upper tubes). Each tube has its own 11-inch square \times 1.0-inch thick front plate, with a similar set of four bars welded to it, each 0.5-inch thick \times 1.0-inch high \times 9-inch long, spaced at 2.5-inch intervals.

Figure 6. The deformable anti-climber test article

Each of the tubes has a 0.25-inch wall thickness. In addition, each tube has four rounded, 0.125-inch deep slots cut into it to promote controlled folding: two on the inside and two on the outside. The two inside slots are cut into the sides of the tubes, and the two outside slots are cut into the top and bottom of the tubes, across the welded seam that joins the two halves of each tube. The slots are centered about 2.375 inches from the front of each tube.

In addition to the four crush tubes, there are two 0.5-inch thick angled support plates that provide stability and vertical strength to the upper set of crush tubes. These are oriented vertically and positioned approximately 17 inches away from one another where they are welded to the front plate and 28.75 inches away from one another where they are welded to the

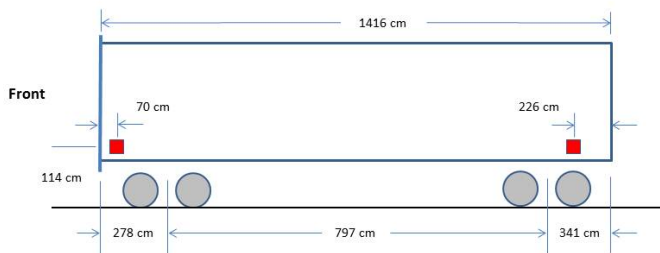
Full-scale dynamic testing was conducted at TÜV SÜD Rail GmbH, in Görlitz, Germany. For both the push-back coupler and deformable anti-climber tests, six accelerometers were mounted onto the impact rail car. There were two sets of three accelerometers. Each set consisted of one accelerometer in each of the three directions: longitudinal, vertical, and lateral. The two sets were mounted on the same (left) side of the car, one in the front and one in the rear, as is illustrated in Figure 7. For all of the impact tests, the data from the accelerometers were used to confirm the data from the load cells. The load cells are described in the following sections.

Figure 7. The positions of the accelerometer sets on the impact rail car

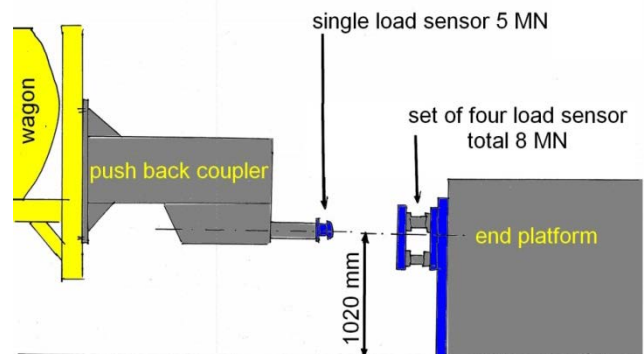
Figure 8 shows an illustration of the test configuration for the push-back coupler test. Figure 9 shows a photograph of the mounted test article. It was mounted to the impacting rail car and has an extension piece that represents an actual coupler shank. There was a load cell mounted on the end of this extension piece, which impacts the end plate of the test wall

load cell system with a steel ring welded to it that limits lateral motion should it occur. The extension piece is normally not restricted from rotating about the coupler pin. It was supported both vertically and laterally by straps to prevent it from moving significantly prior to impact, as shown in Figure 10. These straps did not interfere with the push-back motion of the extension and coupler. Energy absorbing buffers were mounted on the sides of the test article on both the rail car and the crash wall to absorb residual energy if required.

Figure 8. An illustration of the push-back coupler configuration

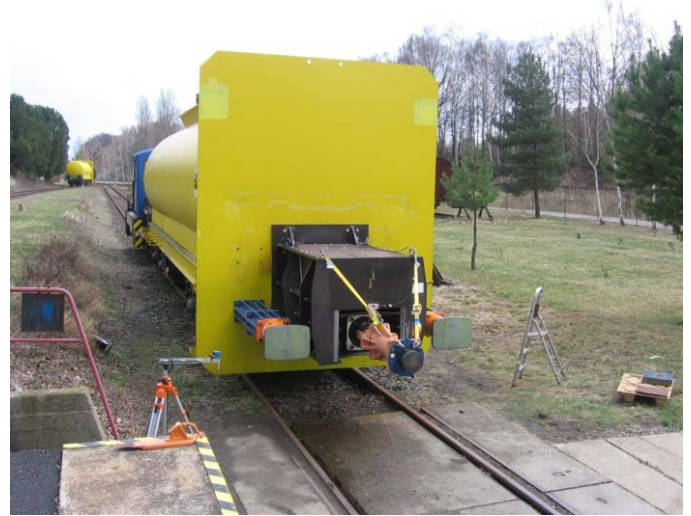
Figure 9. A photograph of the push-back coupler test article mounted on the impact car

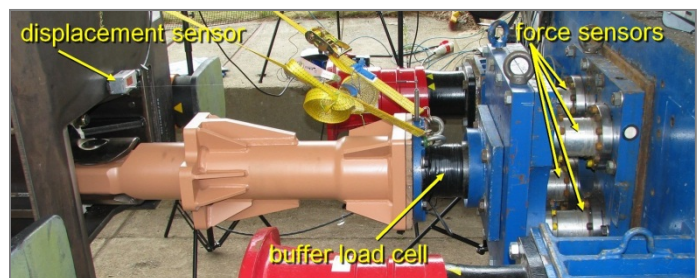
Figure 10. A photograph showing the push-back coupler extension piece supporting straps

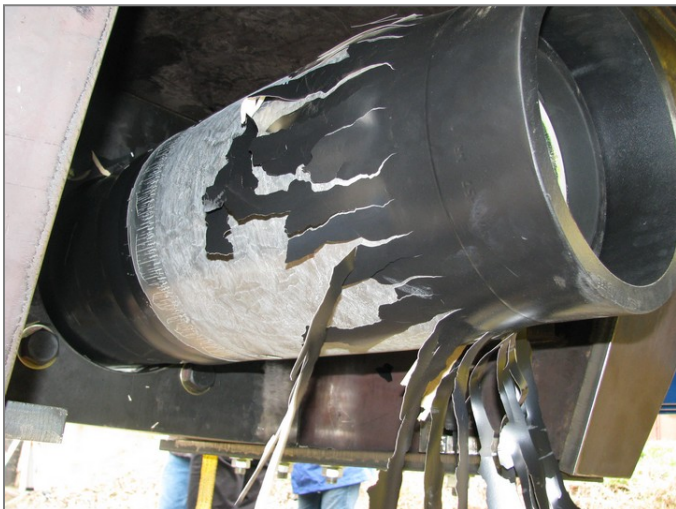
Figure 11 shows that the deformation tube has been essentially exhausted after the first impact. Lubrication ports that extend outward about 0.5-inch from the coupler mounting block were partially crushed, indicating that the back plate of the coupler extension had just made contact in the first impact. This is consistent with the 18 in. stroke measured for this part of the test.

Figure 11. The push-back coupler deformation tube after the first impact

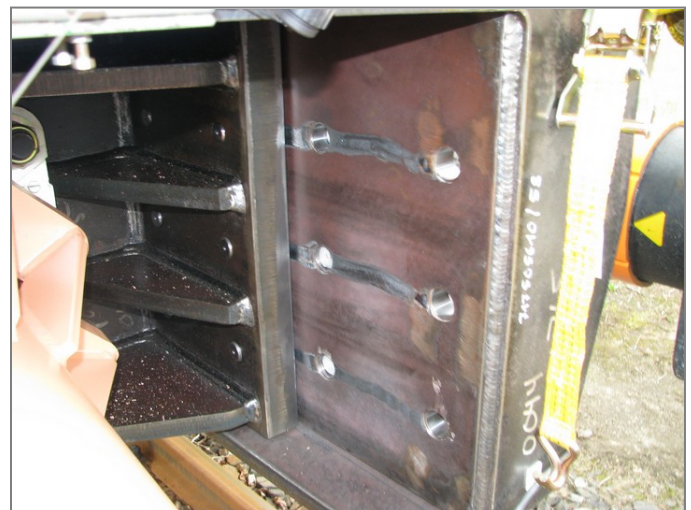
Figure 12 and Figure 13 show the test article after the second impact. The sliding lug has been pushed back about 10

inches. The bolts did not all fail completely on a plane parallel to the direction of motion. The three bolts on the left front of the sliding lug all appear to have sheared at roughly at a 45 degree angle through half of their thickness, as shown in Figure 14. There are also gouge marks on the facing surfaces of the support assembly, as shown in Figure 13, indicating that the sheared bolts scraped along the side of the support assembly as the sliding lug pushed back. In fact, it was not possible to separate the lug from the support assembly immediately after the test because of at least one protruding bolt surface.

Figure 13. Photograph showing gouging marks in the coupler support assembly after the second impact

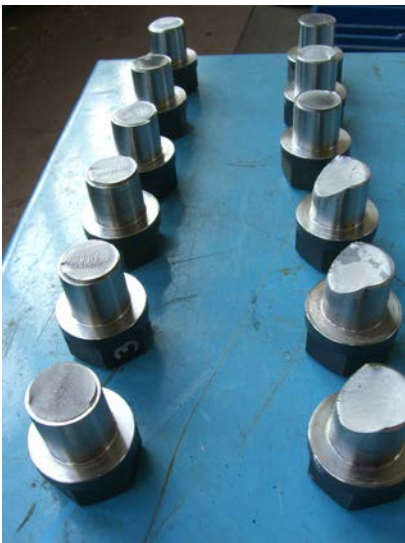
Figure 14. Photograph showing all twelve failed shear bolt heads; note three on bottom right that sheared non-uniformly

The expectation was that the total shear bolt failure load would be about 4,700 kN (1,056 kips). The measured load corresponding to shear bolt failure was 5,640 kN (1,270 kips), which is 20% higher than the expected value. This may partly be due to dynamic effects, but could also be due in part to the non-uniform shearing of the three forward-left bolts.

As noted earlier, model predictions of the force required to break the bolts are based primarily on the measured shear strength of the bolts — $12 \times 88 \text{ kips} = 1056 \text{ kips}$. The raw measured peak load associated with bolt failure is approximately 1,260 kips (see Figure 15), almost 20% higher than the combined shear strength of the bolts. The 20% increase may partly be due to the dynamics of the bolt failure process; however, it is likely that much of the increase is due to the ‘unclean’ nature of the shearing off process for the left, forward set of three shear bolts (see Figure 14).

A better match between the test result and the design shear strength may have been achieved if additional care had been taken to ensure that the gap between the sliding lug and the side plate of the support assembly — across the shear plane of the shear bolt — was balanced across all of the shear bolts. The non-ideal shearing of these three bolts is more likely due to compressive stresses between the sliding surfaces that arose when the bolts were tightened. This, in turn, produced tensile stresses in these bolts that contributed to the observed fracture pattern.

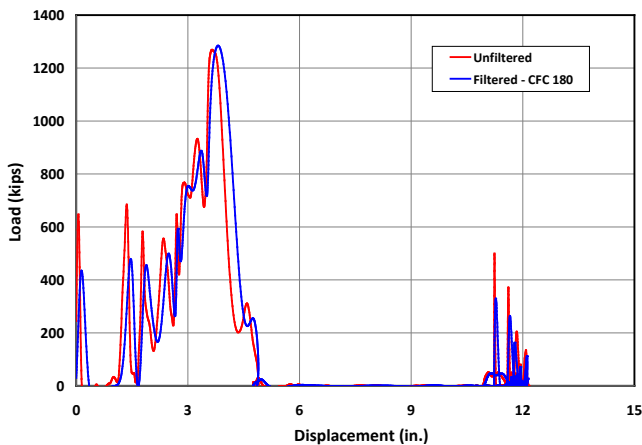
Figure 15 shows the measured load-displacement plot in which the load is taken from the load cell set on the wall and the displacement is taken from the string pot at the coupler extension. Key result metrics from the second impact are as follows:

- Total stroke: 96 mm (3.8 inches), up to complete bolt fracture.
- Maximum force: 5,640 kN (1,270 kips).
- Energy absorbed: 165 kJ (120 ft-kips).

Figure 15. The load-displacement response measured for the second push-back coupler impact test (unfiltered and filtered at CFC 180)

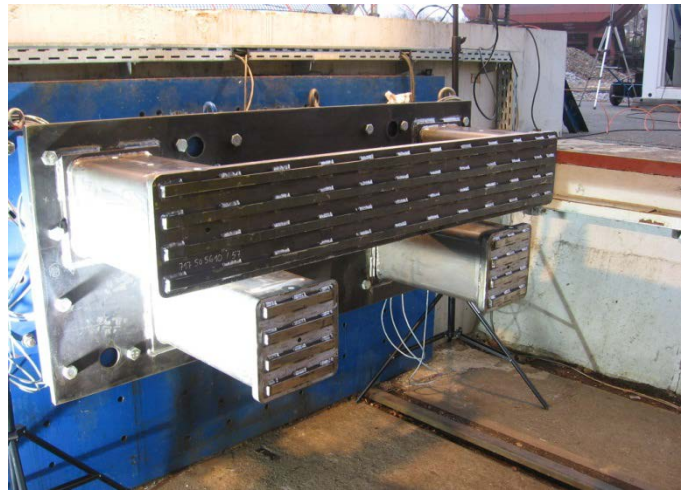
Figure 16 shows a photograph of the deformable anti-climber test article, which is mounted to the load cell sets on the impact wall. The end of the impacting car is flat with no additional structure. Energy absorbing buffers were not used in this test, because no additional stroke was available beyond the design crush stroke. The impact speed of rail car in the single impact was 20.8 km/hr (13.0 mph), 0.8 km/hr greater than the target speed.

Figure 16. A photograph of the deformable anti-climber test article mounted on the impact wall prior to impact

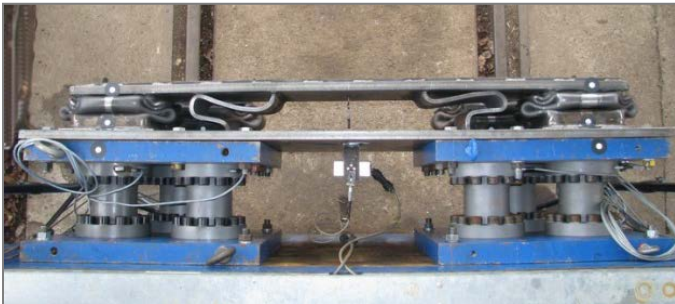
Figure 17 and Figure 18 show the test article after the impact. The energy absorption capacity of the test article has essentially been exhausted. The deformation pattern is very symmetric with respect to the centerline. There are small areas of cracking, as evident in Figure 19, but these are isolated. Figure 20 shows the measured load-displacement plot, with the load taken from the load cell set on the wall and the

The exact value of the push-back trigger load is difficult to define because of dynamic effects. The deformation is very symmetric and the individual tubes exhibit a classic accordion pattern.

Figure 17. The deformable anti-climber test article after impact (top view)

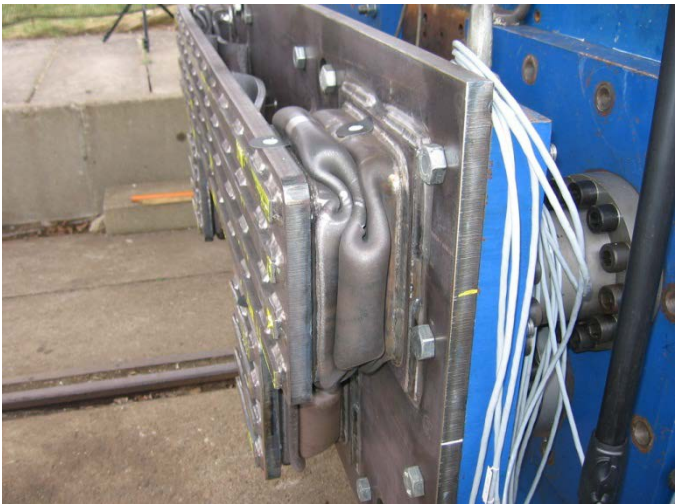
Figure 18. The deformable anti-climber test article after impact (side view)

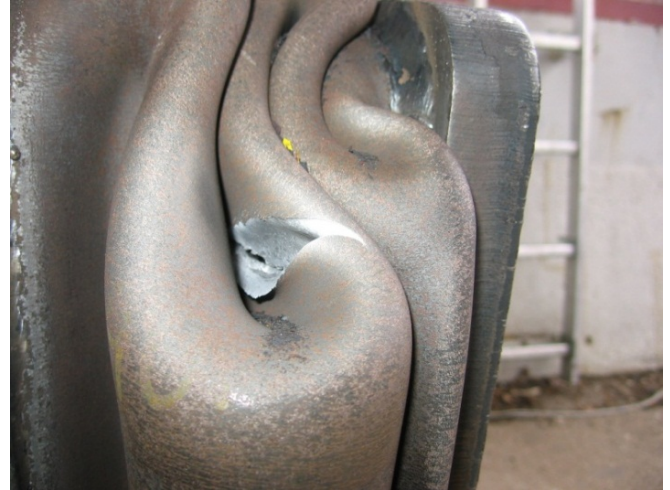
Figure 19. Photograph of a crack in the deformable anti-climber test article after impact

As expected, there were several locations of localized fracture. Without exception, these occurred in the corners of the crush tubes where severe plastic strain arises as the tube folds. Not only were such fracture locations predicted (see Figure 25), they were also observed in identical locations during the quasi-static tests. Given the extremely large plastic strain and complex deformation patterns (and therefore large triaxialities) that arise as the tubes crush, such localized fractures will occur despite the excellent inherent ductility of the A572-50 material. Moreover, these fractures do not appear to hinder the absorption of energy that occurs as the tubes fold.

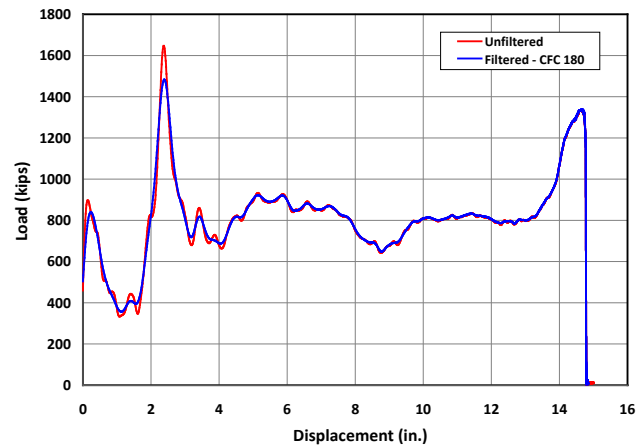
displacement taken from a ruler on the car. They key result metrics from the test are as follows:

- Total stroke: 373 mm (14.7 inches)
- Maximum force: 5,960 kN (1,340 kips).
- Energy absorbed: 1,350 kJ (1,000 ft-kips).

Figure 20. The load-displacement response measured for the deformable anti-climber test (unfiltered and filtered at CFC 180; displacement measured by laser/ruler)

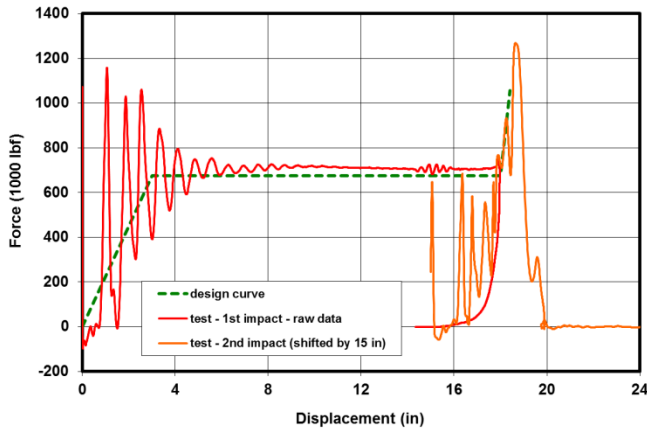
Due to the low impact speed for the first push-back coupler test, the push-back coupler system was tested in two stages: one stage to exhaust the push-back coupler stroke, and one stage to break the bolts. Because of this, in order to compare with the prediction for a single test, the force-displacement results for the two impacts must be combined into a single integrated curve. Figure 21 shows such a comparison. In this figure, the test results for the 1st impact are plotted as measured. The results for the 2nd impact have been shifted by the extent of permanent deformation predicted in the 1st test — about 15 inches (~18 inches of deformation tube stroke minus ~3 inches of rubber spring elastic recoil).

Figure 21. Comparison of measured force-displacement behavior with design curve

As is evident in the figure, there is good overall agreement between the design curve and the test results. In the figure, raw test data indicate a large oscillation, about 270 Hz. This oscillation appears to be associated primarily with the rubber spring deformation and appears to dampen out quickly once the deformation tube begins to deform. However, the test results from both impacts capture the design intention reasonably well. The FE model predictions were also consistent with the design curve and the test data.

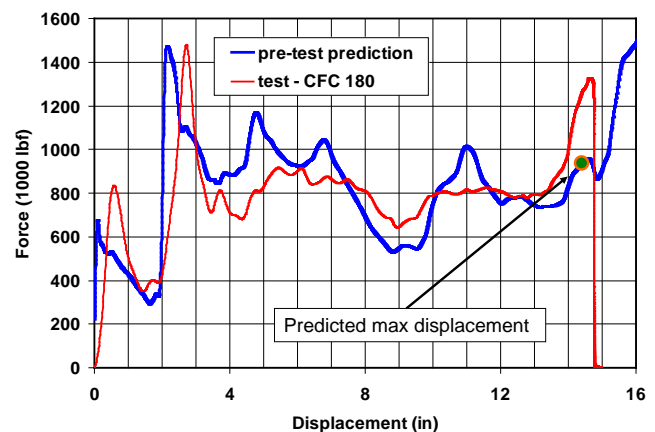
The measured force-displacement curve for the deformable anti-climber test is compared to the pre-test prediction curve in Figure 22. The predicted displacement for the measured impact speed of 20.8 km/hr is 14.4 inches, as is indicated in the figure. The measured maximum displacement is approximately 14.9 inches. Overall, there is excellent agreement between the predictions and the test data. The minor difference between the

- Over the first four inches of displacement, the *predicted* average load is approximately 740 kips, and the *measured* average load is approximately 680 kips. The shape of the test curve indicates that there is more compliance in the system than the FEA model predicts. This may be due to non-uniformities in the initial geometry of the structure, misalignment with the test vehicle, etc. It may also be due to a phase lag in the load cells. The build-up of load associated with impact of the two respective sets of crush tubes appear to be more gradual than the model predicts. This leads to an offset of about 0.5 inches or so in the displacements at which the peaks occur, and this additional compliance lowers the average load.

- Over the displacement range 4–12 inches, the *predicted* average load is approximately 840 kips, but the *measured* average load is only 800 kips. After the impact of the second set of tubes, all four tubes fold in a manner that is quite consistent with both model predictions and the results of quasi-static compression tests. The 40-kip difference between the predicted and average load can be attributed to differences between the modeled and actual hardening and failure behavior of the A572-50 material as well as imperfections in the initial geometry of the tubes. Buckling processes can be quite sensitive to geometrical imperfections, which would tend to lower the load required to fold the tube.

When both of these factors are added up, after 12 inches of crush, there is an additional 560 in-kips of kinetic energy that must be absorbed in the test. This extra energy is consistent with the extra 0.5 inches of crush occurring at an average force of 1,000 to 1,100 kips.

Figure 22. Comparison of measured force-displacement curve for the deformable anti-climber test with the pre-test prediction. The predicted displacement for the measured impact speed of 20.8 km/hr is indicated

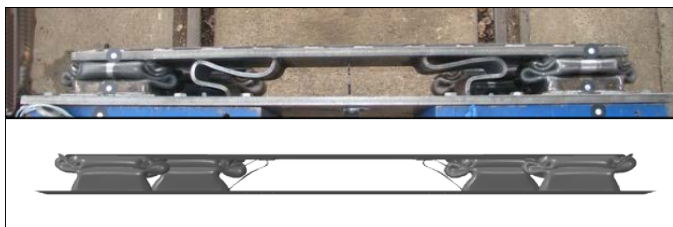
Figure 23. Comparisons of model prediction of test article deformation at 14.9 inches with post-test results: view from above test article

The overhead view shown in Figure 23 indicates that the model captures the essential features of the deformation quite well. The predicted folding pattern of the tubes is identical to the actual pattern, with the exception that, in the model, the ‘ears’ that are formed on the sides of the tubes tend to be oriented more towards the impacted end of the tube than they actually are in the test. The most significant difference between the predicted and actual modes of deformation is that the angled support plates fold in a different manner. The model predicts the front of the plate to fold outwardly and the back of the plate to fold inwardly. The test result is just the opposite. This difference is not surprising, and is likely due to geometrical imperfections and/or pre-stresses in the plates due to welding. More importantly, it is unlikely that the direction of folding has a significant effect on the transmitted load.

In terms of deformation, it is most useful to compare the model predictions with test results *for equivalent extents of displacement*. Therefore, while the model predicted a final displacement of only 14.4 inches for the measured impact speed of 20.8 km/hr, the model predictions are compared with test results at a total displacement of 14.7 inches. These comparisons are shown in Figure 23–Figure 25.

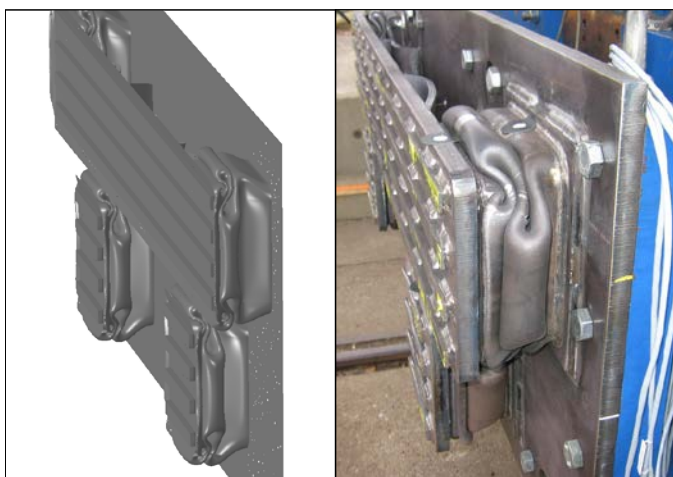
Figure 24. Comparisons of model prediction of test article deformation at 14.9 inches with post-test results: isometric view focusing on left upper crush tube

The isometric view shown in Figure 24 presents a better view of the folded tube. Here again one can see the difference in the orientation of the side folds. Overall, however, the model captures the deformation mode quite well. The folding pattern observed dynamically is also quite similar to the folding pattern observed in the quasi-static crush test.

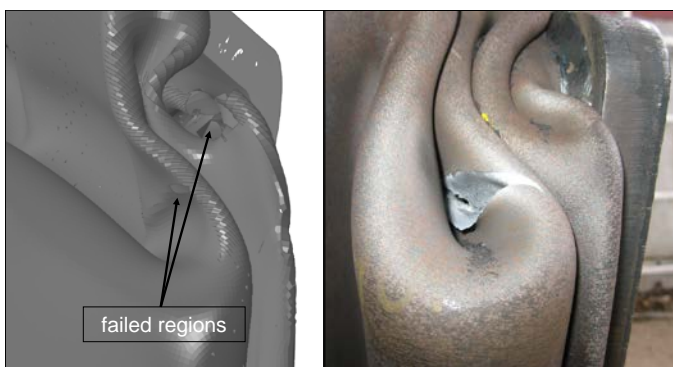
Figure 25. Comparisons of model prediction of test article deformation at 14.9 inches with post-test results: upper right tube showing localized fracture inside of a fold
