## **Effect of Gate Skirts on Pedestrian Behavior at Highway-Rail Grade Crossings**

| 1. AGENCY USE ONLY (Leave blank) | | 2. REPORT DATE<br>December 2013 | | 3. REPORT TYPE AND DATES COVERED<br>Technical Report<br>April 2012–January 2013 |
| 7. PERFORMING ORGANIZATION NAME(S) AND ADDRESS(ES)<br>U.S. Department of Transportation<br>Research and Innovative Technology Administration<br>John A. Volpe National Transportation Systems Center<br>55 Broadway<br>Cambridge, MA 02142 | | | 8. PERFORMING ORGANIZATION<br>REPORT NUMBER<br><br>DOT-VNTSC-FRA-13-01 | |

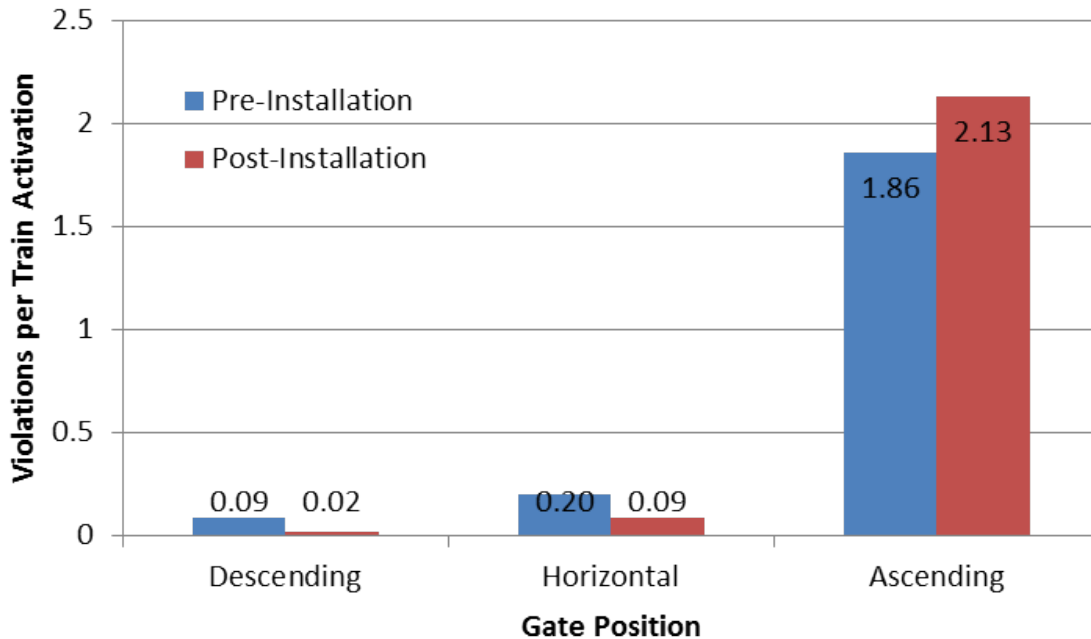
**Figure E-1. Violations per Train Activation**

- A total of 890 pre-installation and 884 post-installation train activations were analyzed.
- A total of 2,461 pre-installation and 2,312 post-installation pedestrian behavior observations were made.
- There was a statistically significant decrease in the number of descending and horizontal violations by pedestrians after the installation of the gate skirts. Descending violations decreased significantly from 80 violations to 19 (a 78 percent reduction). Horizontal violations also decreased significantly from 177 violations to 83 violations (a 55 percent reduction). In contrast, ascending violations rose significantly after the installation of gate skirts from 1,658 violations to 1,887 violations (a 12 percent increase). See Figure E-1 below for the violation rate per train activation pre- and post-installation.

- The number of horizontal violations that were initiated on the sidewalk dropped from 80 percent of violations pre-installation to 45 percent post-installation.
- Horizontal violations that began on the street increased from 20 percent of the violations pre-installation to 55 percent post-installation. Descending violations that were initiated on the street increased from 8 percent pre-installation to 21 percent post-installation.
- Horizontal violations that ended on the street increased a significant amount from 23 percent of the violations pre-installation to 51 percent post-installation.

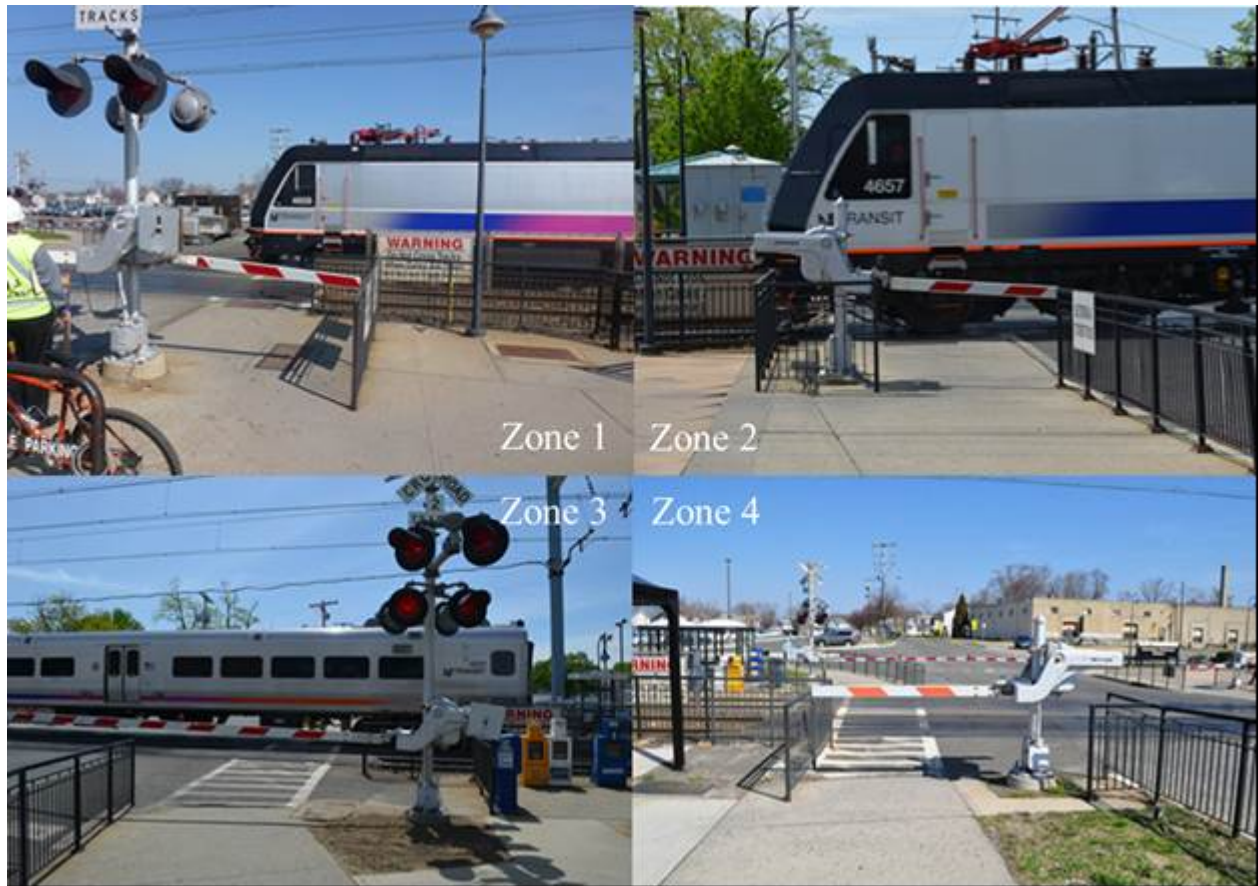
**Figure 2. All Four Pedestrian Gates at the Atlantic Ave. Crossing before Installation of Gate Skirts**

The grade crossing has two vehicle gates, one of which also serves as a pedestrian gate (Zone 3), and three additional pedestrian gates. The pedestrian gates are located next to the vehicle gates (or if there are no vehicle gates, each pedestrian gate is in line with the pedestrian gate on the other side of the street) so that when an activation occurs, the gate will descend into a position that blocks pedestrian traffic from crossing the tracks from all sidewalks. In one quadrant, composed of Zone 1 (sidewalk) and Zone 5 (street), the pedestrian gate and vehicle gate are actually mounted on the same structure. In the diagonal quadrant, composed of Zone 3 (sidewalk) and Zone 7 (street), a vehicle gate is used to block access across both the sidewalk and street. See Figure 3 for an illustration of the Atlantic Avenue grade crossing site characteristics and zones.

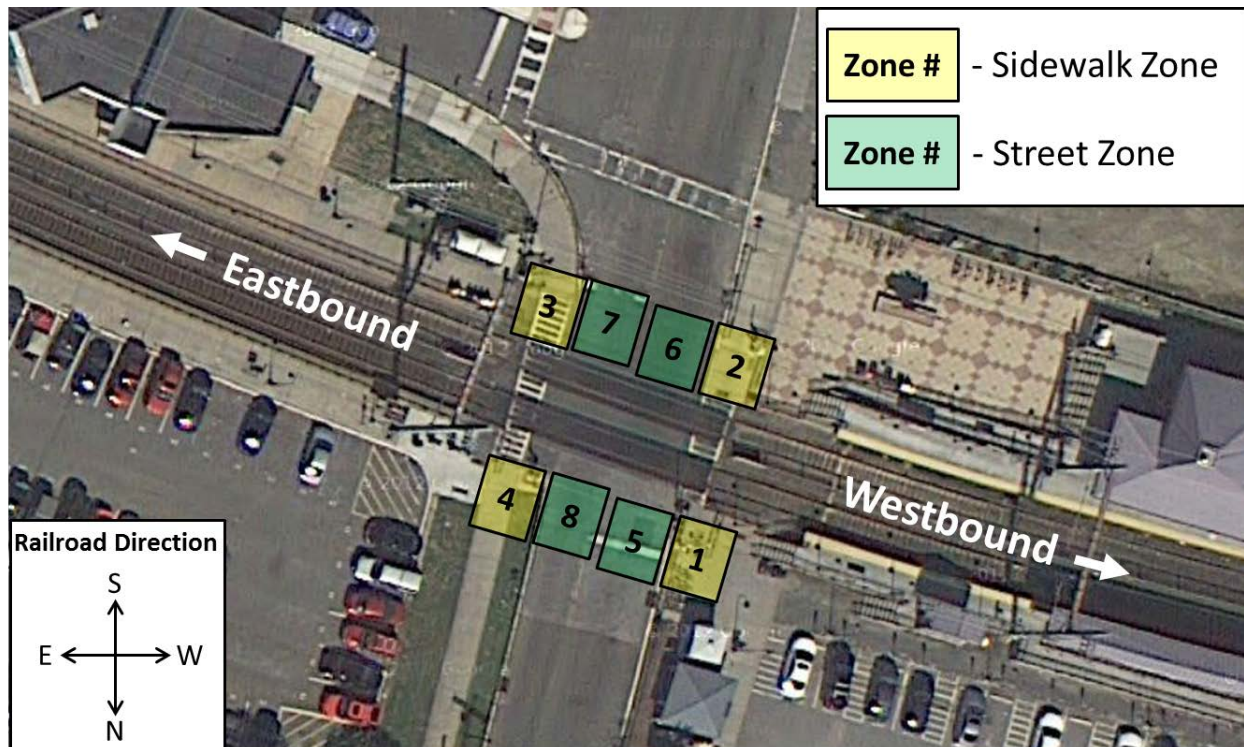
**Figure 3. Atlantic Ave. Grade Crossing Site Characteristics and Zones**

On either side of the sidewalks, across from each of the pedestrian gates, is fencing which prohibits pedestrians from easily going around the gates once they have descended. To better understand the layout of the area, Figure 3 provides an aerial view of the Atlantic Avenue grade crossing. For the purposes of our analysis, the grade crossing is labeled with eight different zones depending on the access and direction a pedestrian will travel through the crossing. There are eight zones in total, labeled from 1 through 8: four zones which cover sidewalk access (Zones 1 through 4) and 4 which cover road access (Zones 5 through 8). Note that the directions provided in Figure 3 are relative to the NJ Transit Rail system and not geographic north. The train that travels eastbound to New York City passes through this crossing from the right to the left. (See the key in the lower left of Figure 3.)

To examine pedestrian movements as they violated the grade crossing, the research team implemented the same zone assignments from Figure 3 (where Zones 1–4 include sidewalks and Zones 5–8 include the street). For pedestrians to cross the tracks, they must depart from a zone on one side of the railroad tracks and ultimately arrive in a zone on the opposite side of the track, although the route they take will vary.

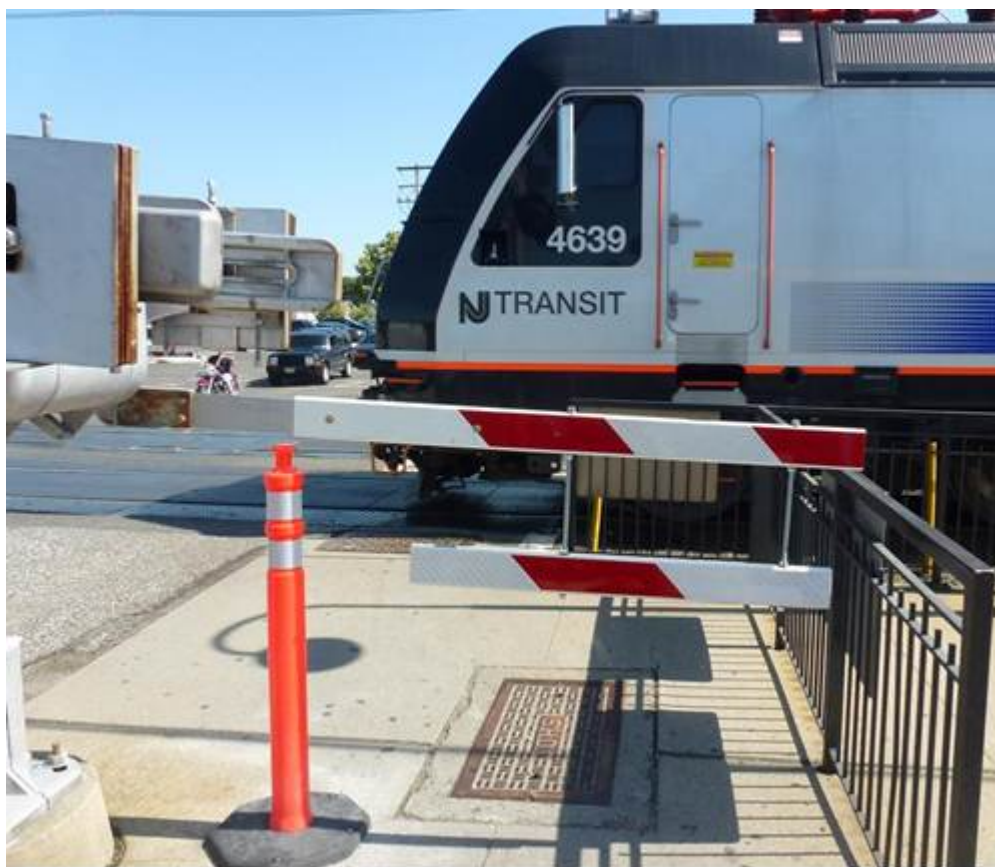
**Figure 7. Prototype Pedestrian Gate Enhancement at Atlantic Ave. – Zone 1.**

Figure 7 through Figure 10 show the installation on all four pedestrian zones. As shown in Figure 7, gate maintenance and pedestrian access issues forced the secondary gate in Zone 1 to be substantially shorter than the existing gate, thereby leaving an approximately 2-foot gap uncovered by the gate skirt. A bollard was installed to block this area but a significant gap still remained. It should also be noted that the secondary gate in Zone 3, as shown in Figure 9, was installed under the long gate used to block access from both the sidewalk and street.

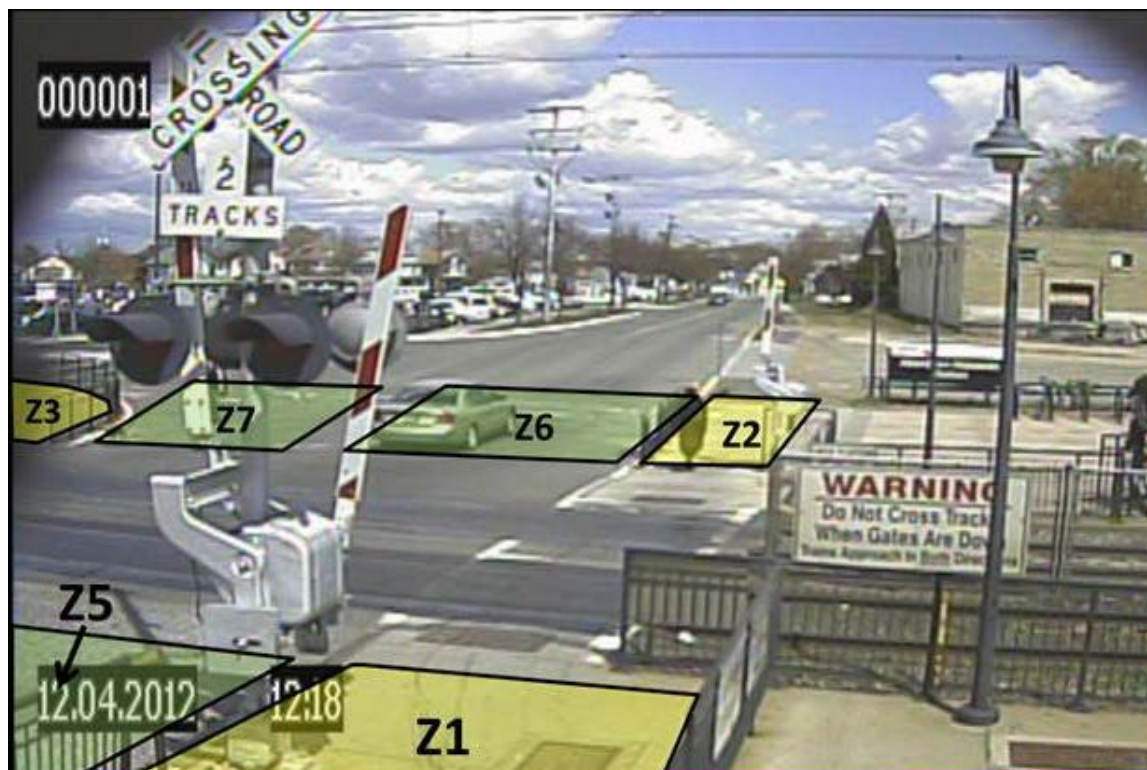
Figure 13. View of Zones from First Camera

The view from the two cameras can be seen in Figure 13 and Figure 14, below. Figure 13 shows the view from the first camera with each of the visible zones labeled (Zone 4 and Zone 8 are out of the camera's view.). The view from the second camera, as seen in Figure 14, shows the two zones not seen from the first camera (Zone 4 and Zone 8) and a better angle of Zone 3.

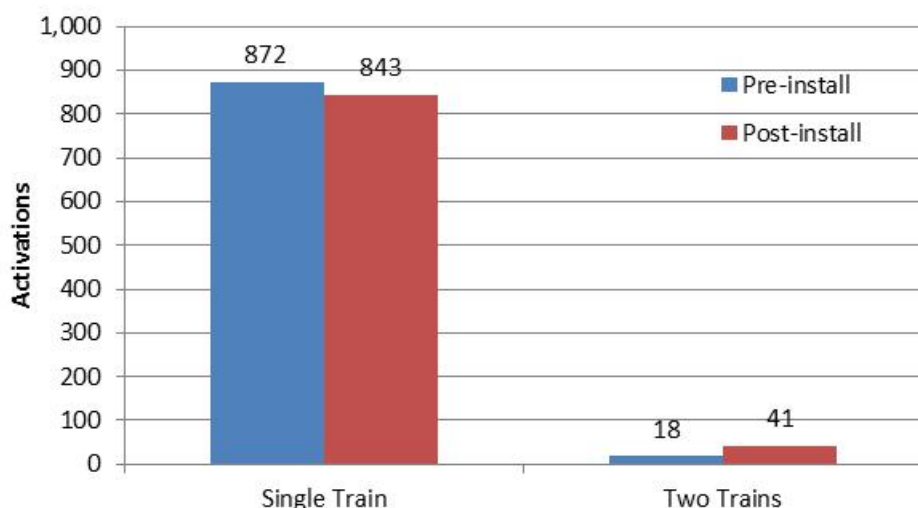
**Figure 15. Number of Trains per Activation Pre- and Post-Installation**

activations, as shown in Figure 15. The direction of the trains was divided almost equally between eastbound and westbound, with no difference by type of activation. Type of train was predominantly commuter, with only 1 percent (n = 10) involving freight train single activations and 11 percent (n = 9) involving freight for second train activations. Overall, there was approximately the same number of activations, with 890 pre-installation and 884 post-installation used in this analysis.

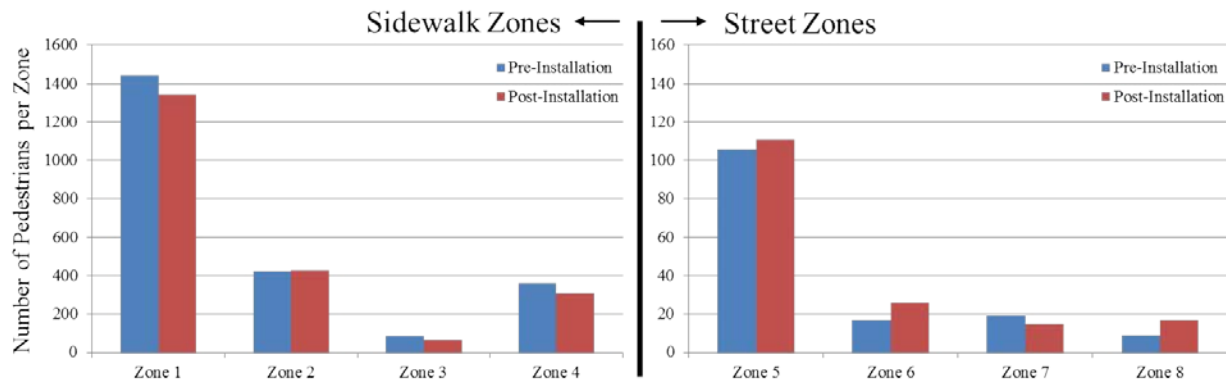
**Figure 16. Number of Pedestrians per Arrival Zone Pre- and Post-Installation**

First, we will examine which zones the pedestrian first encounters the crossing; we refer to this as the “arrival zone.” The most common arrival zone for pedestrians was Zone 1 (58 percent both pre- and post-installation), followed by Zone 2 (17 percent pre- and 18 percent post-installation), and then Zone 4 (15 percent pre- and 13 percent post-installation). See Figure 16 for a breakdown by zone of pedestrian arrivals at the crossing. As shown in Figure 16, pedestrians were far more likely to arrive at a crossing on the sidewalk than on the street. However, Zone 5, a street zone, was found to have more pedestrian arrivals than Zone 3, a sidewalk zone. This was true in both the pre-installation period (86 sidewalk Zone 3 arrivals

versus 106 street Zone 5 arrivals) and the post-installation period (64 sidewalk Zone 3 arrivals and 111 street Zone 5 arrivals). A chi-square statistical test showed a significant difference in the number of pedestrians at the arrival zone after the installation of the gate skirt ( $\chi^2 (7, N = 4,773) = 24.11, P < .01$ ). This change may be attributed in large part to the increase in pedestrian arrivals at Zones 6 and 8, both street zones<sup>1</sup>. Since the overall number of pedestrians is lower after installation of the gate skirt, this finding lends credibility to the conclusion that more pedestrians arrived at the crossing in the street after gate skirts were installed. Based on the data thus far, we know that pedestrian arrival is affected by the installation of gate skirts, but we do not know if the pedestrians still went on to violate the crossing. The next section will address the effect that gate skirts had on pedestrians violating the crossing.

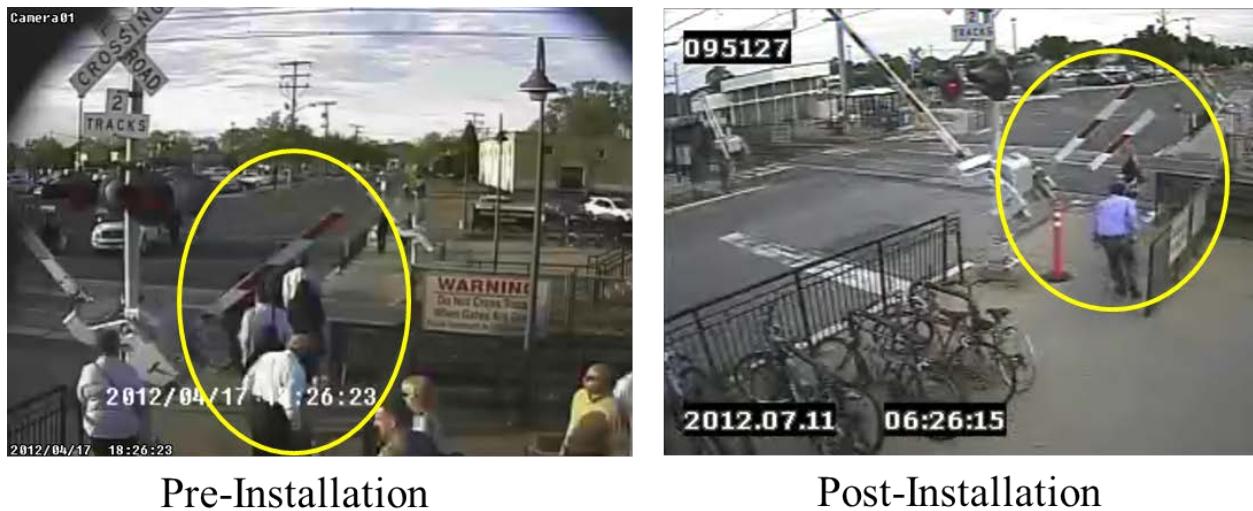
**Figure 17. Examples of Descending Violations Pre- and Post-Installation**

Example images of each of these types of violations, both with and without gate skirts, can be seen in the examples provided below. Examples of descending violations can be seen in Figure 17. In the pre-installation example (left panel), a total of five pedestrians went under the gate after descent had initiated. The woman on the left arrived at the crossing at the same time as the violating pedestrians, but chose to wait until after the activation had completed. In the post-installation example (right panel), the man in the blue shirt is running underneath the gate as they descend and continues through the crossing, exiting in the street in Zone 6.

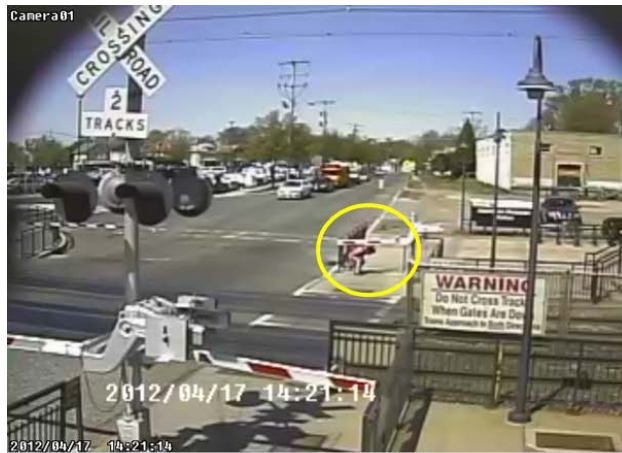
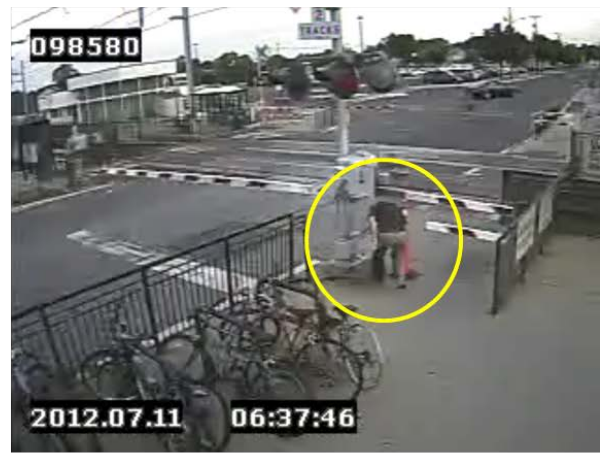
**Figure 18. Examples of Horizontal Violations on the Sidewalk Pre- and Post-Installation**

Examples of horizontal violations can be seen in Figure 18. In the pre-installation condition (left panel) a pedestrian is going under the horizontal gate in Zone 2. This pedestrian crossed the tracks and exited the crossing by going under the gate in Zone 1. In the post-installation example (right panel), the pedestrian is ducking underneath the original gate in the space where the gate skirt does not extend. This pedestrian, like the man in the post-installation example described above for the descending violation, exited the crossing by walking to the street and exiting in Zone 6.

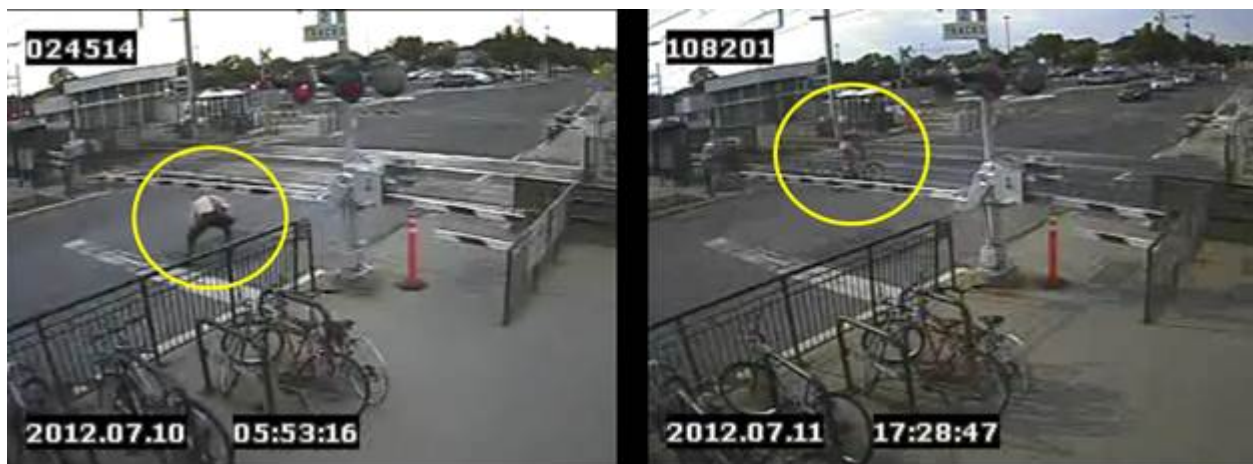
**Figure 19. Examples of Horizontal Violations in the Street**

During both horizontal and descending violations, it was possible for pedestrians to violate the crossing from the street. During horizontal violations, pedestrians could go around or under the vehicle gate (as seen in the left panel of Figure 19), or they could avoid the gates entirely in Zone 6 or Zone 8, as seen in the right panel of Figure 19 with a cyclist riding from Zone 8 to Zone 6.

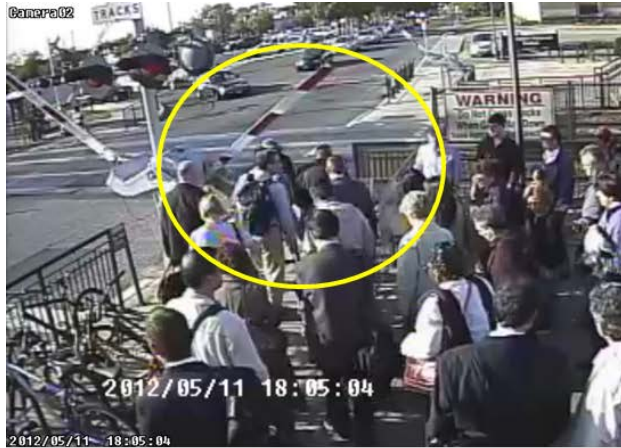
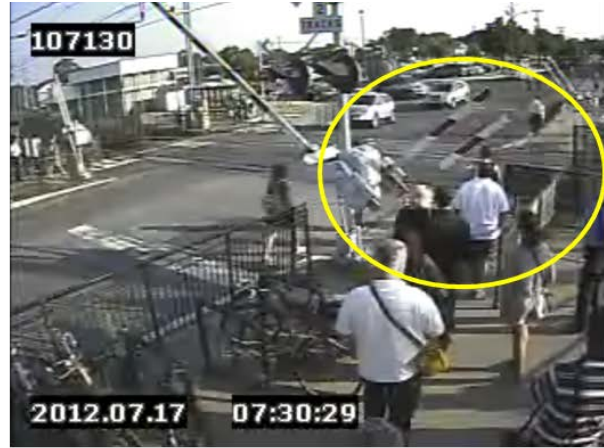
**Figure 20. Examples of Ascending Violations Pre- and Post-Installation**

Lastly, examples of ascending violations can be seen in Figure 20. In both pre- (left panel) and post- (right panel) installation examples, a large group of pedestrians is going underneath the gates as they ascend after a train passes through the crossing. The gates are all fully raised by the time these pedestrians reach the other side of the crossing, so they were not restricted in any way in terms of how they exited the crossing.

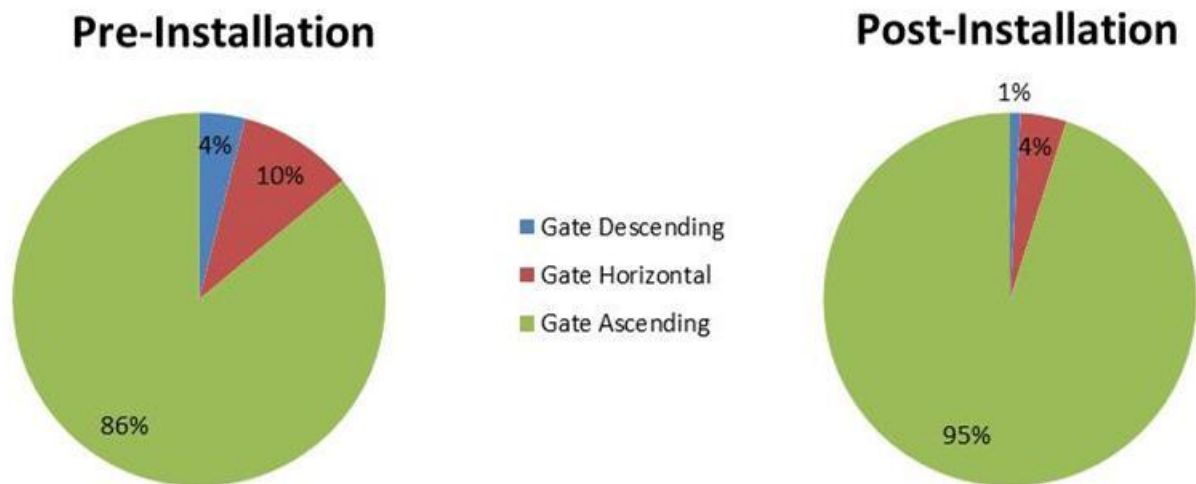
**Figure 22. Frequency of Violations per Activation Phase Pre- and Post-Installation**

Given the total number of pedestrians who approached the crossing during an activation (2,461 before installation and 2,312 after installation) there was a significant difference in the number of violations that occurred before installation (1918 violations) and after installation (1,988 violations), ( $\chi^2$  (2, N = 3904) = 19.23,  $P < .001$ ). Although the overall number of violations was higher post-installation, there was a statistically significant decrease in the number of descending and horizontal violations after the installation of gate skirts, as shown in Figure 22. Descending violations decreased significantly from 80 (4 percent) violations to 19 (<1 percent) violations ( $\chi^2$  (1, N = 96) = 49.27,  $P < .001$ ). Horizontal violations also decreased significantly from 177 (10 percent) violations to 83 (4 percent) violations ( $\chi^2$  (1, N = 268) = 55.01,  $P < .001$ ). In contrast, ascending violations rose significantly after the installation of gate skirts from 1658 (86 percent) violations to 1887 (95 percent) violations ( $\chi^2$  (1, N = 3,904) = 16.52,  $P < .001$ ).

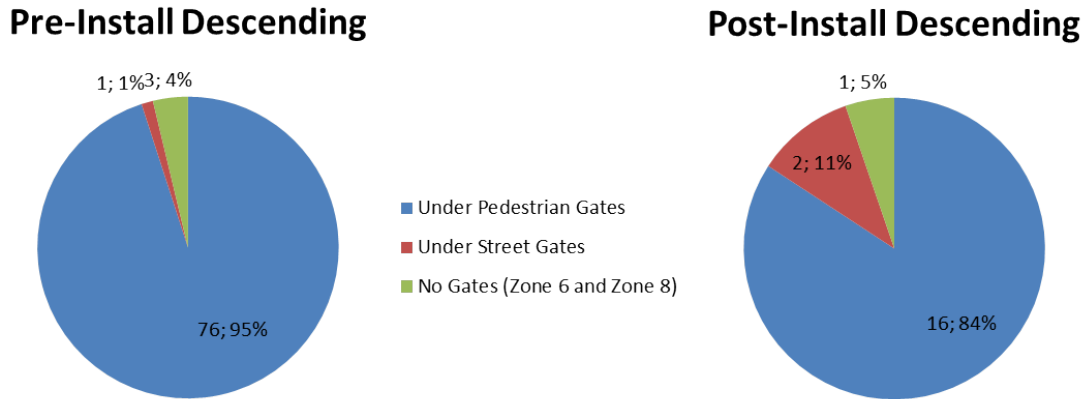
**Figure 23. How the Pedestrian Violated for Descending Violations**

Additionally, the research team was able to look not only at where the pedestrians violated, but how the pedestrians violated (e.g., under or around the gates). The overall number of descending violations was seen to drop after the installation of gate skirts when the pedestrian went under a pedestrian gate or at the zone where no gates were installed (e.g., Zone 6 and Zone 8). Figure 23 illustrates the different ways a pedestrian could violate the crossing while the gates were descending. There are no instances of pedestrians going around either the pedestrian or street gates for descending violations because the gates have yet to fully descend; therefore, pedestrians cannot go around them. The largest reduction in descending violations occurred for going under pedestrian gates: from 76 (95 percent) of all pre-installation violations to 16 (84 percent) of post-installation violations. A slight increase was seen for post-installation violations when pedestrians went under vehicle gates: from one pre-installation violation to two post-installation.

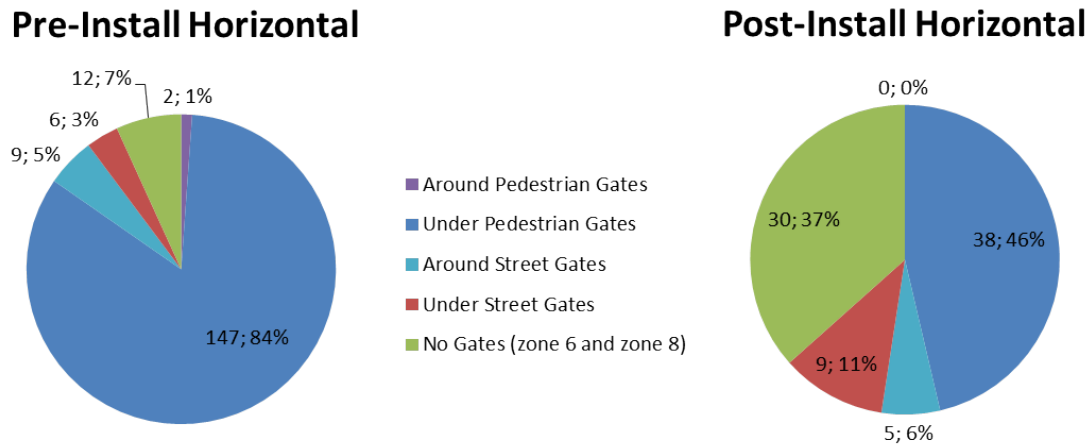
**Figure 24. How the Pedestrian Violated for Horizontal Violations**

Horizontal violations (depicted in Figure 24) when the pedestrian went under a pedestrian gate also dropped in number after the installation of gate skirts: from 147 (84 percent) of all pre-installation violations to 38 (46 percent) of post-installation violations. A large increase (12 or 7 percent pre-installation to 30 or 37 percent post-installation) was seen in the percentage of pedestrians who violated in Zone 6 or Zone 8, which both have no gates installed. A smaller increase was seen in horizontal violations after installation when pedestrians went under vehicle gates: from 6 (3 percent) violations before installation to 9 (11 percent) after installation.

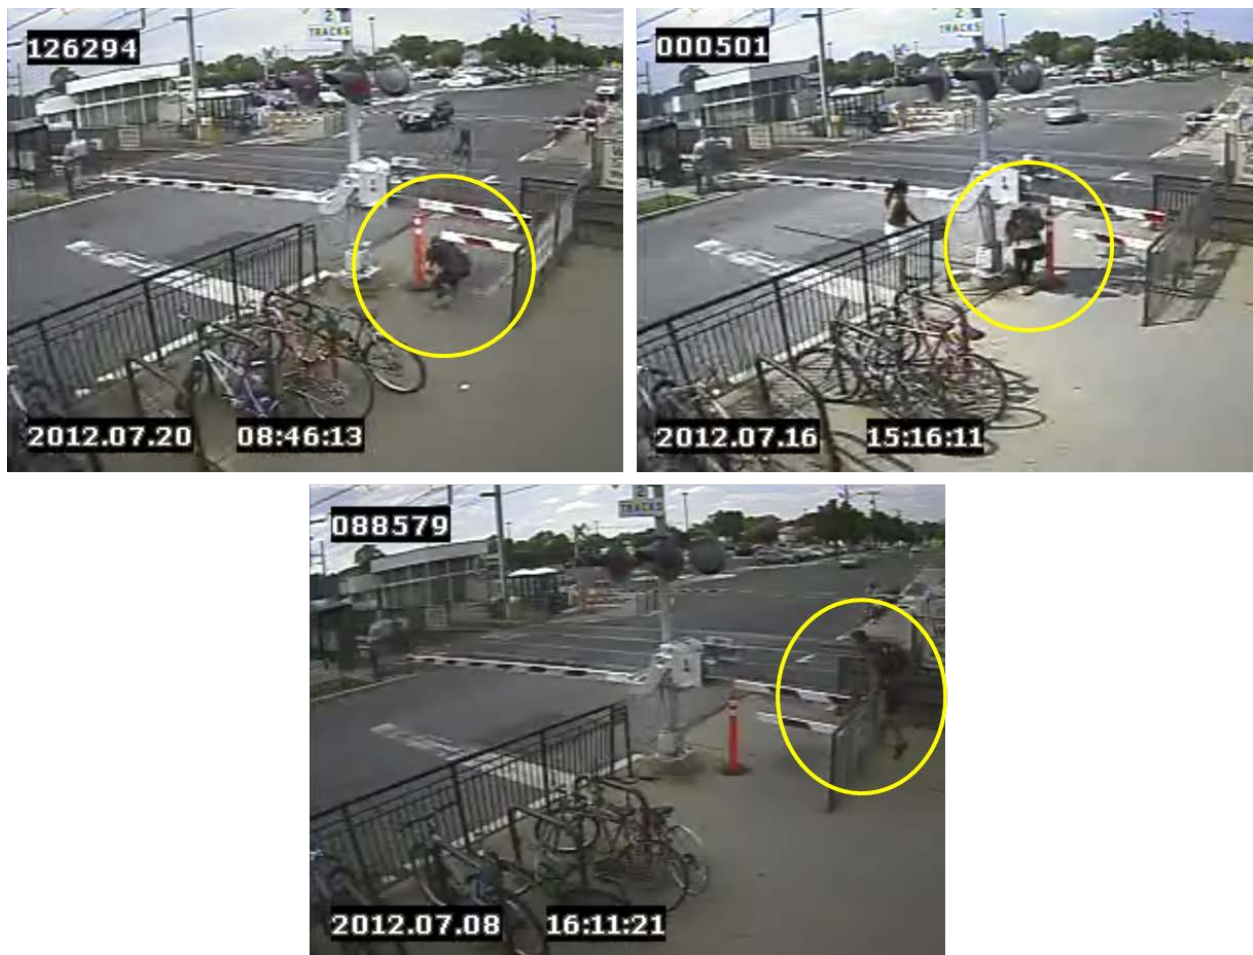
**Figure 25. Zone 1 Pedestrian Violation Behavior**

(37 percent) of post-installation violations used Zone 6 to exit the crossing. Despite an overall decrease in the number of violations using Zone 6 to exit, the proportion of violation from Zone 6 to the total number of post-installation violation exits increased by 14%. For horizontal violations, 28 (16 percent) pre-installation violations used Zone 6 to exit the crossing and 33 (41 percent) exited from Zone 6 after installation. This 25 percent pre- to post-installation increase indicates that a larger percentage of pedestrians were using Zone 6 to exit the crossing after installation of the gate skirt. This increase may also in part be explained by a decrease in the adjacent Zone 2: from 35 to 6 percent of pedestrians exiting. Of the 80 post-installation horizontal violations, 38 pedestrians went under the gates to violate and 17 of those violations originated from Zone 1. Of those 17 violations, only 1 pedestrian violated by going under the gate skirt (upper left of Figure 25); the remaining 16 went through the unobstructed area between the gate skirt and the post holding the gate to the left of the cone (upper right of Figure 25). One pedestrian who jumped the fence next to the gate to avoid going under or around (bottom of Figure 25) is not included in the totals above.

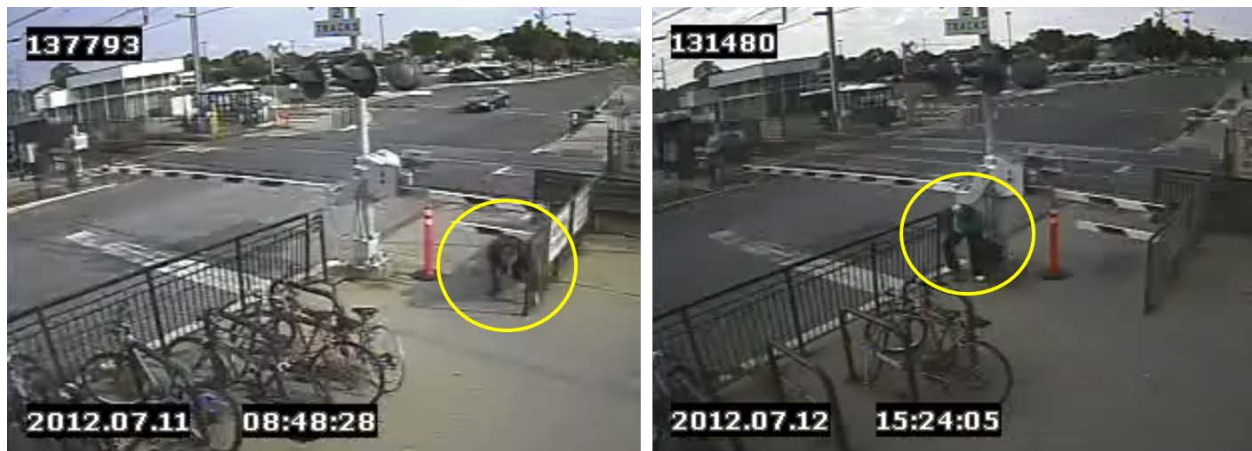
**Figure 26. Zone 1 Pedestrian Violation Exit Behavior**

Additionally, there were 10 violations for which the pedestrian exited the crossing in Zone 1 while the gates were horizontal. Of those 10 violations, the pedestrians went around the gate skirt (to the left of the cone) in 7, under the gate skirt in 1 (see left panel of Figure 26), and 2 pedestrians waited until the gates began to ascend to exit. In three additional cases, the pedestrian went under the vehicle gate to exit (Zone 5) and then squeezed between the gate pole and the fencing to get to Zone 1 (see right panel of Figure 26). However, the movement from Zone 5 to Zone 1 occurred on the same side of the crossing.

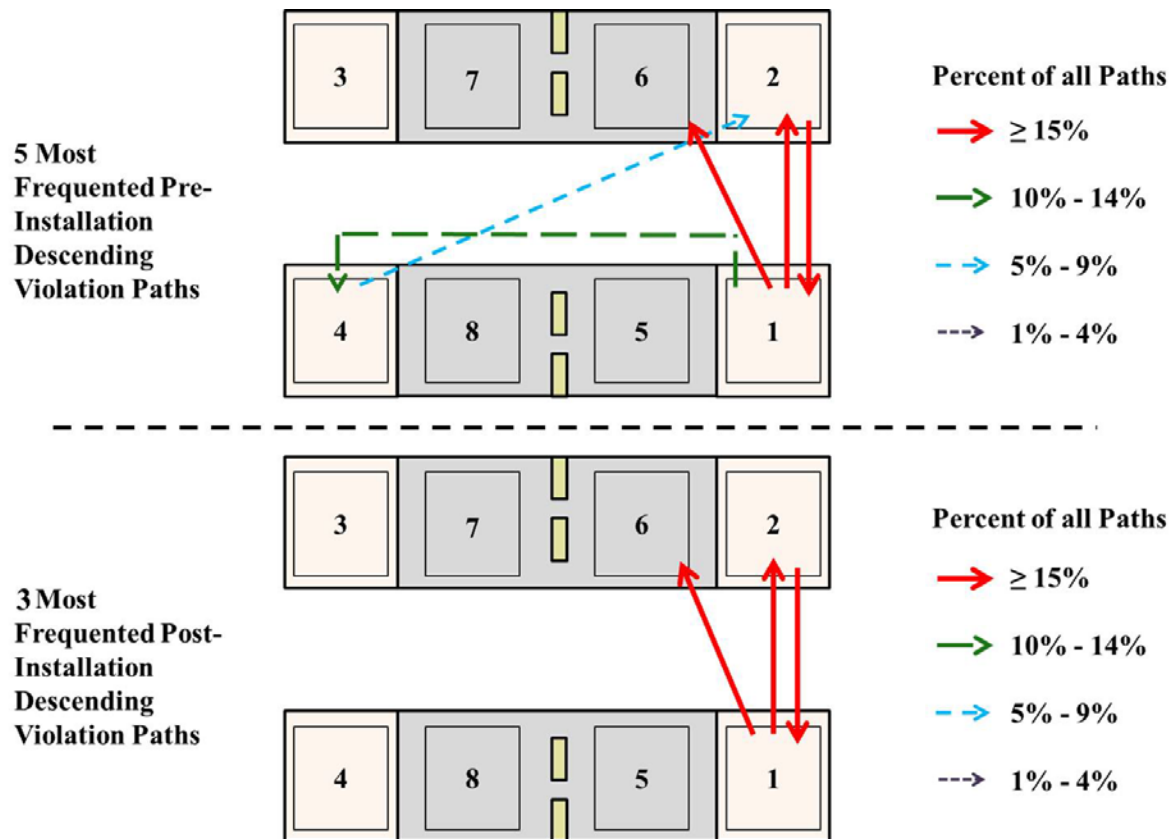
**Figure 27. Most Frequent Paths through Crossing during Descending Violation**

Pedestrian movements (or paths) through the crossing differed by type of violation committed. Figure 27 provides an illustration of the five most frequently used paths during a descending violation before and after installation. Prior to installation of the gate skirts (top half of Figure 27), the most frequented paths were between Zones 1 and 2, in both directions, followed by Zone 1 to Zone 6, Zone 1 to Zone 4, and Zone 4 to Zone 2. After the installation of the gate skirts (bottom half of Figure 27), pedestrians violated between Zone 1 and Zone 6 most frequently, followed by Zone 1 to Zone 2 in both directions, but the other paths were less often used. (Note: only three paths were included in post-installation analysis due to the low overall rate of pedestrians who violated while the gates were descending; all additional paths had an N = 1 or less).

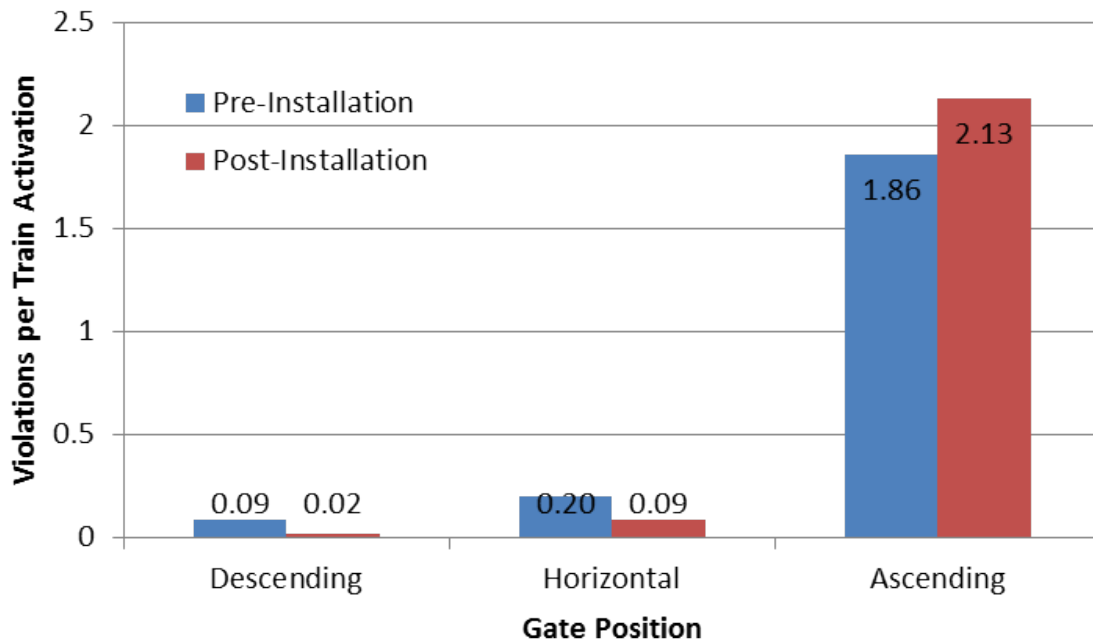
**Figure 30. Pedestrian Violation Rate per Grade Crossing Activation**

Results showed there was a significant increase in total number of violations after installation of the gate skirts. However, this finding is predominately due to an increase in ascending violations. Ascending violations increased significantly after installation of the gate skirts although both descending and horizontal violations significantly decreased, as shown in Figure 30. Figure 30 depicts the number of descending, horizontal, and ascending violations per train activation, which allows for comparison of the increase or decrease in the rate of each type of violation. The increase in ascending violations may be due to the fact that the gate skirt blocks access to the sidewalk, so pedestrians are more anxious to get across the crossing once the gates start to ascend because they know it will be harder to do so once the gate comes down. Alternatively, this increase could be due to the increased number of pedestrians waiting to cross because fewer pedestrians were violating while the gates were descending or horizontal.

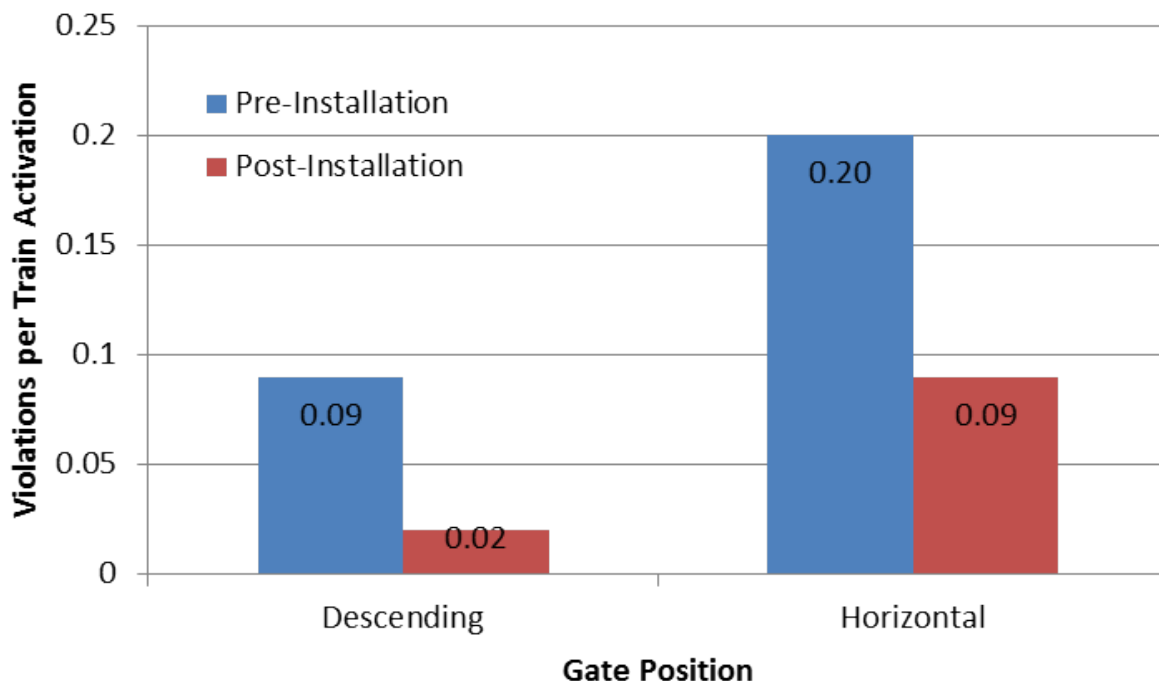
**Figure 31. Descending and Horizontal Gate Violation Rate per Grade Crossing Activation**

A total of 2,461 pre- and 2,312 post-installation pedestrian observations were made with a total of 890 pre- and 884 post-installation train activations analyzed. There was a statistically significant decrease in the number of descending and horizontal violations after the installation. Descending violations dropped significantly from 79 violations to 17. Horizontal violations also decreased significantly from 185 to 83 violations. In contrast, ascending violations rose significantly after the installation of gate skirts from 1,653 violations to 1,887 violations, though the reason is uncertain. The findings illustrate that the addition of gate skirts in this particular case has reduced the number of violations committed while the gates are descending (78 percent reduction in violation rate) or in the horizontal position (55 percent reduction in violation rate), as shown below in Figure 31. The addition of gate skirts may also have changed pedestrian behavior in that pedestrians may now be more likely to enter and exit the crossing from the street when committing a descending or horizontal violation. Horizontal violations (entering the crossing) on the sidewalk dropped from 82 percent of the violations before installation to 47 percent after installation, while violations that began on the street jumped from 18 percent of the violations before installation to 53 percent after installation. Horizontal violations that exited on the street jumped a significant amount: from 19 percent of the violations before installation to 35 percent after installation, though again the reason for this jump is uncertain.
