## Construction and Monitoring of the Fine PFC Section for Odessa

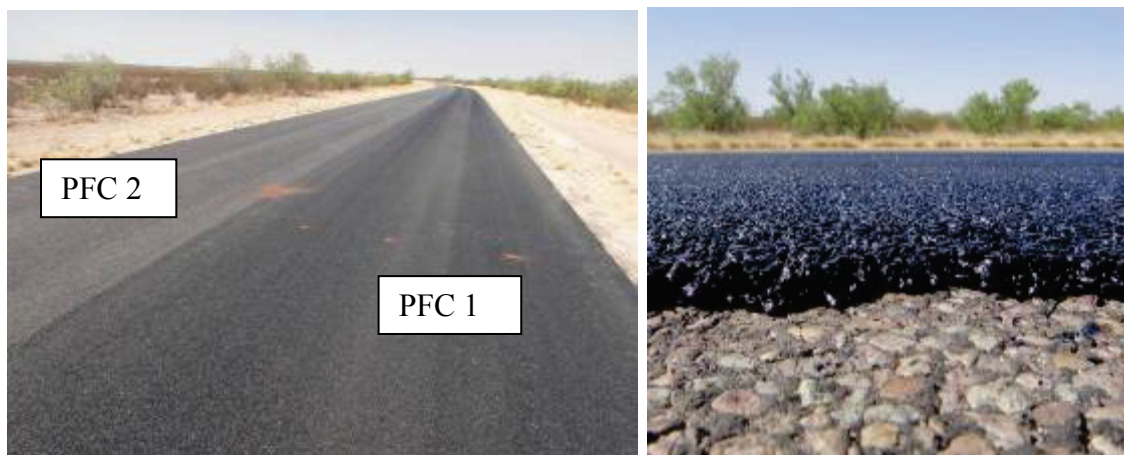
**FIGURE 3 PFC Mix in Odessa.**

The mixtures were placed side-by-side on the entry road to the facility as shown in Figure 3. Standard equipment for asphalt concrete pavement construction was used, including a material transfer vehicle, paver equipped with an infrared monitoring system, and 3 passes with a 13.5-ton tandem steel wheel roller operated in static mode.
