# Evaluation of Maintenance Procedures for Bridge Spalling on Parapet Walls

State Job Number 135313

Final Report

On November 15th, 2016, the members of the UC research team visited District 6 to see typical examples of damage, deterioration and repair of parapet wall. The team met with Shawn Rostorfer and toured a number of bridge sites.

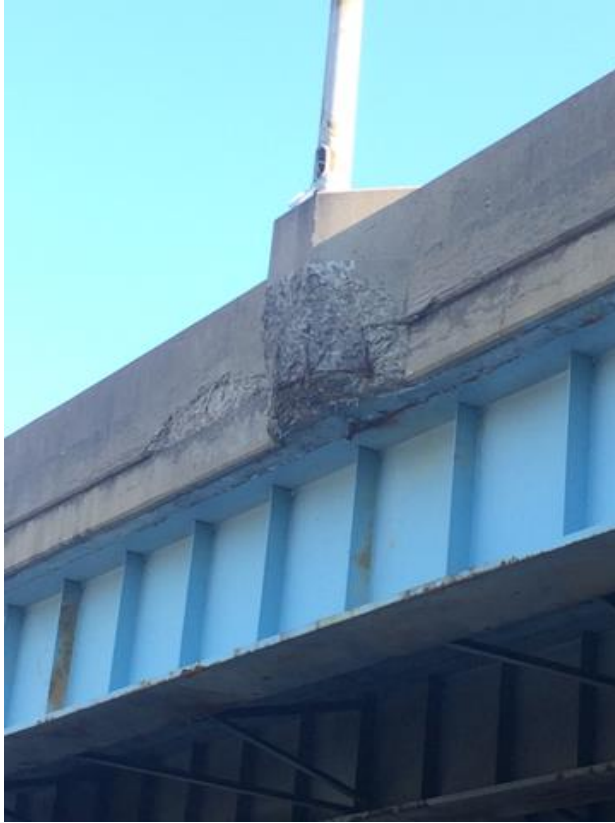
**Figure 1** shows a typical spall. Here, the crews have simply removed deteriorated concrete. The cause of the spall appears to be that the reinforcing bar had been placed without sufficient cover and the corrosion of the bar has caused the concrete to debond.

**Figure 1 - Typical spall with exposed bar**

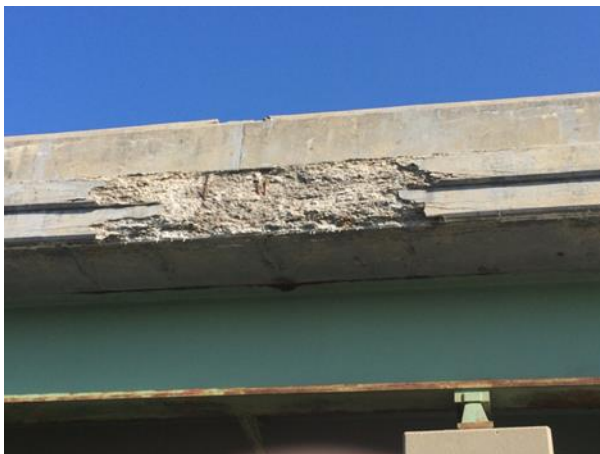
**Figure 2** shows a somewhat different situation. Again, there is some exposed, corroded bar clearly placed too close to the surface. However, there is also a large amount of spall where no corroded rebar is present. Normally, when there is a corrosion problem only, there is bar exposed behind all the spalling. Here, there are large areas of spall with no bar apparent. This does not necessarily mean corrosion is not a problem, as there may be badly rusted bar just below the surface, but the lack of exposed bar is a concern.

**Figure 2 - Spalled concrete with some exposed bar, but with areas with no exposed bar.**

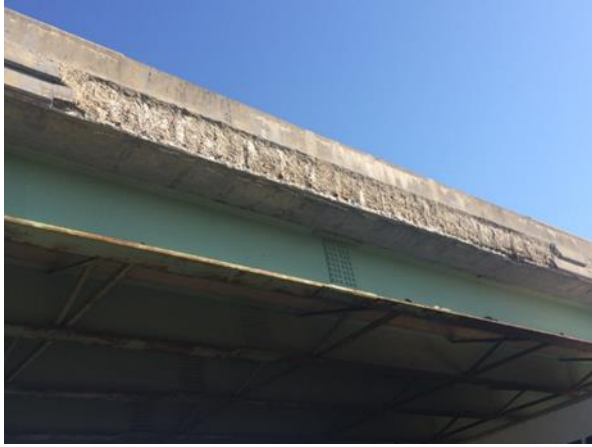
**Figure 3** another picture from the same bridge. In this case, the bar near the surface is apparent and deterioration is likely due to insufficient cover and corrosion.

**Figure 3 - Damage due to corrosion**

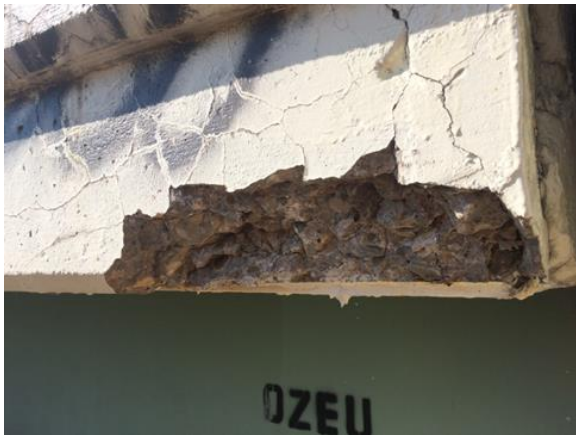
**Figure 4** is a photo of another bridge. This photo is taken near the support; no concrete removal has taken place as it is not over a traffic lane. Note the occurrence of “map” cracking. Map cracking is not usually associated with rebar corrosion, but instead usually indicates a problem with the concrete itself. Map cracking is often the sign of some type of expansive failure. Common causes of map cracking are freeze/thaw deterioration, alkali/aggregate reaction (AAR a.k.a. alkali silica reaction; ASR) or delayed ettringite formation (DEF).

**Figure 4 - Map cracking, no indication of corrosion**

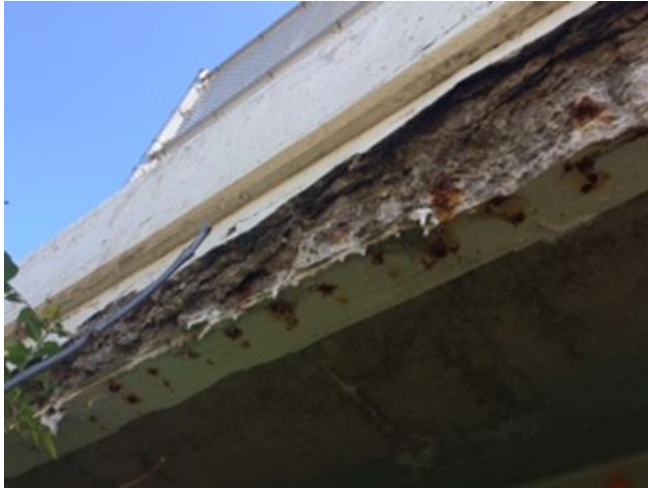
**Figure 5** is another photo from the same bridge. There is corroded reinforcing bar, but it is clear that bar had sufficient cover. The corrosion may have occurred after the concrete had spalled away or it may have contributed to the failure. For bars with sufficient cover, it is usually not possible for chlorides to reach the reinforcing steel simply by permeation. Usually, it is necessary for there to be cracks which allow chloride ingress. The damage is consistent with some type of a freeze/thaw or AAR mechanism so this might have cracked the concrete, which then allowed chlorides to penetrate to the steel. Subsequent corrosion might have contributed to the failure.

**Figure 5 - Severe deterioration with corrosion. The corrosion may have occurred after the concrete was damaged.**

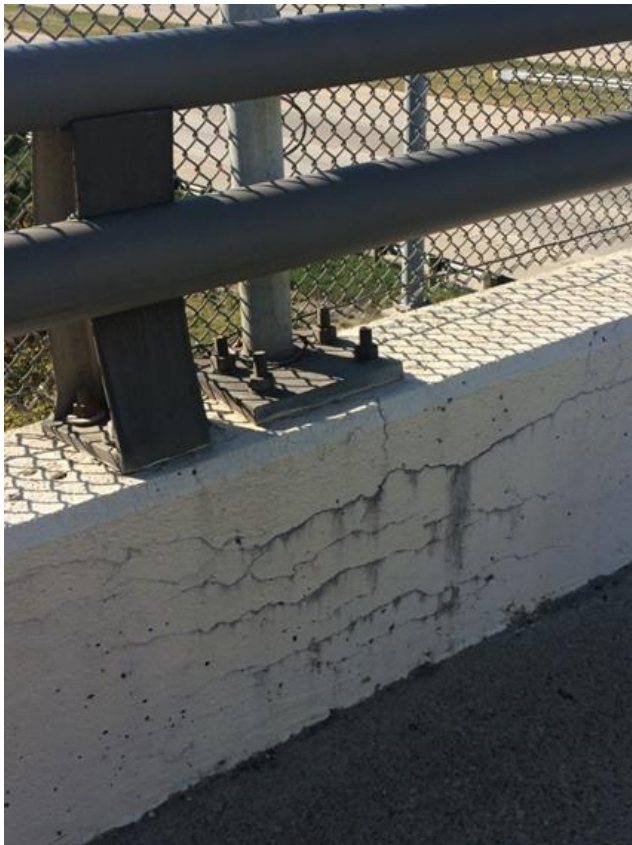
One of the more interesting bridges visited was the Sullivant Avenue Bridge. The bridge runs approximately east/west giving one side a southerly exposure and the other a northerly exposure. The side with the southern exposure was cracked and damaged as shown in **Figures 6-9**.

**Figure 6 - Cracking on the parapet under a vandal fence support.**

In **Figures 6-9** the deterioration does not appear to be related to any corrosion of the reinforcing bar; however, that is not possible to determine from a visual inspection. **Figure 10** is a picture of the north side of the bridge. Note the lack of damage. This was typical of the entire bridge; the north side showed no damage while the south side showed extensive damage.

The extensive damage to the south side suggests a freeze/thaw mechanism. In Ohio, the sun is always to the south in the winter with a low declination. As a result, southern exposures are heated by the sun during the day while northern exposures are not. This will initiate many more freeze/thaw cycles for the southern exposures of structures while northern exposures receive far fewer and less severe cycles.

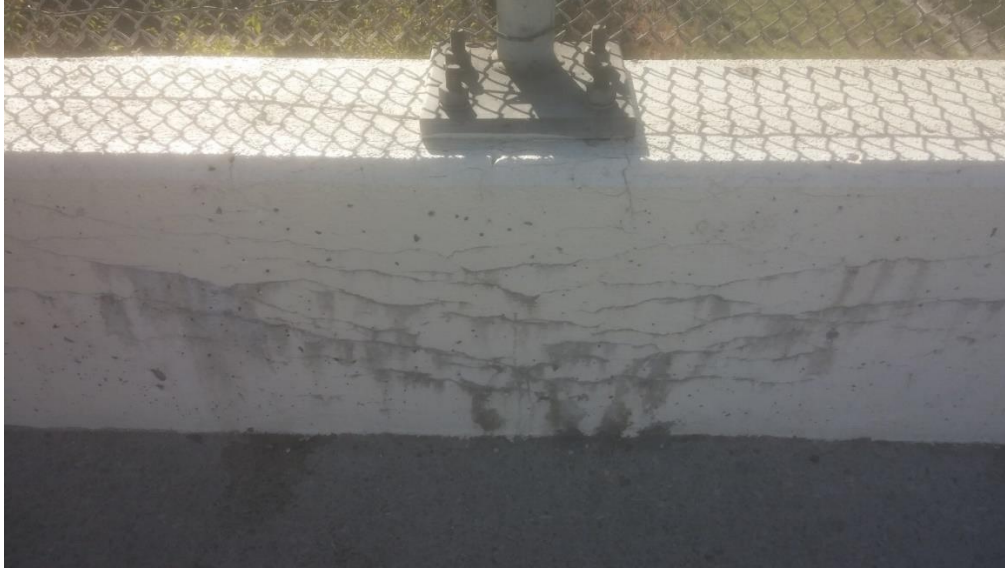
**Figure 7 - Cracking on the parapet wall.**

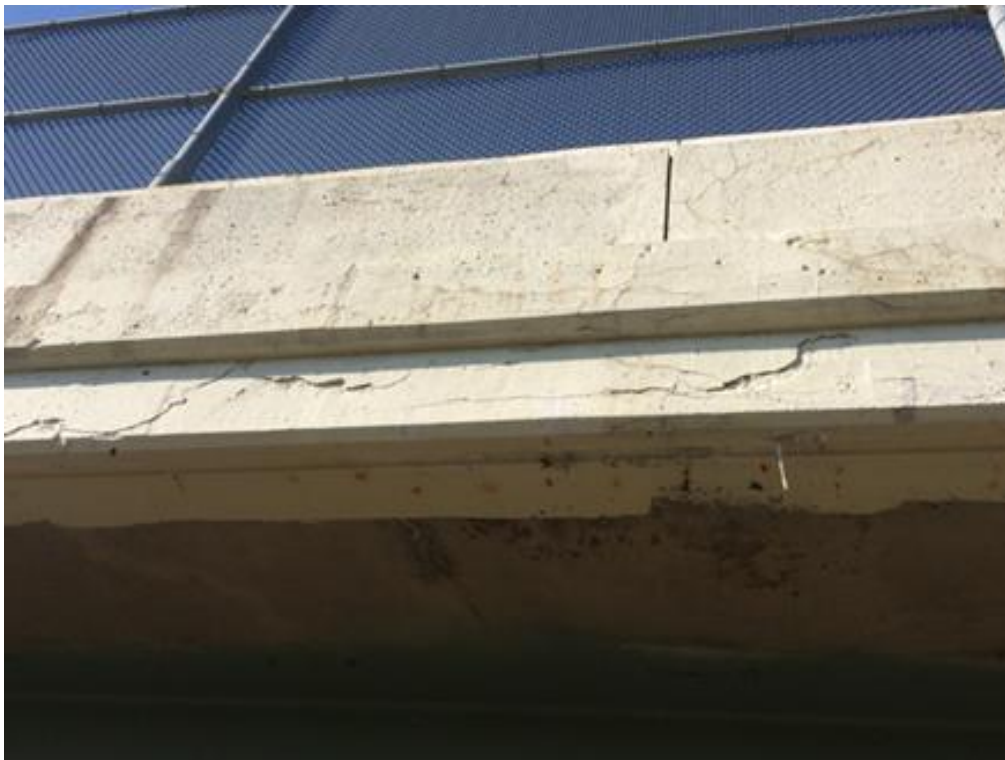
**Figure 8 - Cracking on the south face of the bridge.**

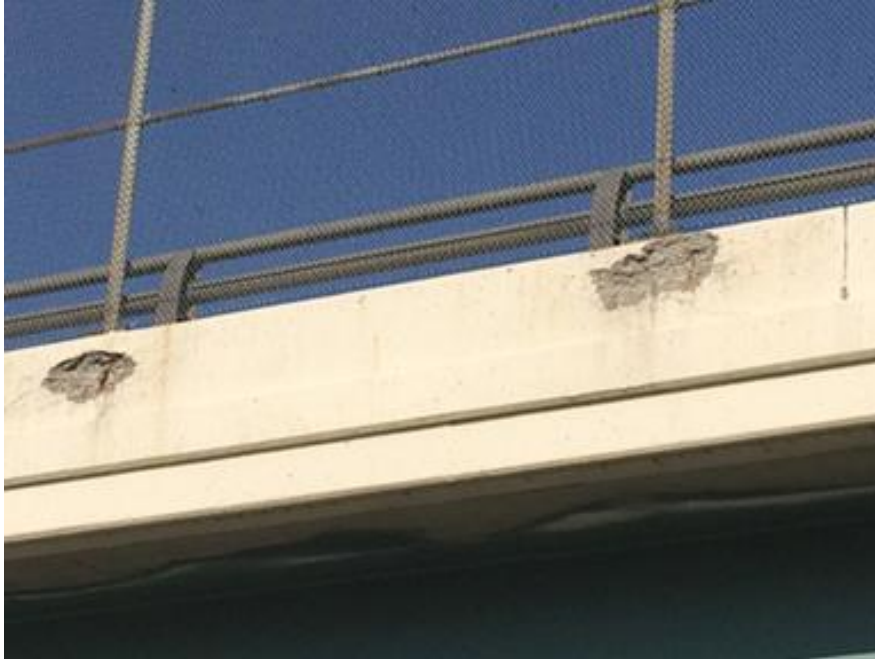
**Figure 9 - Spalling on the south face of the bridge.**

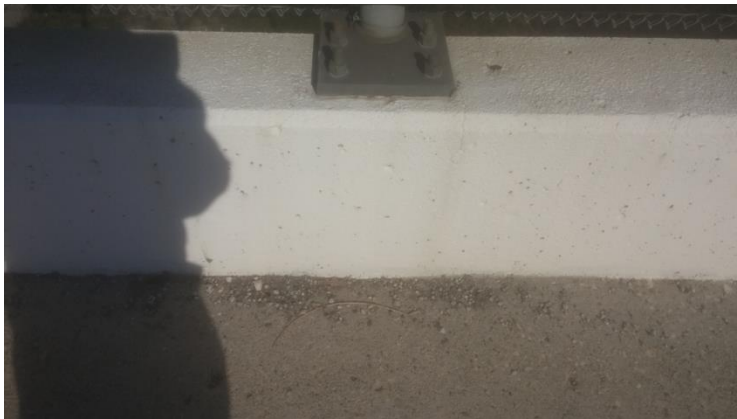
**Figure 10 - North side of the bridge is undamaged.**

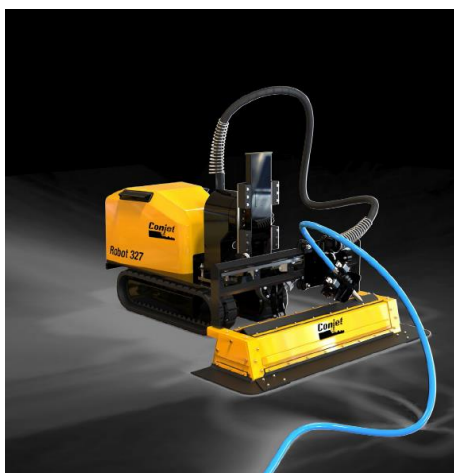
Some recently developed hydrodemolition equipment may be suitable for parapet walls. As noted, hydrodemolition generally needs to be done by a robot to be most effective. Three products have been found that may work with parapet walls: the CONJET 327, 367 and 557. The 327 model is shown in **Figure 11**. **Figure 12** shows the accompanying power unit, and **Figure 13** shows the 327 model in use on a bridge.

**Figure 11: CONJET 327 (Graphic courtesy of National Hydro, Inc.)**

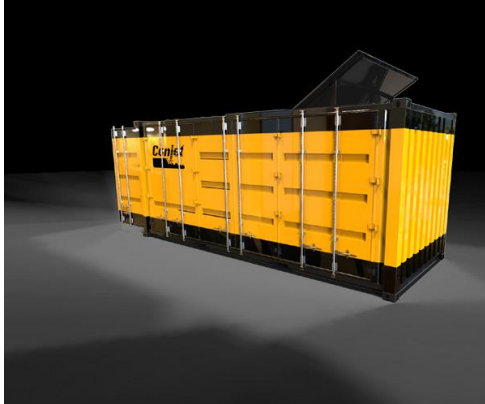
**Figure 12: Power Unit (Graphic courtesy of National Hydro, Inc.)**

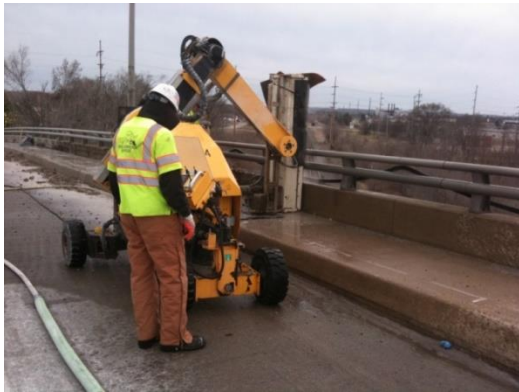
**Figure 13: CONJET 327 used on a bridge railing (Photo courtesy of National Hydro, Inc.)**
