Bridge Maintenance Program for the City of Columbia, Missouri

Final Report
September 2017

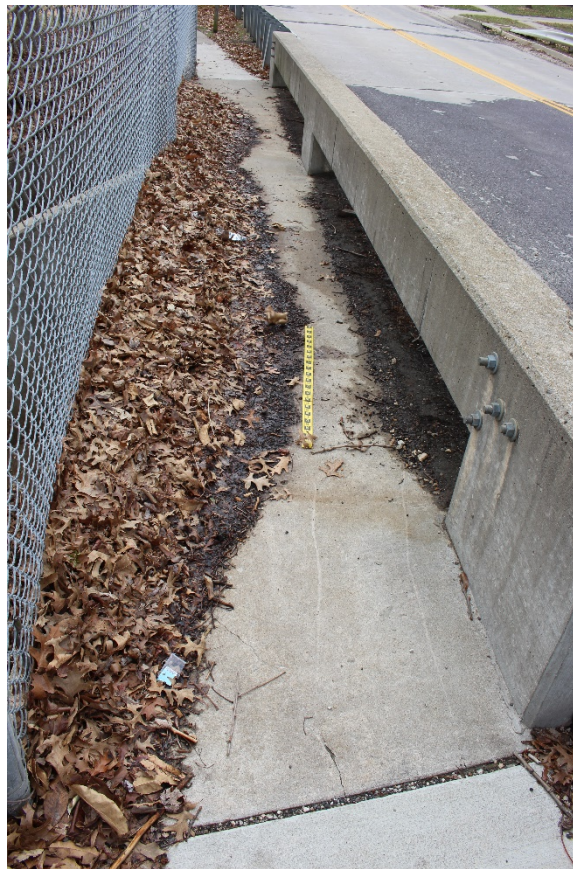
Figure 2. Debris accumulation on a deck (culvert 0930021)

In some cases, vegetation may grow from this debris. The debris traps moisture against the concrete and accelerates the deterioration of the concrete. Deck sweeping and/or mechanical removal (i.e., using a shovel) of this debris would reduce the long-term effect of this debris accumulation and slow the deterioration of the bridge elements. Cleaning and removal of debris should be completed on bridge decks, beam seats/bearing areas of bridges, and superstructure members, where appropriate. Removal of the accumulated debris is typically completed prior to bridge washing or deck flushing.

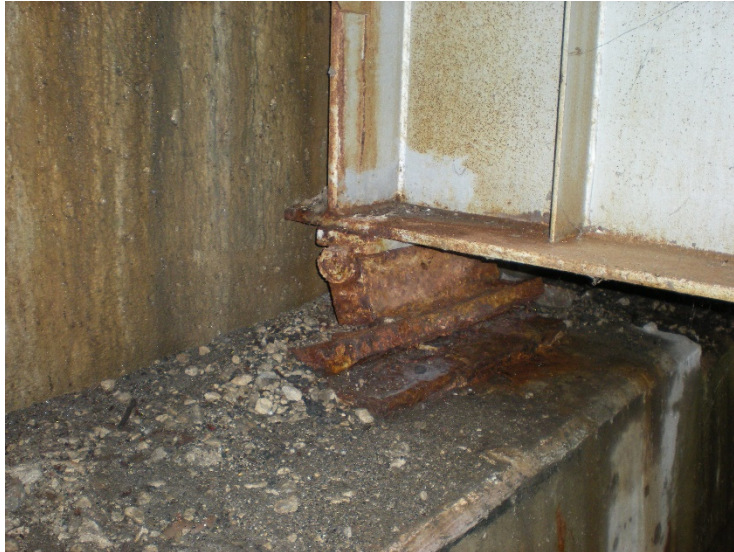
Debris accumulation in the beam seat area is particularly prevalent where deck joints are failing and can result in a significant increase in the rate of deterioration. Figure 3 shows an example of debris collected in the beam seat area as a result of a failed deck joint, which is allowing debris from the deck surface to accumulate on the beam seat.

Figure 3. Debris accumulated in the beam seat area as a result of a failed joint/seal in the deck above the bearing

High water events can also deposit debris in the beam seat area. Periodic cleaning of the beam seat area may not be required in areas where joints and seals are performing adequately if the bridge is not subject to periodic high water. When joints and seals are damaged, frequent cleaning of the bearing/beam seat area is necessary to clear debris and remove chlorides that typically drain from the bridge deck through the failed seal and directly onto the bridge bearings. Repair or replacement of joint seals and failing joints can reduce the need for cleaning.

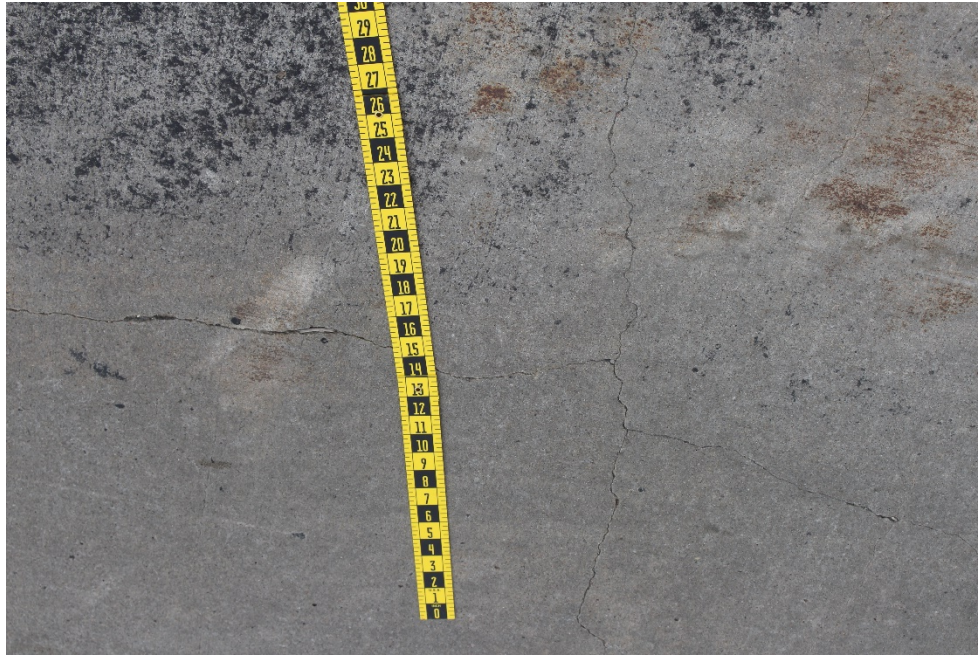
Sealing individual cracks, such as those shown in Figure 4, can be a cost-effective method of preserving a bridge deck.

Figure 4. Example of concrete bridge deck cracking

Local staff can apply the crack sealer using the bottle method. This is sometimes referred to as “crack chasing.” Crack sealers include epoxies, topically applied repair resins such as high molecular weight methacrylate (HMWM), and other polymers. The crack sealing approach is usually effective if the spacing between cracks is 2 ft or greater. When cracks are more closely spaced, sealers applied by flooding the deck (i.e., flood coat) are typically more effective. Research described later in this report (Section 4.2.2) indicates that crack sealing is an effective method for protecting against the ingress of water and chlorides, thereby reducing deterioration due to corrosion damage to the reinforcing steel in concrete bridge decks.

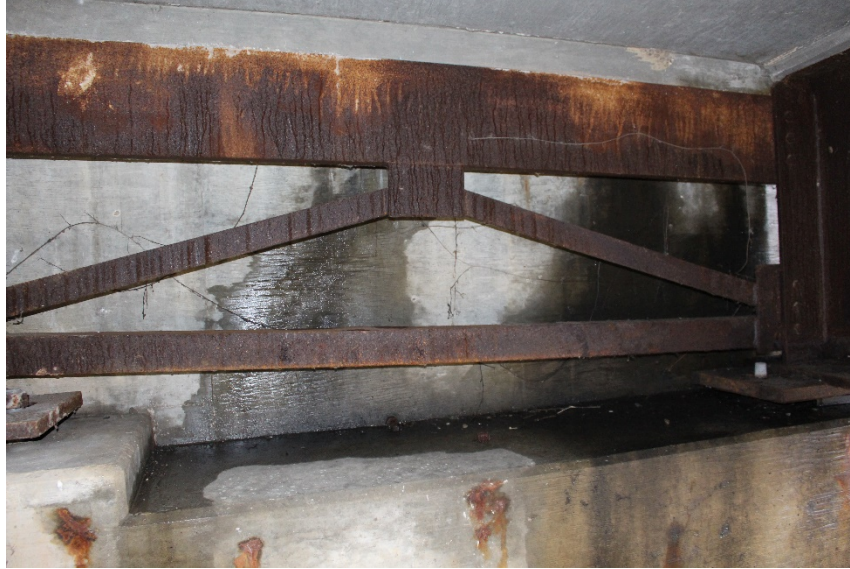
A significant issue in the deterioration of beam ends, bearings, and beam seats is leaking joints at the end of the bridge deck. Damage in the beam ends usually results from leaking joints in the bridge deck, which allow water to pass the joint and run onto the supporting structural elements. Figure 5 shows the type of damage that can result from leaking joint seals.

Figure 5. Corrosion damage at a beam end caused by a leaking joint

Corrosion on the flange, web, and bearing results from water leaking through the joint above the bearing. Joint seal repairs should be prioritized for weathering steel bridges, bridges with damaged or deteriorated coating, and concrete and prestressed girders.

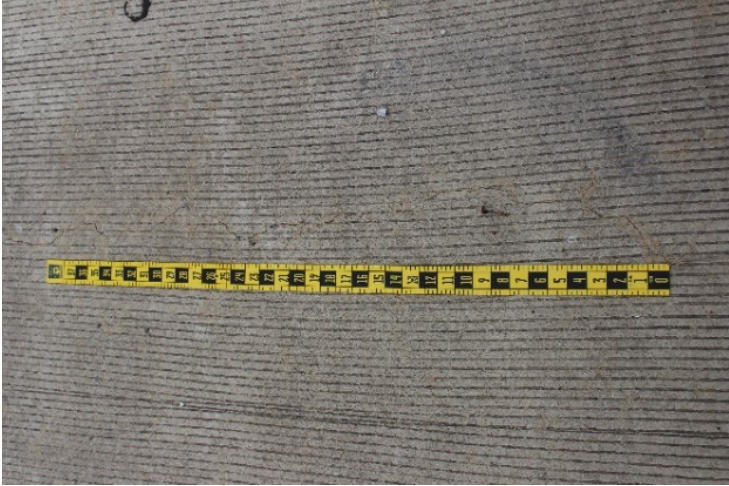
Bridge No.	Actions Required
930038	<p>Bridge deck has extensive, long cracks. These cracks should be sealed.</p>

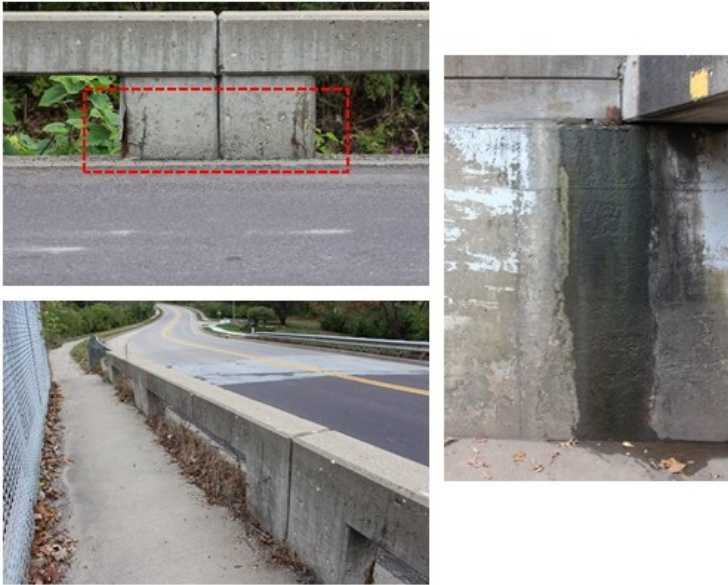
930019	<p>Debris accumulated on sidewalks is causing corrosion of the railing and spalling. Clean the debris accumulated in both sidewalks of the bridge. Correct drainage issue at abutment.</p>

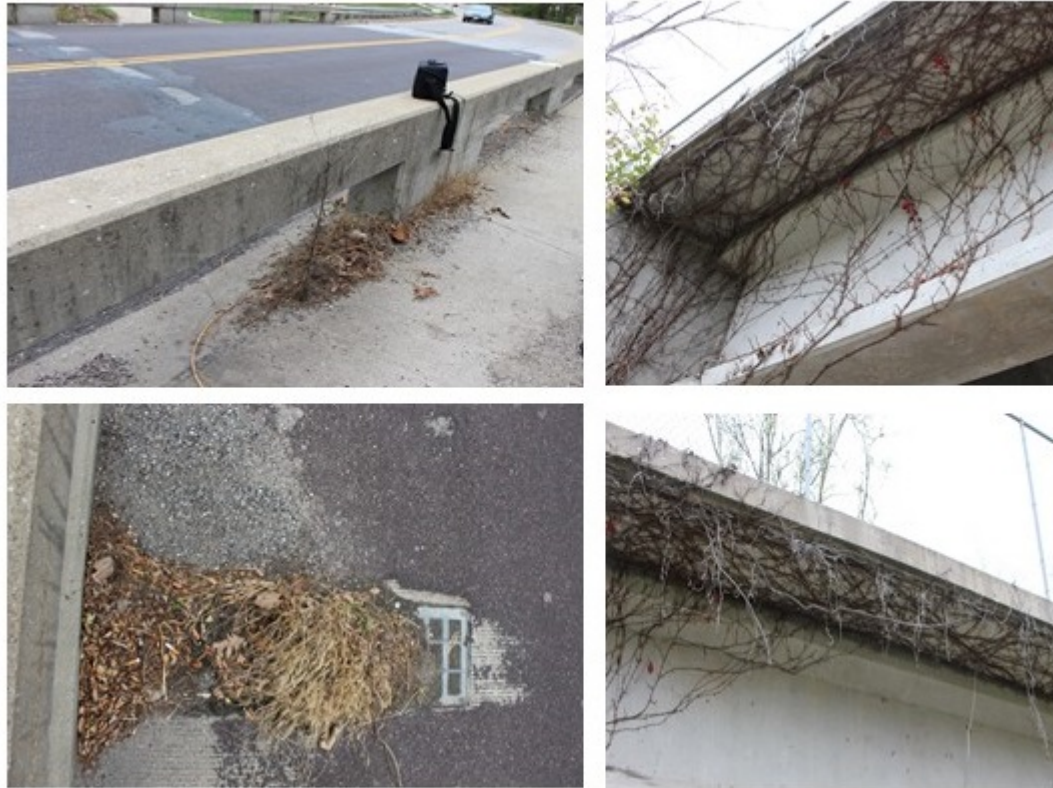
930009

Clean the debris accumulated along the handrail of the bridge. Remove and clean the bridge water drains that are filled with debris. Remove the vegetation covering the sidewalk soffit.

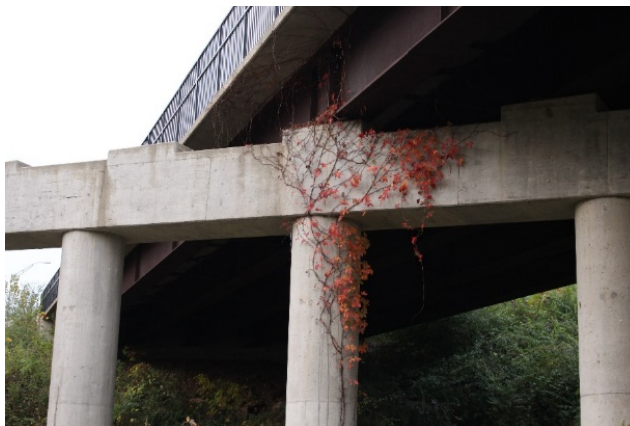
930034

Remove the vegetation that has climbed on the bridge.

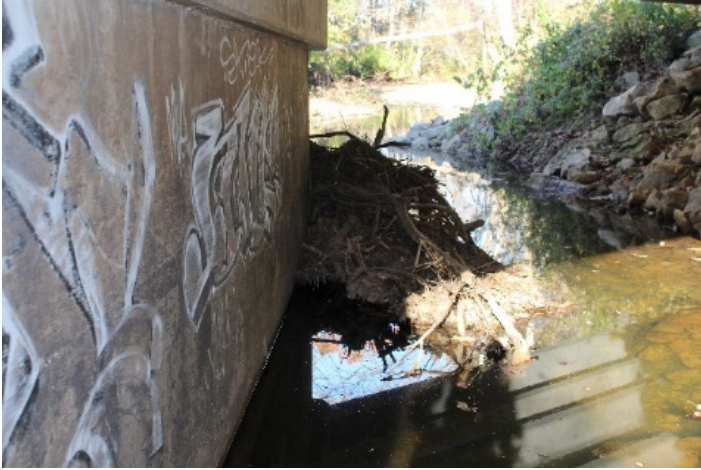
Bridge No.	Actions Required
930018	Remove and clean debris accumulated in the approach slabs. Remove the trees and branches stacked in pier wall on the upstream.

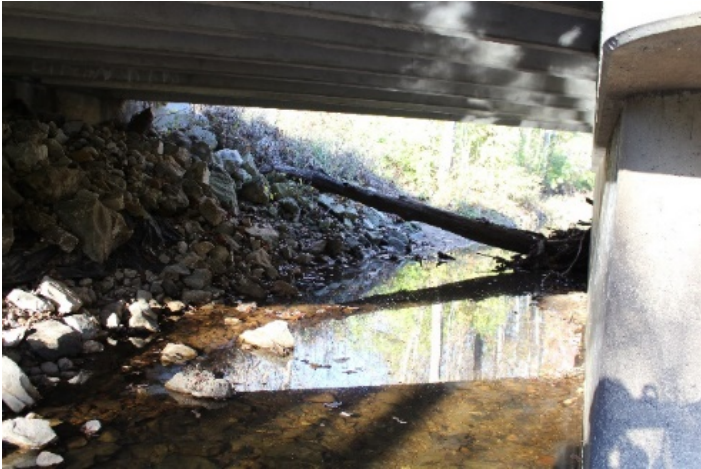
930024	Fix the damaged expansion joint on one side of the bridge. Remove the trees and branches stacked in the pier wall on the upstream.

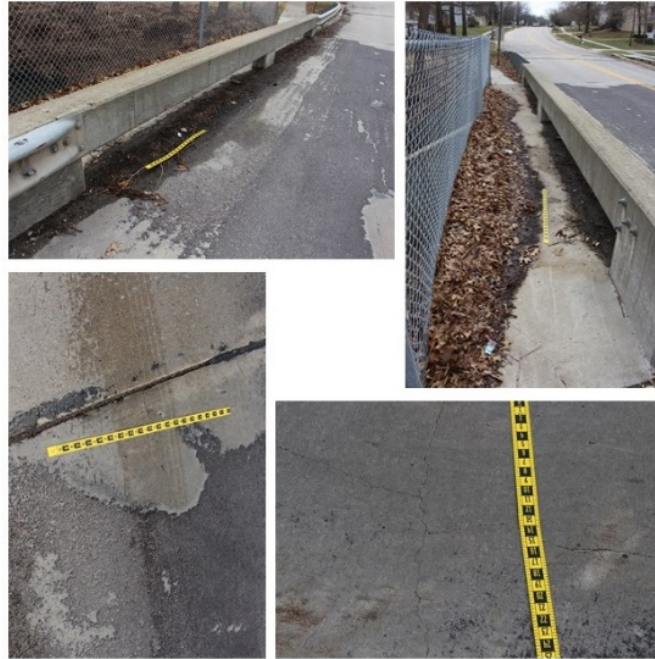
930021

Remove and clean the accumulated debris from sidewalk and bridge deck. The cracks should be sealed and the damaged pourable seal should be fixed.

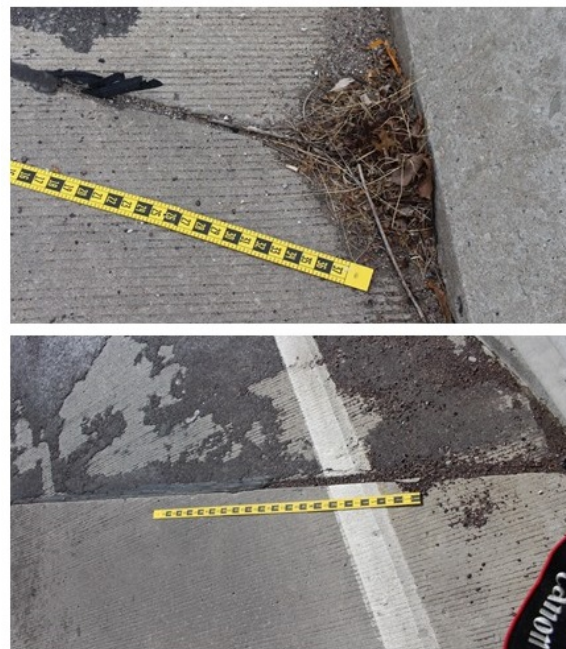
930017

Clean the accumulated debris from the deck. Fix the damaged pourable joint seal.

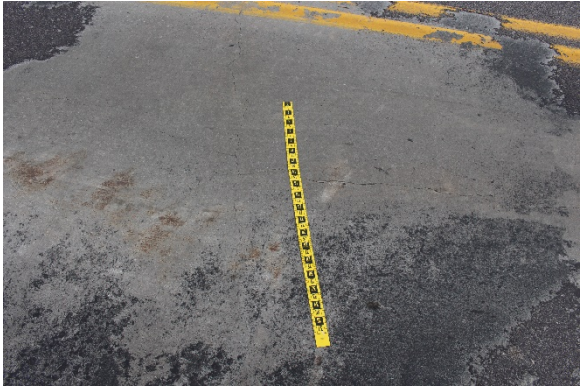
Question	Image of Typical Condition
1	Are there any unsealed cracks in the surface of the deck? Y/N Notes

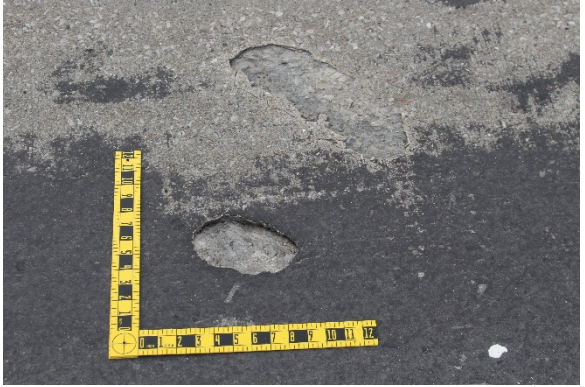
2	Are there any spalls in the bridge deck that require patching? Y/N Notes

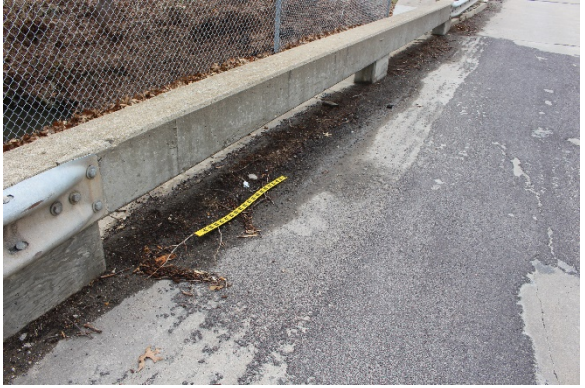
3	Is there debris on the surface of the deck? Y/N Notes

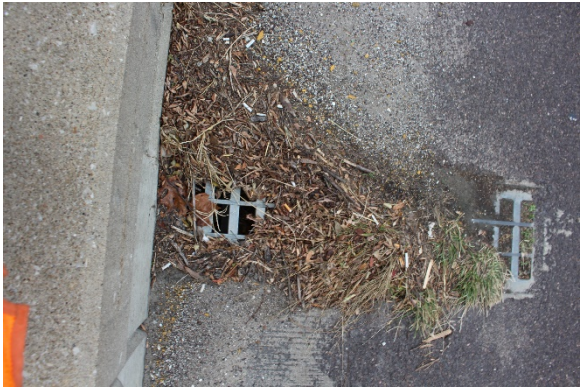
Question	Image of Typical Condition
4	Are the deck drains impacted by debris? Y/N Notes

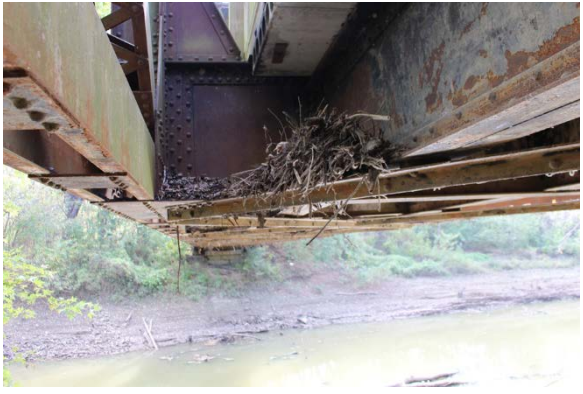
5	Is there debris collected on the superstructure of the bridge? Y/N Notes

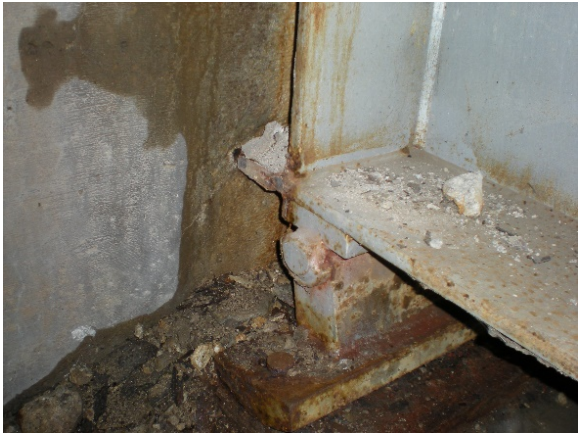
6	Is there water draining/leaking onto the bearing or substructure elements? Y/N Notes

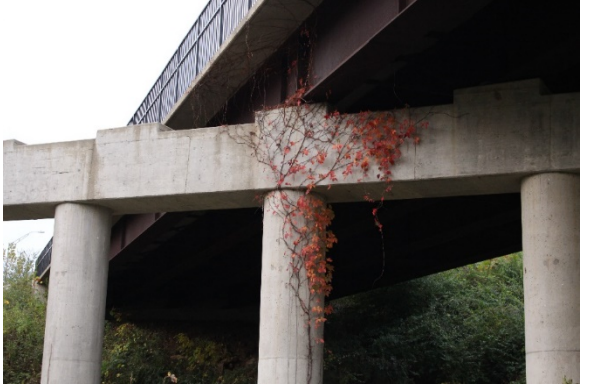
A photograph showing the underside of a concrete bridge spanning a waterway. A large pile of debris, primarily dry sticks and branches, is caught in the channel between the bridge piers, partially obstructing the water flow. The surrounding area is rocky and has some sparse vegetation.
9	Is there vegetation growing onto the superstructure/substructure? Y/N Notes

A photograph of a concrete bridge substructure, specifically a pier. Red-leafed vines are growing up the side of the pier, reaching towards the bridge deck. The background shows green foliage and a clear sky.
