Evaluation of Wildlife Crossing Structures on US 93 in Montana's Bitterroot Valley

Final Presentation to Montana
Department of Transportation
January 30, 2017

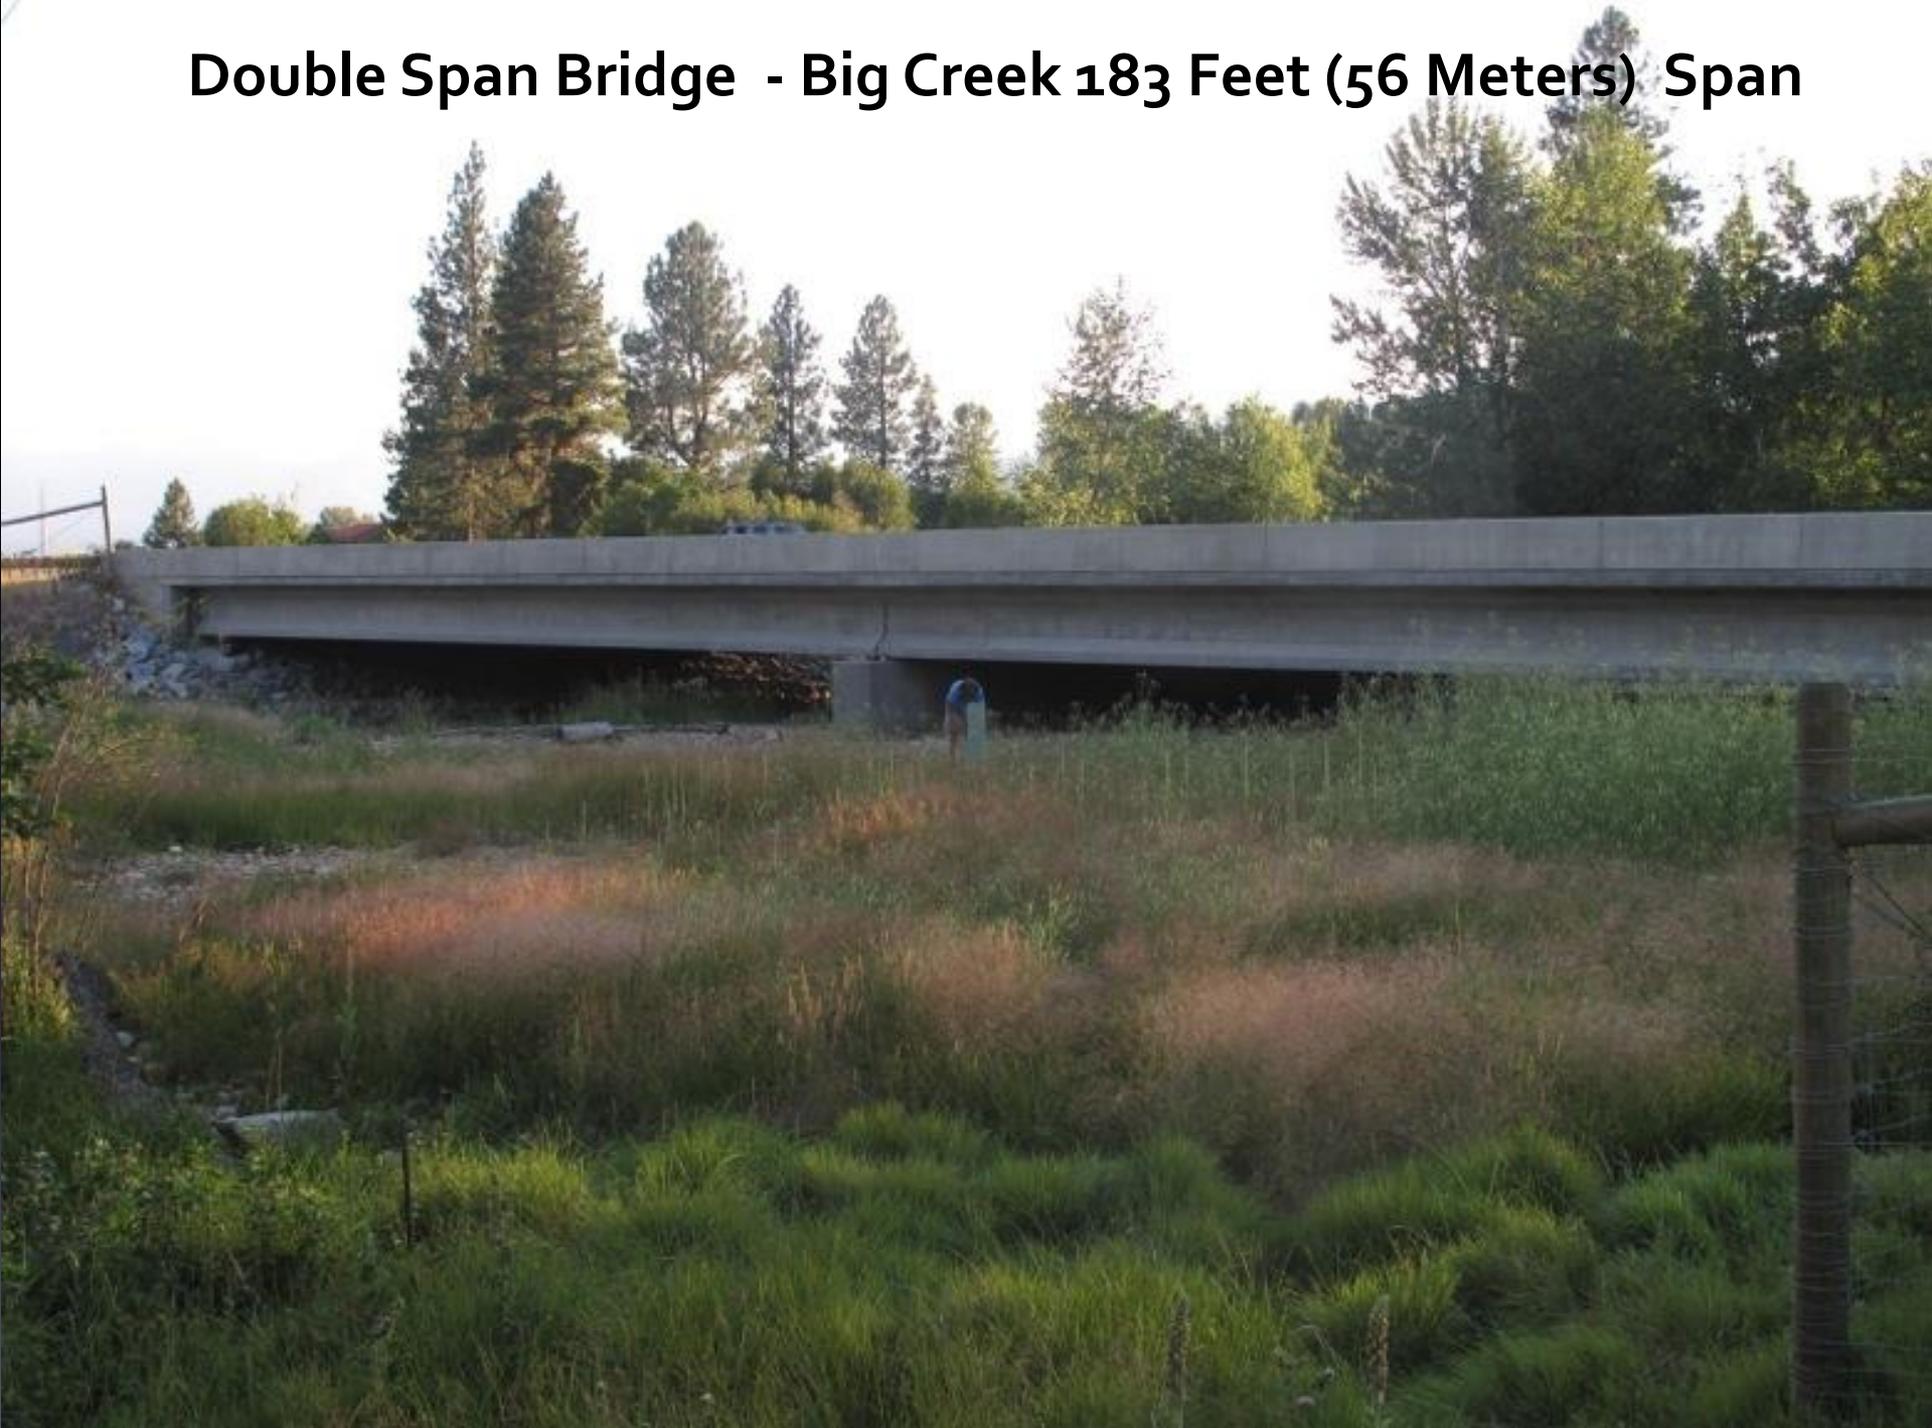
Double Span Bridge - Big Creek 183 Feet (56 Meters) Span

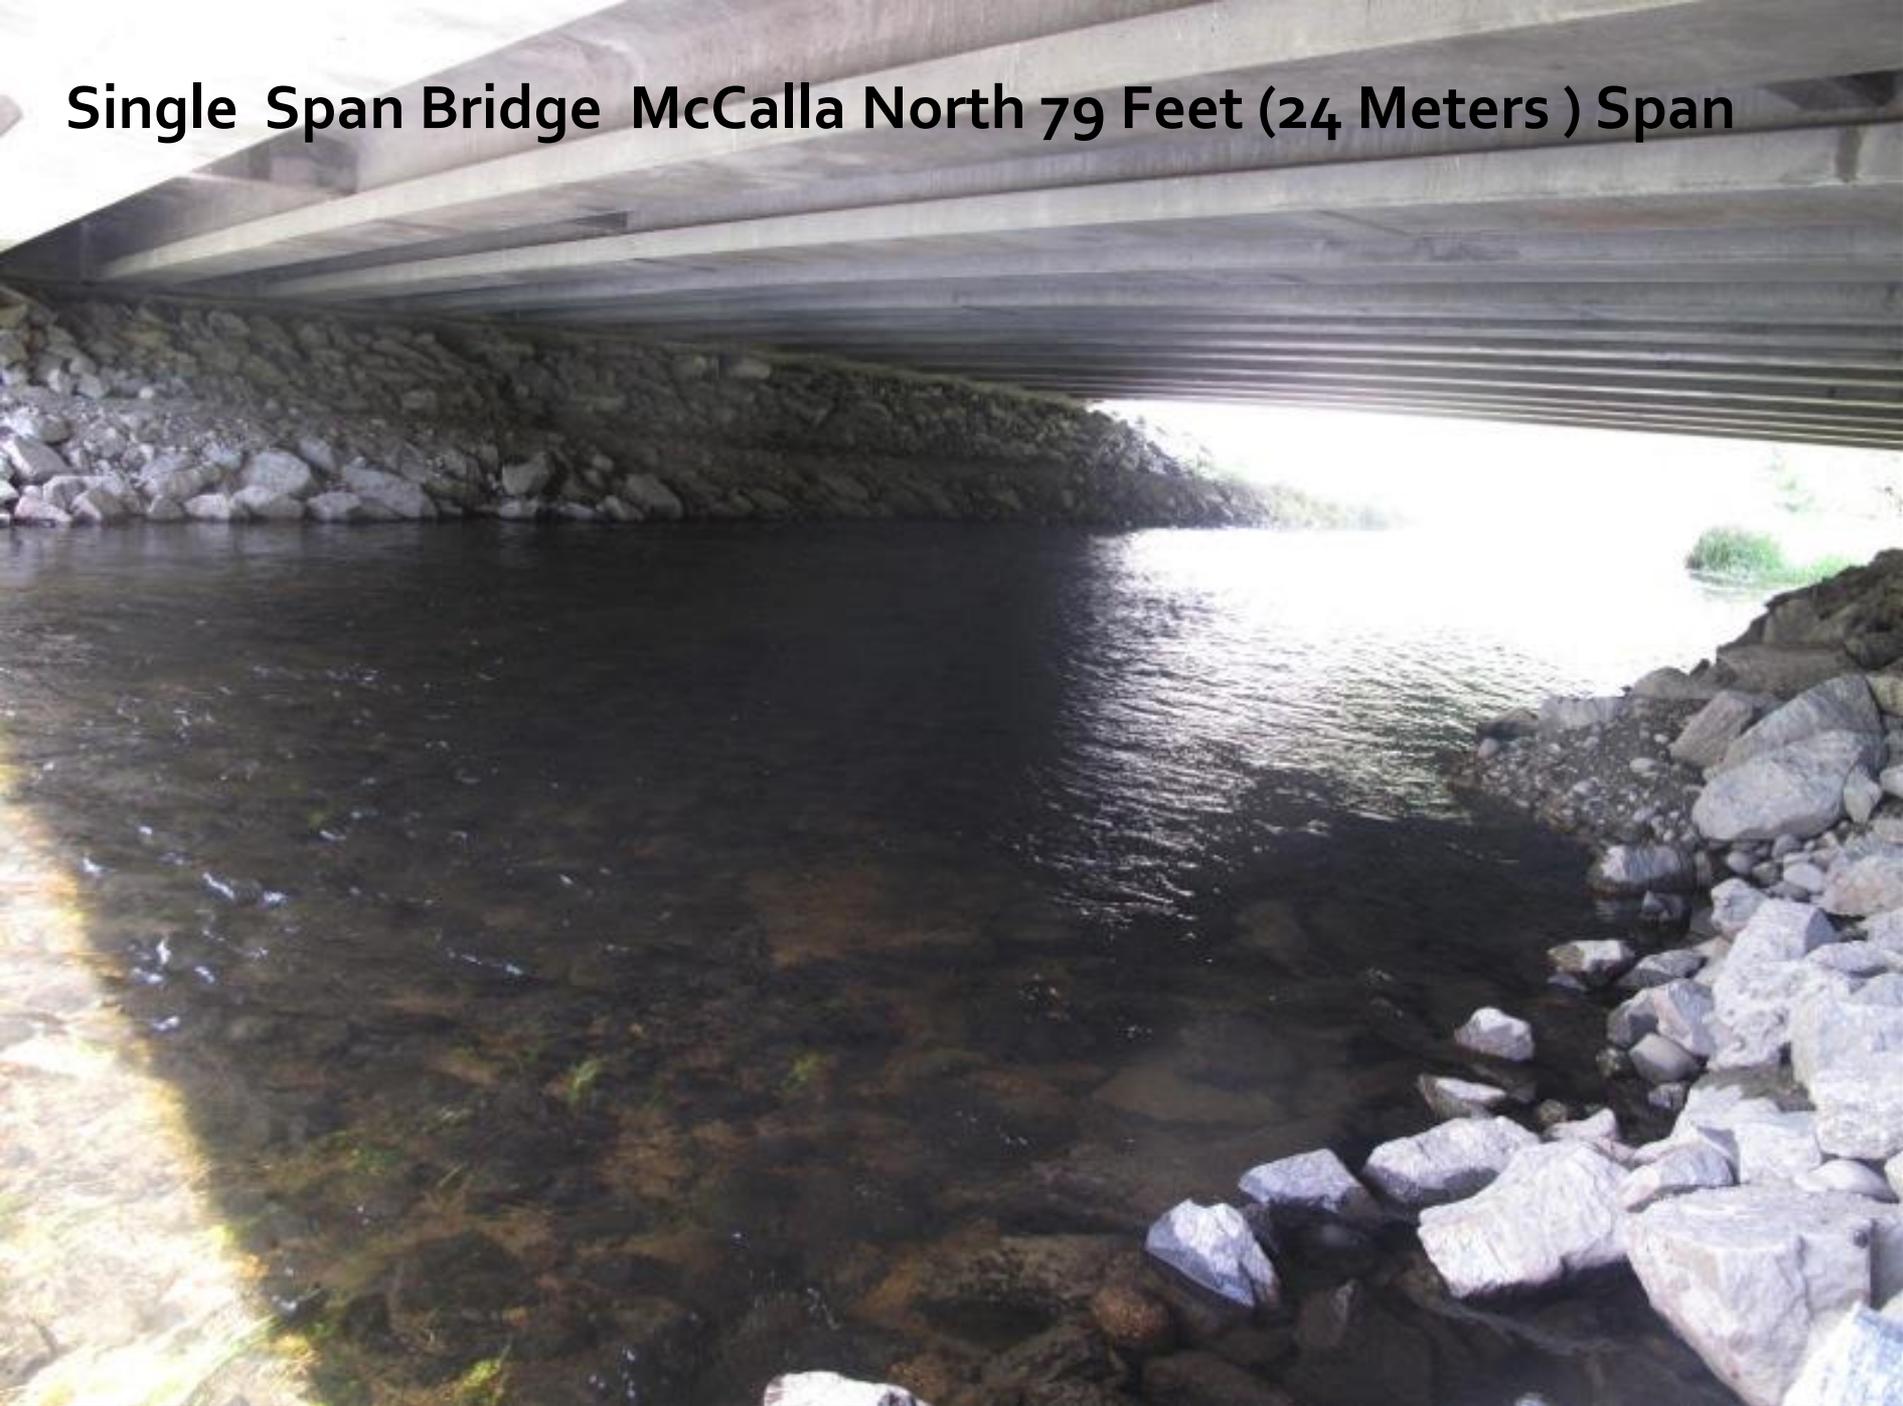
Single Span Bridge McCalla North 79 Feet (24 Meters) Span

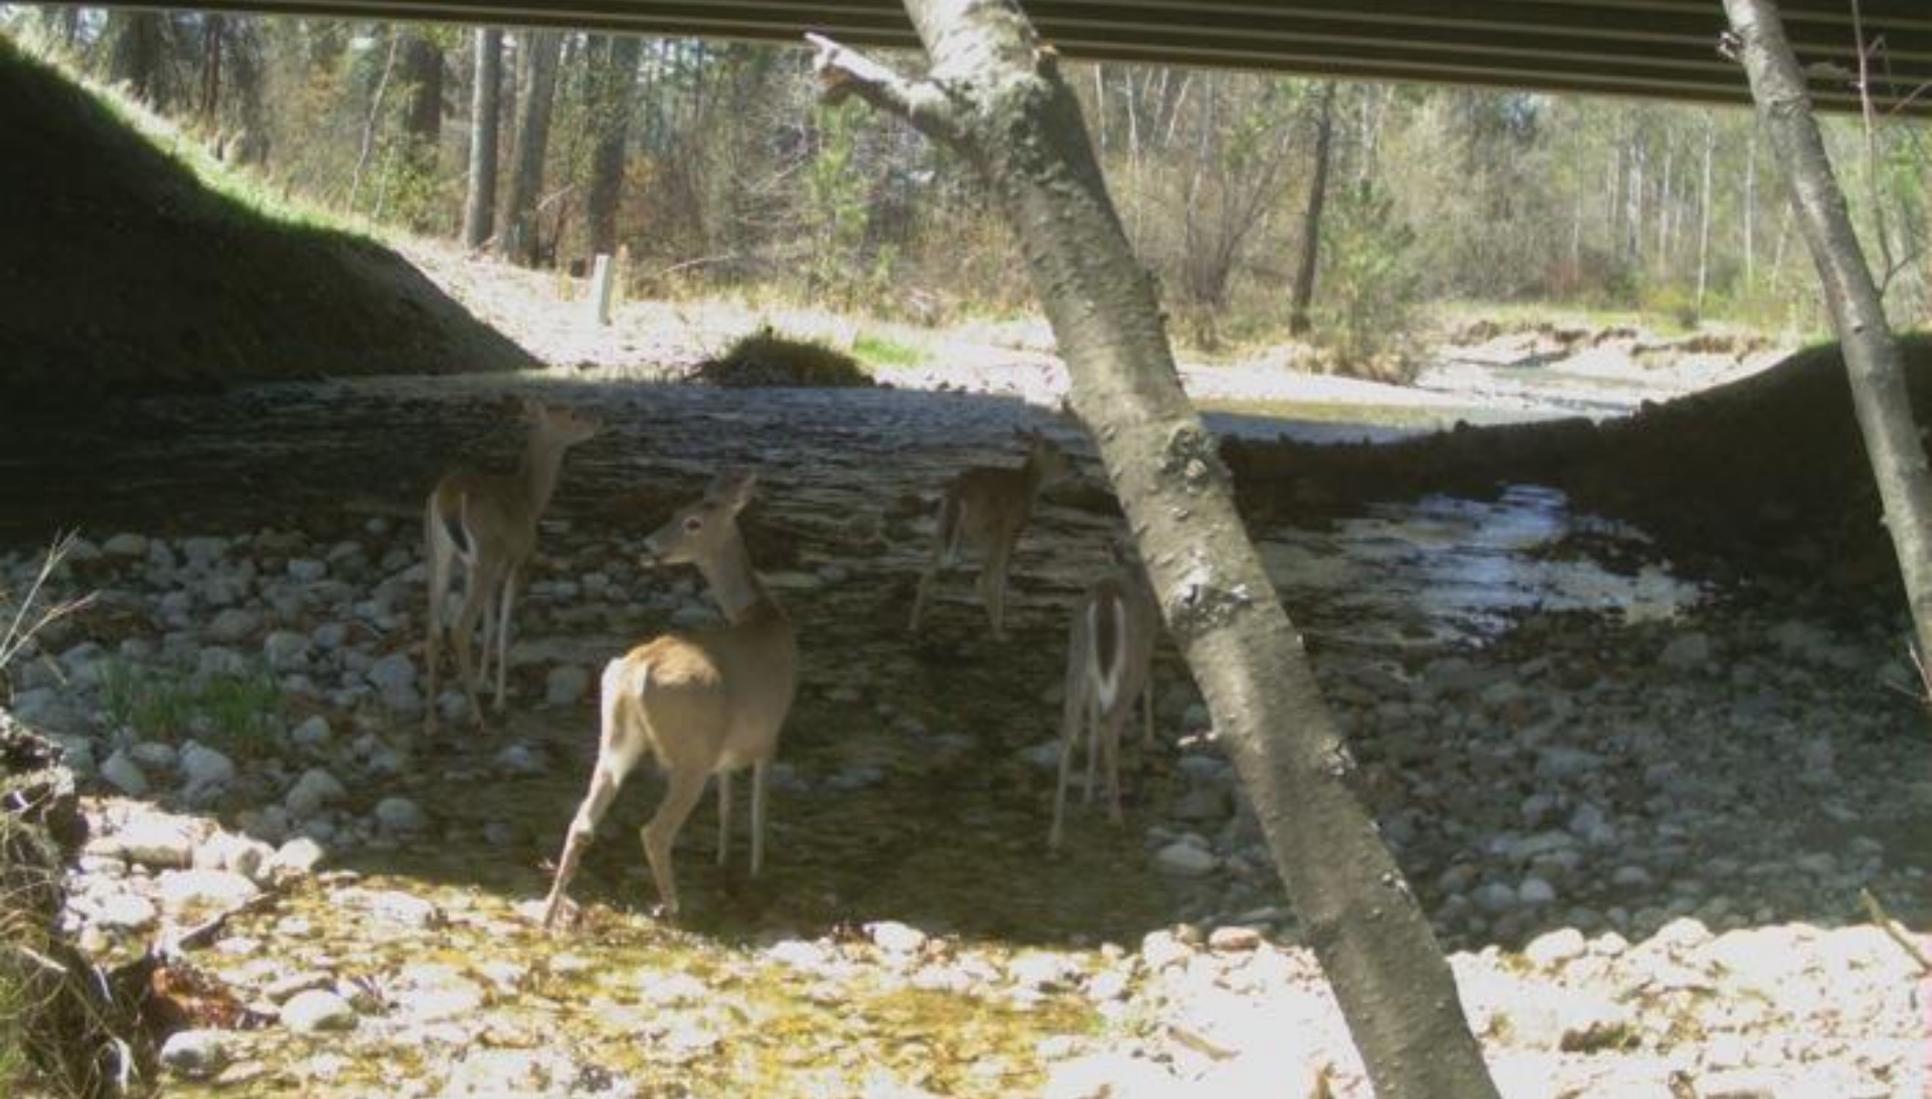
Bear Creek South Bridge – 12.5 Feet High (3.8 Meters) on Hillside Pathways

| Wildlife Crossing Structure | Success | Repel- lency | Parallel | Total Movements | Success Rate (%) | Rate of Repel- lency (%) | Parallel Rate (%) |
|---|---|---|---|---|---|---|---|
| Bear Creek South Bridge | 2554 | 30 | 113 | 2697 | 95 | 1 | 4 |

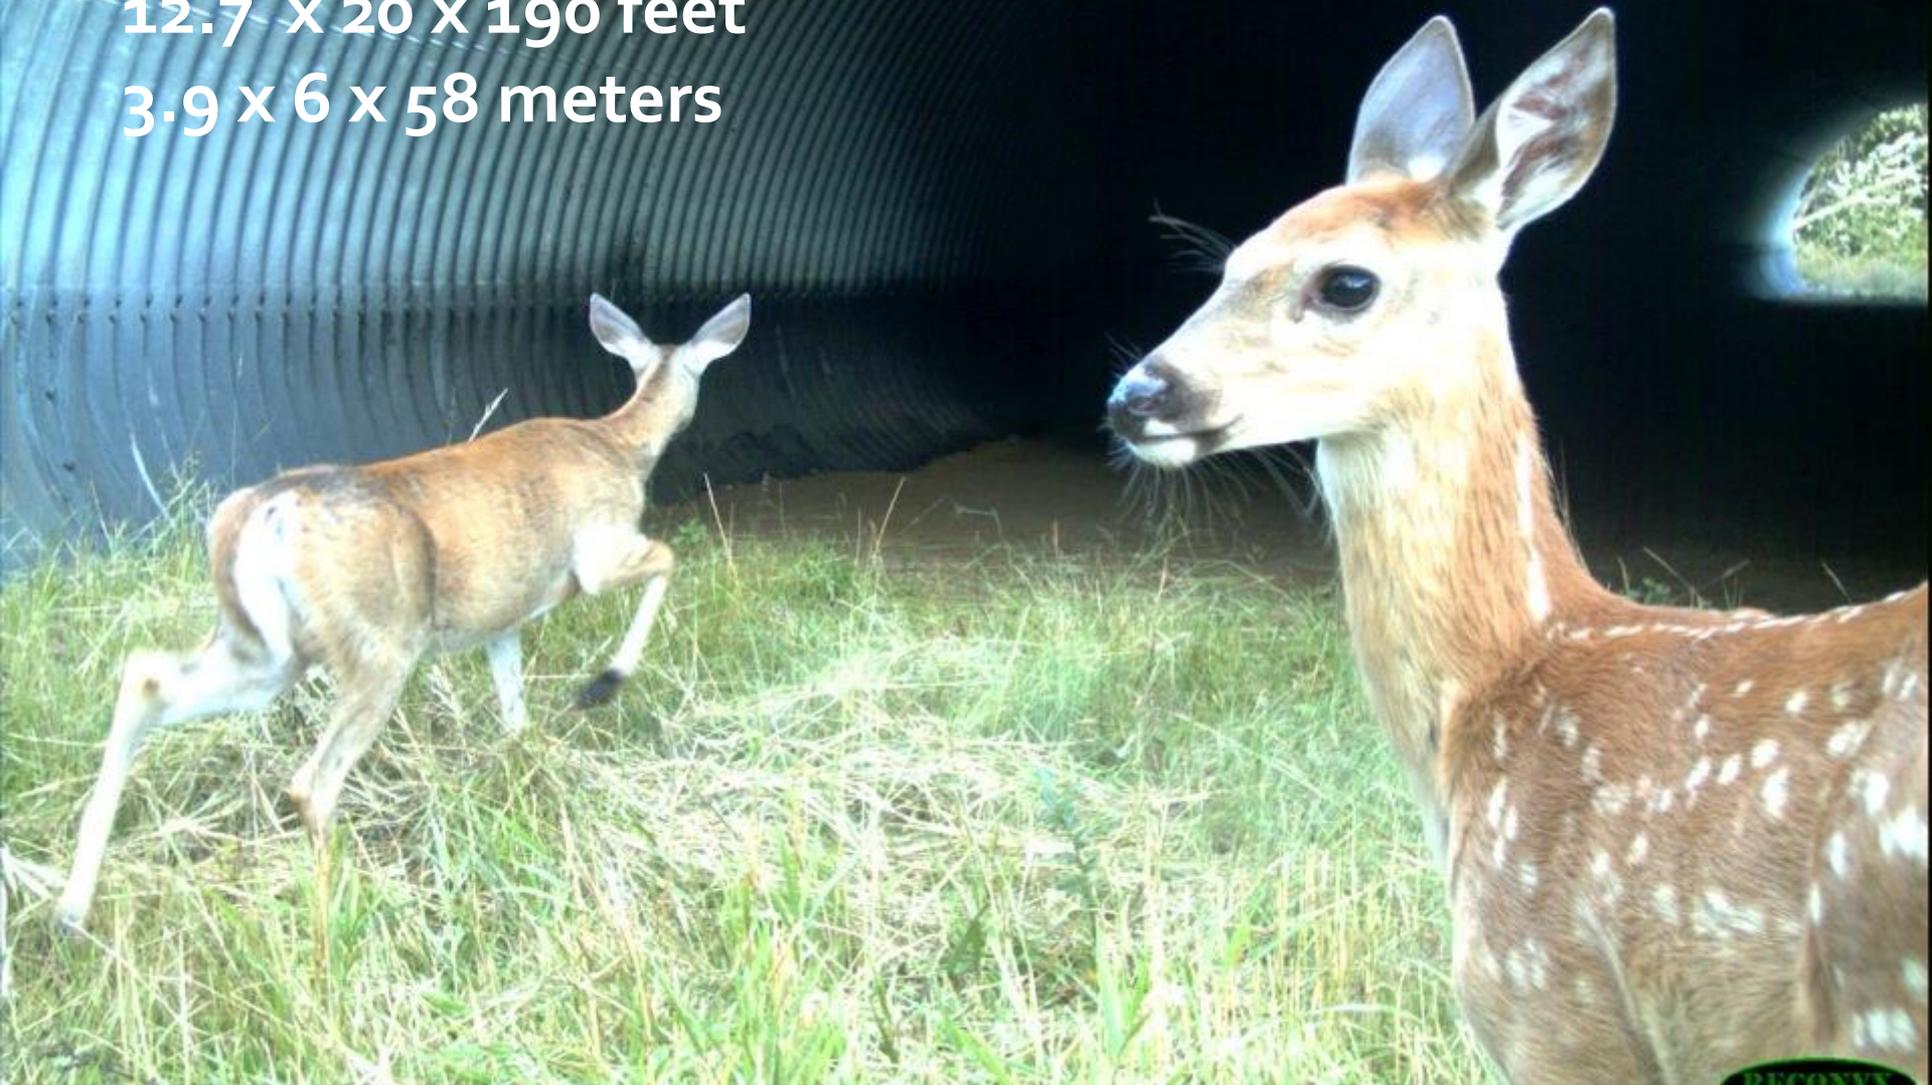
Larger Corrugated Steel Culvert Bass Fishing Access Culvert

12.7 x 20 x 190 feet

3.9 x 6 x 58 meters

| Wildlife Crossing Structure | Success | Repel- lency | Parallel | Total Movements | Success Rate (%) | Rate of Repel- lency (%) | Parallel Rate (%) |
|---|---|---|---|---|---|---|---|
| Bass Creek Fishing Access Culvert | 3257 | 118 | 21 | 3396 | 96 | 3 | 1 |

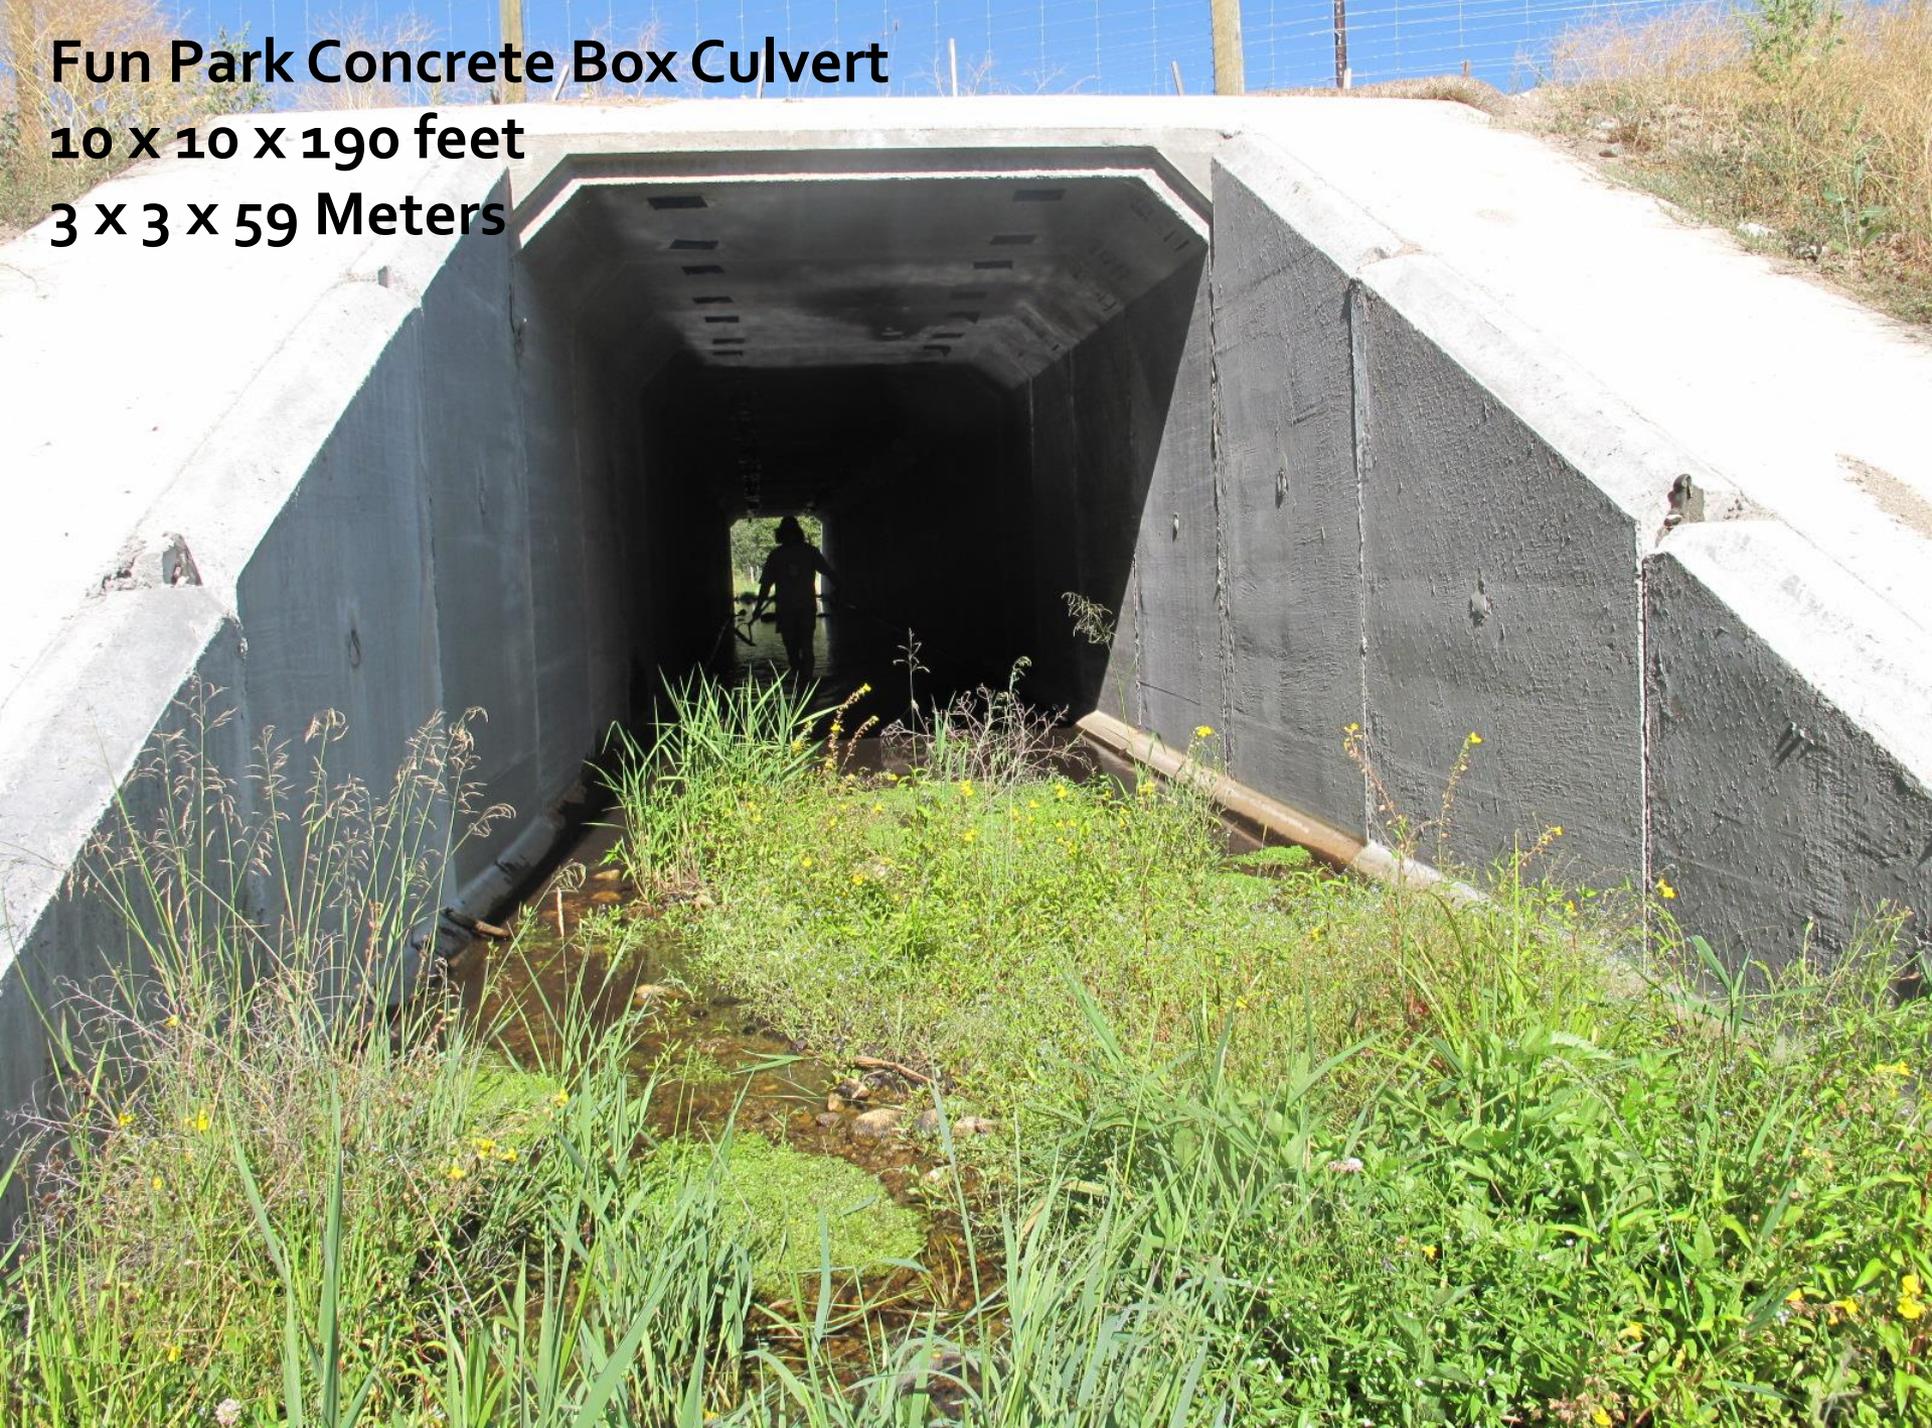
Fun Park Concrete Box Culvert

10 x 10 x 190 feet

3 x 3 x 59 Meters

| Wildlife Crossing Structure | Success | Repel- lency | Parallel | Total Movements | Success Rate (%) | Rate of Repel- lency (%) | Parallel Rate (%) |
|---|---|---|---|---|---|---|---|
| Fun Park Culvert | 0 | 40 | 410 | 450 | 0 | 9 | 91 |

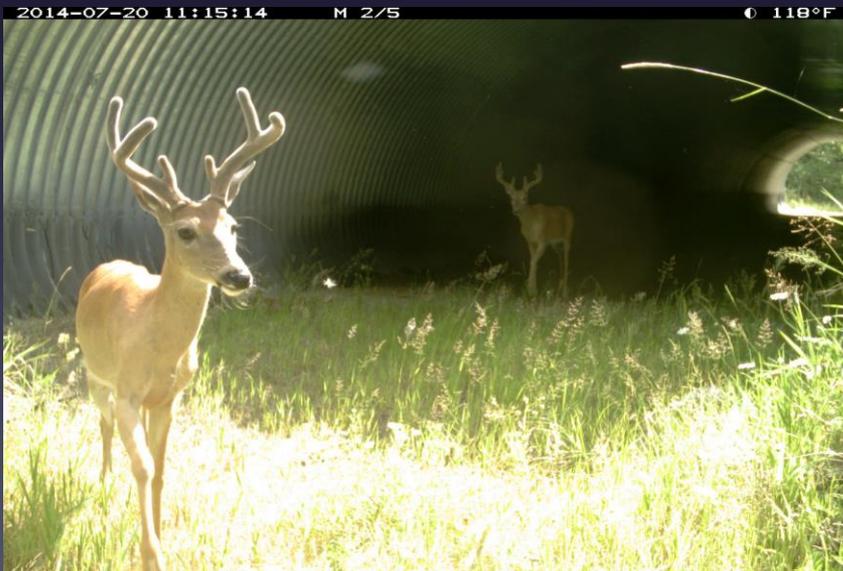
Bass Fishing Access Culvert

12.7 x 20 x 190 feet,

Openness (meters): 0.4: 1.3 in feet

Success Rate: 96%

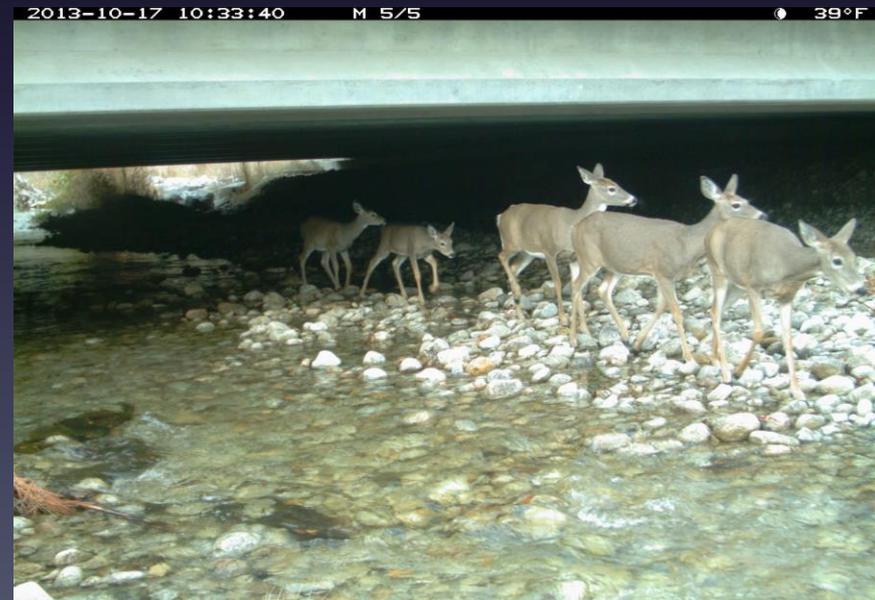
Bear Creek North Bridge 4.3 x 69 x 90 feet

Openness (meters): 1.0: 3.3 in feet

Success Rate: 37%
