# Developing Crash-Modification Factors for High-Friction Surface Treatments

PUBLICATION NO. FHWA-HRT-20-061

SEPTEMBER 2020

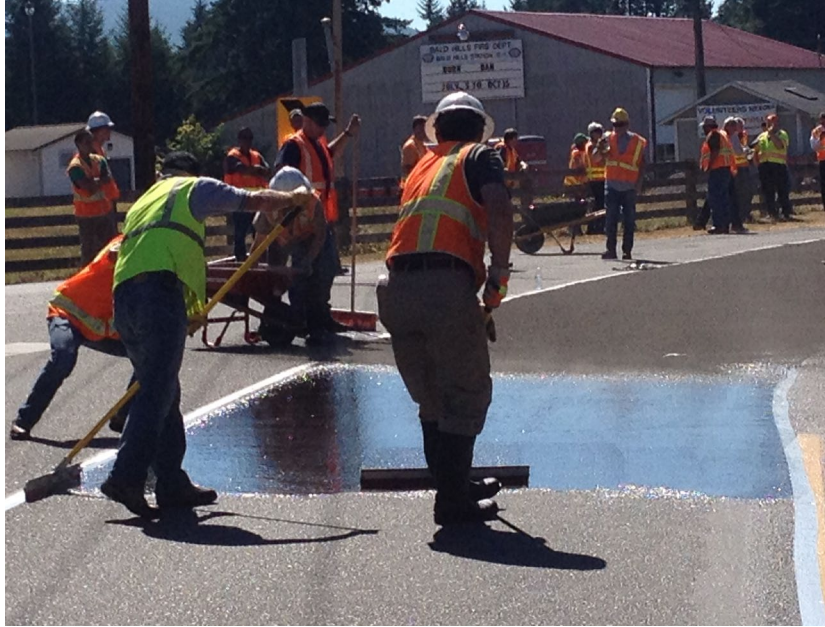
**Figure 1. Photograph. Manual HFST installation.**

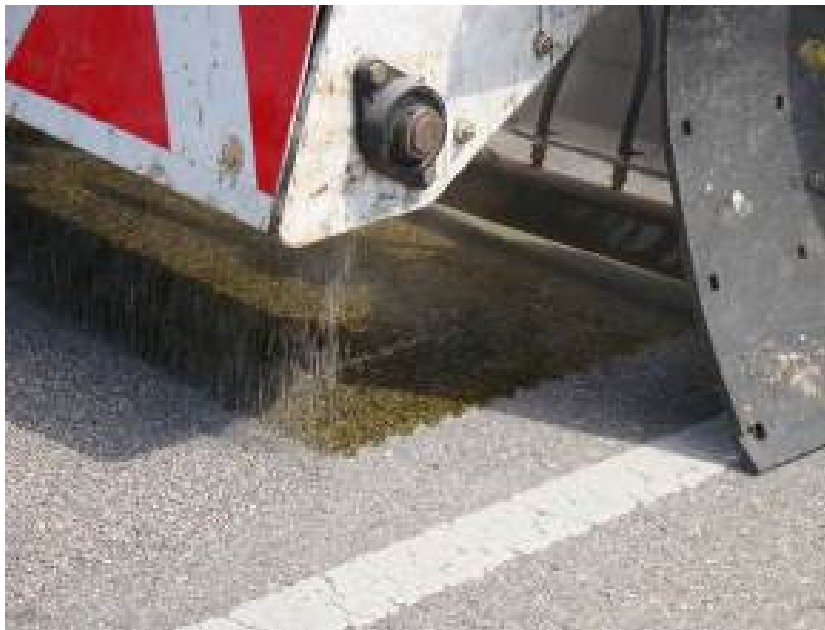
**Figure 2. Photograph. Fully automated HFST installation.**

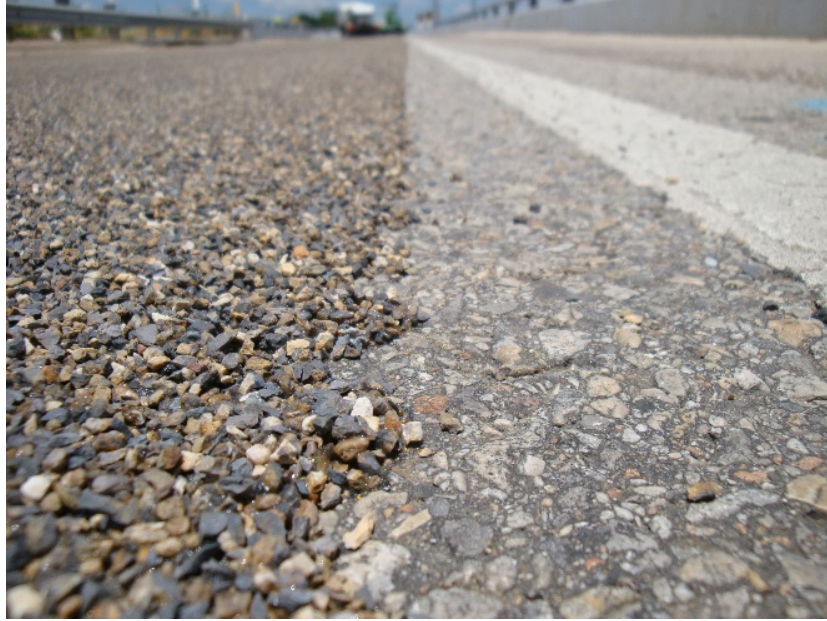
**Figure 3. Photograph. HFST post installation.**

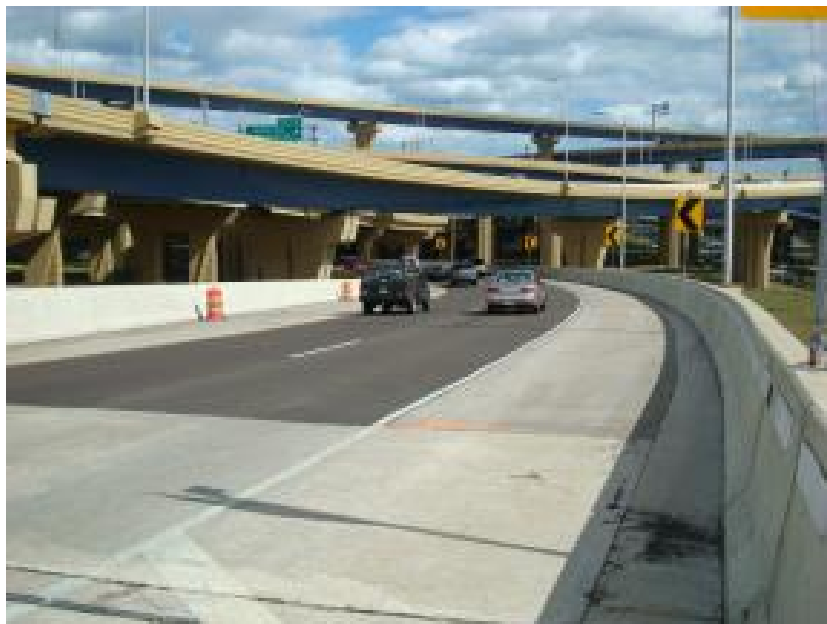
**Figure 4. Photograph. Curve with an HFST installed.**

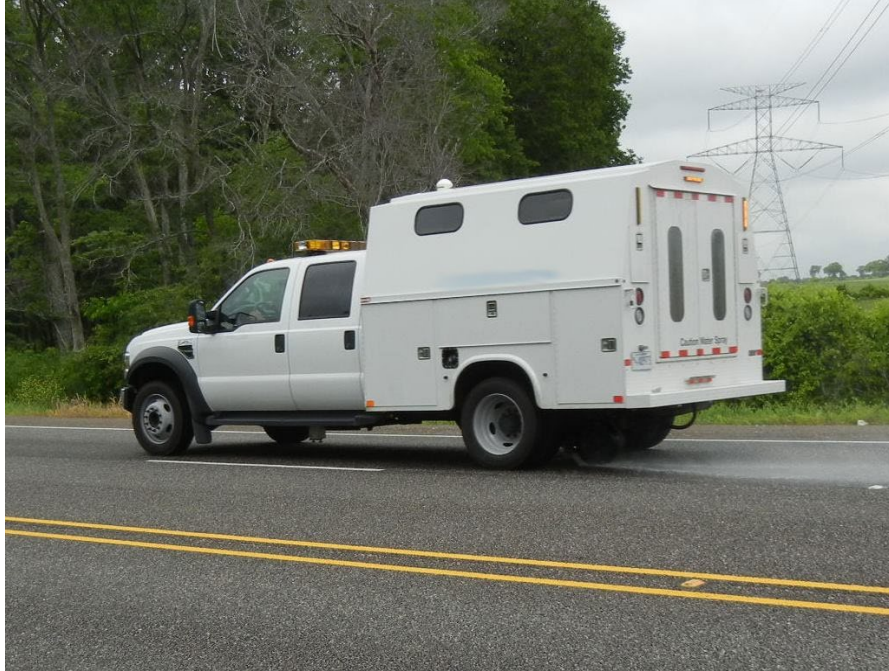
Continuous friction-measurement systems report measurements as frequently as every 1 ft over the section of pavement. This allows for any variations in friction to be measured and quantified. Because of this advantage of continuous friction measurement and the nature of the location of most HFST installations, friction data for this current study were collected using FHWA's 6875H HFT (figure 7). The HFT is a continuous fixed-slip measurement device that complies with ASTM E2340, *Standard Test Method for Measuring the Skid Resistance of Pavements and Other Trafficked Surfaces Using a Continuous Reading, Fixed-Slip Technique*, and provides a continuous measurement of friction at prevailing highway speed (ASTM 2006). Friction data are reported by the HFT every 1 ft over the length of the pavement surface. The HFT uses a smooth-tread test tire that complies with ASTM E1551, *Standard Specification for a Size 4.00-8 Smooth Tread Friction Test Tire*, located in the left wheelpath of the lane with a slip ratio of 14 percent (ASTM 2016). The HFT applies a 0.5-millimeter water film to the pavement surface in front of the test tire during testing. The HFT is also equipped with a texture laser to estimate pavement texture as MPD.

**Figure 7. Photograph. FHWA's HFT.**

The HFT was selected for friction data collection due to its ability to measure friction continuously and report results at high resolution (i.e., every 1 ft), thereby capturing any changes in friction within a given curve or ramp. However, the quality of the pre-HFST friction data collected was inadequate. The issues related to friction data collection are discussed in the following section and in the companion report FHWA-HRT-20-062.
