Investigation of Elastomeric Bearing Pad Failures in Louisiana Bridges

LTRC PROJECT NO. 98 – 2SS
STATE PROJECT NO. 736-99-0503

LOUISIANA DEPARTMENT OF TRANSPORTATION AND DEVELOPMENT
LOUISIANA TRANSPORTATION RESEARCH CENTER

September 1999

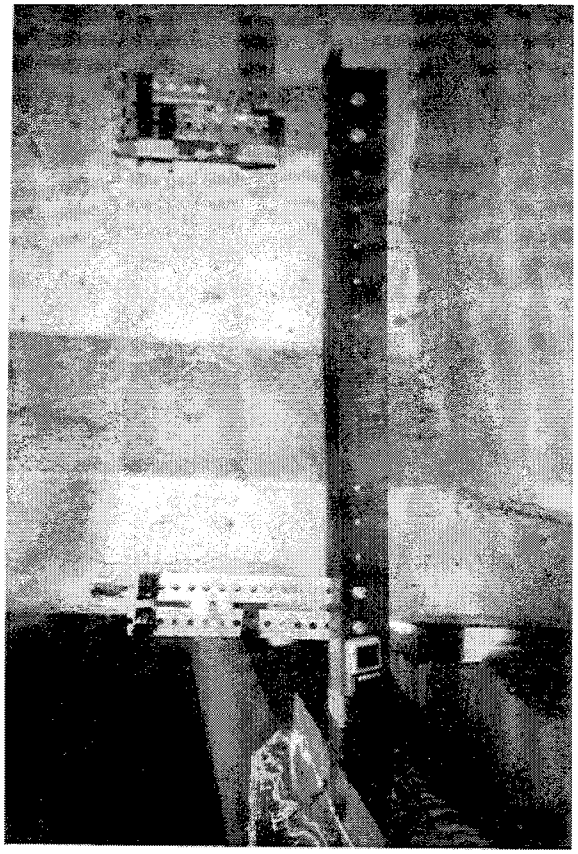
At three sites, US 190 in Pointe Coupee, I310-LA3127 Interchange, and I310 Westbound exit ramp to River Road, maximum girder thermal movements were measured at the girder flange and web levels. A frame was mounted to the abutment bridge seat and pointers attached to the bridge girder to monitor movements with respect to a fixed point, (Figure 1). Attachments of the frame to the abutment and girder pointers to the girder were made using a high strength epoxy. The initial position at the start of each study period, approximately two weeks, began with the frame markers butting against the girder pointer. During girder contraction or elongation, the girder pointer pushed the frame markers to locations of extreme girder thermal movement. These maximum values for contraction and elongation were then recorded over each study period of approximately two weeks to monitor any relationship between girder thermal movement and bearing pad slippage. A thermometer was attached to the frame to record maximum and minimum temperatures over the study period. Measurements from the field investigation are included in the final report *[12]*.

Figure 1
Frame to monitor girder thermal movements attached to the bridge abutment

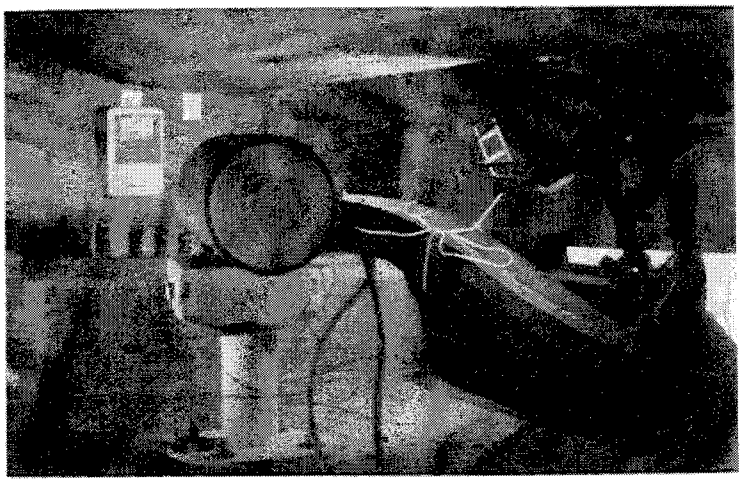
ran the length of the bent. On site visits, access to the pier was made using a temporary ladder on the side of the bridge, which was then removed after measurements were taken. Two video cameras and two time-lapse video recorders were used. The video equipment was found invaluable in understanding the type of movements that occurred on a daily basis and to rule out any relationship between traffic and pad movement. Figure 2 shows the camera setup on the bridge pier where the camera was focused on the bearing pad. The pad was marked to easily identify any bearing pad movement. The camera was encased in a PVC tube to protect against ambient conditions and attached to a 10" pedestal. Figure 3 is a typical snap shot taken from the superstructure camera, which recorded traffic movements at 3-second intervals.

Figure 2
Camera setup on substructure

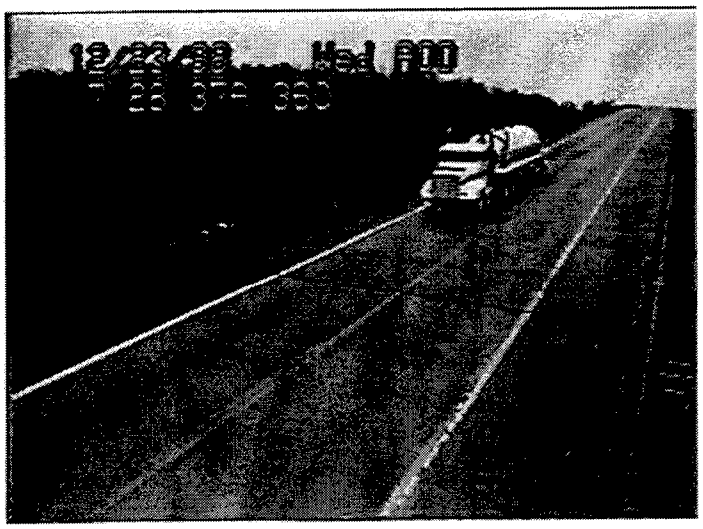
Figure 3
Snap-shot from superstructure camera

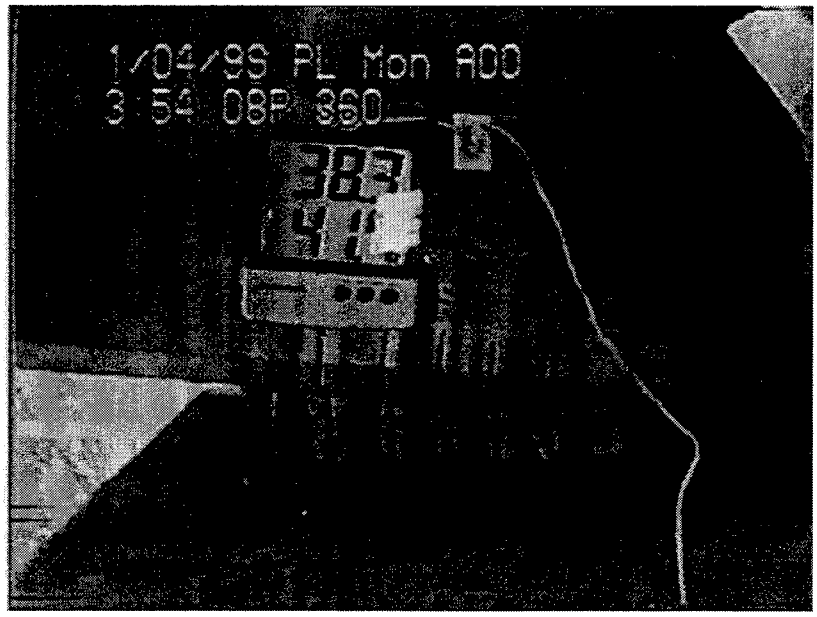
By reviewing the videotapes, it was found that the bridge girder slides over the bearing pad on a daily basis due to temperature fluctuations, Figures 4 and 5. Continuous black lines were drawn on the bearing pad, girder, and riser to easily determine any relative movement along the contact surfaces. The variation from a vertical position of the black lines on the pad, Figure 4, indicates that the pad deflects only slightly in shear before the coefficient of friction at the contact surface is overcome.

Figure 4
Girder position afternoon of 1/4/99 (T=38°F)

- For repositioning of pads that have experienced walking, the contact surfaces and bearing pad surfaces must be scrubbed with a degreasing agent to remove any wax. The pad should be soaked with chlorobenzene to soften the pad and allow a greater contact bond between the pad and contact surfaces.

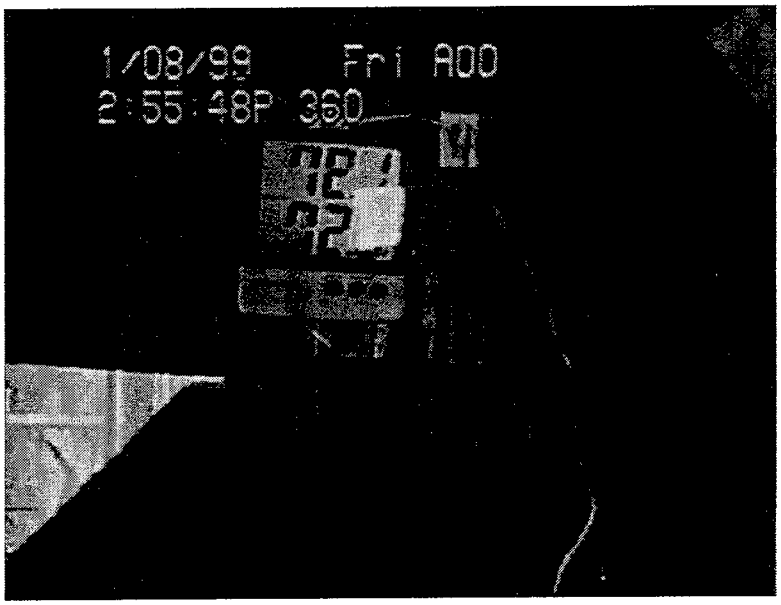
Figure 5
Girder position afternoon of 1/8/99 (T=72°F)
