# Full-Scale Crash Evaluation of a Modified Eccentric Loader Terminal, Final Report

PUBLICATION NO. FHWA-RD-99-031

SEPTEMBER 1999

| 9. Performing Organization Name and Address<br><br><b>Southwest Research Institute<br/>6220 Culebra Road<br/>San Antonio, Texas 78238-5166</b> | | 10. Work Unit No.(TRAIS) | |

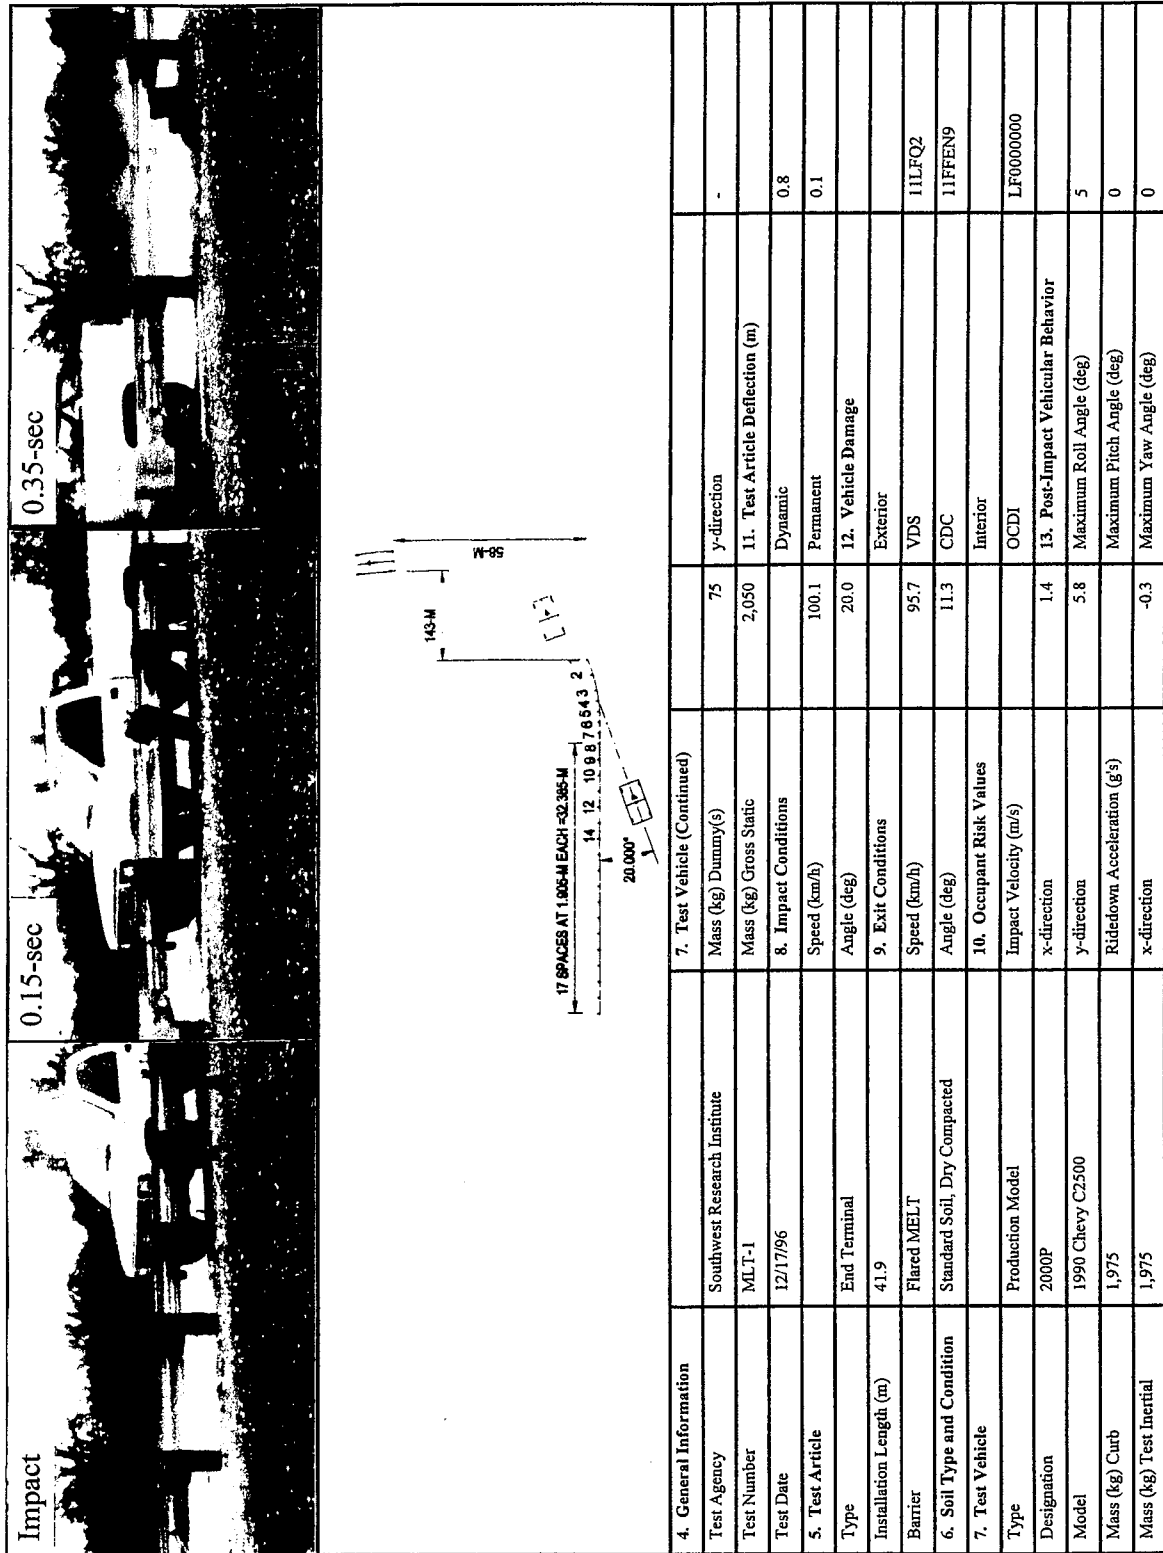
Figure 7. Impact sequence and summary of test conditions and results - Test MLT-1.

**Test MLT-1.** This was the first test of the series and utilized a 1990 Chevrolet, six-lug, light-duty C2500 pickup truck as the test vehicle. Gross test weight, including the dummy and instrumentation, was 2050 kg. Actual test conditions were 100.1 km/h and a 20° impact angle. Ambient temperature at test time was 15° C. As shown in the test summary diagram of figure 7, the vehicle impacted the barrier 0.5 m upstream of post 4. The vehicle fractured post 3, was smoothly redirected, and rolled to a stop 150 m downstream of impact. Figures 8 and 9 show the redirection sequence of the vehicle from overhead as well as behind the barrier viewpoints. The postimpact trajectory of the vehicle was such that it traveled in a relatively straight line after loss of contact with the barrier. Maximum 50-msec average accelerations measured from onboard transducer data indicated -1.1 G's longitudinal and 0 G's lateral.

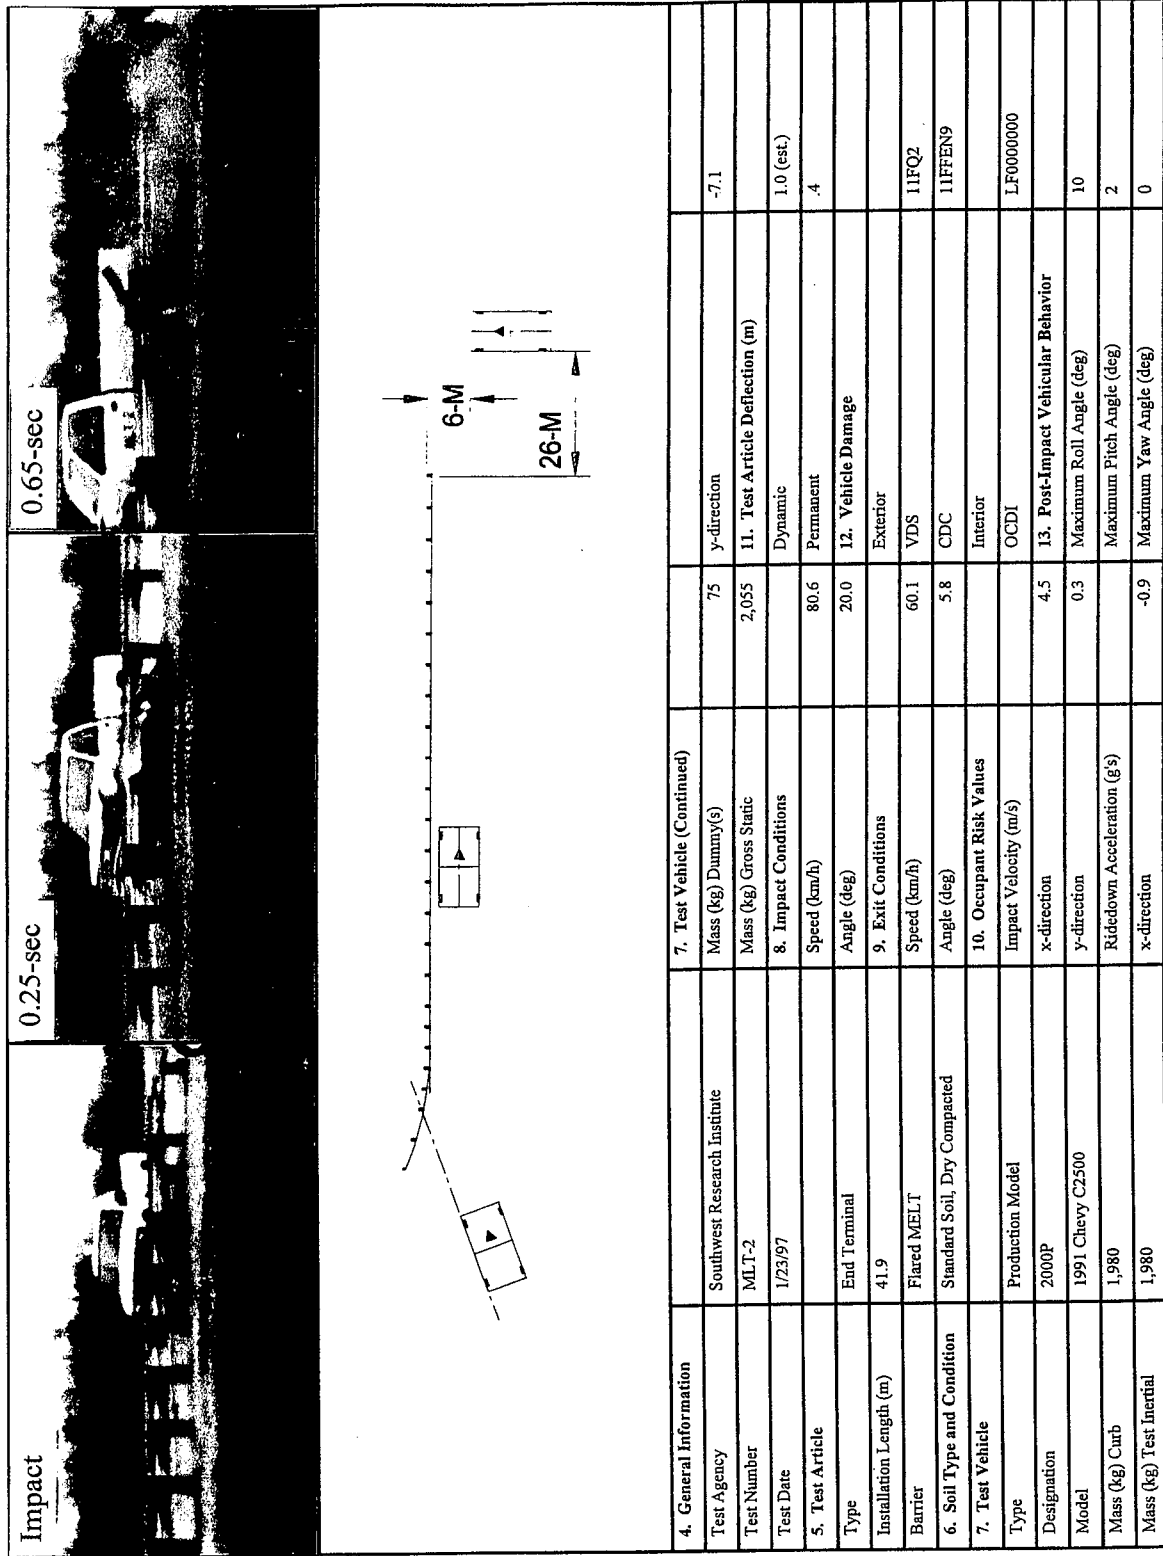
Figure 10. Impact sequence and summary of test conditions and results - Test MLT-2.

C2500 pickup truck. Gross test weight, including the dummy and instrumentation, was 1970 kg. Actual test conditions were 80.6 km/h and a 20° impact angle. Ambient temperature was 15° C. As shown in the test summary diagram of figure 10, the vehicle impacted the barrier at post 3 of the installation. The vehicle fractured posts 4 through 8, was smoothly redirected, and rolled to a stop 26 m downstream of impact. Figure 11 shows the redirection sequence of the vehicle from behind the barrier. Maximum 50-msec average accelerations measured from onboard transducer data indicated 4.5 G's longitudinal and 0.3 G's lateral.

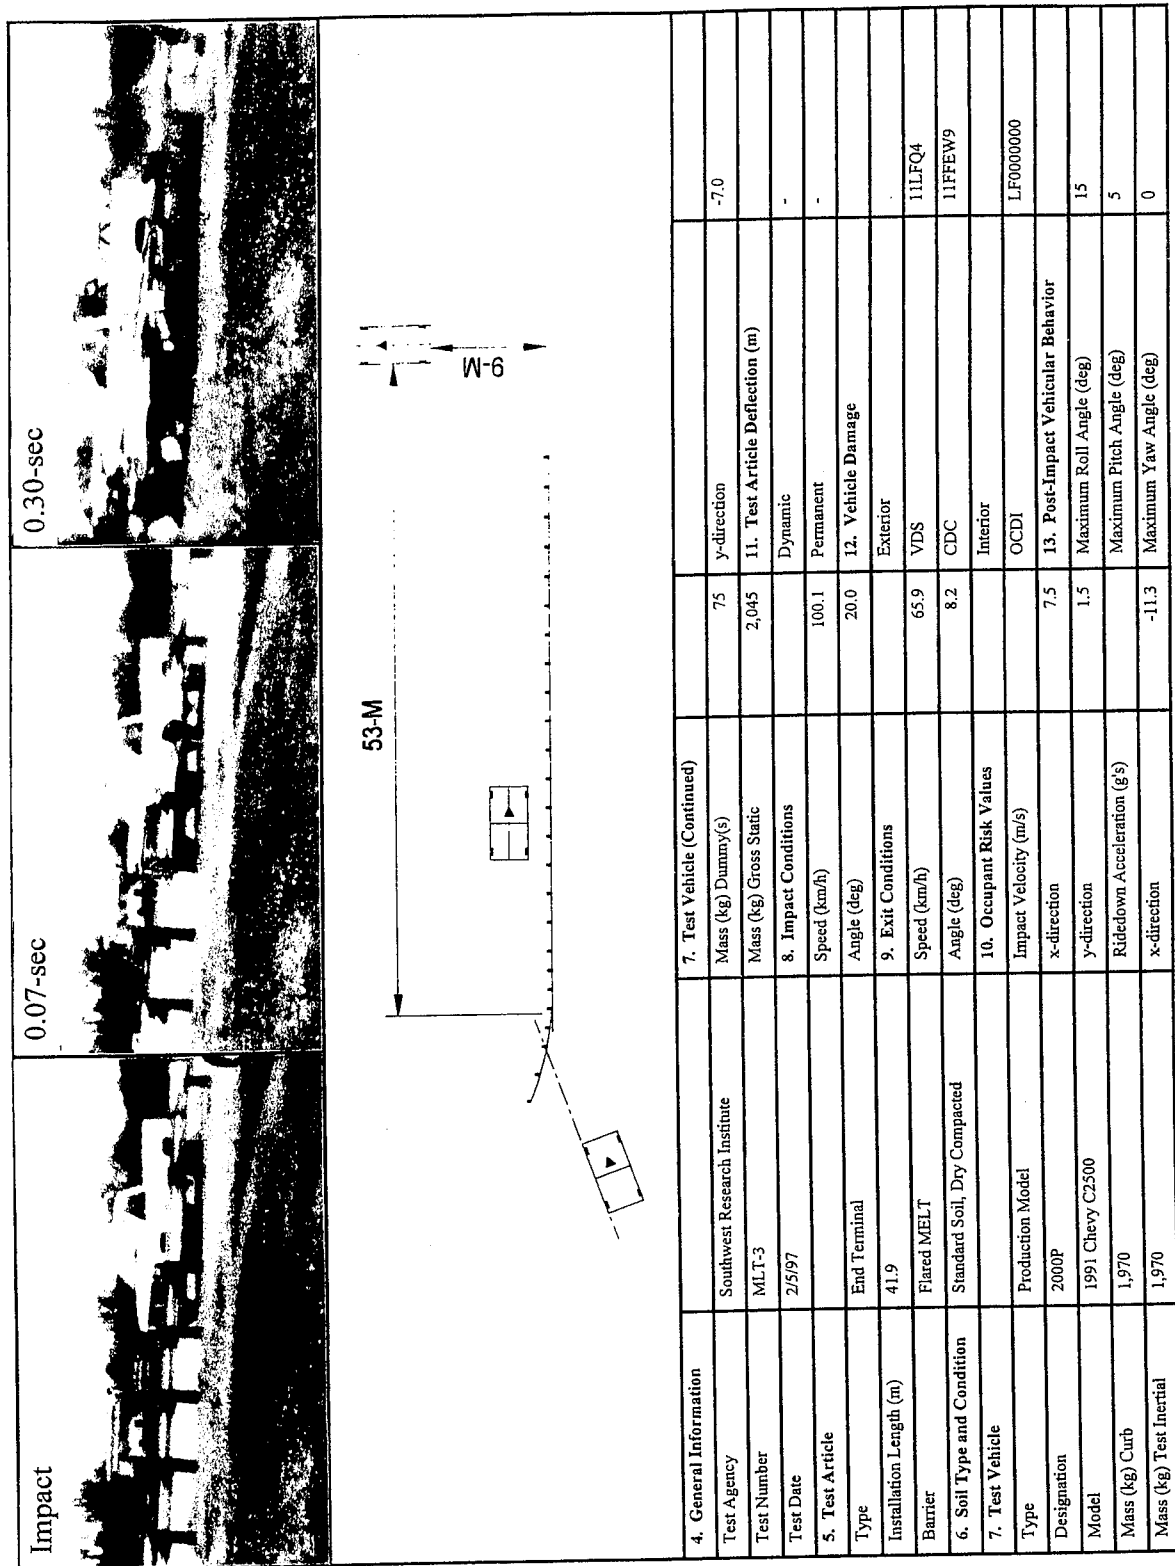
Figure 12. Impact sequence and summary of test conditions and results - Test MLT-3.

**Test MLT-3.** The vehicle used in this test was a 1991 Chevrolet, six-lug, light-duty C2500 pickup truck. Gross test weight, including the dummy and instrumentation, was 2045 kg. Actual test conditions were 100.1 km/h and a 20.0° impact angle. Ambient temperature was 5° C. As shown in the test summary diagram of figure 12, the vehicle impacted the barrier at post 3 of the installation. The vehicle fractured posts 3 through 13, the w-beam rail section fractured, and the vehicle penetrated the system. The vehicle was braked to a stop 55 m downstream of impact behind the rail. Figures 13 and 14 show the impact sequence of the vehicle from above and behind the barrier. Maximum 50-msec average accelerations measured from onboard transducer data indicated 7.5 G's longitudinal and 1.5 G's lateral.
