# VEHICLE CRASH TESTS OF THE TYPE 80 BRIDGE RAIL

**VEHICLE CRASH TESTS OF THE  
TYPE 80 BRIDGE RAIL**

| 4. TITLE AND SUBTITLE<br><b>VEHICLE CRASH TESTS OF THE<br/>TYPE 80 BRIDGE RAIL</b> | | | | 5. REPORT DATE<br>March 1999 | |
| 7. AUTHOR(S)<br>Robert Meline, John Jewell, Rich Peter | | | | 8. PERFORMING ORGANIZATION REPORT NO.<br>59-680600 | |

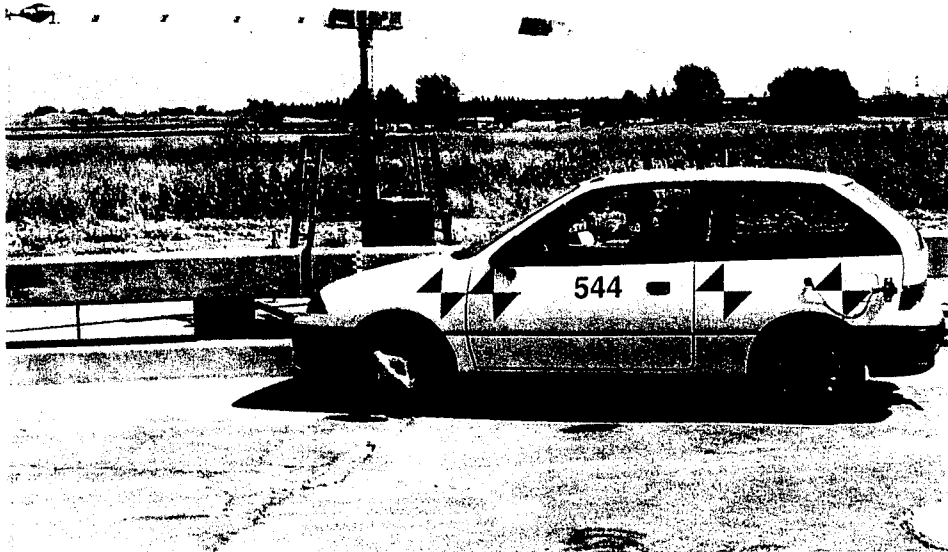
Figure 2-17  
Close up of  
Passenger Side  
Front Damage,  
Vehicle 544

The right front section of the vehicle sustained crushing of the bumper and frame, damage to the suspension and a flat tire, Figure 2-16 through Figure 2-18. The right side of the vehicle from the front bumper to the rear bumper was scraped during contact with the beam section of the rail. The hood was also crushed on the right side but remained attached at the latch and hinges.

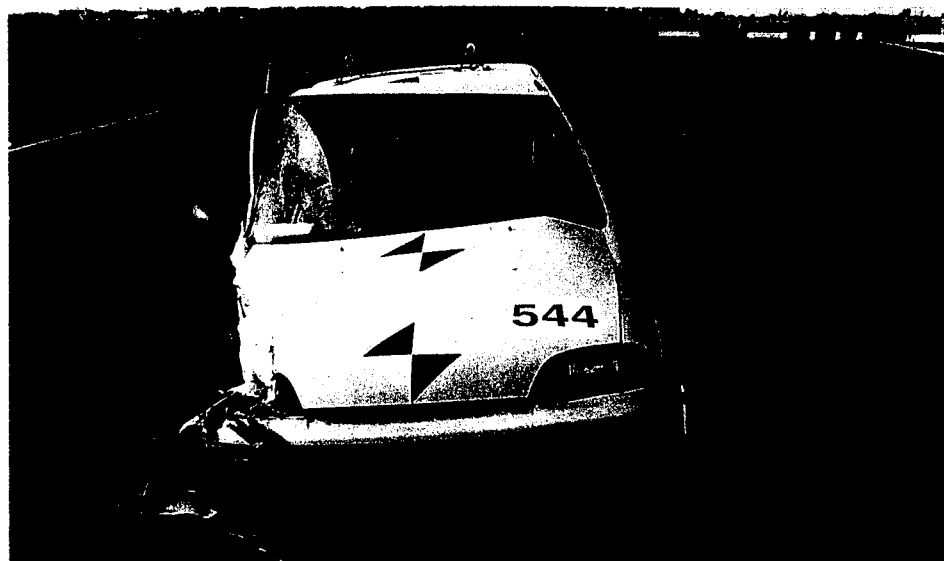
Figure 2-19  
Post Impact View  
of Barrier and  
Vehicle 544

Contact with the bridge rail continued for approximately 2.5 m, determined by visible marks on the rail. The left rear wheel rose off the ground to a maximum of 0.1 to 0.15 m. As shown in Figure 2-19 through Figure 2-21, there were some black tire marks on the face of the barrier posts, but there was no evidence of wheel snagging. At 0.097 s after impact, the dummy's head was out of the right front passenger window. The dummy's head did not come into contact with the barrier or any other items and returned to its original position once the lateral accelerations decreased.

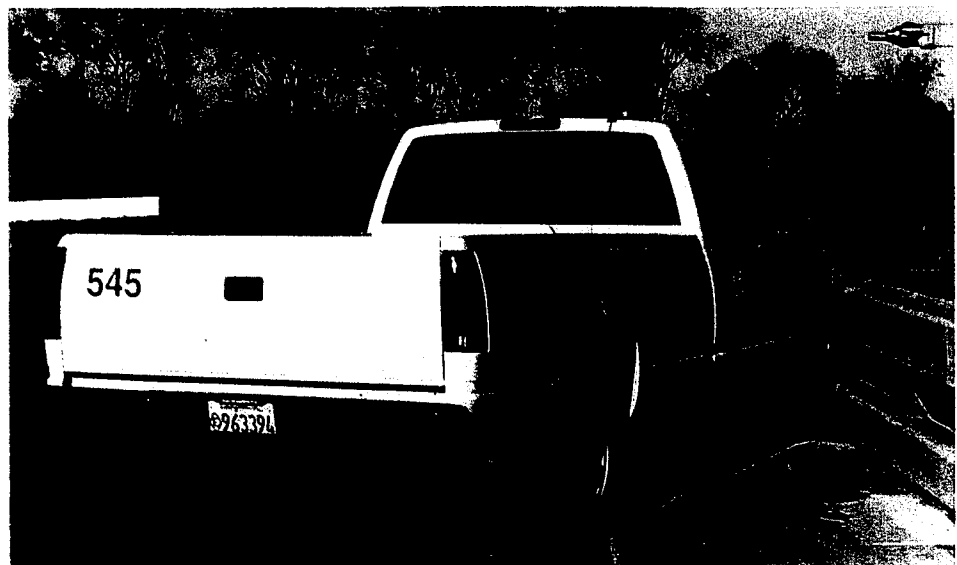
Figure 2-26  
Final Position Of  
Test Vehicle 545

The vehicle stayed in contact with the rail for approximately 4.2 m. The exit angle and speed were 7 ° and 88.5 km/h respectively. The vehicle remained upright throughout and after the collision. Brakes were applied 0.829 s after initial contact with the rail and the stopping point for the vehicle was 58 m from the point of last contact with the barrier. Figure 2-26 through Figure 2-28 shows the vehicle in its resting position.
