VEHICLE CRASH TESTS OF THE AESTHETIC, SEE-THROUGH CONCRETE BRIDGE RAIL WITH SIDEWALK, TYPE 80SW

STATE OF CALIFORNIA
DEPARTMENT OF TRANSPORTATION
ENGINEERING SERVICE CENTER,
OFFICE OF MATERIALS ENGINEERING AND TESTING SERVICES

3. RECIPIENT'S CATALOG NO.	
4. TITLE AND SUBTITLE VEHICLE CRASH TESTS OF THE AESTHETIC, SEE-THROUGH CONCRETE BRIDGE RAIL WITH SIDEWALK, TYPE 80 SW		5. REPORT DATE August 1998, revised 8/99

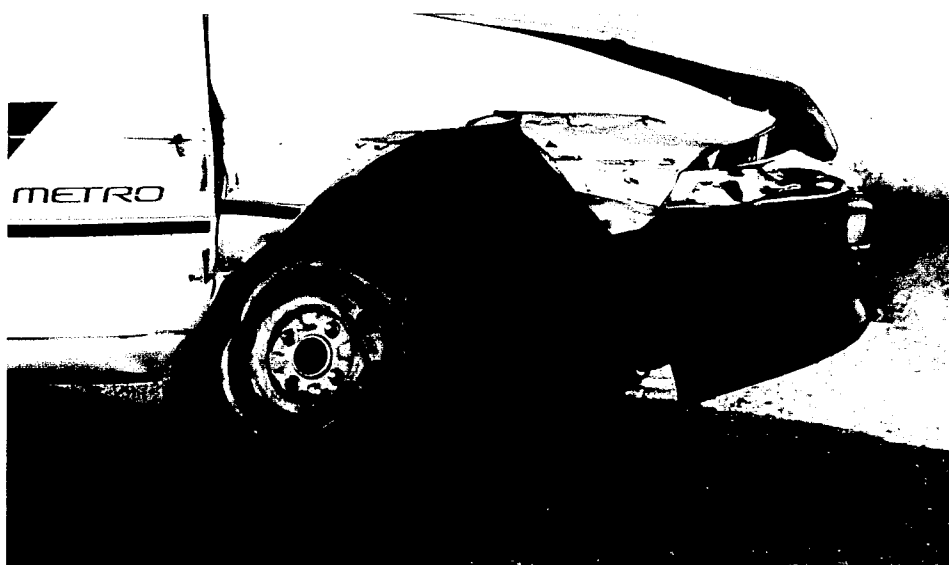
Figure 2-21 -
Close up of
Passenger Side
Front Damage,
Vehicle 541

The right front section of the vehicle sustained crushing of the bumper and minor unibody frame deformation, damage to the suspension and a flat tire. Initial right front wheel damage occurred on impact with the sidewalk 0.38 m from the beginning of the bridge rail installation. The sidewalk contact caused deformation of the wheel and tire deflation. Other tires experienced minor deformation on impact with the sidewalk but remained inflated. After contacting the bridge rail the right front wheel was pushed back, forcing the wheel well area to deform (Figure 2-21).

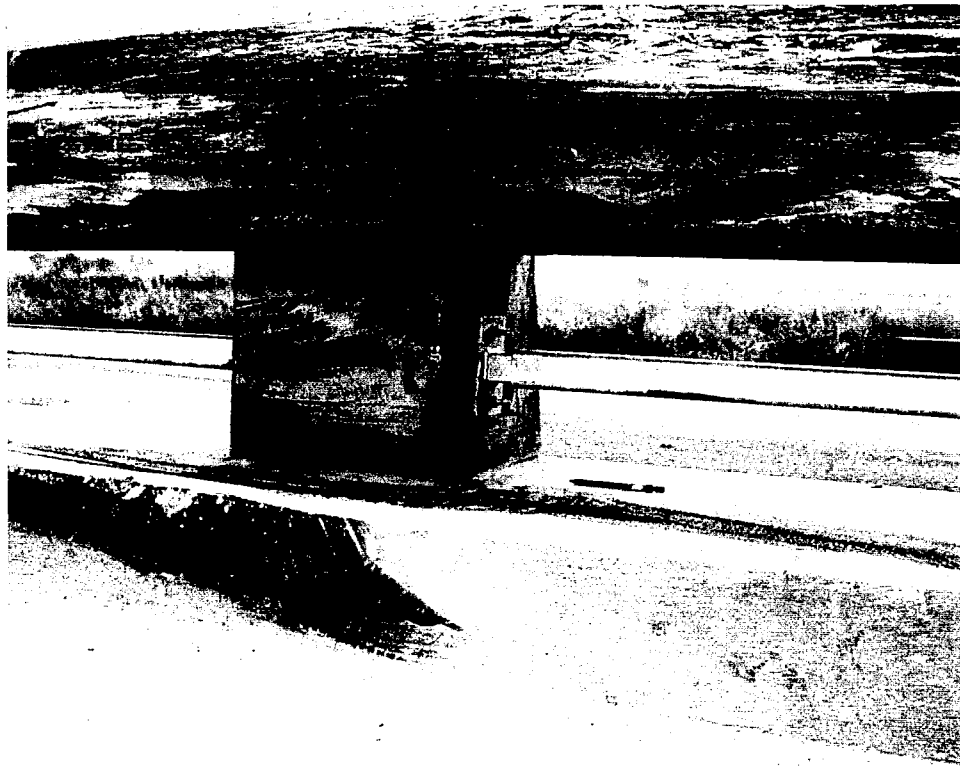
The first point of contact for the constructed test article was the sidewalk. The right front passenger wheel was damaged and the tire deflated as a result of the impact with the sidewalk curb. During the examination of the impact area after the test there was evidence that the front passenger wheel had contacted and rotated around the post 6 m from the upstream end of the barrier (Figure 2-25 and Figure 2-26). The tire also contacted the pedestrian steel tube within the gap. The next post at 8 m had black tire marks along its face, but the wheel did not enter into the gap (Figure 2-23). It was the contact and rotation around post 6 and the contact with the steel tube that led to the decision to reduce the gap and re-run the 820 kg test. The retest was performed as Test 548 and is discussed starting in Section 2.2.1.11.

Figure 2-26 -
Wheel Rotation
Marks Around
Bridge Rail Post

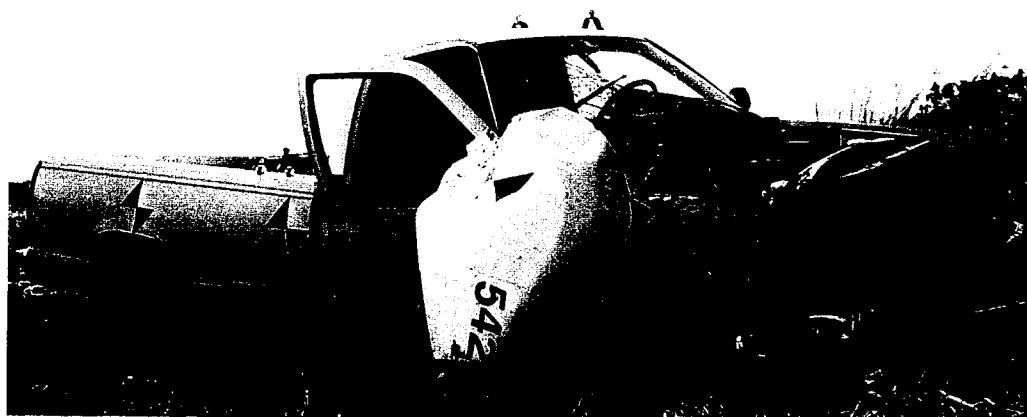
Figure 2-36 -
Close-up of
Impacting
Corner Of
Tested
Vehicle 542

The extra speed of the vehicle, 10.2 km/h over target, undoubtedly contributed to higher deformation of the impacting right corner of the vehicle than would have otherwise occurred. Figure 2-36 shows the right front wheel pushed back into the wheel well, caused by impact with the rail curb and beam face. All of the wheels stayed connected to the vehicle throughout the test. The front right shock absorber, stabilizer bar and upper and lower control arms were bent but still attached. The rear and left front suspension components were intact and appeared undamaged. There was minor deformation of the right front frame.

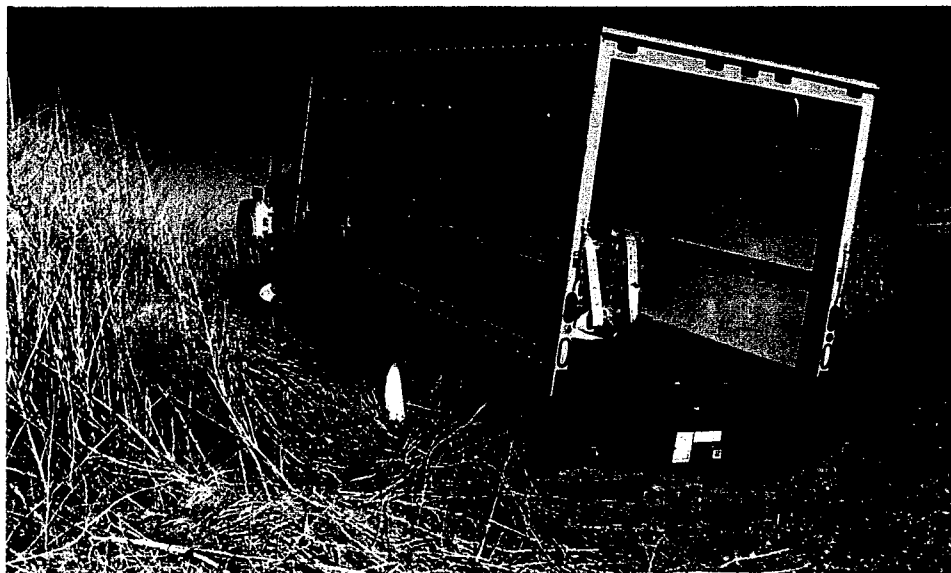
Figure 2-49 -
Impact Side View
of Vehicle 543
after Impact

The 2918 kg of ballast, comprised of two separate pallets of sand bags strapped down to the cargo floor. The pallets were constrained by 150 mm angle iron and the sand bags were held down by 100 mm trucking straps as shown in Figure 2-47. The sand was allowed to shift slightly but is unlikely to have affected the test. None of the sand bags broke loose during the test (Figure 2-49).

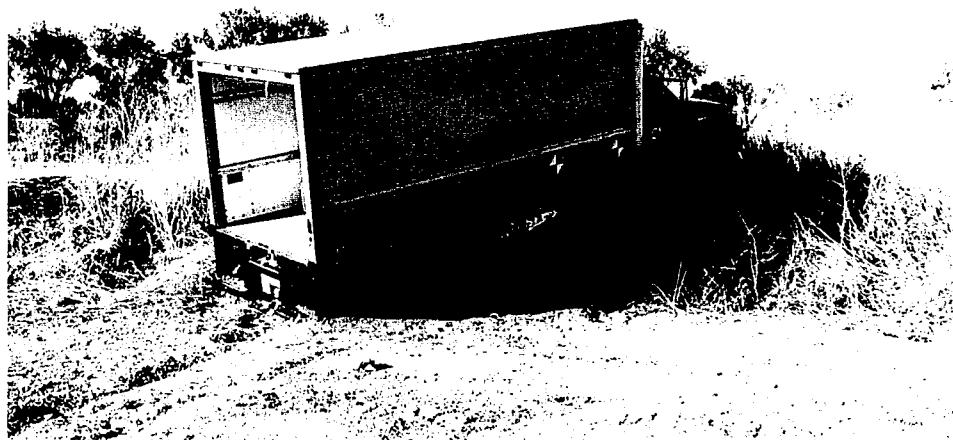
Figure 2-50 -
Vehicle 543 after
Impact

Also damaged were the battery box, fuel tank and right front quarter panel. The battery box sustained substantial crushing. The fuel tank was deflected about 0.5m and dented in about 0.15 m, but was not penetrated. Damage to the right front quarter panel occurred on contact with rail face and handrail. There was no visible damage to the cargo box or frame beyond minor scuffing. Both doors, the hood and rear rolling door functioned properly with no visible occupant compartment deformation.

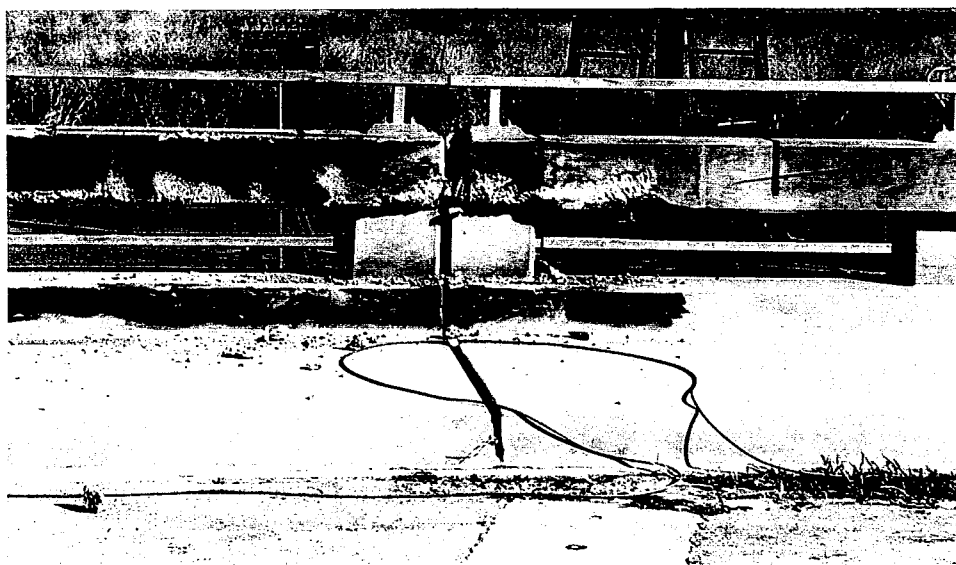
Figure 2-54 -
Impact Area for
Test 543

The barrier was scraped along the face and edges over a 3 m length. There was also spalling on the underside of the beam and at the expansion joint with no structural damage.

The barrier was scraped along the face and edges over a 3 m length. There was also spalling on the underside of the beam caused by the downward force of the rotating right front wheel lug nuts. The tire marks along the barrier were only a little longer than the scraping along the face. A concrete spall at the expansion joint was 80 mm to 100 mm deep and extended to the back face of the rail, shown in Figure 2-55 and Figure 2-56. The spall exposed the end of a piece of rebar but no structural damage was evident. The bridge rail withstood the impact from vehicle 543 well with only spall repairs necessary before subsequent tests.

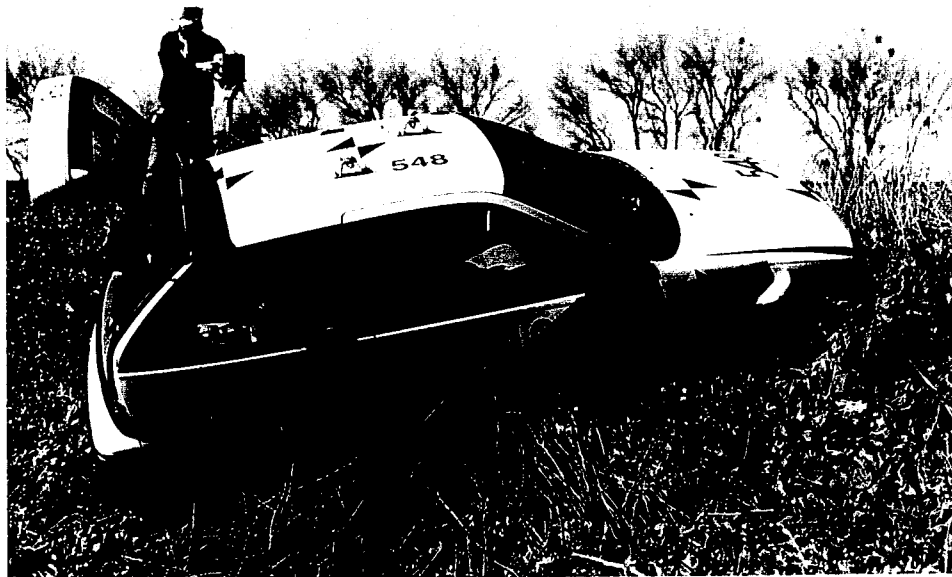
Figure 2-64 -
Final Resting
Position of
Vehicle 548

The exit speed and angle were approximately 62 km/h and 4°, respectively. The maximum roll of -14.3° occurred during the initial contact with the bridge rail and a maximum pitch of 5° was obtained as the vehicle's side came into contact with the beam section. The vehicle remained upright throughout and after the collision. Brakes were not applied and the stopping point for the vehicle was approximately 37 m from the point of last contact with the barrier. Figure 2-64 and Figure 2-67 show the vehicle in its resting position.

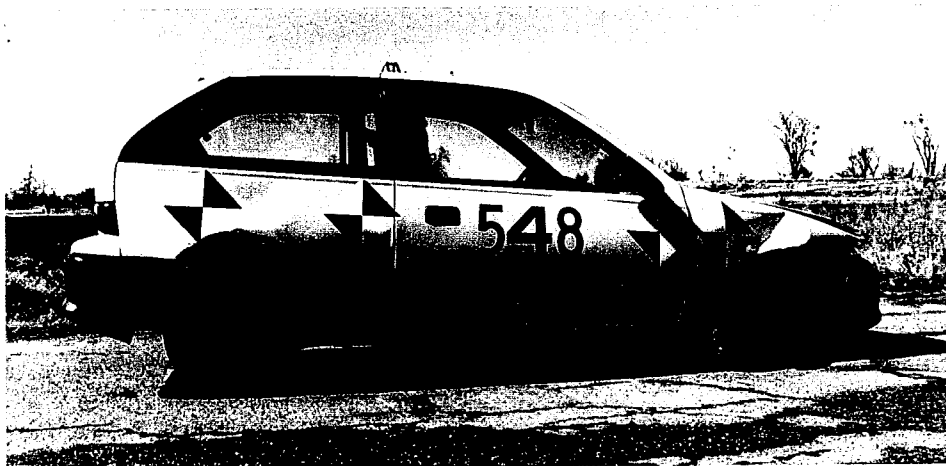
Figure 2-65 -
Right Side of
Vehicle 548
after Impact

The right front section of the vehicle sustained crushing of the bumper and right front quarter panel, damage to the suspension and a flat tire. Initial right front wheel damage occurred on impact with the sidewalk 0.4 m from the beginning of the bridge rail. The sidewalk contact caused deformation of the wheel and tire deflation. Wheel damage is shown in Figure 2-66. Other wheels were slightly deformed upon impact with the sidewalk, but the tires remained inflated. The vehicle first contacted the bridge rail on the curb section below the beam approximately 5.1 m from the beginning of the rail. After contacting the bridge rail, the right front wheel was pushed back, forcing the wheel well area to deform (Figure 2-65). The strut and axle for the right front wheel were bent, but remained attached.
