# ***Evaluation of the Cause of Cracking in Bridge #MEG-124-6.78***

**Draft Final Report to the Sponsors:  
Ohio Department of Transportation  
Federal Highway Administration  
October 1999**

**University of Cincinnati  
Department of Civil and Environmental Engineering  
P. O. Box 210071  
Cincinnati, OH 45221-0071**

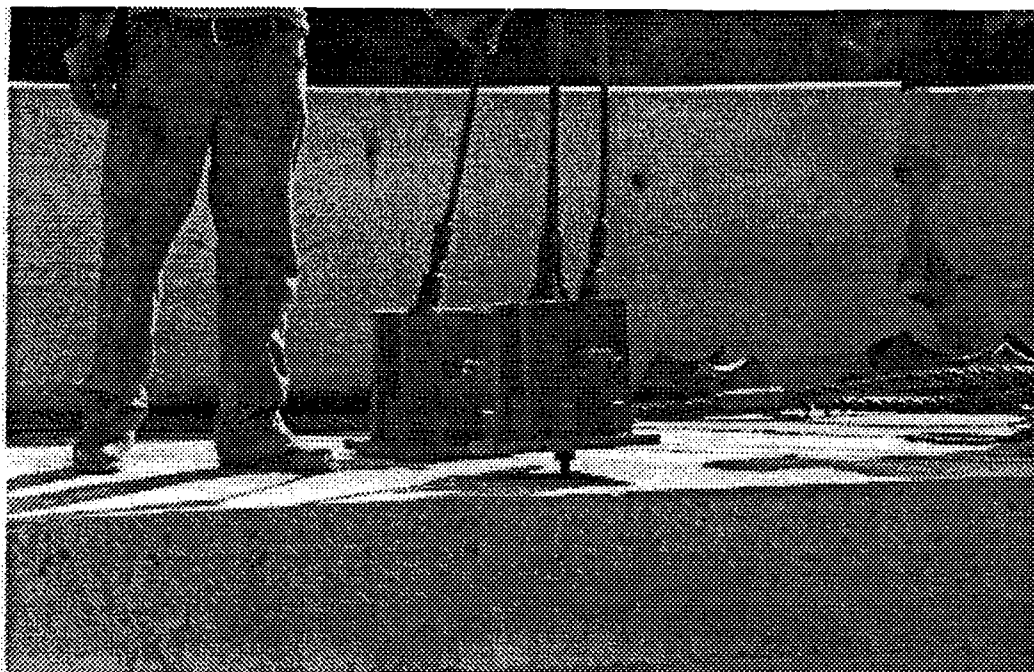
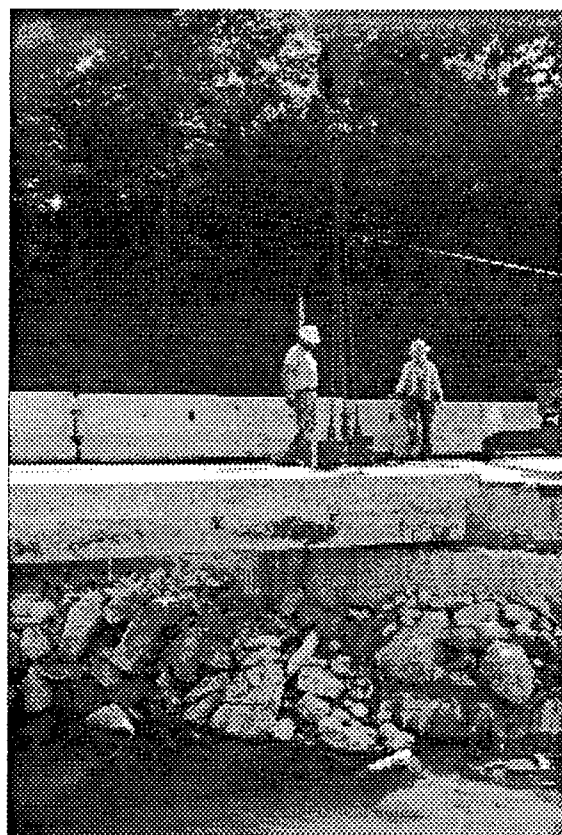
- 2) Because the beams were adjacent, it was not possible to put lifting straps around the beams to lift them. Holes were drilled in each end of the beam near the abutments and 1" diameter threaded rods were embedded approximately 6" into the holes and epoxied in place. Lifting lugs were attached to rods and two cranes lifted the beams just enough to slide them slightly sideways, creating a gap between the beams so that lifting straps could be placed around the beams (Figure 3.1).

**Figure 3.1 - Moving the beams after cutting the joints.**

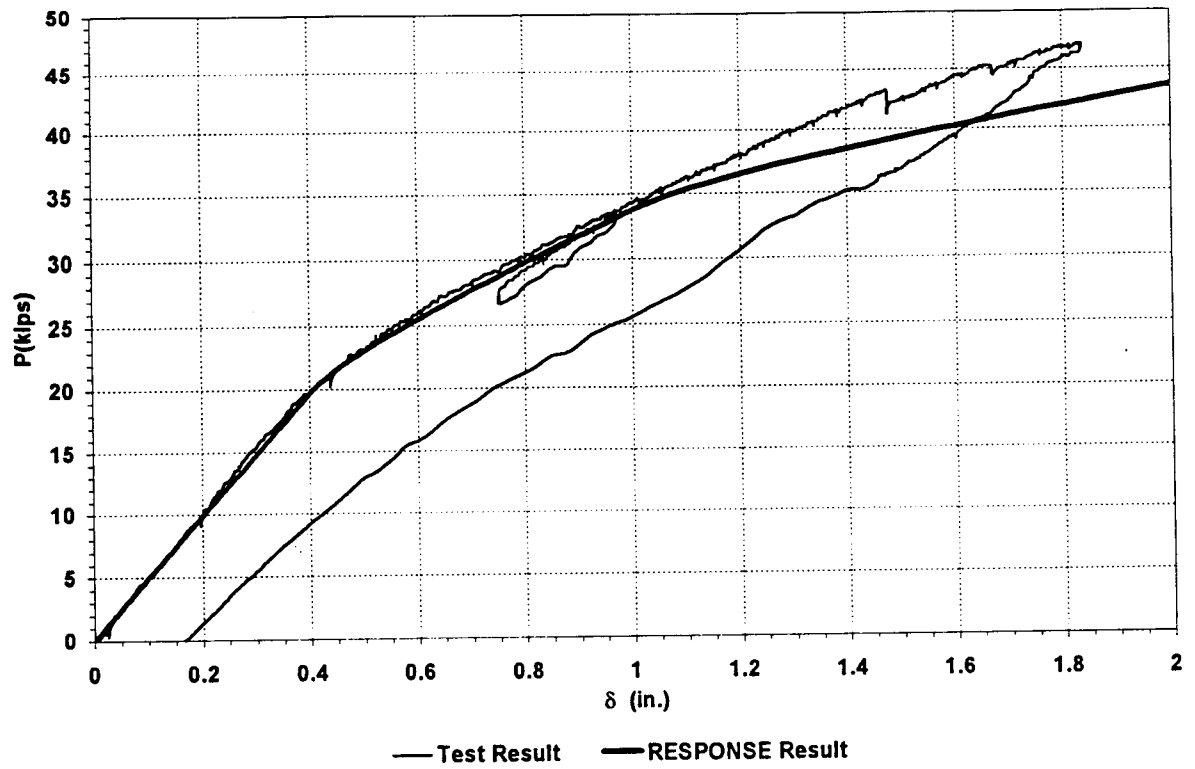
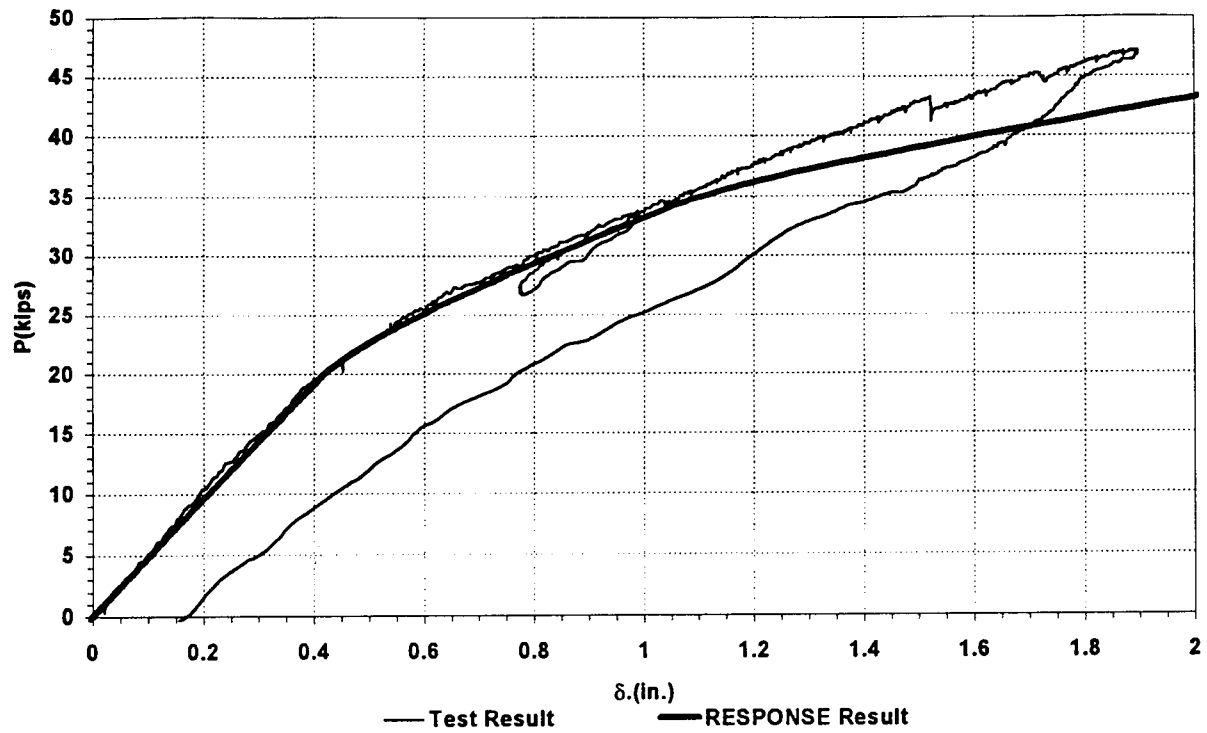
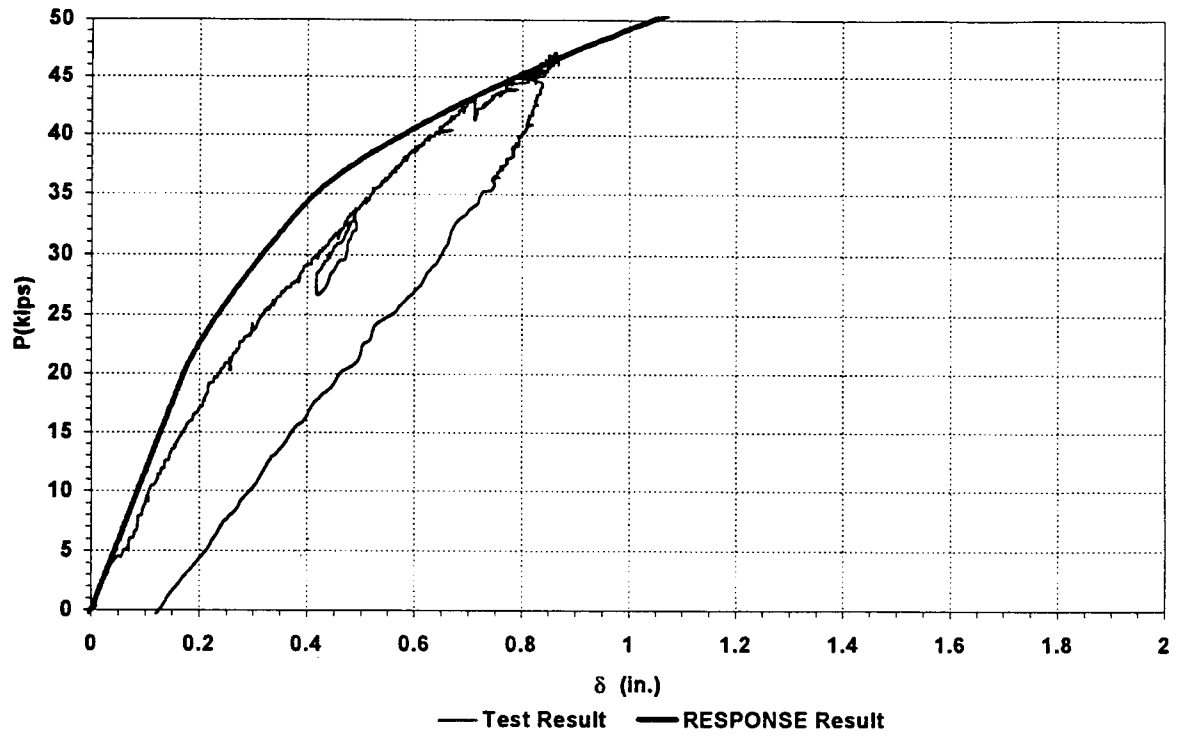
In looking at Figures 3.9-11, it is amazing that this beam held as much load and was as ductile as it was, in spite of having a section which was, for all intents and purposes, an unreinforced section.

**Figure 3.9 - Load vs. deflection - east load point - uncracked beam**

**Figure 3.10 - Load vs. deflection - midspan - uncracked beam.**

**Figure 3.11 - Load vs. deflection - west load point - uncracked beam.**

Prior to conducting the destructive load tests, some simple analyses were performed. A computer program called "RESPONSE", which models the prestressed beam as a series of lengthwise segments and considers the moment-curvature relationship of each segment, was employed to predict general response, identify points at which flexural cracking might develop, and characterize the load-displacement relationships for critical points along the length of the beam. Results from this preliminary analysis were used to guide the experimental program, to suggest approximate load magnitudes that might cause cracking and to indicate points at which wire potentiometers would be placed to best represent the displacements of the beam under various load levels. The load versus deflection results from RESPONSE were not expected to have great accuracy since this program does not model all features of the prestressed concrete beam characteristics, however, it did provide a very reasonable approximation of the beam behavior (see Figure 3.9-3.11).

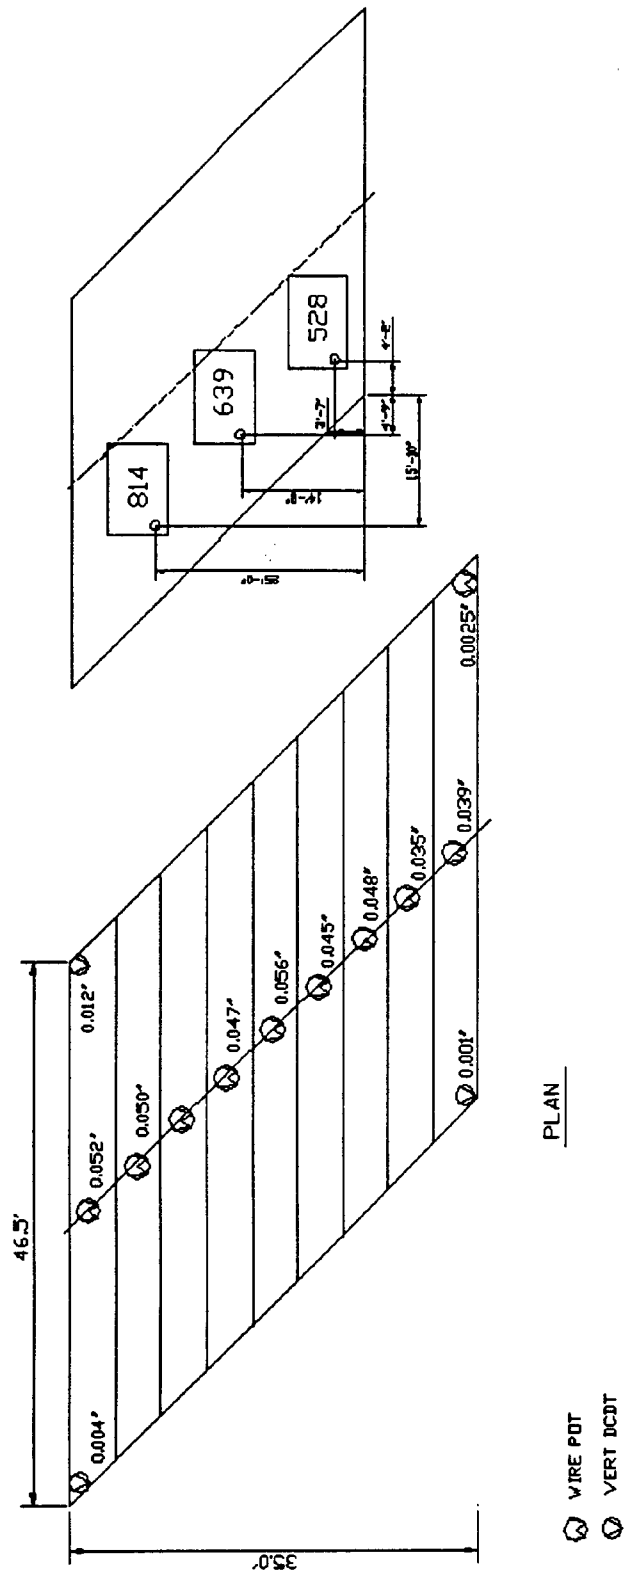
CASE #1

**Case 1 (Figure 4.2):** The trucks are placed with back axles along the centerline of the bridge. This maximizes moment at the midspan. Deflections are not uniform with the beams on the NE side of the bridge (beam #1) deflecting more than those on the SW side (beam 9). These deflection decrease about 20% from beam 1 to beam 9, probably because of the effect of skew. There is a slight uplift on the corners along the southeast edge. It appears the bridge behaves as one way, skewed slab.

Figure 4.2 - Load case #1

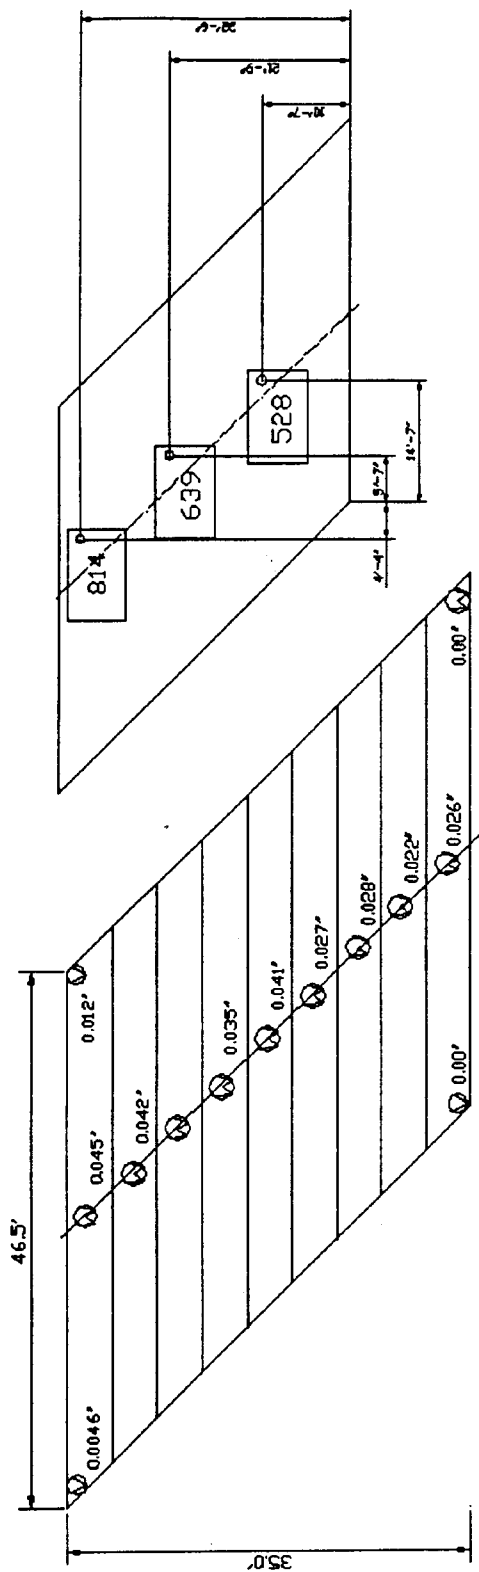
CASE #2

**Case 2 (Figure 4.3):** For this case, the trucks are parked with the front axles along the centerline of the bridge. In this configuration, shear is maximized on the northwest edge of the bridge (this is the edge where the diagonal cracks were found in the #9 beam in the original bridge). The deflection of the #9 beam is about half that of the #1 beam. This again seems to be caused by the skew, with the obtuse corner being stiffer than the acute corner.

Figure 4.3 - Load case #2

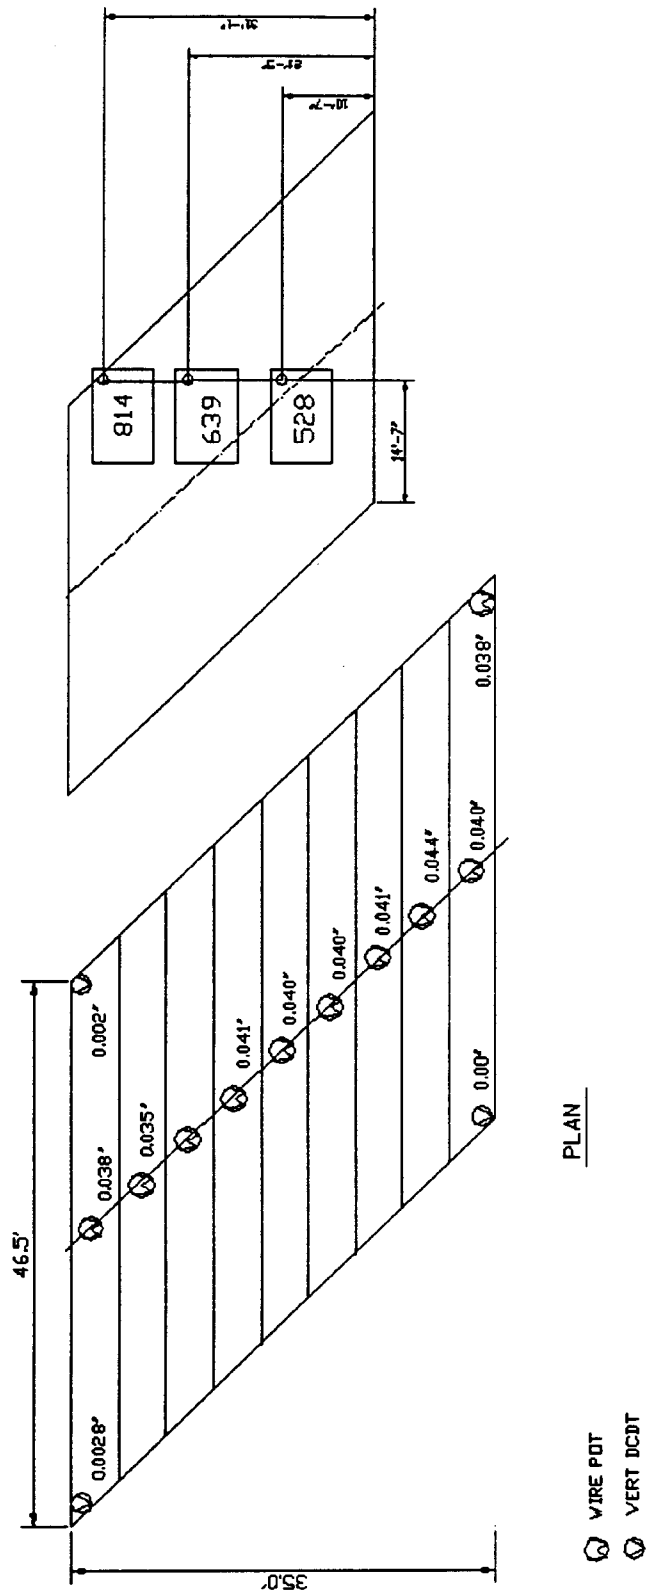
CASE #3

**Case 3 (Figure 4.4):** This case examines the effect of skew. The first truck is placed with the front axle at midspan of the #8 beam and the other trucks are set so that the front tires are aligned. Although the truck loads do not follow the skew, the deflections are uniform.

Figure 4.4 - Load case #3

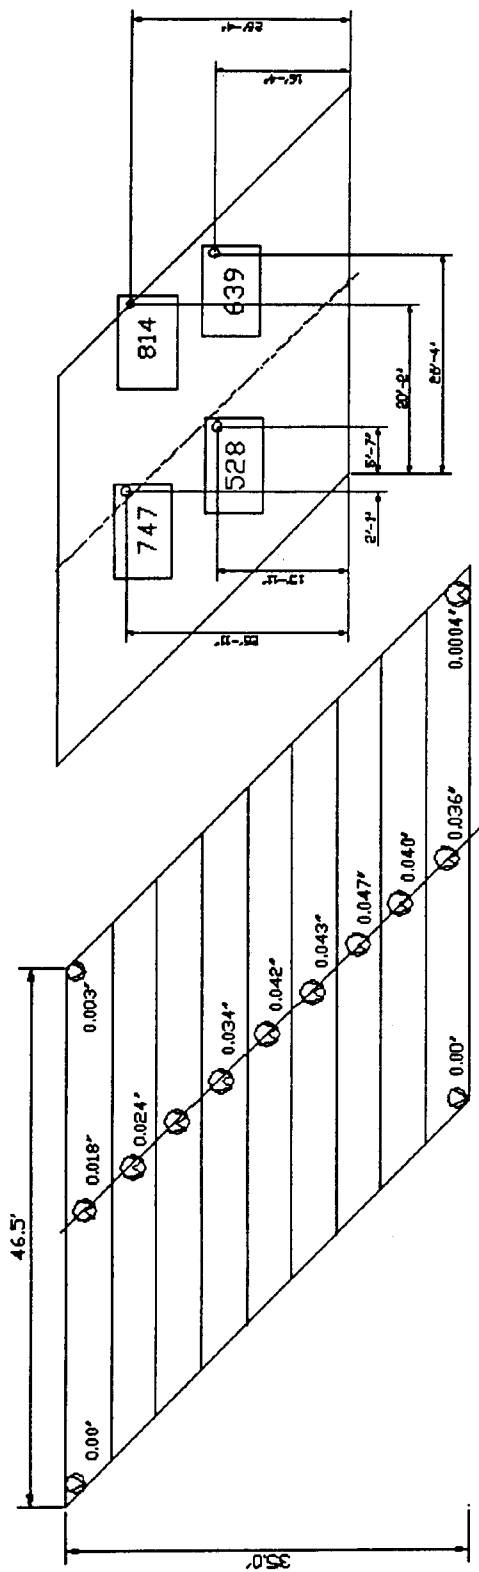
CASE #4

**Case 4 (Figure 4.5):** For Load Case 4, four trucks are placed bumper to bumper in the lanes, all facing southeast. This attempts to maximize lane load and shear at the northwest edge. Although the bridge appears uniformly loaded, beams 4-9 appear to carry most of the load as they have the largest deflections. Again, there seems to be a flow of load to the obtuse corner.

Figure 4.5 - Load case #4

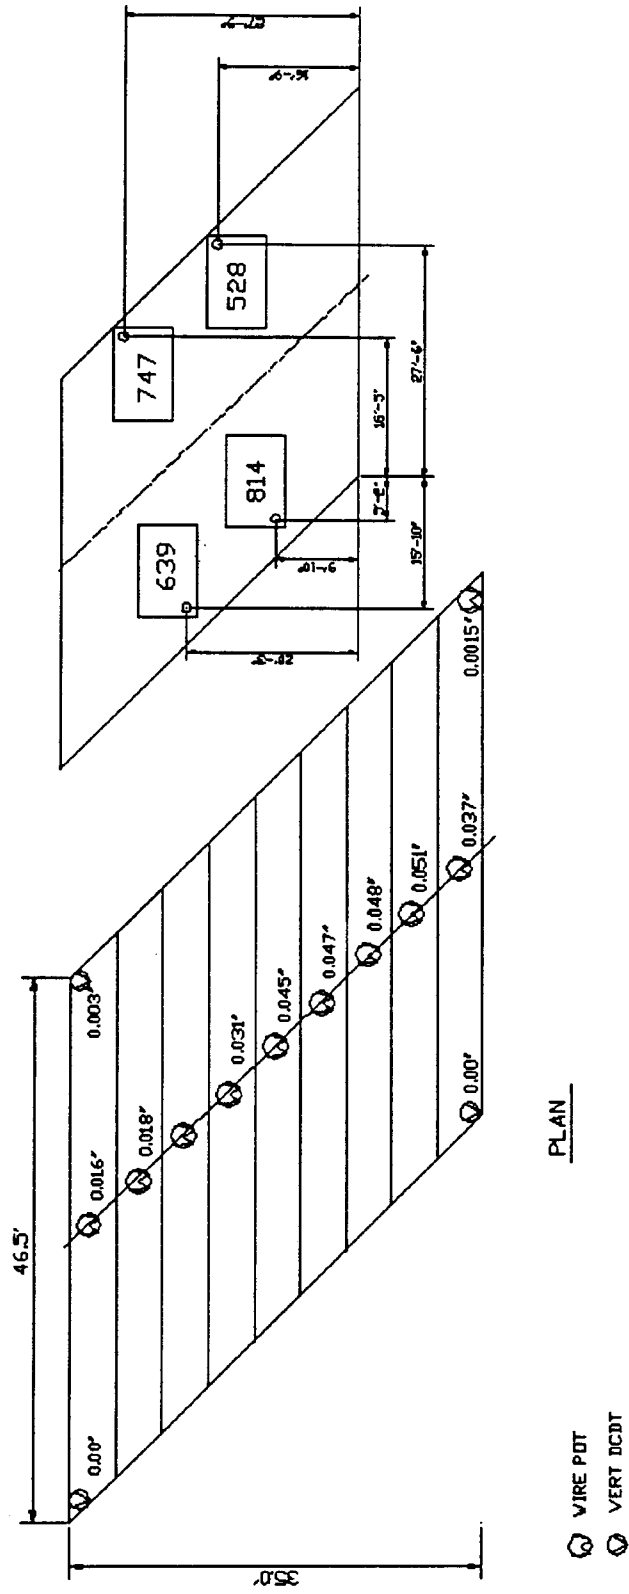
CASE #5

**Case 5 (Figure 4.6):** In this case, the trucks are placed in the lanes, but “back-to-back”. This maximizes lane load and moment. As with Cases 1 and 4, the apparently uniform loading pattern produces nonuniform deflection.

Figure 4.6 - Load case #5

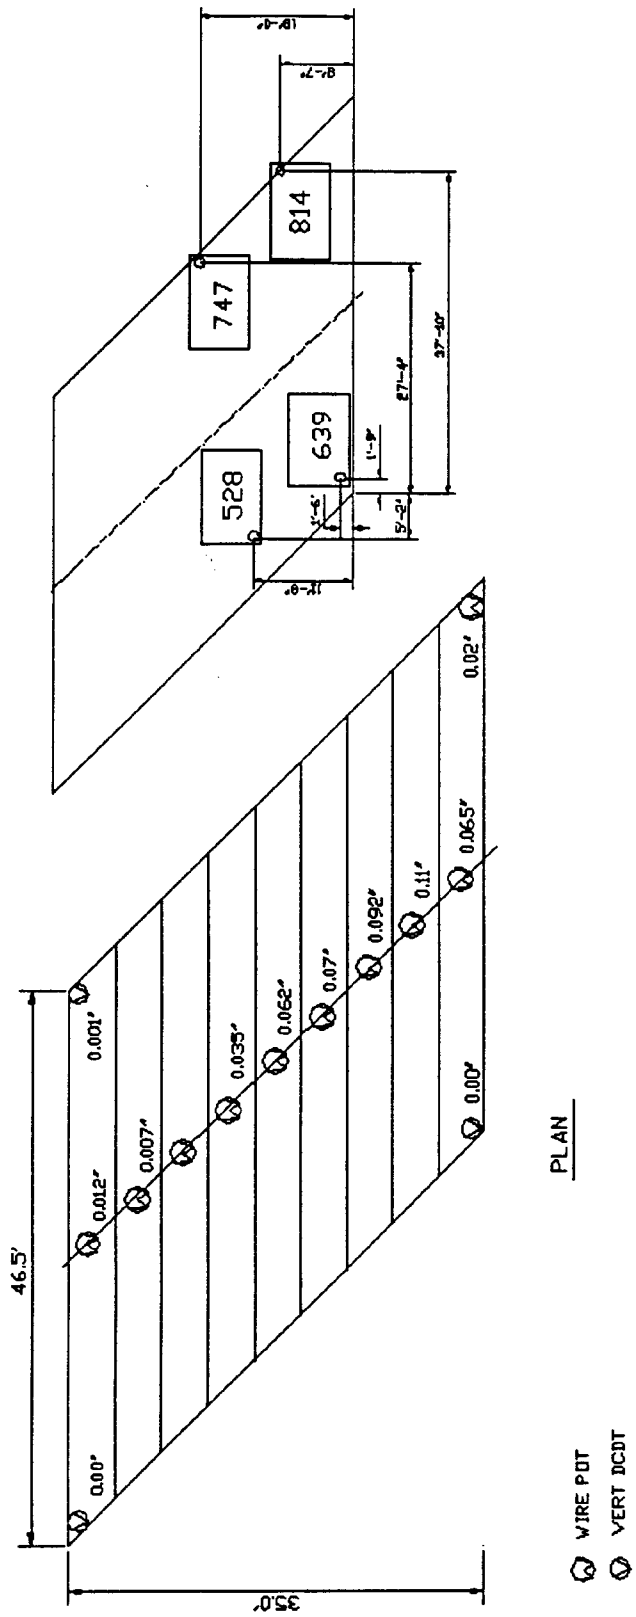
CASE #7

measured in beam 9 in load case 7 (four trucks placed on the SW side of the bridge, Figure 4.8). This corresponds to a live load tensile stress of about 250 psi at the gage position, which is approximately 3" from the bottom of the girder (midheight of the bottom flange). The measured strain can be extrapolated to a maximum bottom fiber tensile stress of about 320 psi. Even if the precompression from the prestressing is taken as 0 (i.e. an extreme case of 100% loss of prestress), the maximum measured stress is still 25% below the allowable tensile stress. Thus, the new structure seems to be very satisfactory.

Figure 4.8 - Load case #7
