Research Report
KTC-90-23

GROUND MODIFICATION SYSTEMS
(STONE COLUMNS AND WICK
DRAINS IN JEFFERSON COUNTY)

SOUTH ABUTMENT WALL FAILURE

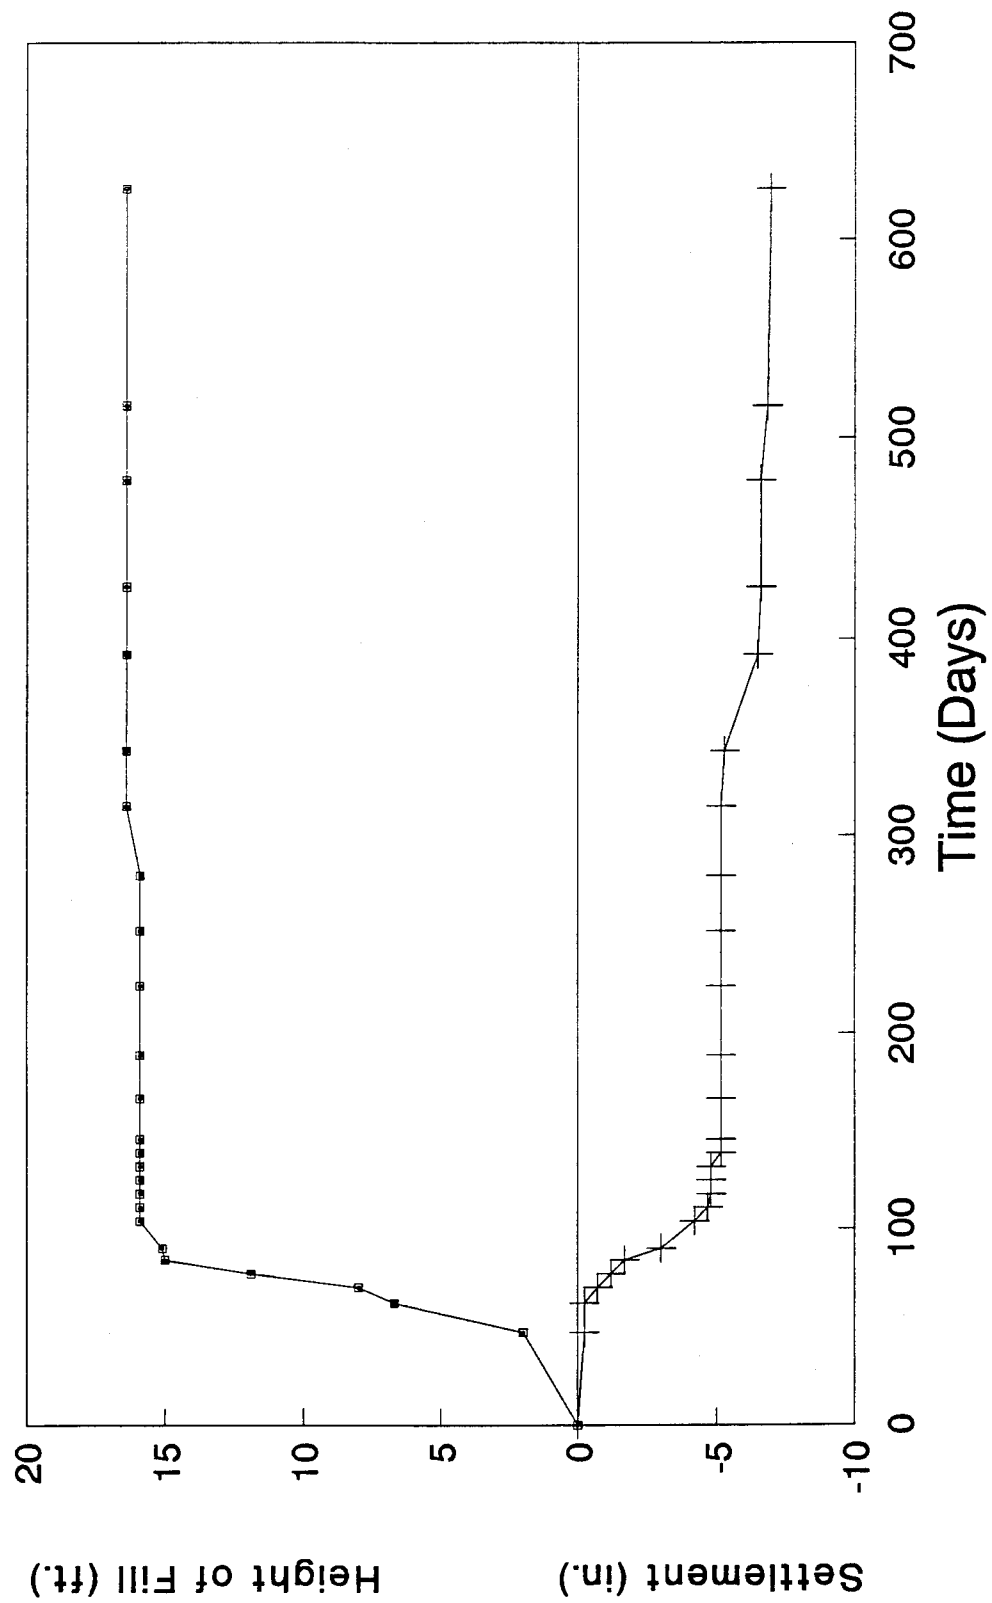
Figure 11. Foundation Settlement and Embankment Height at Station 2008+00.

Settlement platform data indicate foundation settlement of 12.5 in. and 7.0 in. at Stations 2013+00 and 2008+00, respectively. Ninety percent settlement occurred in approximately 90 and 50 days after the embankment was completed at these respective locations. Settlement and embankment height are plotted versus time in Figures 11 and 12.

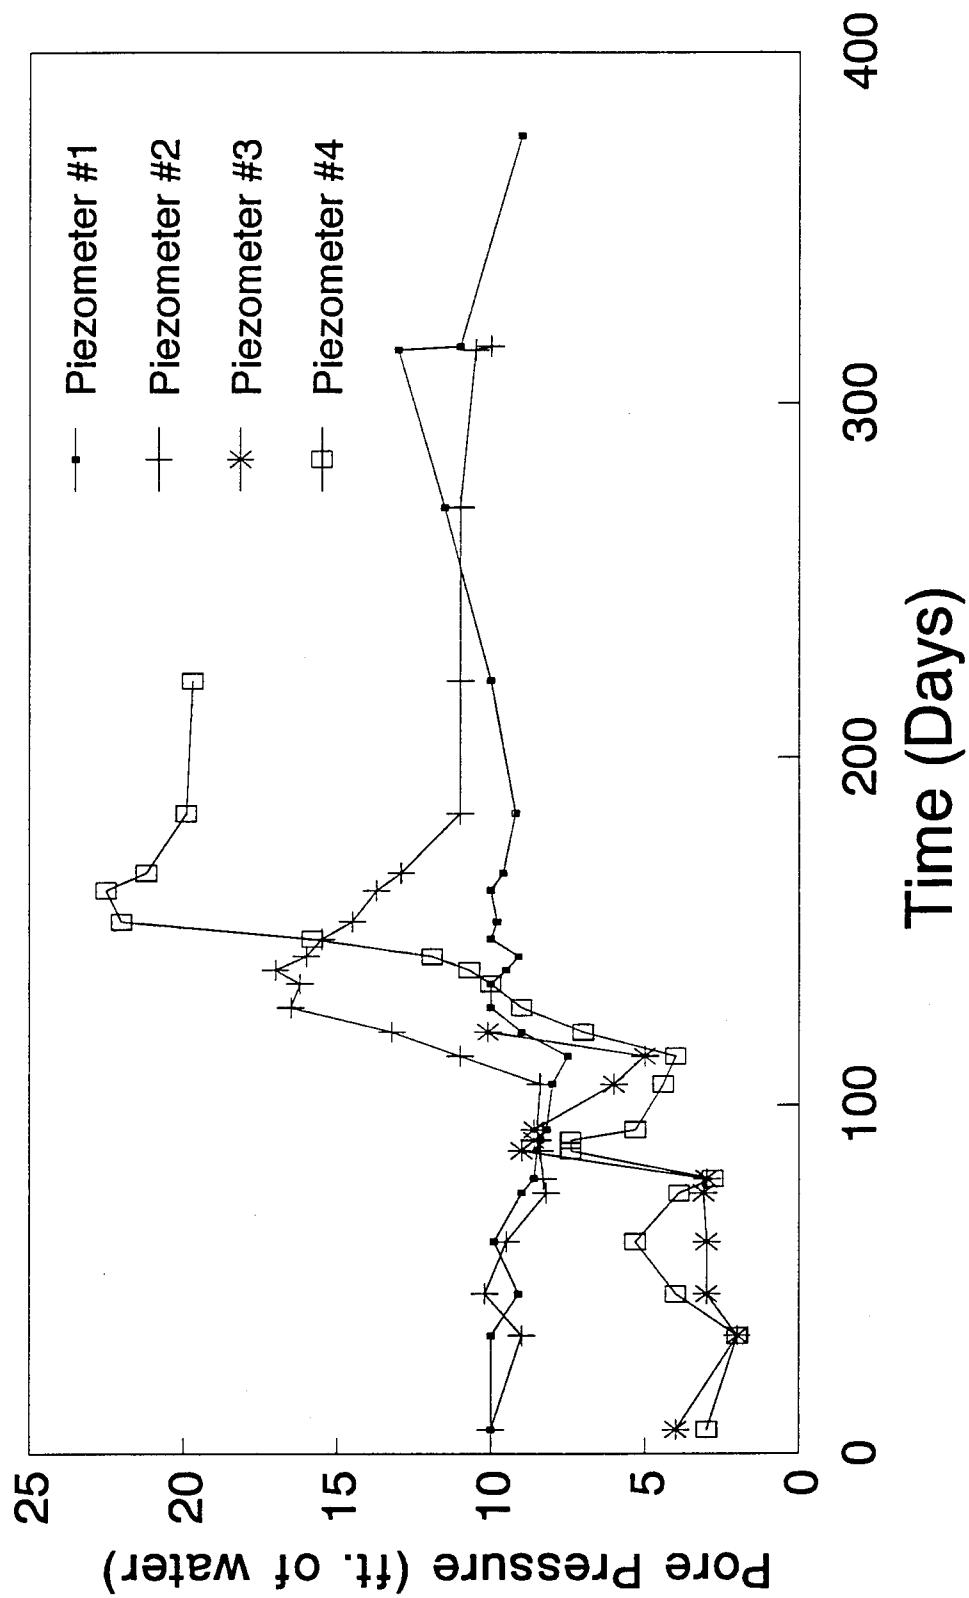
Figure 13. Foundation Pore Pressure at Station 2008+00.

Piezometers 1 through 4 are located at depths of 5 to 10 ft in the wick drained foundation south of the bridge. Piezometers 9 through 12 are located at depths of 20 to 25 feet in the in the same approach foundation. All piezometers show foundation pore pressure changes that appear to reflect construction activity. All piezometers that operated past the time the embankment was completed indicate foundation pore pressure returned to preconstruction levels except at Piezometer 4. South approach foundation piezometer data are shown in Figures 13 and 14.

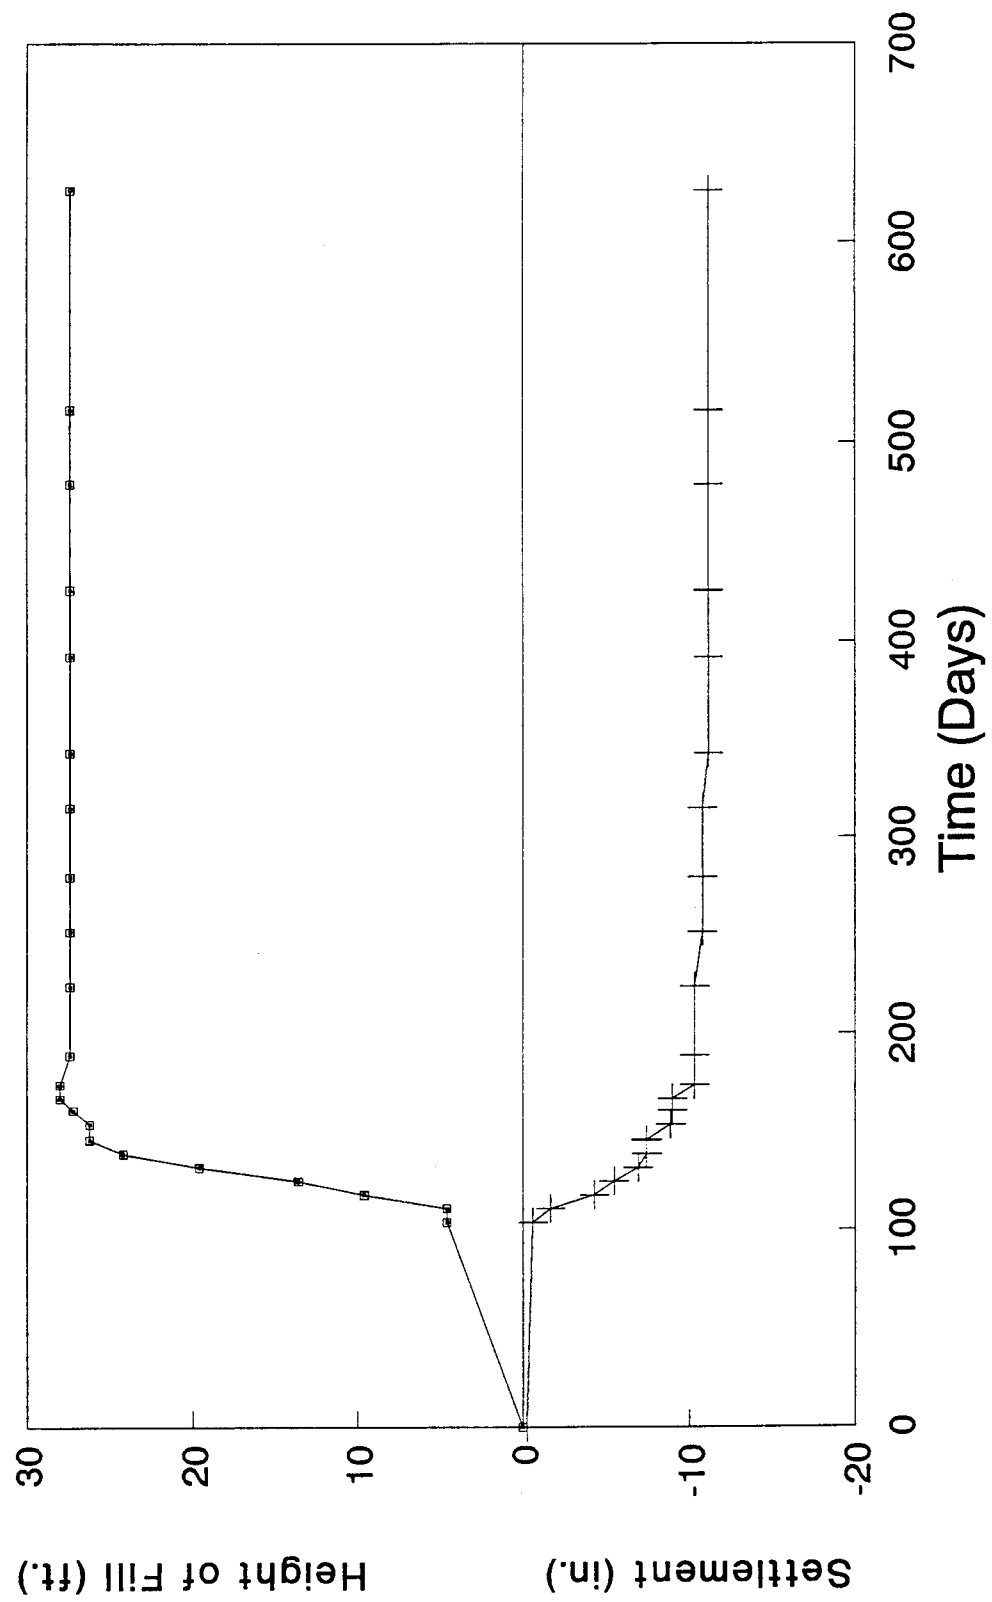
Figure 15. Foundation Settlement and Embankment Height at Station 310+00 (Ramp C).

Foundation settlement at the north approach was 11.2 in. at Station 310+00 and 4.2 in. at Station 315+00. Ninety percent settlement occurred approximately 60 days after the embankment was completed at Station 310+00 and 20 days at Station 315+00. Embankment height and foundation settlement for both locations are plotted versus time in Figures 15 and 16. A settlement gage at Station 315+60 indicated settlement of 4.5 in. at centerline.

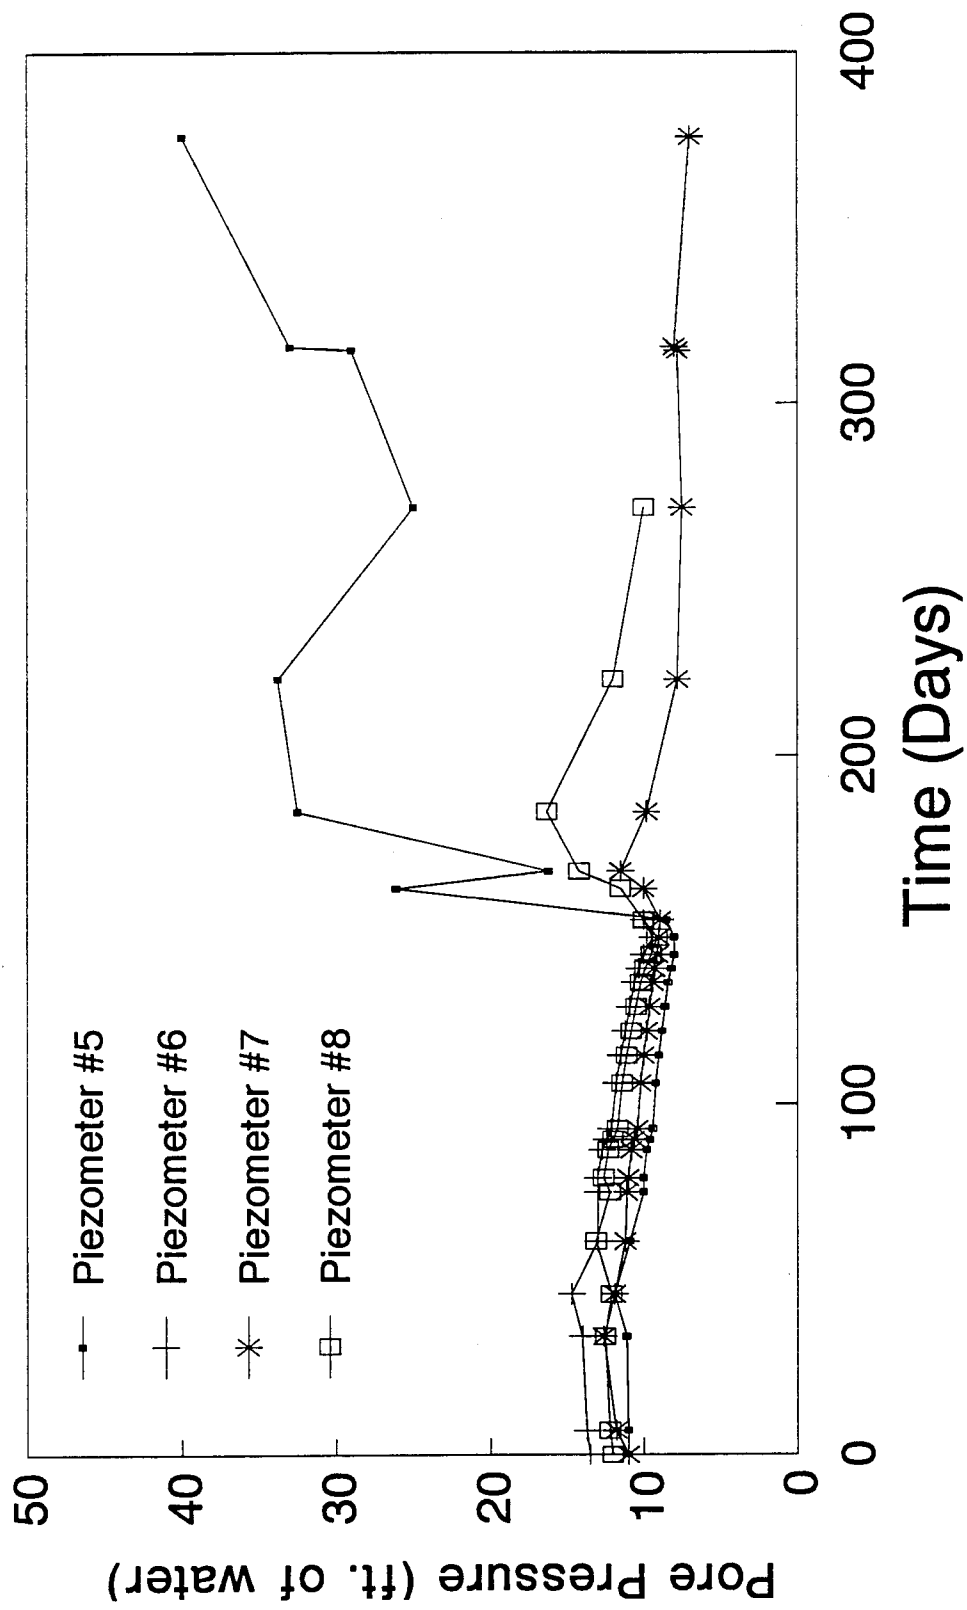
Figure 17. Foundation Pore Pressure at Station 310+00 (Ramp C).

Foundation pore pressure in the north approach followed the same pattern as in the south approach foundation. All piezometers, except Piezometer 5, indicated pore pressure increases with embankment construction and pore pressure returning to initial levels or lower after the embankment was complete. Piezometer 5 is the nearest piezometer to the north abutment stone columns. Piezometer 5 indicated an elevated pore pressure until it ceased operating in May 1986. The north reinforced soil wall was not removed until September 1986. North approach piezometer data are shown in Figures 17 and 18.

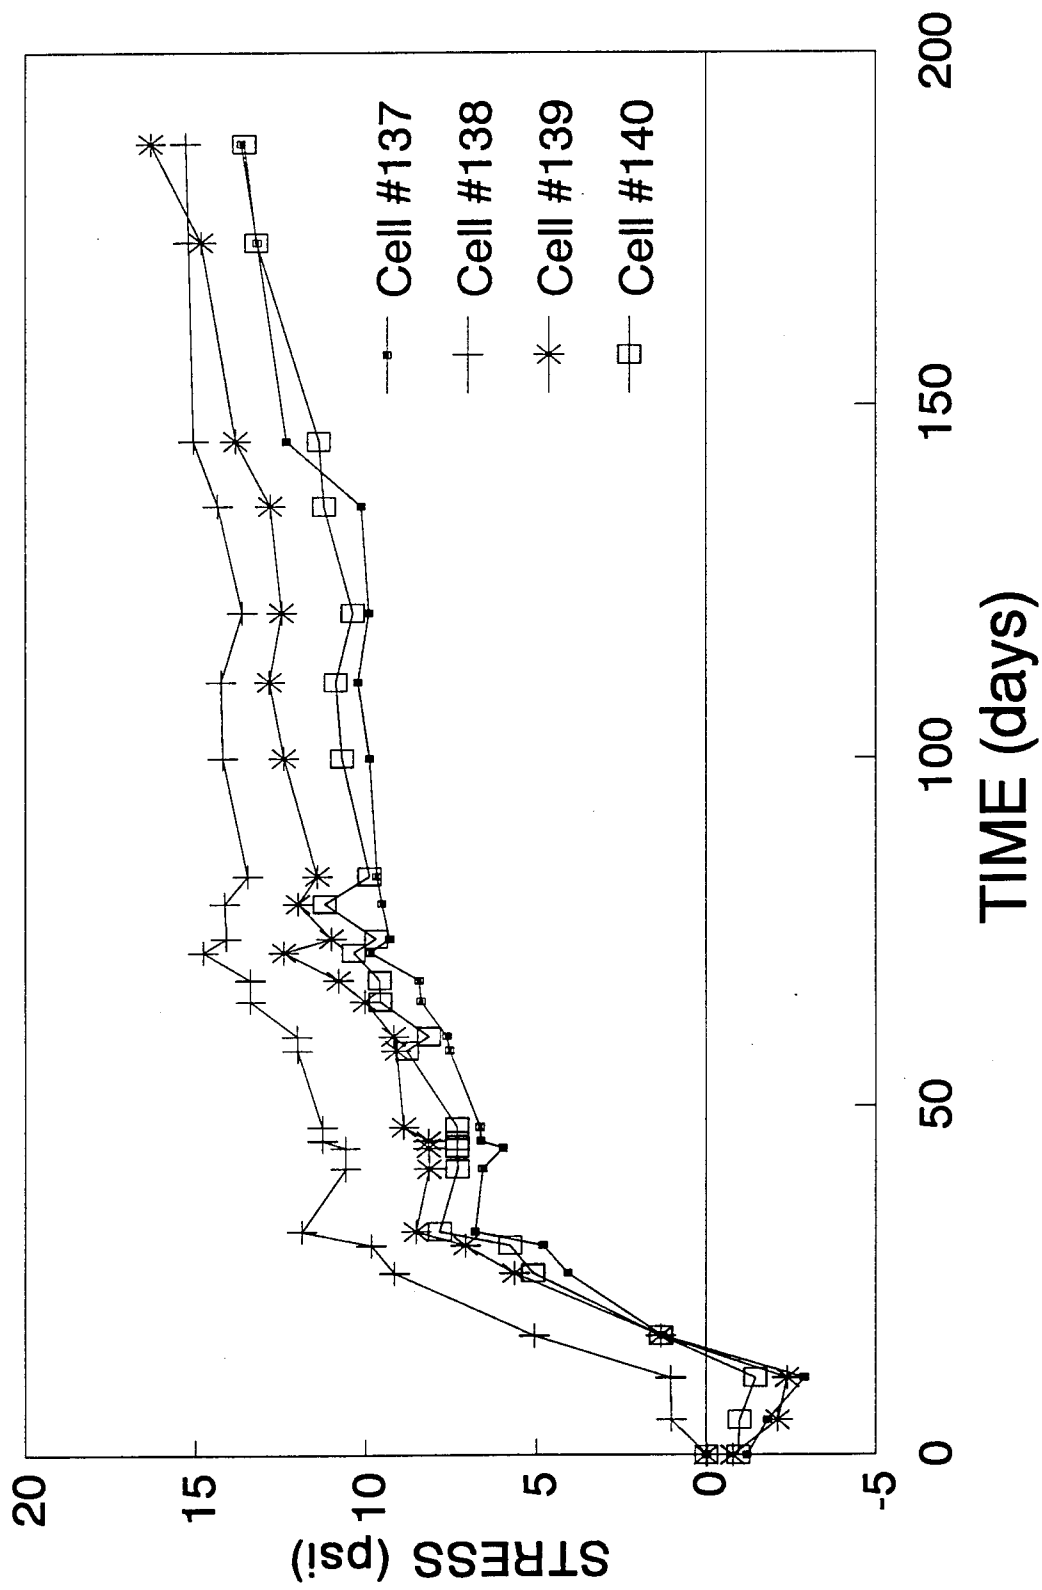
Figure 21. Earth Pressure Data on the Foundation at Abutment 1.

Earth pressure meters indicated very little stress concentration in the stone columns. Meters at the north wall indicate pressures of 16 and 17 psi on stone columns and 14 psi between columns. Meters at the south wall indicate the stone column temporarily carried approximately 3.0 psi more pressure than the surrounding soil, but near the time of failure, the stone column had less load, approximately 1.0 psi, than the soil. Earth pressure data for the north and south abutments are shown in Figures 21 and 22, respectively.
