## TRUCK ROUTE ACCESS EVALUATION

Fulton County  
Hickman Riverport Area  
Site No. 16

Report No. KTC-98-35

“Freight Movement and Intermodal Access in Kentucky”  
SPR 98-189

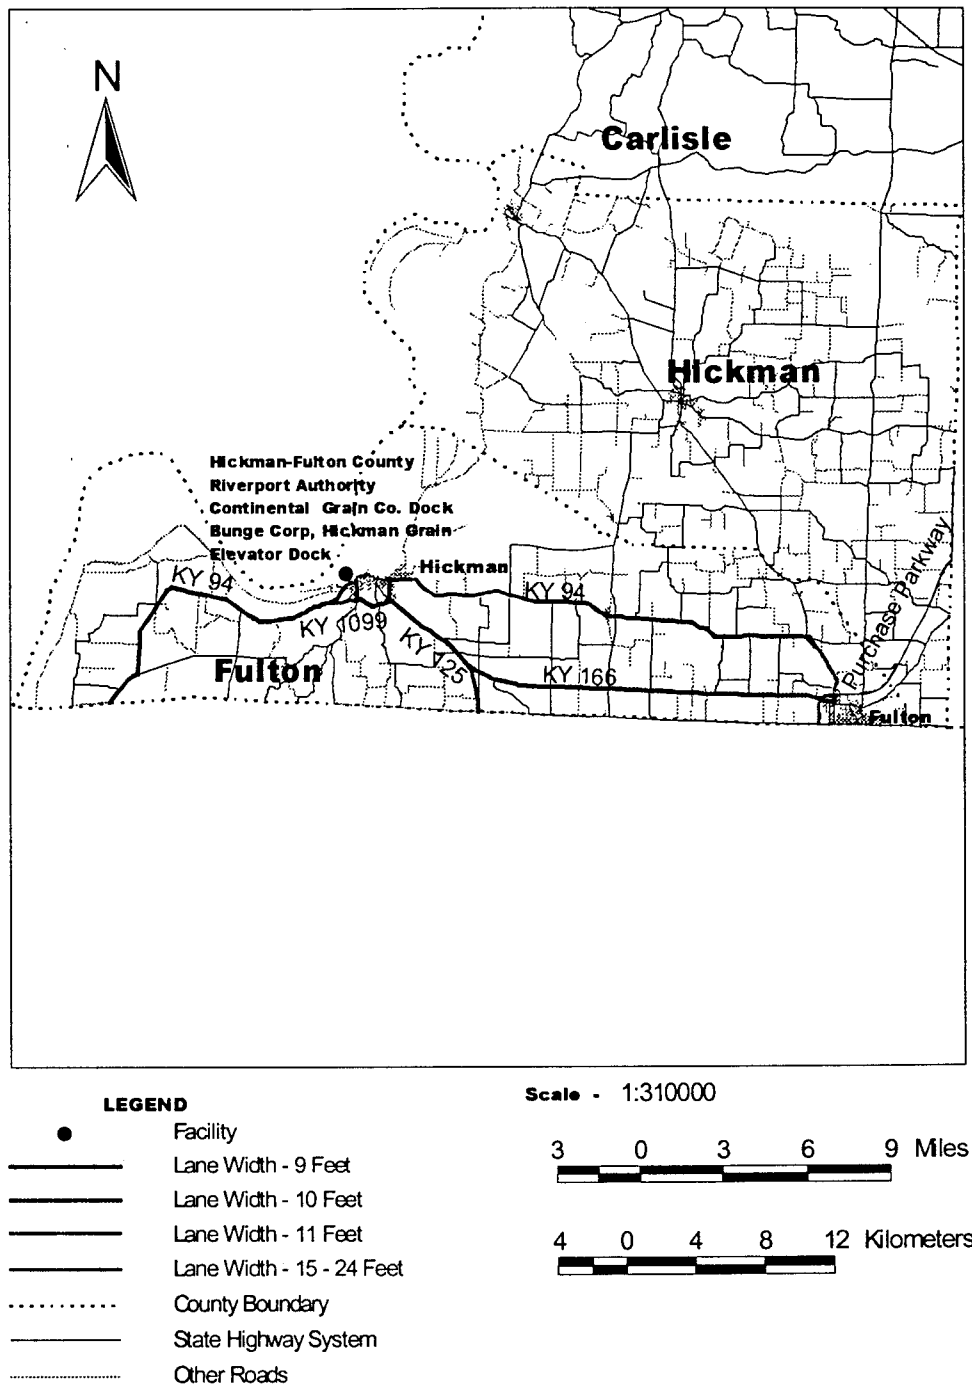
**Figure 7: Lane Widths**

Figures 7 through 10 illustrate the sections of the routes having different widths of lanes and shoulders. Except for very short sections of KY 94 and KY 125 the majority of these routes have “less than adequate” 10 foot lanes. The shoulders (except at intersections and along one improved section of KY 94) ranged from 2 to 4 feet of either gravel or turf to 1 to 2 feet of paved shoulder with gravel. These types of narrow shoulders, regardless of surface type, are considered “less than adequate” in this study as they do not allow for emergency stopping of large trucks.

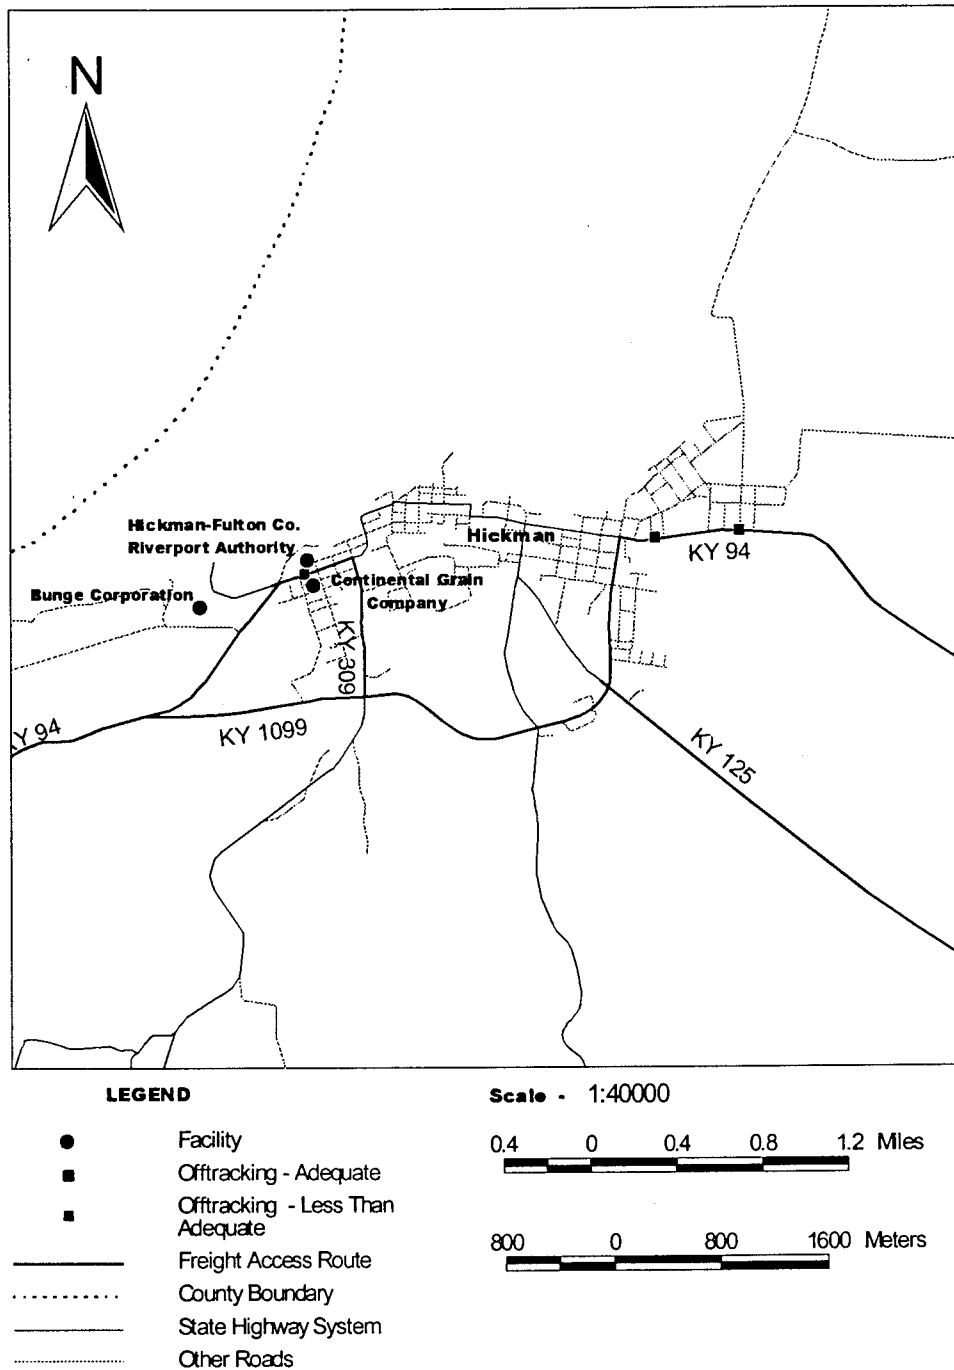
**Figure 12: Potential Offtracking Problems in Town of Hickman**

Locations where offtracking may occur were estimated using wheel base lengths, horizontal curvature information from the HIS database and lane widths measured in the field. No curve widening was noted in the field. Locations of potential offtracking problems (19 in total) are shown in Figures 11 and 12, while details are listed in Appendix B. Only 7 of the curves on these routes (all on KY 94) also failed the ball bank reading guidelines when traveled at the speed limit or the posted advisory speed for these curves. These locations are shown in Figure 13.

However, despite the very small radii indicated on Figures 11 and 12 very little opportunity to widen the paved area is possible at these intersections. Deep ditches are found on all four corners at KY 309 and KY 1099. The headwalls of a very narrow bridge over a creek start only 20 feet south of the edge of the KY 1099 travel lanes. At the intersection of KY 125 and KY 1099 the same creek crosses under the intersection on an angle as shown in Figure 14. All four corners of this intersection have commercial land uses and parking lots which abut the intersection. There are many utility poles and signs also at the corner. Both of these intersections are rated “less than adequate” according to this study methodology.

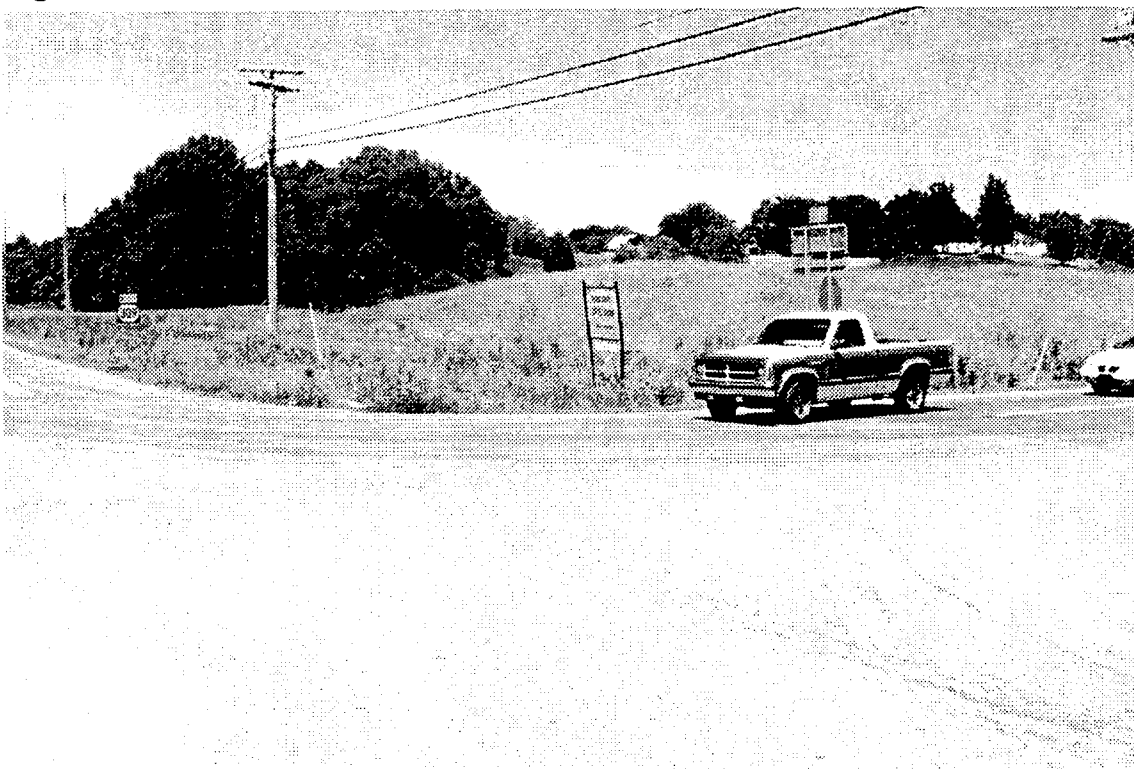
**Figure 16: Intersection of KY 309 and KY 1099**

The right turning radii at two intersections within the town of Hickman are “less than adequate” for the trucks traveling these routes. A sketch of the intersection of KY 125 and KY 1099 is shown in Figure 14, while the intersection of KY 1099 and KY 309 is shown in Figure 15. Trucks were observed offtracking into opposing traffic lanes while making both left and right turns at these intersections. Figure 16 illustrates the tire marks on the road at the intersection of KY 309 and KY 1099 where trucks make right turns from KY 1099 (on the right in the picture) onto KY 309 as well as make left turns from KY 309 to KY 1099. The tire marks clearly indicate trucks moving out of their travel lanes.

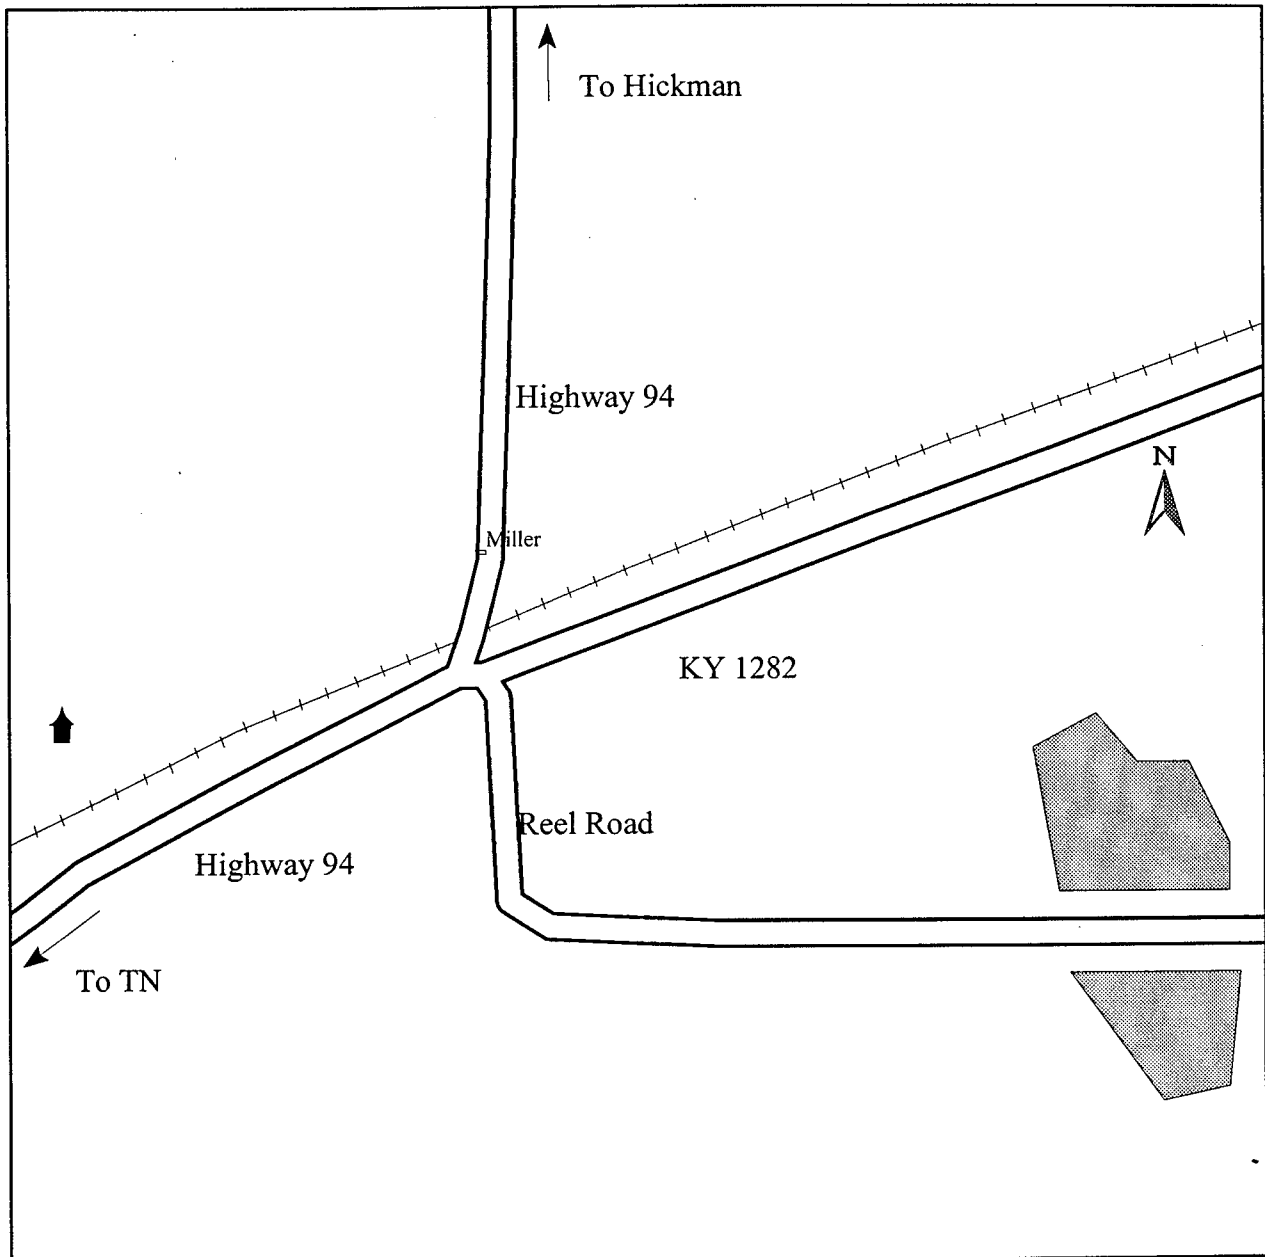
**Figure 21: Intersection of Highway 94 and KY 1282 near Railway Crossing**

There were four at-grade railway crossings along these routes as shown in Figure 20. The rail crossings on KY 1099 have no warning signs, lights or gates. There is poor sight distance in one direction at each crossing. The rail lines appear unused so are not rated “less than adequate” in the tallies provided in section 4. This assessment is further confirmed by the tracks being paved over on KY 94 at the riverports (shown in Figure 20). All three of these crossings have good smooth pavement surfaces. The rail crossing immediately north of the Tennessee border on KY 94 occurs on a sharp corner as shown in Figure 21. Although there is sufficient sight distance, the crossing could be confusing or awkward. The surface is very rough and might pose problems for trucks. Although this rail line may not be used by trains the configuration and surface quality indicates it be assigned a “less than adequate” rating.
