## HIGHWAY ACCIDENT REPORT

COLLISION OF CSXT FREIGHT TRAIN  
AND MURRAY COUNTY SCHOOL  
DISTRICT SCHOOL BUS  
AT RAILROAD/HIGHWAY  
GRADE CROSSING  
CONASAUGA, TENNESSEE  
MARCH 28, 2000

**NTSB/HAR-01/03  
PB2001-916203  
Notation 7415  
Adopted December 11, 2001**

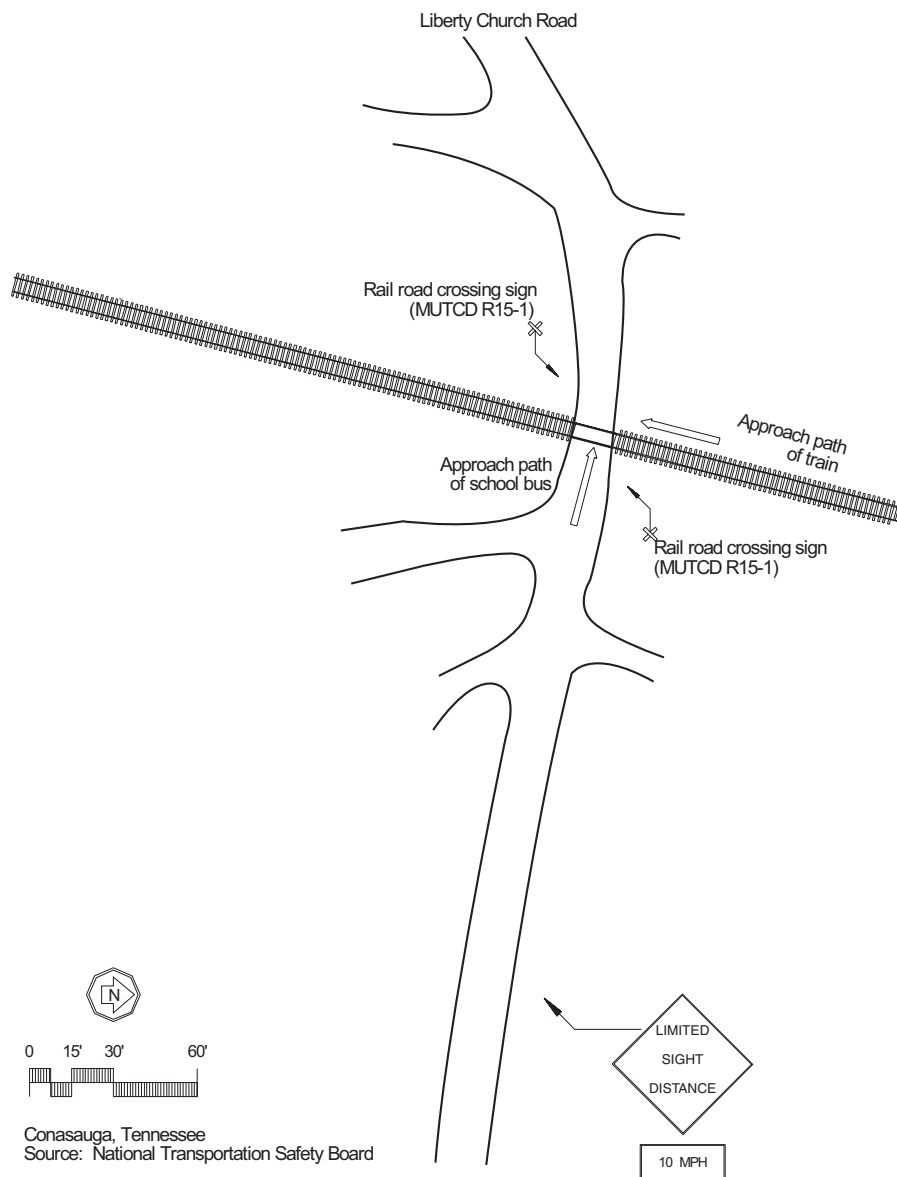
**Figure 2.** Scene diagram.

On its approach to the crossing, the school bus encountered two advisory signs. The first was a round railroad advance warning sign<sup>1</sup> with a placard that stated “ONE LANE.” The second was a diamond-shaped warning sign<sup>2</sup> that stated “LIMITED SIGHT DISTANCE.” Beneath the second sign was a speed advisory sign<sup>3</sup> that stated “10 MPH.” Also at the crossing was a railroad crossing sign (crossbucks)<sup>4</sup> on the right side of the approach (see figure 2).

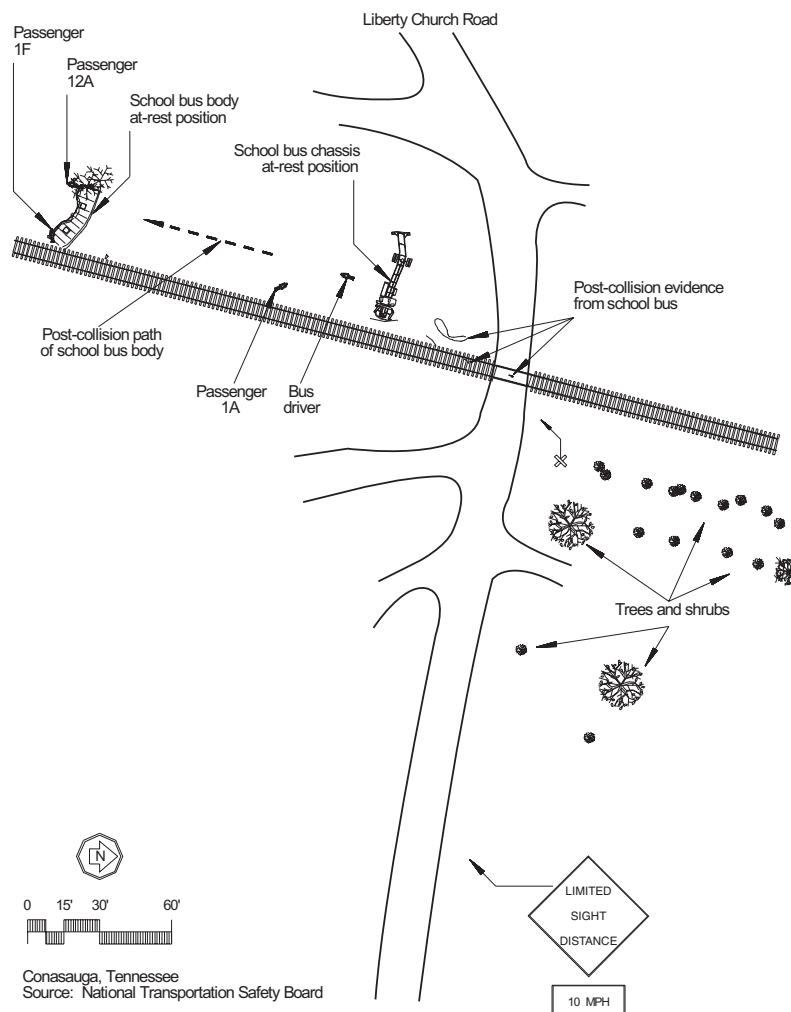
**Figure 3.** Postaccident scene diagram.

The train struck the school bus on the passenger side between the axles. During the accident sequence, the bus body and its chassis struck the crossbucks and separated, and the chassis came to rest 64 feet west-southwest of the center of the grade crossing; the chassis was facing east. The front of the bus body, including the section to which the driver's seat was attached, separated from the rest of the body and remained with the chassis, which rolled on its passenger side and later rolled back upright. The body, pushed down the tracks by the locomotive before pivoting off and rotating clockwise about 180 degrees, came to rest 192 feet west-southwest of the center of the crossing (see figure 3). That part of the bus body immediately behind the separation point was flush with the train body (see figure 4). Broken branches and scrape marks were found on rows of trees approximately 112 feet and 157 feet from the grade crossing. The train did not derail, and the locomotive came to rest about 1,990 feet from the crossing. During the accident sequence, the bus body scraped several branches and struck a tree near the area where the bus came to rest. Bus tire rub marks were found on the inside of the rail.

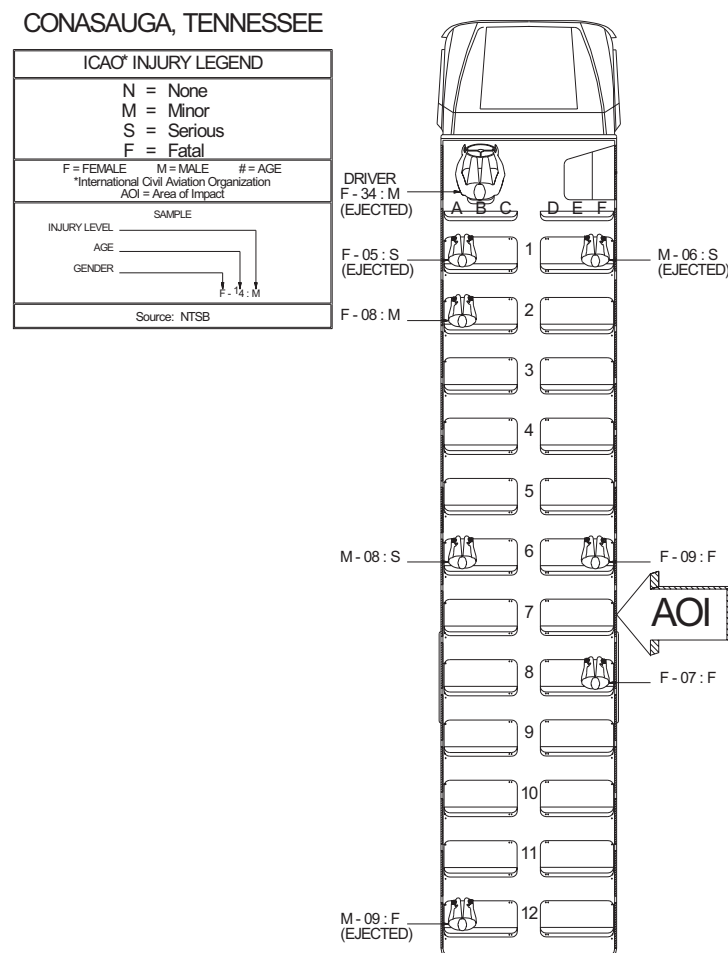
Figure 5. Seating chart.

The busdriver was wearing a lap/shoulder belt, which broke during the accident sequence, resulting in her ejection from the bus. Her minor injuries included a fractured nose, contusions, abrasions, and lacerations. The passenger seated in the second row (seat 2A) (see figure 5) also sustained minor injuries, including blunt abdominal trauma with abrasions and contusions. This passenger was reportedly wearing a lap belt.

One of the ejected passengers (seat 1A), who was ejected through the front opening of the bus body after its separation from the chassis and was severely injured, sustained a closed head injury, multiple scalp lacerations, left arm and leg fractures, and wedging of several thoracic vertebrae. The seriously injured passenger who was ejected and found pinned under the front passenger-side corner of the bus (seat 1F) sustained a closed head injury, liver contusions, multiple facial lacerations, abrasions, and contusions. The seriously injured passenger who was seated across from the area of intrusion (seat 6A) sustained a closed head injury with intraventricular hemorrhage, a right frontal lobe contusion, right first rib fracture, and multiple facial lacerations.

Two fatally injured passengers (seats 6F and 8F) were seated in the area of impact, and each sustained a linear skull fracture, left subdural hemorrhage, cerebral cortical contusions, lacerations, and contusions. In addition, the passenger in seat 6F received a posterior right rib fracture with right hemothorax, hemoperitoneum, and spleen laceration. The passenger in seat 8F also received a severe facial fracture, subarachnoid hemorrhage, and left femur fracture. The fatally injured passenger seated in the last row (seat 12A), who was ejected, sustained a transected aorta; lacerations of the right atrium, liver, and spleen; bilateral hemothorax; left lateral pericardial sac hemopericardium; fractures to the left ribs, right clavicle, and right tibia-fibula; and multiple contusions, lacerations, and abrasions. This passenger also had abrasions and linear contusions from the chest midline extending laterally to the right and left of the chest midline.
