## RAILROAD ACCIDENT REPORT

COLLISION OF NATIONAL RAILROAD PASSENGER CORPORATION (AMTRAK)  
TRAIN 59 WITH A LOADED TRUCK-SEMITRAILER COMBINATION AT A  
HIGHWAY/RAIL GRADE CROSSING IN  
BOURBONNAIS, ILLINOIS, MARCH 15, 1999

**NTSB/RAR-02/01  
PB2002-916301  
Notation 7168A  
Adopted February 5, 2002**

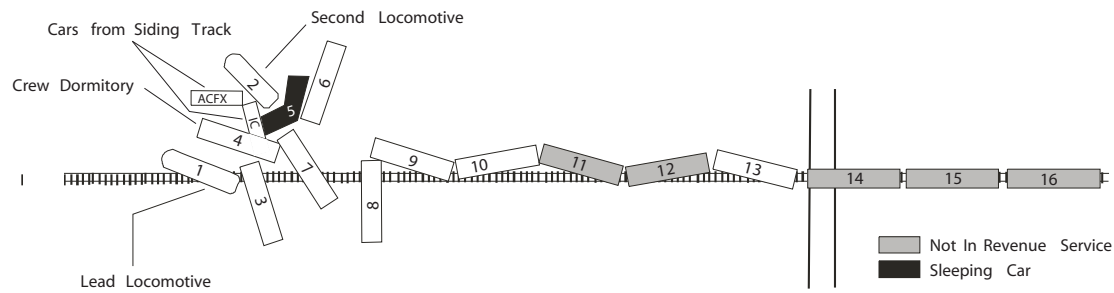
**Train.** The impact caused both locomotives and 11 of the 14 cars in the consist to derail. The lead locomotive came to rest at a point about 560 feet south of the grade crossing. Adjacent to this was the second locomotive, the baggage car, a transition sleeper car, a sleeping car #32035, diner car #38020, and coach car #34089, which came to rest on its side, all of which were involved in a general pileup of wreckage. (See figure 9.) The remaining cars in the consist either derailed and remained upright or did not derail at all. None was involved in the general pileup of wreckage. These cars did not display any evidence of serious carbody breach, and damage was mostly limited to the carbody end-structures.
