DERAILMENT OF UNION PACIFIC RAILROAD TRAIN  
QFPLI-26 AT EUNICE, LOUISIANA, MAY 27, 2000

**NTSB/RAR-02/03  
PB2002-916303  
Notation 7450  
Adopted April 2, 2002**

The National Transportation Safety Board determines that the probable cause of the May 27, 2000, derailment of Union Pacific train QFPLI-26 was the failure of a set of joint bars that had remained in service with undetected and uncorrected defects because of the Union Pacific Railroad's ineffective track inspection procedures and inadequate management oversight.

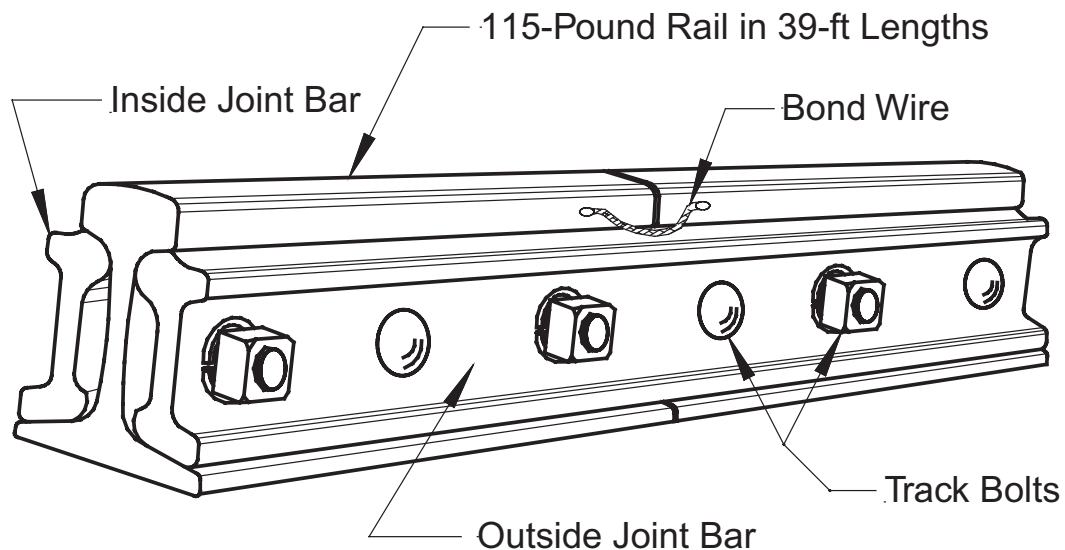
**Figure 5.** Sketch of a typical joint bar.

In jointed rail territory, the individual rails are joined to one another by joint bars. (See figure 5.) The Beaumont Subdivision used a common form of rail joint that consists of two joint bars plus six track bolts, nuts, and spring washers. Two joint bars, one on each side of the rail ends, are considered to be a pair. Oval-shouldered track bolts, typically 1 inch in diameter, are arranged in an alternating pattern through holes in the joint bars and rail. When the bars are matched up to form a rail joint, one on the gage side and one on the field side of the rail, the bolts are tightened and the joint bars are drawn toward each other, squeezing them toward the side of the rail. In addition to joining the rail ends together, the joint bars act as a beam that distributes over several adjacent ties the downward vertical load that is imposed on the rail joint by the weight of the train.

During the postaccident inspection of the derailment area, portions of two broken joint bars, still bolted to the end of a section of the south rail, were found on the bridge at about the fourth span. Each joint bar portion had a break in the transverse plane at the center of the joint bar, near the end of the rail. Later, portions of another pair of broken joint bars were found. These bars also had remained bolted to a piece of rail and had breaks in the transverse plane at the center of the joint bar. The fractured surfaces of the two pairs of broken joint bar pieces matched one another in both the location of the broken surfaces and the type of fracture.
