# **DEVELOPMENT OF THE *MIDWEST GUARDRAIL* SYSTEM (MGS) FOR STANDARD AND REDUCED POST SPACING AND IN COMBINATION WITH CURBS**

MwRSF Research Report No. TRP-03-139-04

September 1, 2004

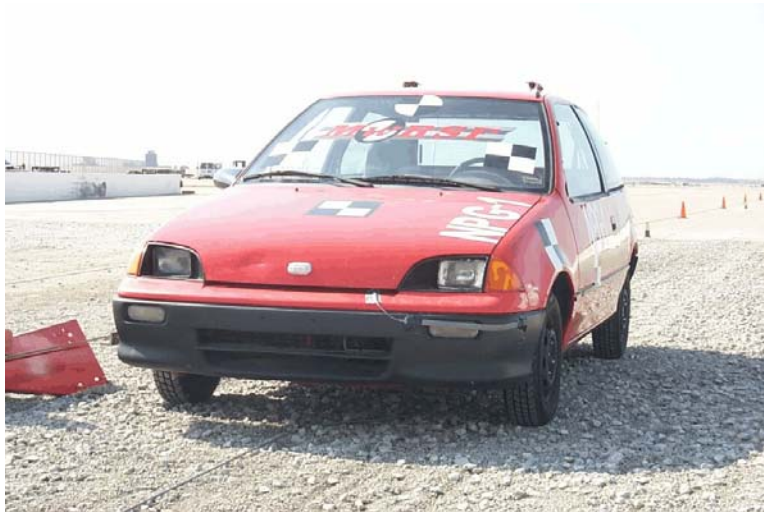
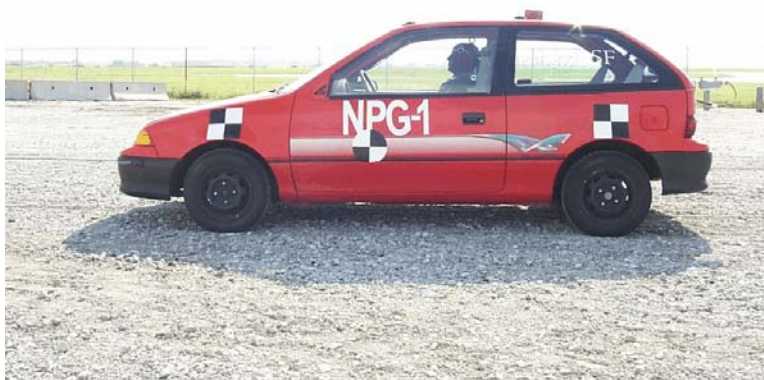
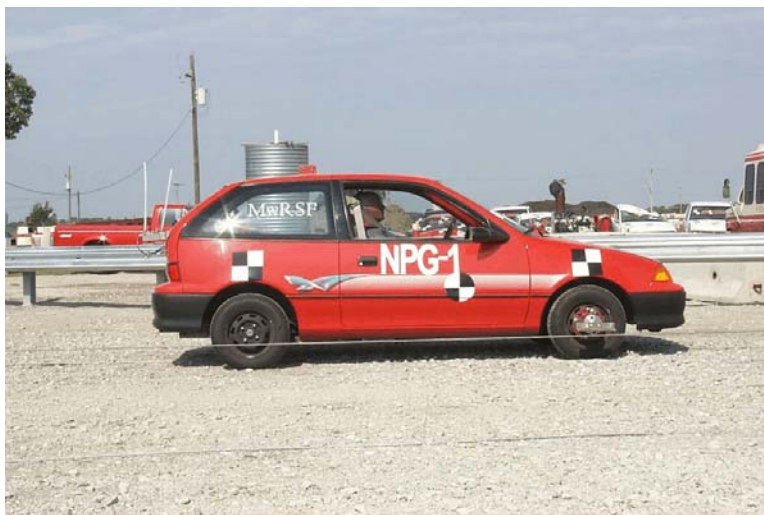
Figure 1. Test Vehicle, Test NPG-1

Note any damage prior to test: Minor dents: hood & rear hatch

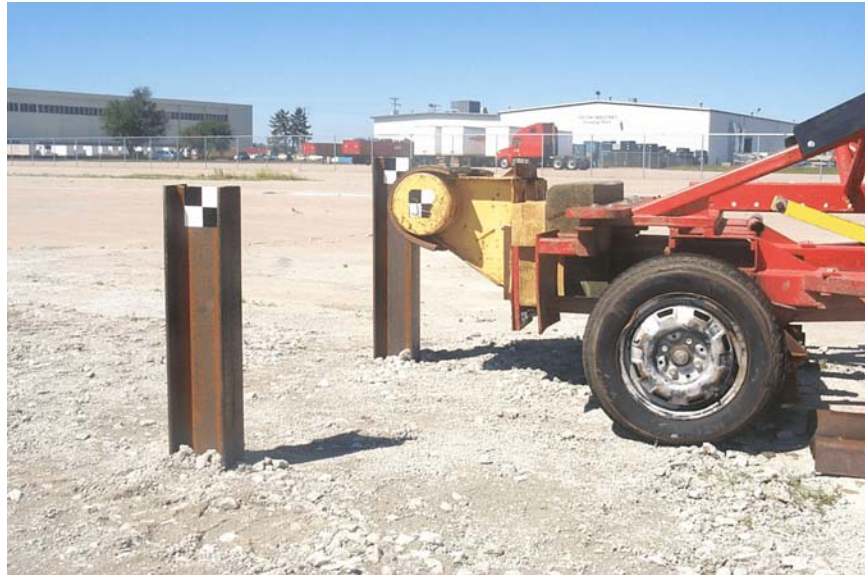
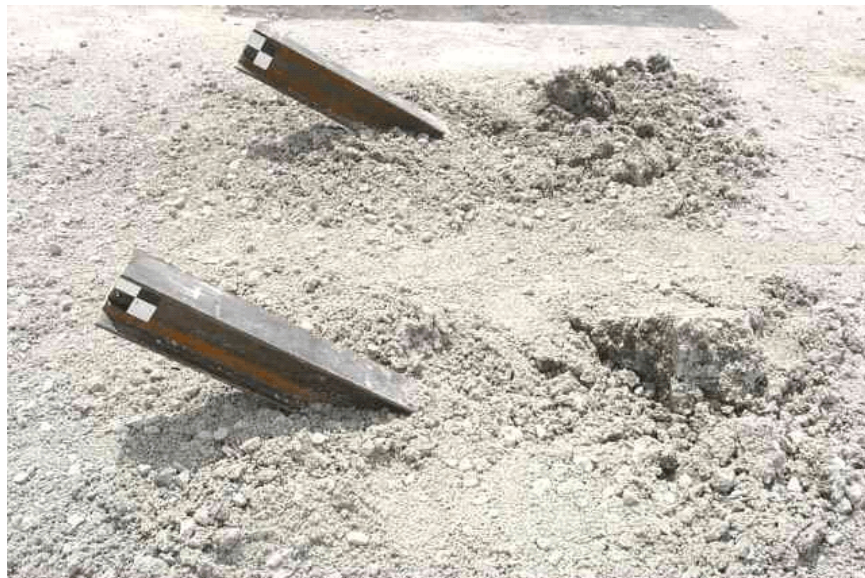
Figure 28. (a) Typical Installed Post for Bogie Tests, (b) Typical Post-Soil Behavior

Failure of the posts was found to be dependent upon embedment depth. For post embedment depths of 1,016 mm (40 in.) or greater, soil failure was observed with occasions of slight yielding within the post. For post embedment depths of 940 mm (37 in.) or less, the posts were pulled out of the ground after rotating in the soil for some distance. In addition, there were measurable differences in the impact forces observed for the two modes of failure. As a result of these differing impact forces, the amount of energy dissipated also varied. Posts that failed by rotating in the soil dissipated more energy than posts that initially rotated but eventually pulled out of the ground. Additional discussion of the post testing results is provided in the referenced MwRSF research report (30).

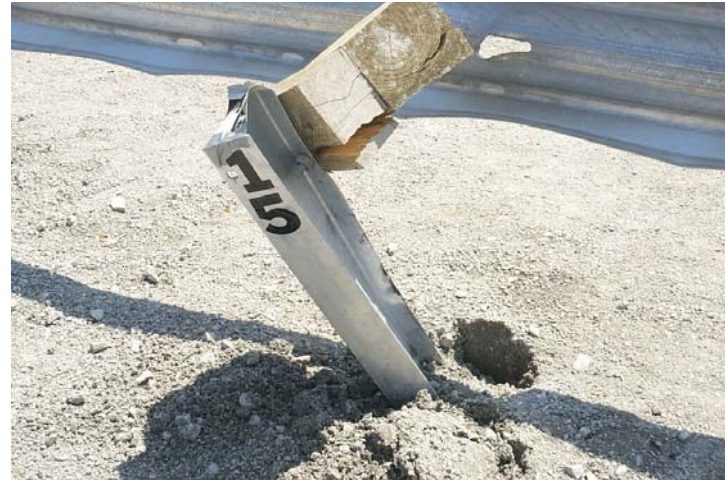
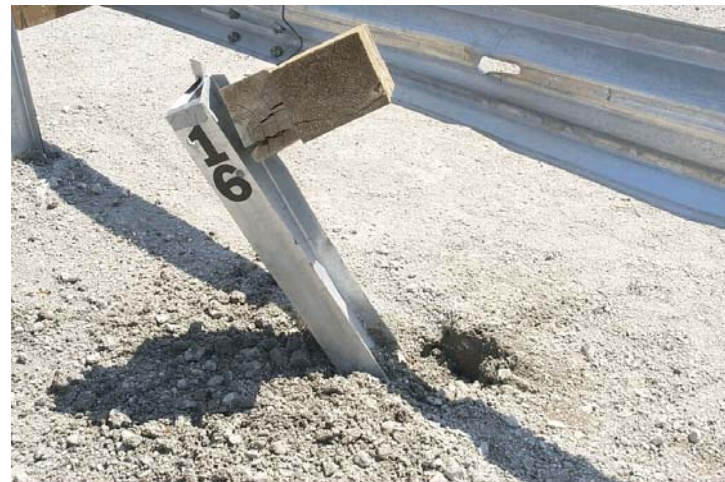
Figure 44. Post Nos. 15 and 16 Damage, Test NPG-1

Steel post nos. 3 through 12 were slightly twisted but did not encounter any rotational deflections. Post nos. 13, 14, 17, and 18 rotated backward slightly in the soil. Post nos. 15 and 16 rotated in the soil and bent laterally toward the ground. Contact marks were found on the front face of post nos. 15 and 16. Longitudinal splitting through the bolt holes was found on the wooden blockouts at post nos. 15 and 16. No significant post damage or movement occurred to post nos. 19 through 28, and the blockouts at post nos. 3 through 14 and 17 through 28 remained undamaged. The upstream and downstream anchorage systems slightly moved longitudinally, but the posts in both the upstream and downstream anchorage systems were not damaged.

The permanent set of the guardrail and posts is shown in Figures 43 through 45. The maximum lateral permanent set rail and post deflections were 238 mm (9 3/8 in.) at the centerline of post no. 15 and 432 mm (17 in.) at post no. 15, respectively, as measured in the field. It should be noted that the rail was removed from this post. The maximum lateral dynamic rail deflection was 443 mm (17 3/8 in.) at the centerline of post no. 15, as determined from the high-speed film analysis.

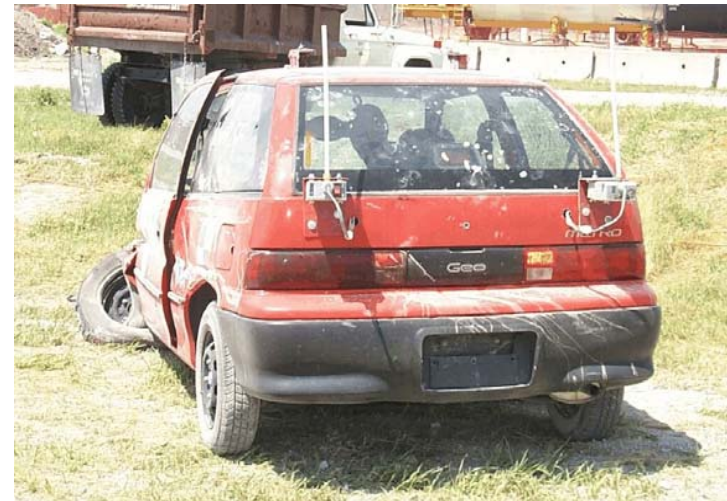
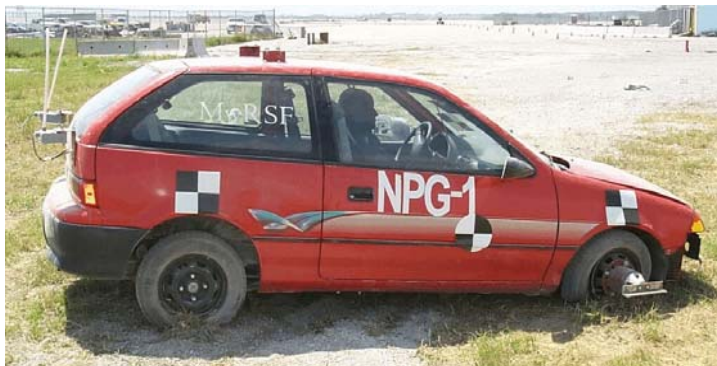
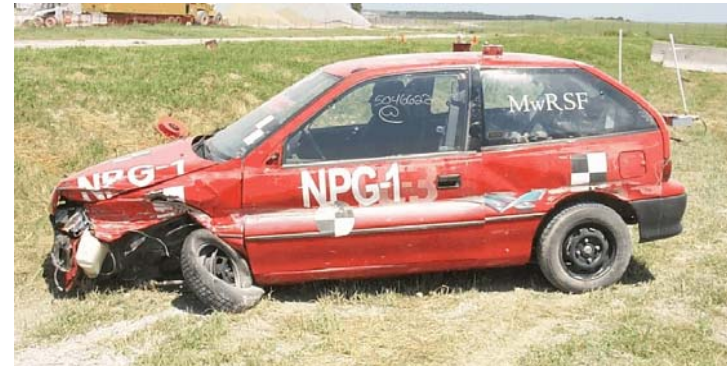
Figure 46. Vehicle Damage, Test NPG-1

Exterior vehicle damage was moderate, as shown in Figures 46 and 47. Minimal occupant compartment deformations occurred with only slight deformation of the forward floorpan area and the left-side rocker panel. Damage was concentrated on the left-front corner and left side of the vehicle. The left-front corner of the vehicle was crushed inward, including the fender, bumper, hood, and wheel assembly. The outer plastic cover was removed from the bumper, while the bumper's inner steel reinforcement was deformed slightly inward on the left end. The left-front wheel

assembly was deformed inward toward the engine compartment. The lower control arm along with the shock and spring assembly were bent and deformed back toward the occupant compartment but remained attached. The wheel assembly joint connected to the transfer case was disengaged. The left-front tire disengaged from the rim and the side wall was torn. The right-front tire also disengaged from the rim. Scrape marks and deformations were found along the middle portion of the entire left side of the vehicle from contact with the W-beam guardrail. The left-side headlight region was damaged and crushed inward toward the engine compartment. The top of the left-side door was jarred open. The lower-left side of the windshield sustained minor spider cracking with several of the cracks extending across the entire windshield. The roof, the right side and rear of the vehicle as well as the left-side, right-side, and rear window glass remained undamaged.

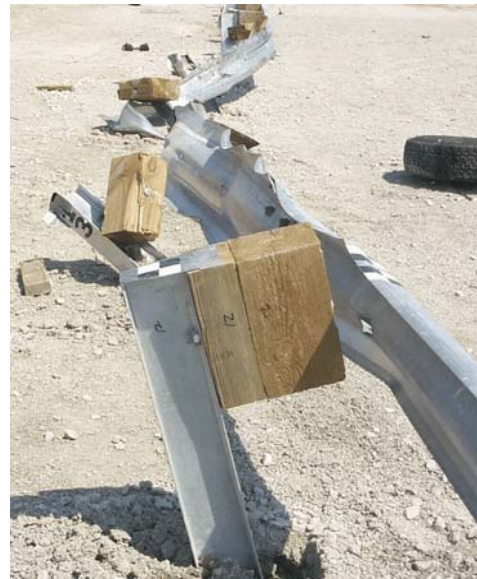
Figure 64. System Damage, Test NPG-2

Damage to the barrier was extensive, as shown in Figures 64 through 67. Barrier damage consisted of deformed W-beam and guardrail posts, contact marks on a guardrail section, and disengaged wooden blockouts.

The guardrail damage consisted of moderate deformation and flattening of the impacted section of W-beam rail between post nos. 13 and 17. Contact marks were found on the guardrail between post nos. 12 and 18. The guardrail buckled at post nos. 11, 12, and 17. The W-beam guardrail was torn through the cross section, beginning at the bottom of the W-beam rail 254-mm (10-in.) downstream of the centerline of the splice between post nos. 14 and 15, propagating up through the post bolt slot at post no. 15, and ending at the top of the W-beam rail 203-mm (8-in.) downstream of the centerline of post no. 15. The W-beam was pulled off of post nos. 1 through 5,

12 through 17, and 20 through 24. The W-beam rail sustained significant yielding around the post bolt slots at post nos. 3 through 5. No significant guardrail damage occurred downstream of post no. 25.

The wooden blockouts at post nos. 13, 14, 15, 17, 21, and 22 fractured, but remained attached to the post. The wooden blockouts at post nos. 18 through 20 encountered only minor deformations. The wooden blockout at post no. 16 disengaged from the system. The blockout bolt at post nos. 13, 14, 15, and 17 bent and subsequently rotated the blockout toward the downstream side of the post. The blockouts at post nos. 3 through 12 and 23 through 27 remained undamaged.

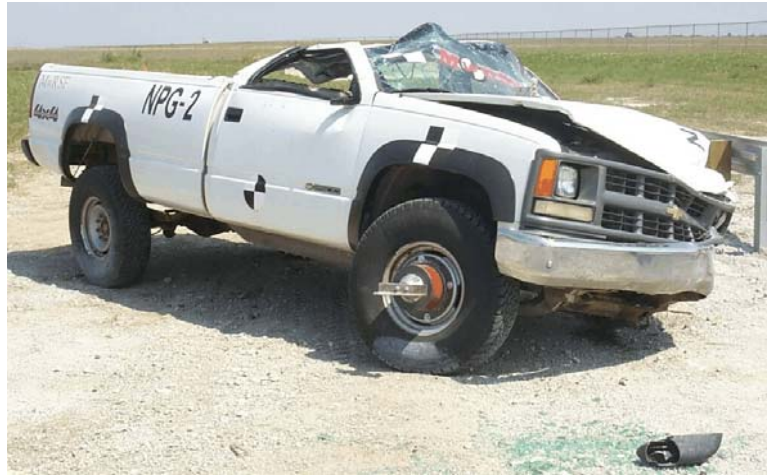
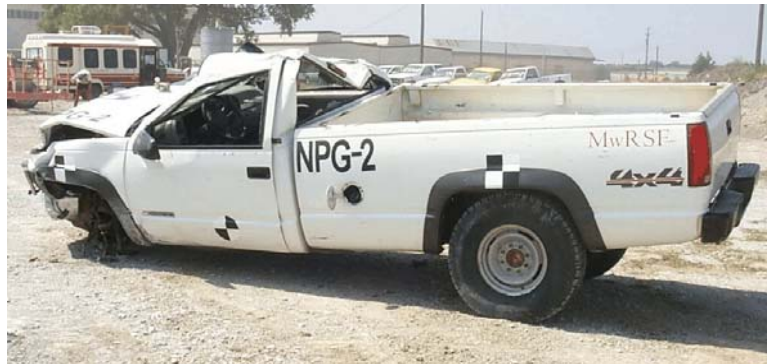
Figure 68. Vehicle Damage, Test NPG-2

Exterior vehicle damage was extensive, as shown in Figures 68 and 69. Extensive occupant compartment deformations occurred due to vehicle rollover. The left-front quarter panel was crushed inward. The front bumper was flattened from the centerline out toward the left side as the left side of the bumper was bent back toward the engine compartment. The frame of the vehicle was bent near the left-front tire. The left-front tire's tie rods as well as the upper and lower ball joints disengaged, causing the wheel to be removed from the vehicle. The four-wheel drive shaft

disengaged from the vehicle. The left side of the hood was creased and sustained cuts. The roof, the A- and B-pillars on both sides, and both the left- and right-side doors were crushed and deformed due to vehicle rollover. The windshield was cracked and deformed. Both the left- and right-side door windows as well as the rear window were shattered. The box portion of the vehicle remained undamaged.

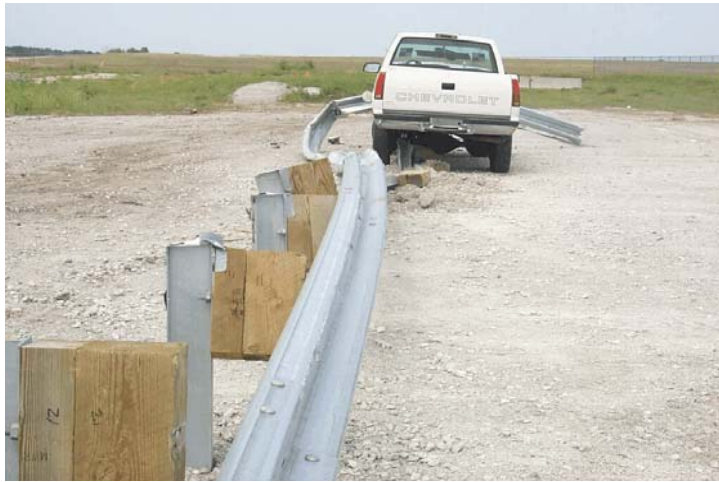
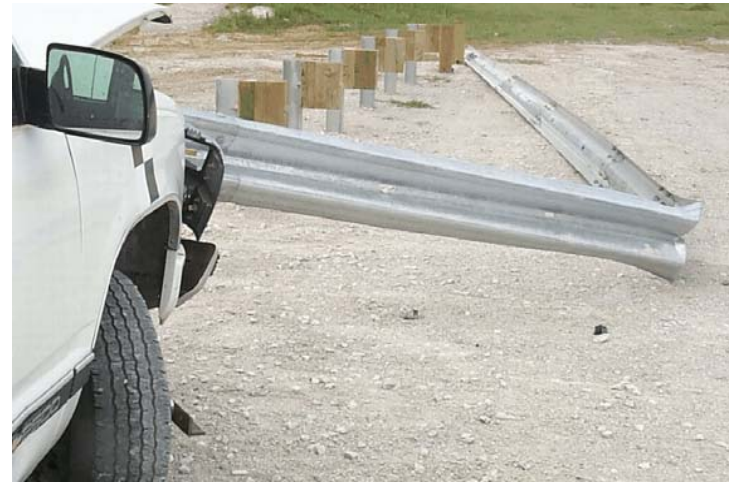
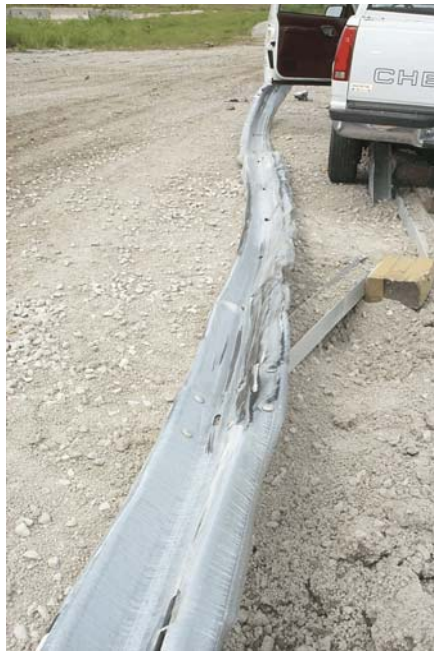
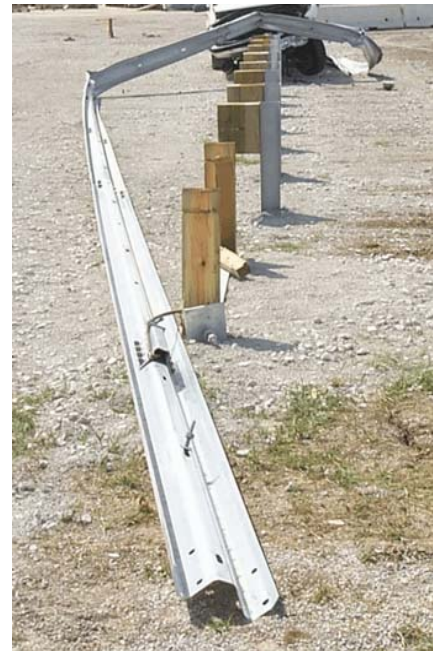
Figure 76. System Damage, Test NPG-3

Damage to the barrier was moderate, as shown in Figures 76 through 80. Barrier damage consisted mostly of deformed W-beam and guardrail posts, contact marks on a guardrail section, deformed guardrail posts, uprooted guardrail and anchor posts, and failure of the upstream cable anchor system. The increased length of the bolt slots in the guardrail caused the guardrail to release from the posts too early, thereby absorbing less energy. In addition to the early release of the posts, the increased guardrail height increased the moment on the anchorage tubes on the upstream end, causing failure of the upstream anchor system. The failure of the BCT cable anchor system caused significant damage to the posts and guardrail, as shown in Figures 76 through 80.

Steel post nos. 3 through 10 encountered very little movement. Post no. 11 twisted with a large soil gap around the post. Post no. 12 rotated backward and also twisted slightly. Post nos. 13 and 14 bent about the ground line and laid on the ground. Post nos. 15 and 16 pulled completely out of the ground. Post nos. 17 through 19 were bent and rotated downstream due to the vehicle being positioned on top of the posts. Major soil failure occurred around post nos. 13 through 16. Steel post nos. 20 through 27 did not encounter significant damage or movement. The first wooden post in the

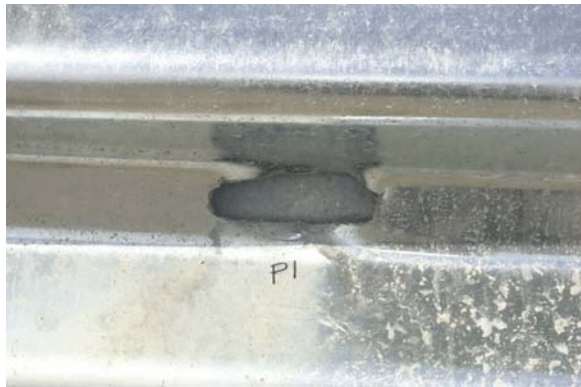
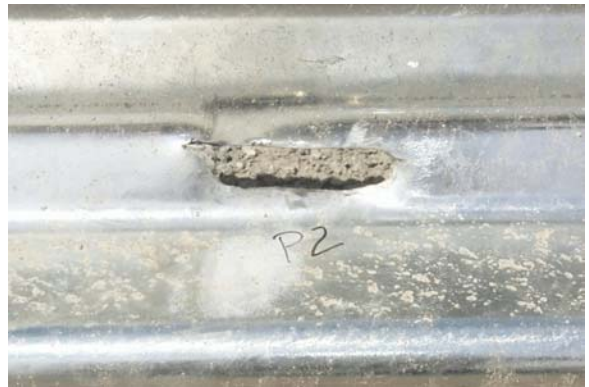
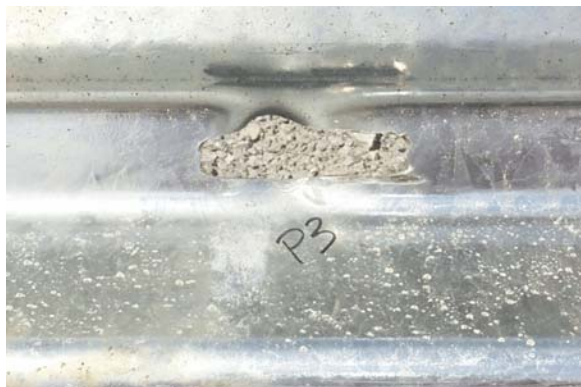
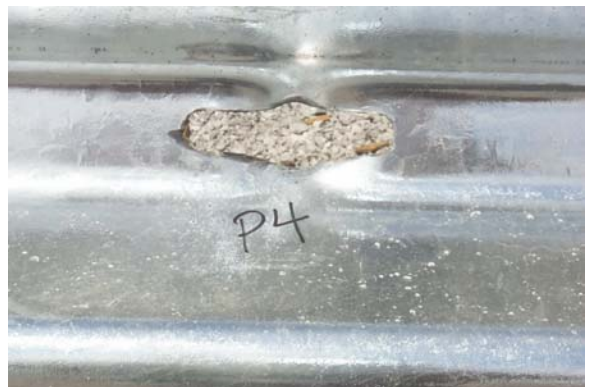
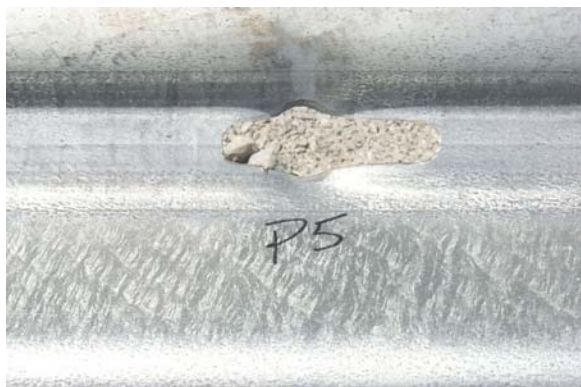
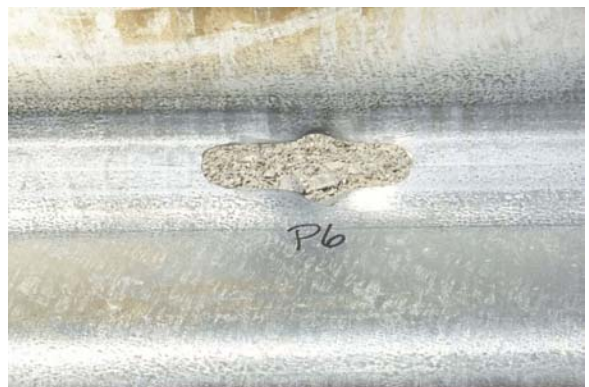
Figure 77. System Damage, Test NPG-3

The W-beam was pulled off of all of the posts in the system. All the post bolt slots were deformed, as shown in Figures 77 through 79. Contact marks were found on the guardrail between post nos. 12 and 17. The guardrail between post nos. 12 and 17 was also flattened. Major guardrail buckling occurred at post no. 17.

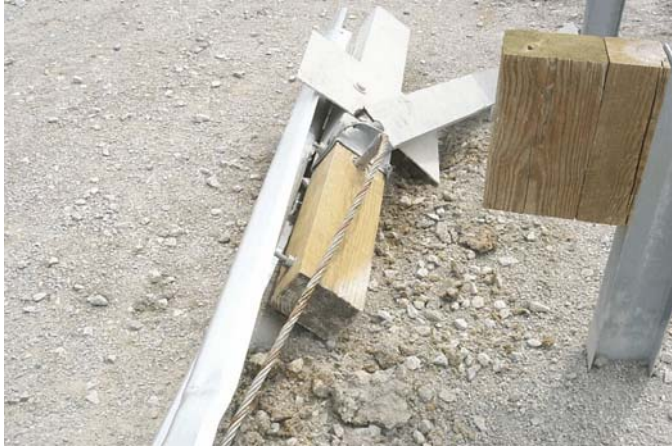
Figure 80. System Damage, Test NPG-3

upstream anchor, post no. 1, pulled completely out of the ground and was found downstream between post nos. 3 and 4. The other wooden post in the upstream anchor, post no. 2, encountered deformations on the upstream edge and moved downstream in the soil. The wooden posts in the downstream anchor, post nos. 28 and 29, split and were severely deformed. Damage to both the upstream and downstream anchor systems is shown in Figure 80.

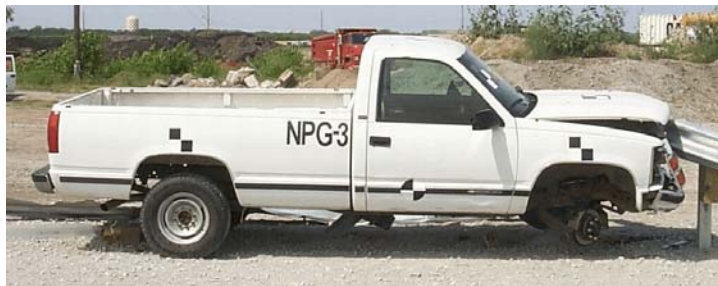
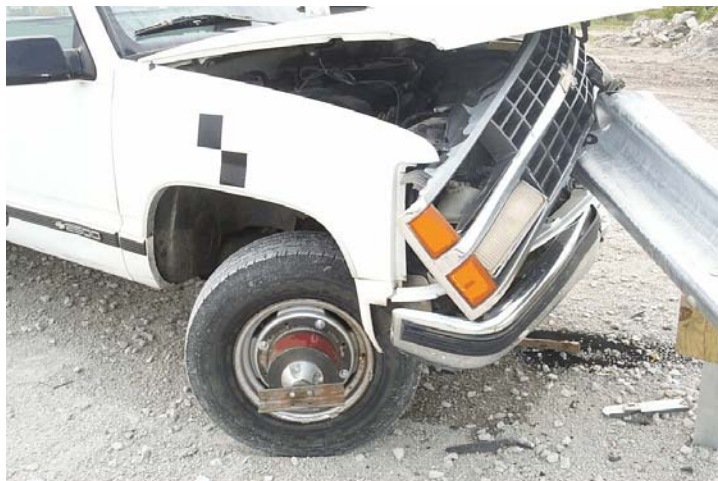
Figure 81. Vehicle Damage, Test NPG-3

Exterior vehicle damage was minimal, as shown in Figure 81. Occupant compartment deformation was negligible. Occupant compartment deformation and the corresponding locations are provided in Appendix D. The vehicle experienced frontal crush, as shown in Figure 81. The radiator was crushed inward toward the engine. The front bumper was flattened, and the left-front frame horn was bent and encountered heavy contact marks. Deformation occurred to the left-front quarter panel. The left-side tie rod disengaged, while the rest of the suspension components remained attached. The hood popped open but remained undamaged. The roof, right side and rear of the vehicle, the rims and tires, and all window glass remained undamaged.

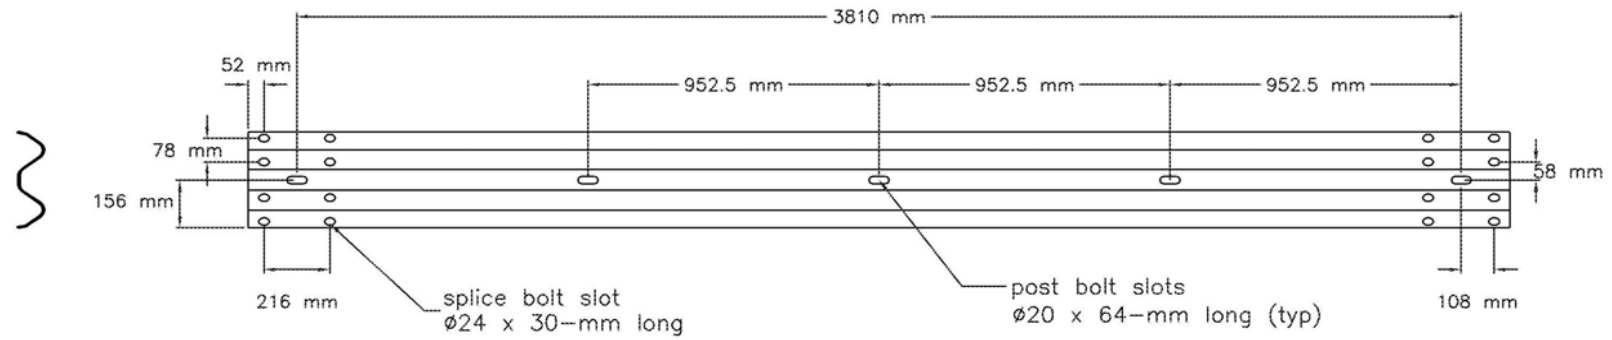
Figure 82. *Midwest Guardrail System* Rail Design Details

Standard 2.66-mm (12-gauge) thick W-beam rails with additional 64-mm (2 ½-in.) long post bolt slots at half post spacing intervals were placed between post nos. 1 and 29, as shown in Figure 82. The nominal top W-beam rail height was 787 mm (31 in.) with a 632-mm (24 7/8-in.) center mounting height. The rail splices have been moved to the center of the span location, as shown in Figures 82 through 85. All lap-splice connections between the rail sections were configured to reduce vehicle snag at the splice during the crash test.

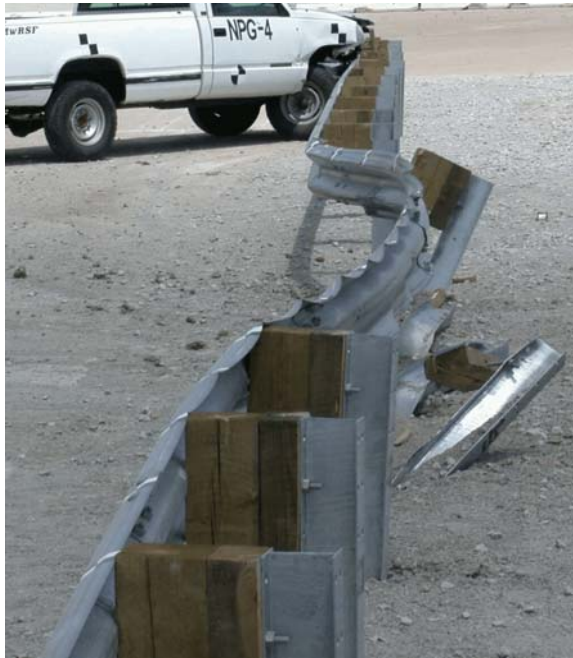
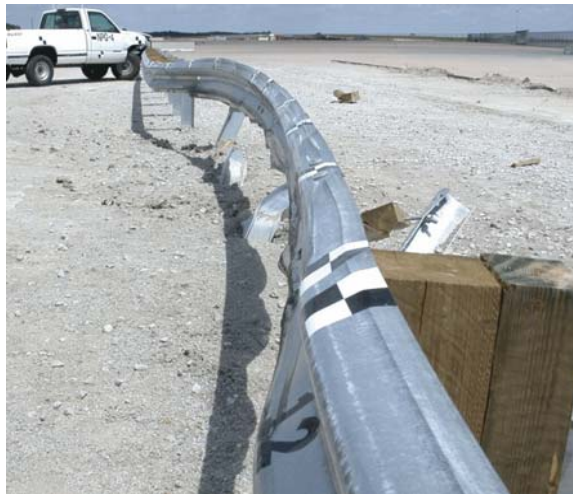
Figure 94. System Damage, Test NPG-4

Damage to the barrier was moderate, as shown in Figures 94 through 97. Barrier damage consisted of deformed W-beam and guardrail posts, contact marks on a guardrail section, and disengaged wooden blockouts.

The permanent set of the guardrail and posts is shown in Figures 94 and 95. The upstream and downstream cable anchor ends encountered slight permanent set deformations, as shown in

Figure 97. The maximum lateral permanent set barrier deflection was 652 mm (26 in.) at the midspan between post nos. 14 and 15, as determined from high-speed film analysis. The maximum lateral dynamic barrier deflection was 1,094 mm (43 in.) at the midspan between post nos. 14 and 15, as determined from the high-speed film analysis.

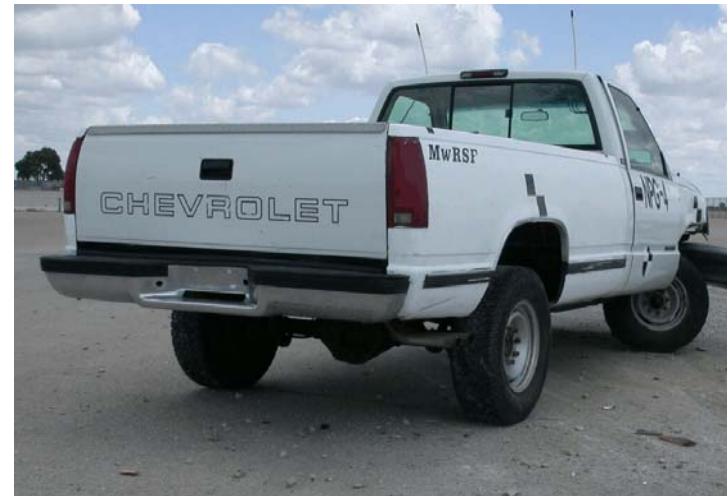
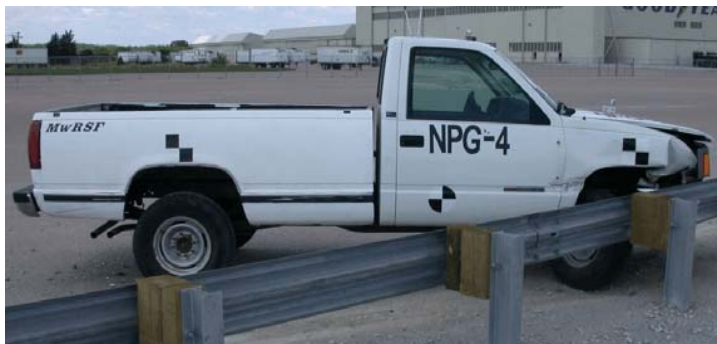
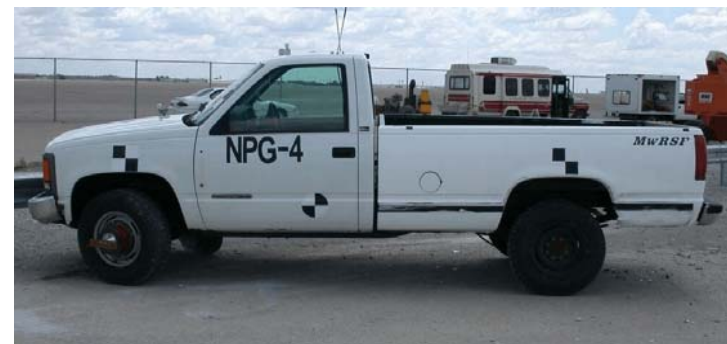
Figure 98. Vehicle Damage, Test NPG-4

Exterior vehicle damage was minimal, as shown in Figures 98 through 100. Occupant compartment deformation was negligible, as shown in Figure 100. Occupant compartment deformations and the corresponding locations are provided in Appendix D. The minor damage was concentrated on the right-front corner of the vehicle. The right-front quarter panel was crushed inward, and the right side of the front bumper was also bent back toward the engine compartment. The joint between the lower-front portion of the right-side door and the right-front quarter panel was crushed and deformed, but the door could be opened. The right-front wheel assembly was deformed slightly with disengagement of the tie rod which resulted in outward rotation of the right-front tire. The grill was broken and deformed around the right-side headlight assembly, and the right-side headlight was fractured. The windshield encountered minor cracks approximately 203-mm (8-in.) long. The roof, hood, left side, and rear of the vehicle, the rims and tires, and all window glass remained undamaged.

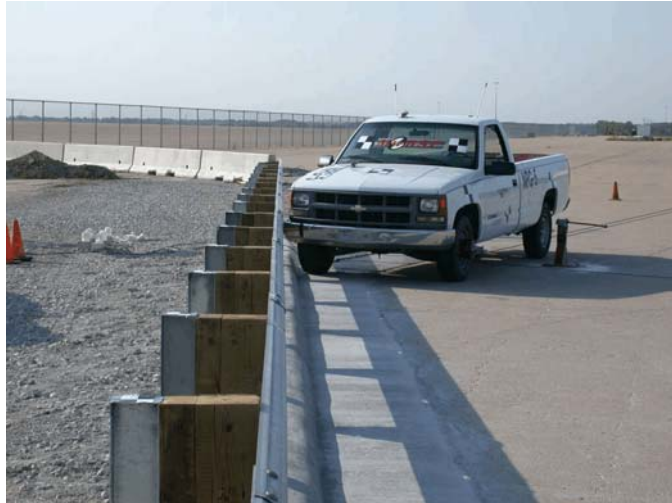
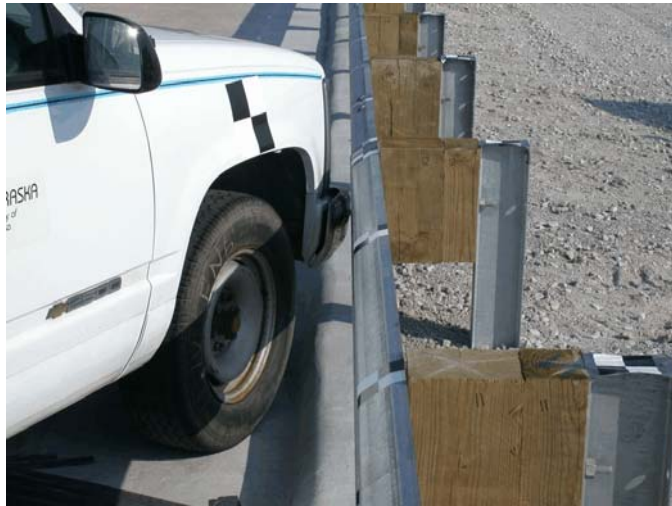
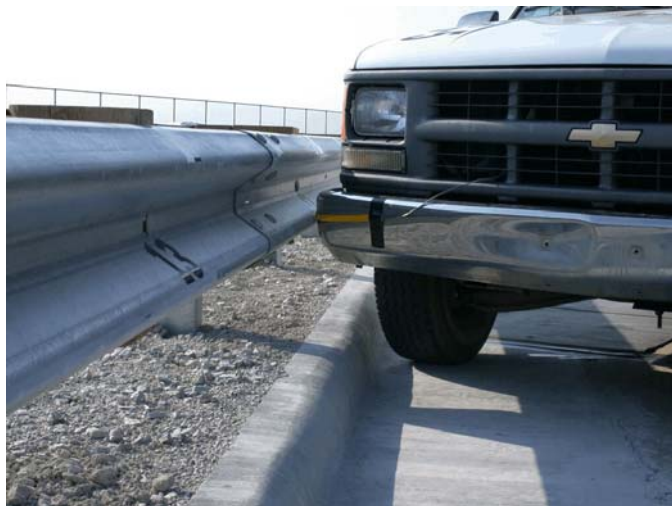
Figure 109. Impact Location, Test NPG-5

Initial impact was to occur between post nos. 12 and 13 or 4,597-mm (15-ft 1-in.) upstream from the centerline of the splice between post nos. 14 and 15, as shown in Figure 109. Actual vehicle impact occurred 4,547-mm (14-ft 11-in.) upstream from the centerline of the splice between post nos. 14 and 15. At 0.018 sec after impact, post no. 13 began to deflect. At 0.038 sec, the right-front corner of the vehicle crushed inward as the right-front tire became airborne. At 0.066 sec, the front of the vehicle was located at post no. 13 as post nos. 10 through 12 rotated backward. At 0.080 sec, the wooden blockout at post no. 13 disengaged from the system, and post no. 14 deflected. At this same time, the vehicle began to redirect as the right-front tire contacted the ground, and the hood’s left-side opened up. At 0.102 sec, post no. 14 rotated CCW. At 0.130 sec, the wooden blockout at post no. 14 disengaged from the system, post no. 14 continued to deflect, and post no. 15 rotated CCW. At this same time, the vehicle rolled CW away from the rail. At 0.151 sec, the right-front tire rolled up on top of post no. 14 which had previously bent over toward the ground. At 0.179 sec, the

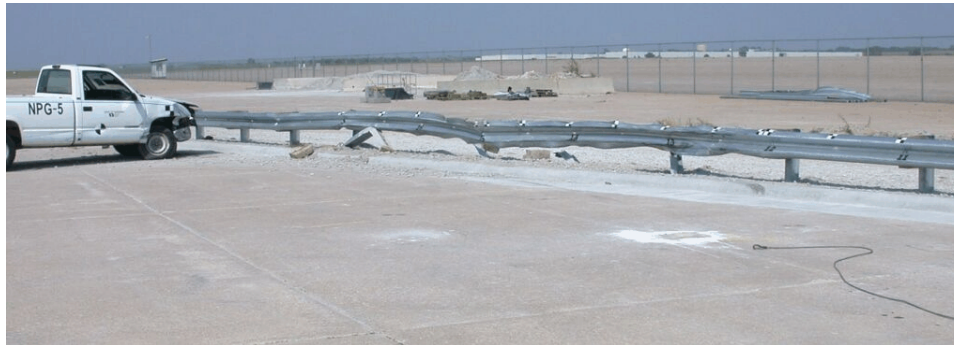
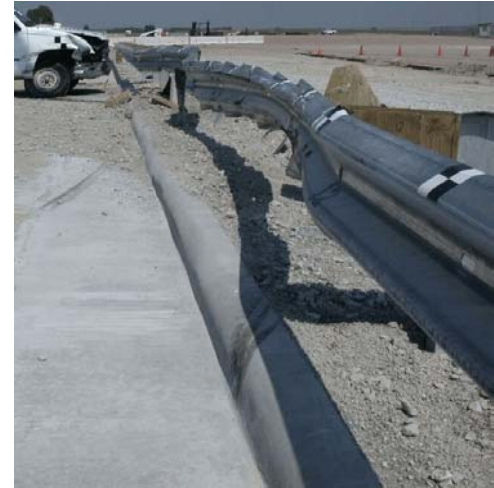
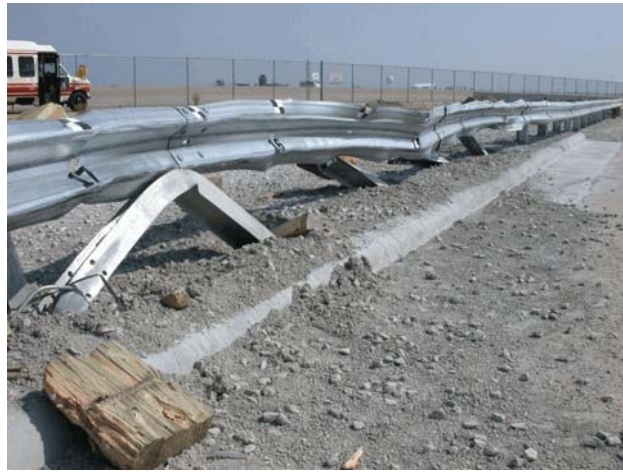
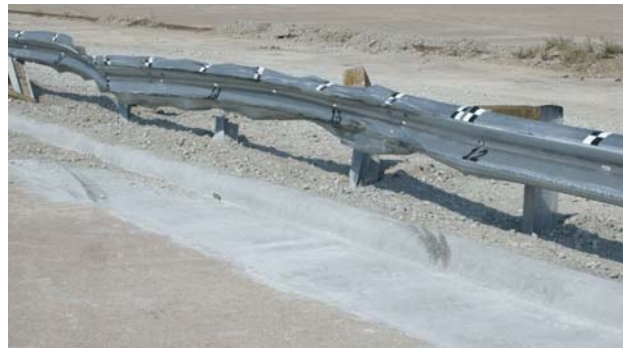
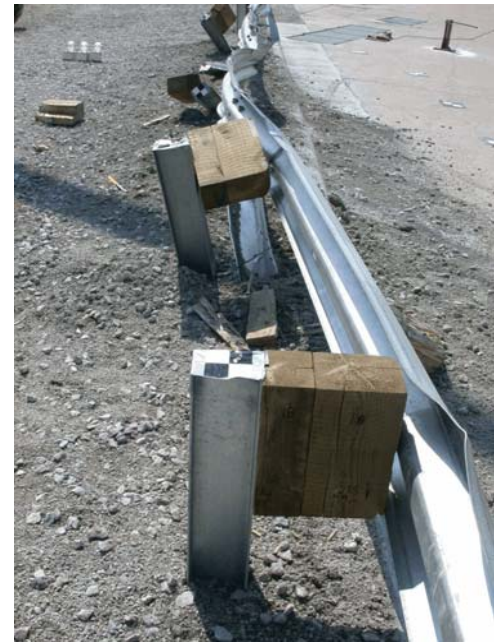
Figure 111. System Damage, Test NPG-5

Damage to the barrier was moderate, as shown in Figures 111 through 116. Barrier damage consisted of deformed W-beam and guardrail posts, an uprooted post, contact marks on a guardrail section and a curb section, and disengaged wooden blockouts. A 483-mm (19-in.) long black tire mark was found on the front and top faces of the curb beginning 76-mm (3-in.) upstream of post no.

The permanent set of the barrier system is shown in Figures 111 through 114. The upstream and downstream cable anchor ends encountered slight permanent set deformations, as shown in Figure 116. The maximum lateral permanent set post deflection was 611 mm (24 in.) at the centerline of post no. 13, as determined from high-speed film analysis. The maximum lateral dynamic rail and post deflections were 1,024 mm (40 in.) at the midspan between post nos. 14 and 15 and 611 mm (24 in.) at post no. 13, respectively, as determined from the high-speed film analysis.

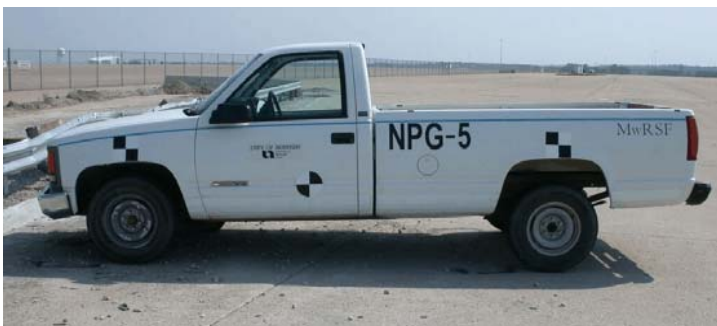
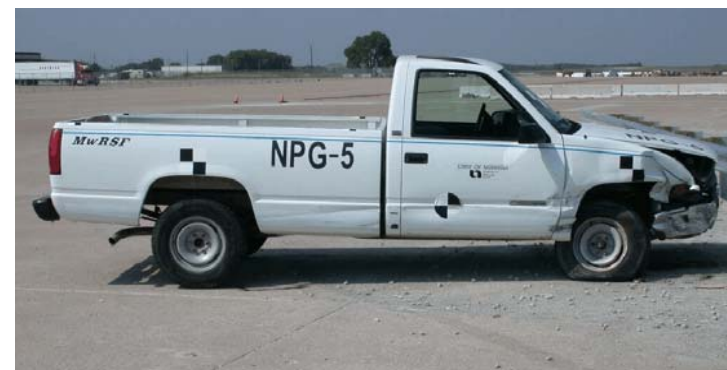
Figure 117. Vehicle Damage, Test NPG-5

Exterior vehicle damage was moderate, as shown in Figures 117 through 119. Occupant compartment deformations were negligible, as shown in Figure 119. Occupant compartment deformations and the corresponding locations are provided in Appendix D. Damage was concentrated on the right-front corner of the vehicle. The right-front quarter panel was crushed inward and downward. The right side of the front bumper was bent back toward the engine compartment. The joint between the lower-front portion of the right-side door and the right-front quarter panel was crushed and deformed. Light contact marks from vehicle-rail interlock were observed along the entire right side of the vehicle. The right side of the grill was fractured and deformed. The right-side headlight was fractured. The right-side wheel assembly's upper A-frame

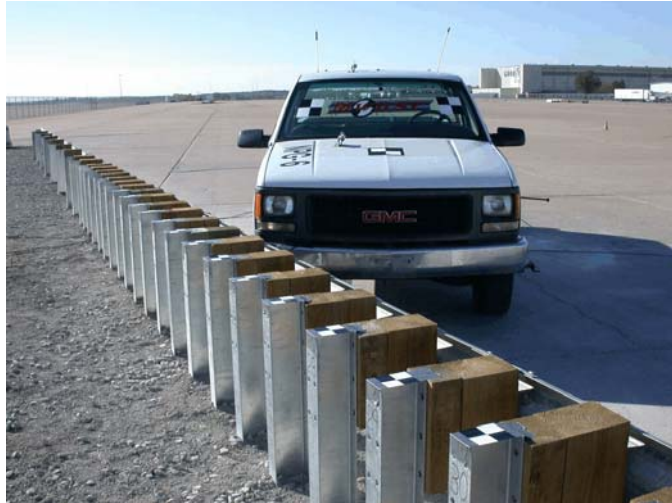
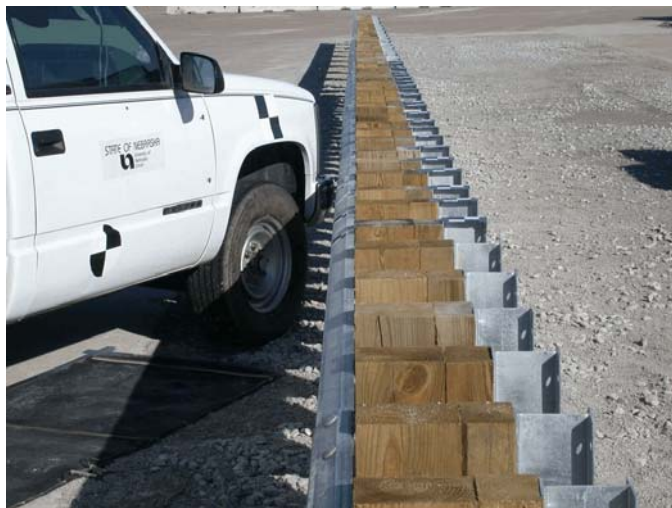
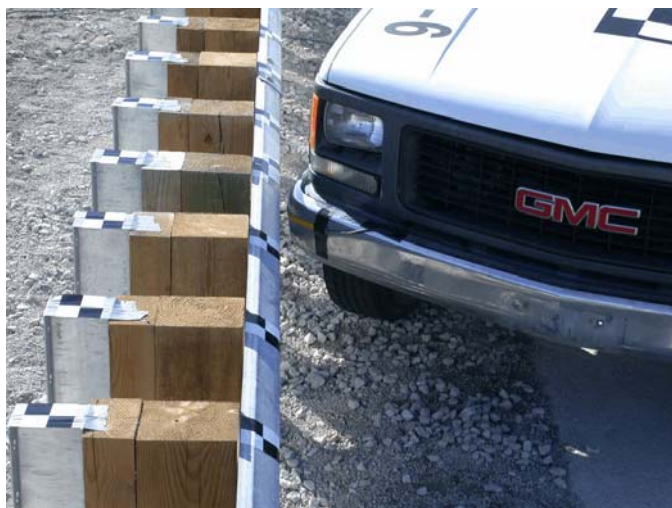
Figure 129. Impact Location, Test NPG-6

Initial impact was to occur between post nos. 22 and 23 or 2,920-mm (9-ft 7-in.) upstream from the centerline of post no. 29, as shown in Figure 129. Actual vehicle impact occurred 2,946-mm (9-ft 8-in.) upstream from the centerline of post no. 29 or 89-mm (3.5-in.) upstream from the center of post no. 23. At 0.020 sec after initial impact, the front of the vehicle was located at post no. 24. By this same time, post nos. 22 through 25 deflected. At 0.038 sec, the front of the vehicle was located at post no. 25. At this same time, the left side of the hood popped open as the right side was crushed inward. At 0.057 sec, the front of the vehicle was located at post no. 26, and post nos. 12 through 21 rotated CW. At this same time, the top of the right-side door jarred open. At 0.077 sec, the vehicle was located at post no. 27 and began to redirect. At this same time, post no. 26 deflected downstream. At 0.101 sec, the front of the vehicle was located at post no. 28 with the left-front tire rotated inward to approximately perpendicular to the rail. At this same time, post no. 31 began to deflect. At 0.123 sec, the front of the vehicle was located at post no. 29, and post nos. 32 and 33

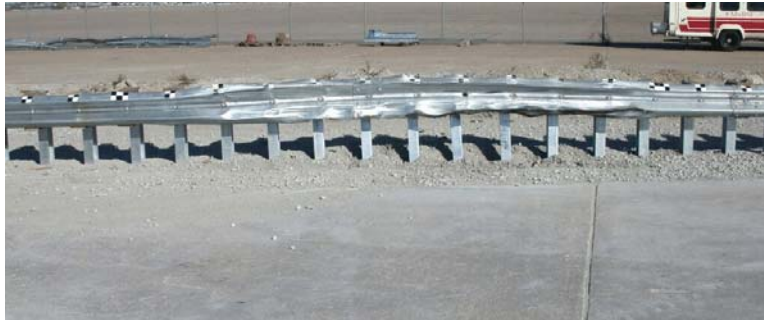
Figure 132. System Damage, Test NPG-6

Damage to the barrier was moderate, as shown in Figures 131 through 133. Barrier damage consisted of deformed W-beam and guardrail posts, contact marks on a guardrail section, and disengaged wooden blockouts. The guardrail damage consisted of moderate deformation, flattening, and buckling of the impacted section of W-beam rail between post nos. 23 and 34. Contact marks

were found on the guardrail between post nos. 22 and 34. The W-beam was pulled off of post no. 27. No significant guardrail damage occurred upstream of post no. 20 nor downstream of post no. 35, except for slight post movement of steel post no. 59 as well as to anchor post nos. 60 and 61 due to vehicle contact with the system before coming to rest.

Steel post nos. 21 through 34 rotated backward. Tire contact marks, 165-mm (6.5-in.) and 216-mm (8.5-in.) long, were found on the front faces of post nos. 25 and 26, respectively. Light contact marks were also found along the upstream side of the front face of post no. 27. The front face of the wooden blockout at post no. 25 was damaged above the rail line. The upstream edge of the wooden blockout at post no. 26 encountered major contact damage and subsequently split longitudinally. The corner between the upstream and front faces of the wooden blockout at post nos. 27, 28, and 31 encountered contact damage, but the damage on the blockout at post no. 31 was more extensive. The corner of the wooden blockout at post no. 32 was removed between the upstream and front faces.

The permanent set of the barrier system is shown in Figures 131 and 132. The maximum lateral permanent set rail and post deflections were 305 mm (12 in.) at the centerline of post no. 28 and 286 mm (11¼ in.) at post no. 27, respectively, as measured in the field. The maximum lateral dynamic rail and post deflections were 447 mm (17½ in.) at the centerline of post no. 27 and 424 mm (16 ⅝ in.) at post no. 28, respectively, as determined from the high-speed film analysis.

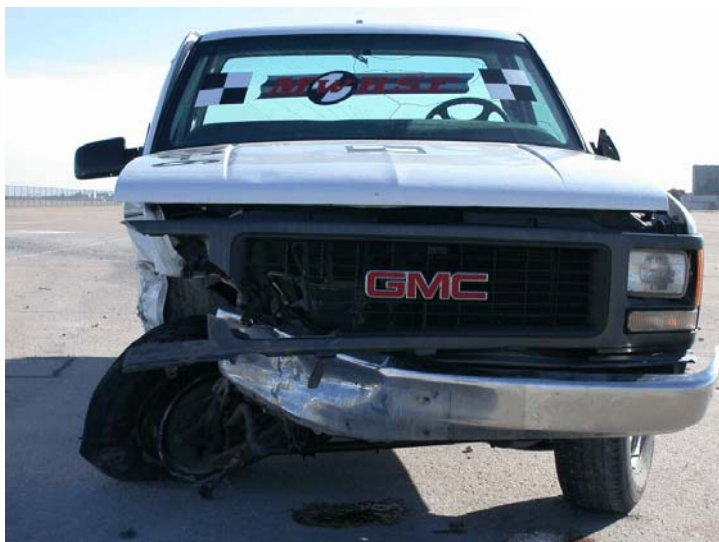
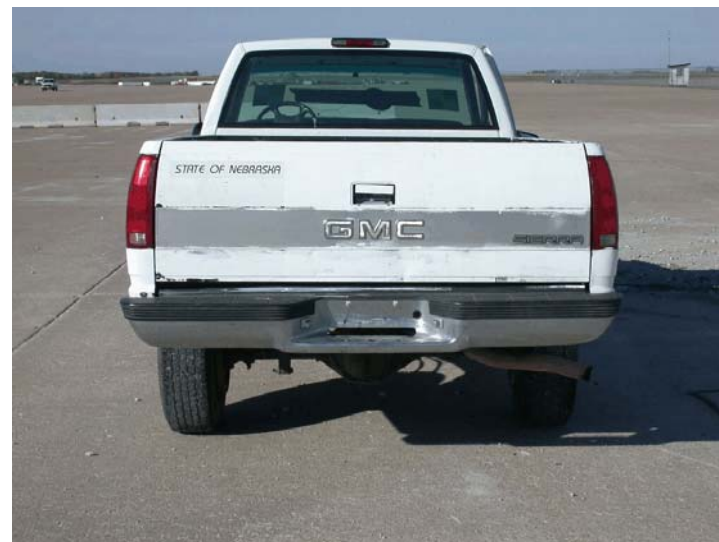
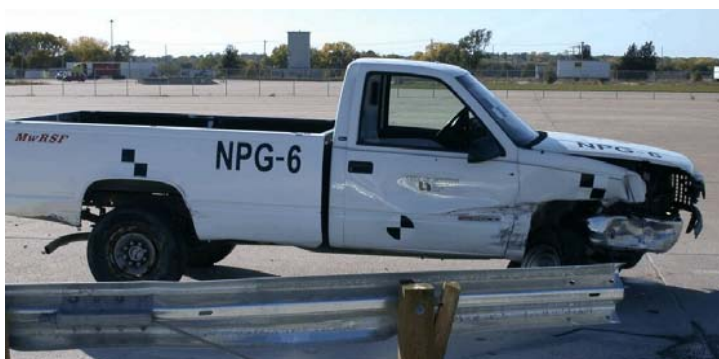
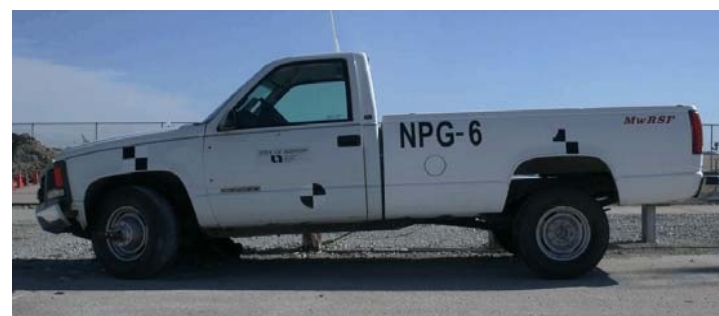
Figure 134. Vehicle Damage, Test NPG-6

Exterior vehicle damage was moderate, as shown in Figures 134 through 137. Damage was concentrated on the right-front corner of the vehicle and below the hood line. The right-front quarter panel and wheel well were crushed inward. The right side of the front bumper and bumper supports

were flattened and deformed and bent back toward the engine compartment. The front bumper also buckled at its centerline. The joint between the lower-front portion of the right-side door and the right-front quarter panel was crushed and deformed. The right side of the radiator was crushed inward. The right side of the plastic grill was fractured around the headlight region. Heavy wheel assembly damage occurred to the right-front tire, including disengagement of the outer tie rod, heavy rim damage and deformation into the lower frame rail, and tire removal from the rim. The left-front quarter panel also sustained a small buckle point near the front of the left-side door. The lower-right side of the truck's box was crushed inward. The right-rear steel rim also was deformed, and the tire's side wall was scuffed. The windshield encountered minor cracks. The roof, the hood, and the rear and side window glass remained undamaged.

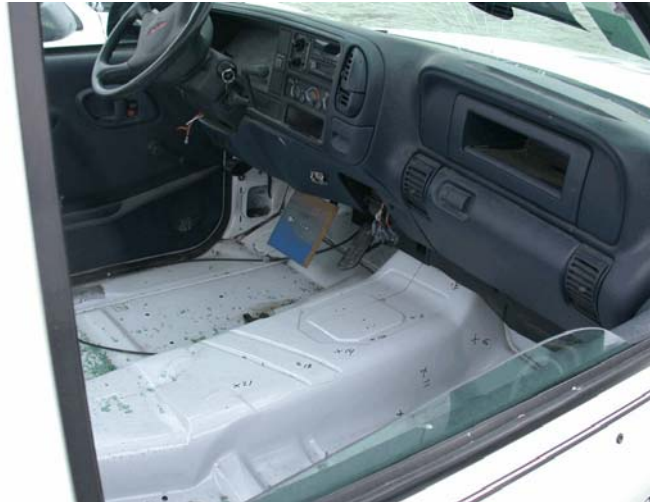
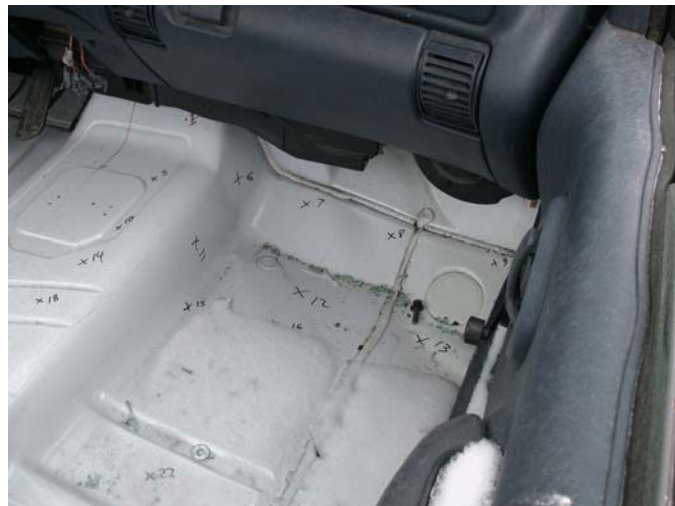
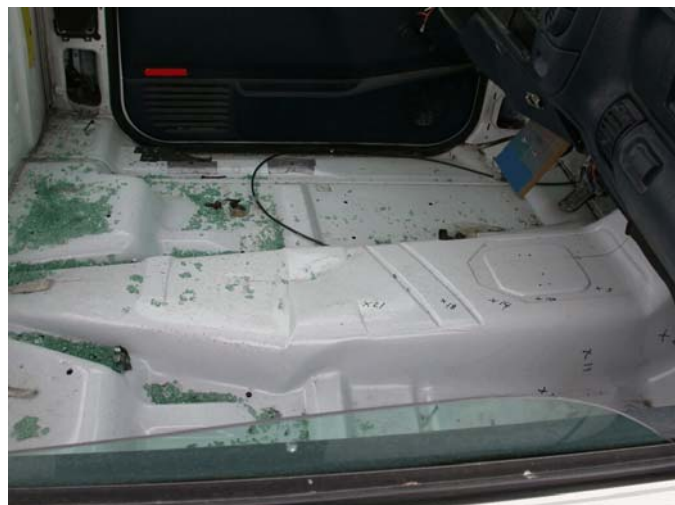
Figure 137. Occupant Compartment Damage, Test NPG-6

Minor occupant compartment deformations occurred with slight deformations to the right-side floorboard, as shown in Figure 137. Occupant compartment deformations and the corresponding locations are provided in Appendix D. A maximum vertical deflection of 44 mm (1.75 in.) was found near the firewall at the center of the right side. Maximum longitudinal and lateral deflections of the floor pan were measured as 44 mm (1.75 in.) and 13 mm (0.5 in.), respectively. Maximum dash deflection was found to be approximately 64 mm (2.5 in.).
