# **DEVELOPMENT OF THE *MIDWEST GUARDRAIL* SYSTEM (MGS) FOR STANDARD AND REDUCED POST SPACING AND IN COMBINATION WITH CURBS**

MwRSF Research Report No. TRP-03-139-04

September 1, 2004

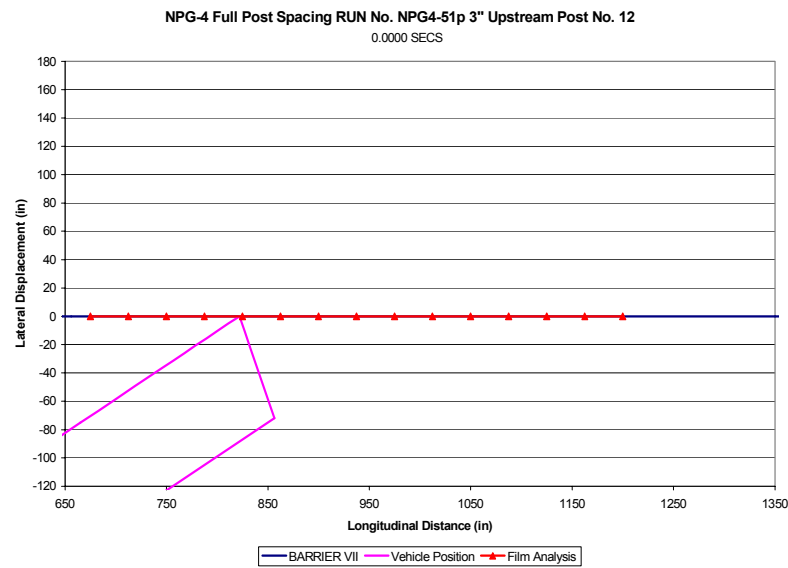
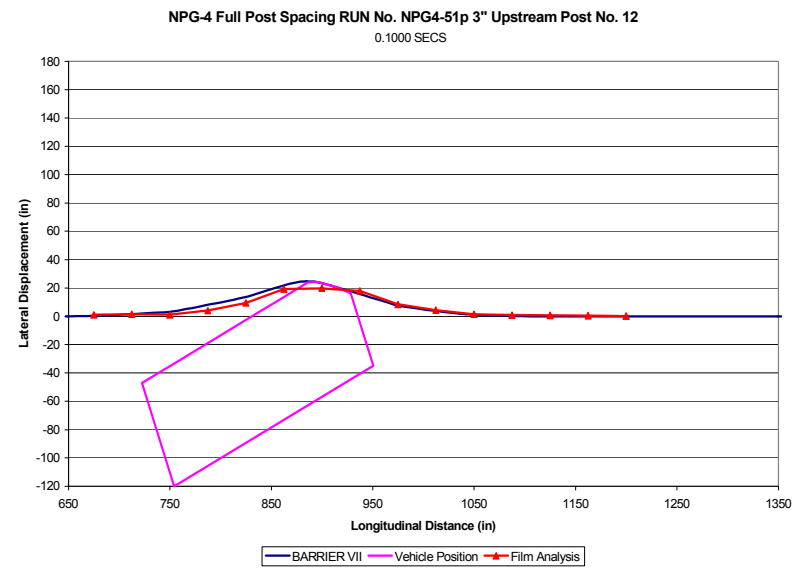
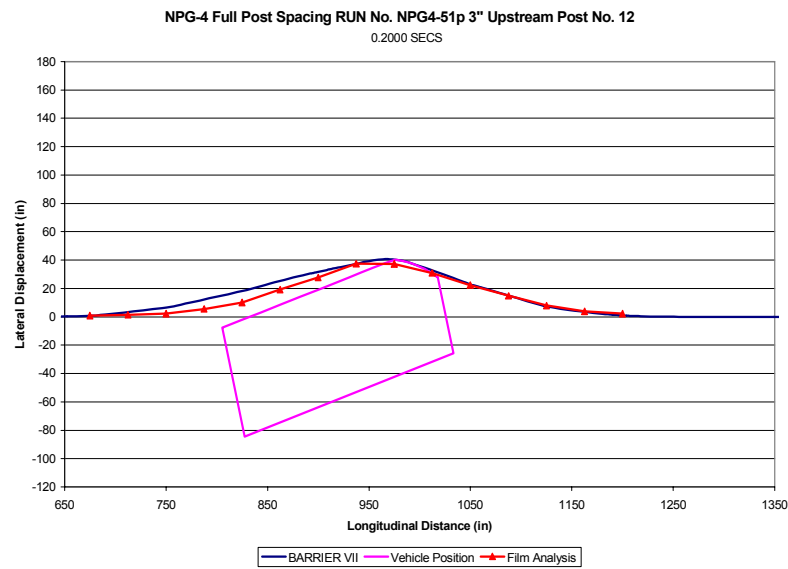
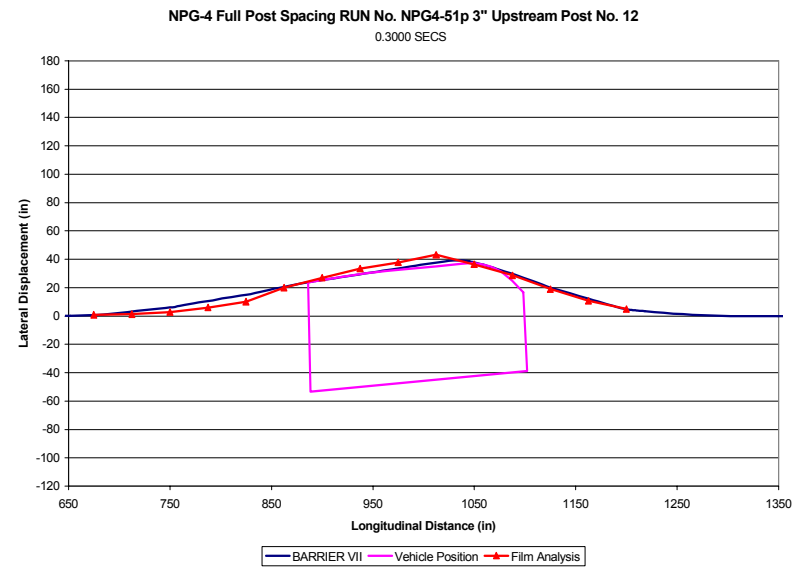
Figure 138. Sequential Figures from BARRIER VII Simulation of NPG-4

BARRIER VII had some difficulty fully reproducing the guardrail shape near the upstream end of the deformed region, as shown in Figures 138 through 140. However, it should be noted that during the actual test, the vehicle's rear end pitched upward and protruded over the rail during

redirection. Since BARRIER VII is limited to planar motion, it is unable to reproduce roll and pitch angular motions. Therefore, it would calculate vehicle tail slap into the barrier, thus potentially increasing the predicted barrier displacements in this region. Tabulated validation results for vehicle behavior, barrier displacements, and working width for test no. NPG-4 are shown in Table 5. From this effort, researchers determined that the final simulation accurately predicted barrier performance and vehicle behavior for the standard post spacing configuration.

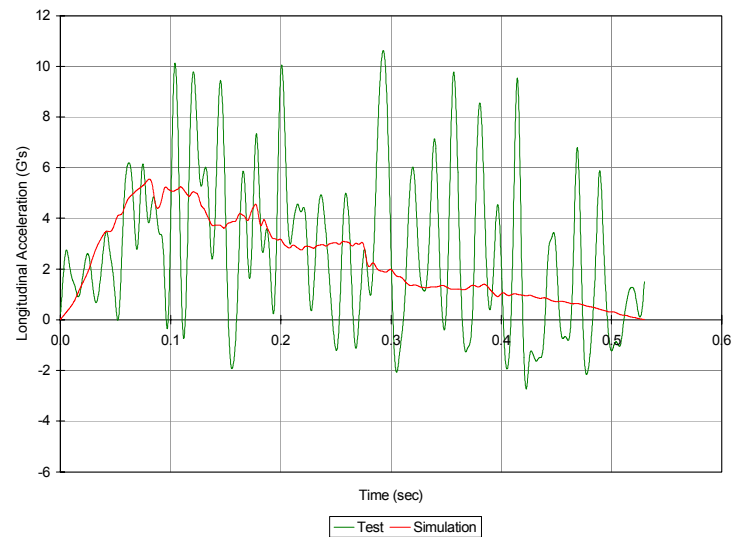
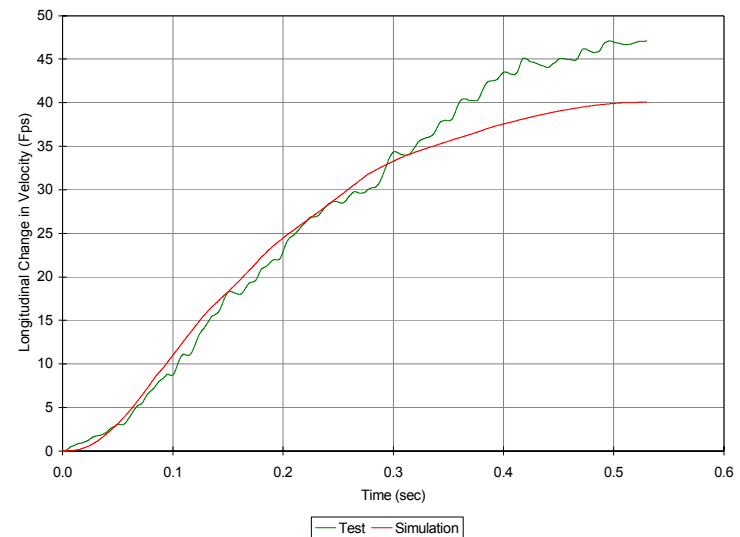
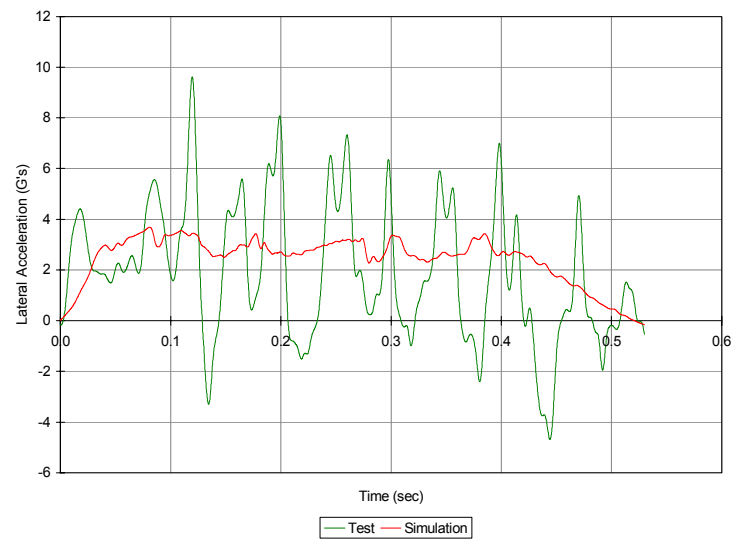
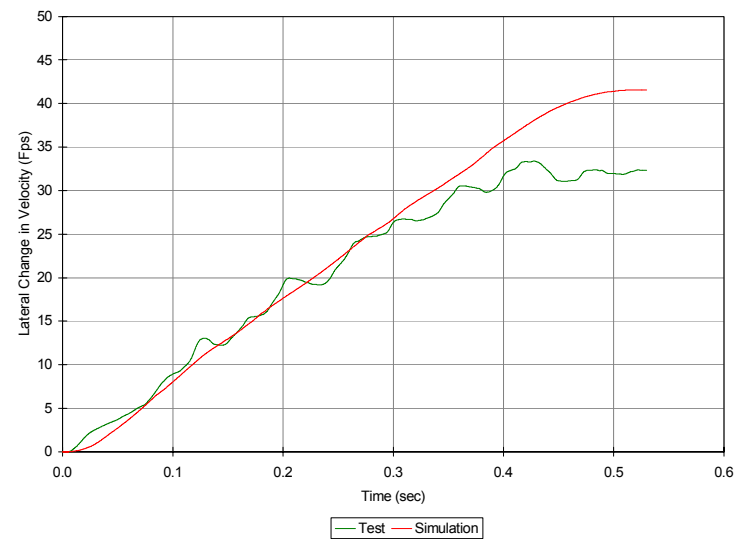
Figure 147. Comparison of Test and Simulation Results for Test NPG-4: (a) Longitudinal Direction and (b) Lateral Direction

In addition to the comparisons shown previously, researchers chose to compare the longitudinal and lateral accelerations as well as changes in the vehicle's velocity after the final NPG-4 and 6 validation runs were completed. Therefore, the same SAE filtering procedures outlined in NCHRP Report No. 350 were applied to the simulation data in order to obtain CFC 60 (100 Hz) vehicle accelerations and CFC 180 (300 Hz) changes in velocity and on data acquired with the same sample rate. The results of this comparison are shown in Figures 147 and 148. For the NPG-4 comparison, BARRIER VII generally predicted the acceleration trends but could not predict peaks. While peak accelerations could not be reproduced, changes in vehicle velocity were shown to be reasonably accurate through approximately 300 ms or close to the vehicle parallel condition. For

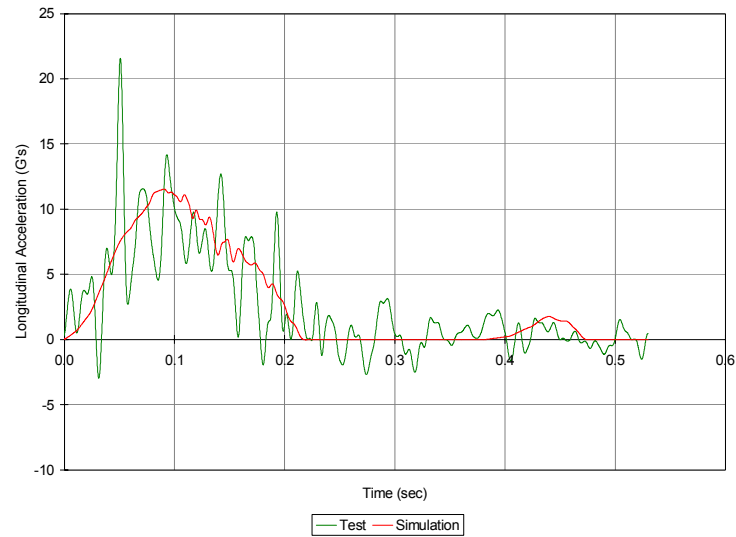
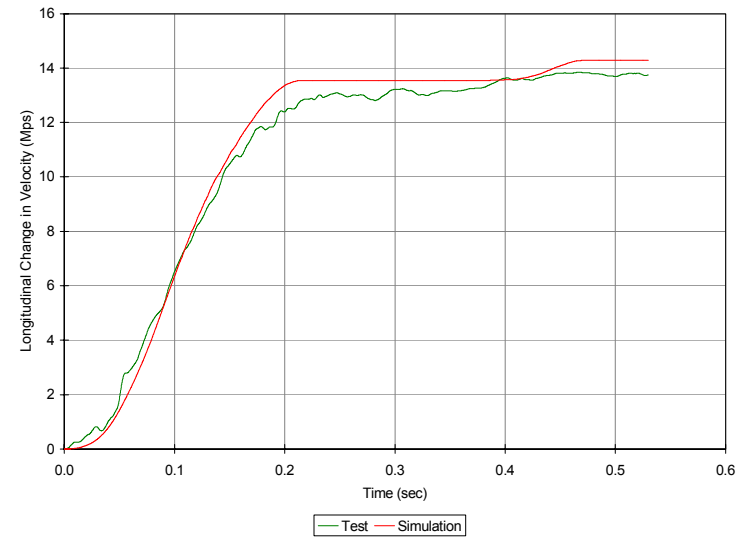
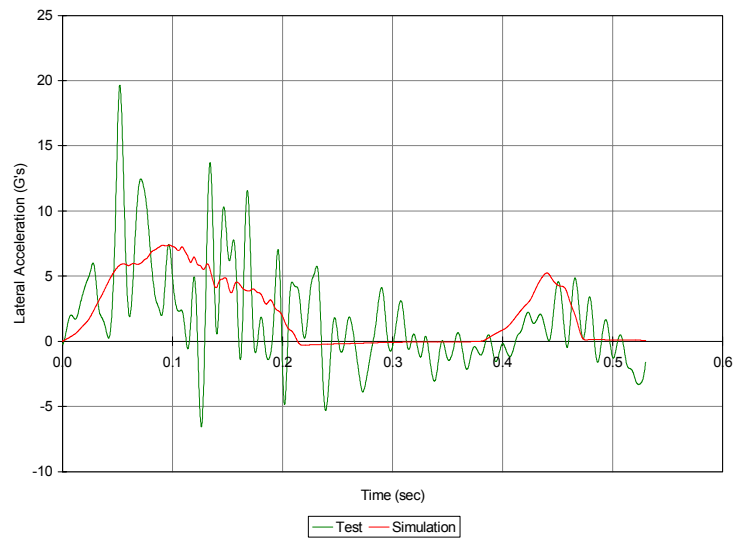
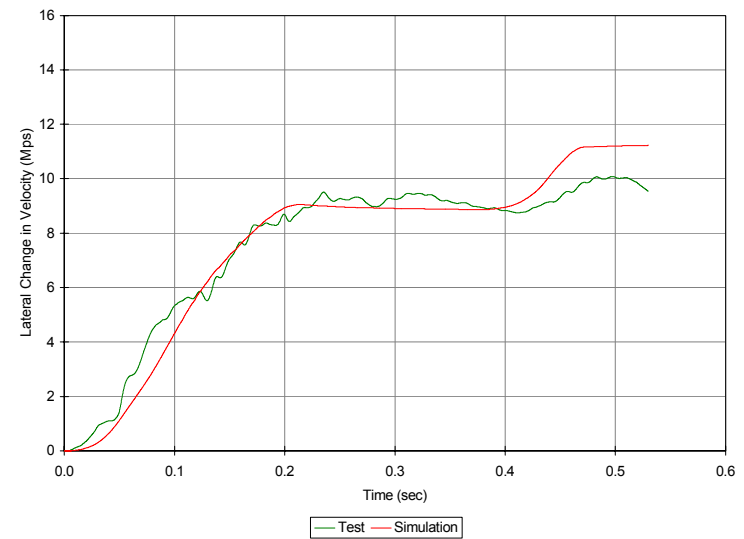
Figure 148. Comparison of Test and Simulation Results for Test NPG-6: (a) Longitudinal Direction and (b) Lateral Direction

the NPG-6 comparison, BARRIER VII more accurately predicted the acceleration trends than observed in the NPG-4 comparisons. However, it was once again incapable of predicting peak accelerations. More importantly though, BARRIER VII was very accurate in predicting vehicle changes in velocity for the stiffened barrier configuration.

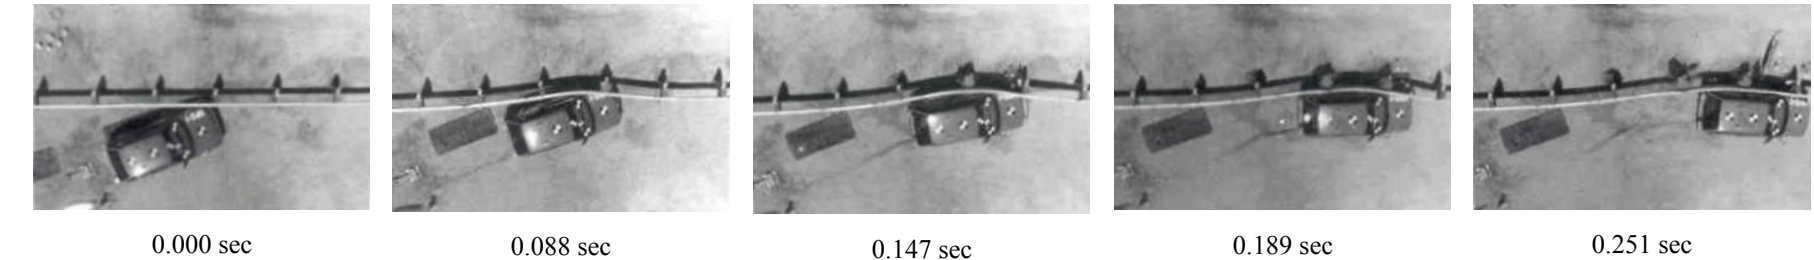
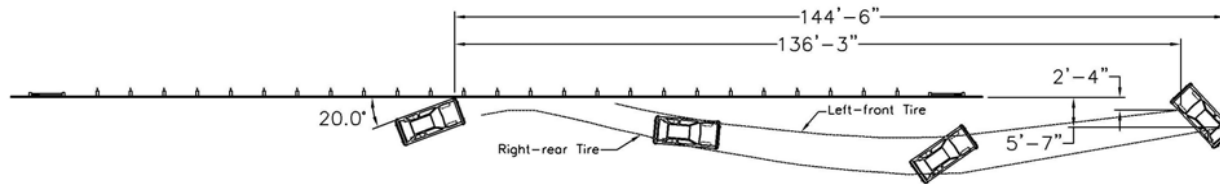
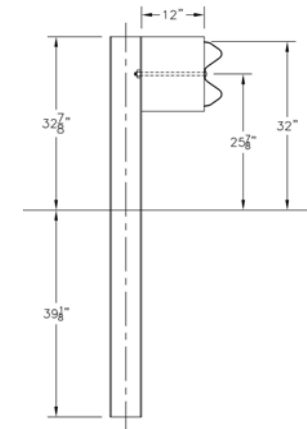
- Test Number . . . . . NPG-1
- Date . . . . . 6/29/01
- Appurtenance . . . . . *Midwest Guardrail System*
  - Key Elements . . . . . increased mounting height, blockout depth, and bolt slot length, mid-span splices

- Lateral (not required) . . . . . 18.63 ft/s
- Vehicle Damage . . . . . Moderate
  - TAD<sup>31</sup> . . . . . 11-LFQ-3
  - SAE<sup>32</sup> . . . . . 11LFEW3

- Vehicle Stopping Distance . . . . . 136 ft-3 in. downstream
  - 2 ft-4 in. traffic-side face
- Barrier Damage . . . . . Moderate
- Maximum Rail Deflections

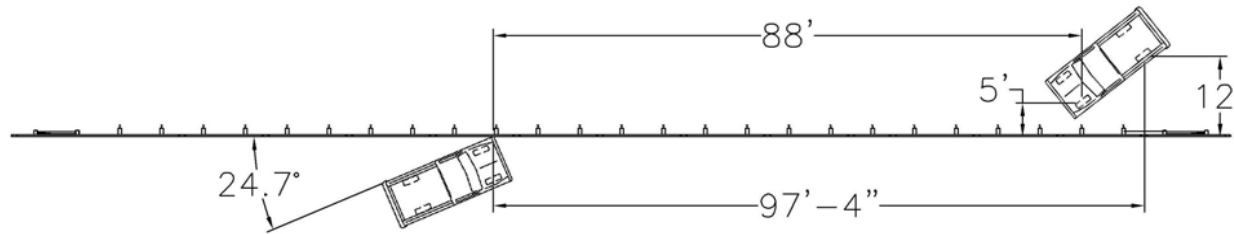
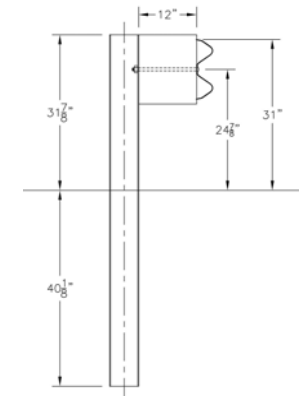
Figure A-2. Summary of Test Results and Sequential Photographs (English), Test NPG-2

- Test Number . . . . . NPG-2
- Date . . . . . 8/9/01
- Appurtenance . . . . . *Midwest Guardrail System*
  - Key Elements . . . . . increased mounting height, blockout depth, and bolt slot length, mid-span splices

- Vehicle Angle
  - Impact (trajectory) . . . . . 24.7 deg
  - Exit (trajectory) . . . . . NA
- Vehicle Stability . . . . . Unsatisfactory
- Occupant Ridedown Deceleration (10 msec avg.)
  - Longitudinal . . . . . 6.51 g's < 20 g's
  - Lateral (not required) . . . . . 8.19 g's
- Occupant Impact Velocity
  - Longitudinal . . . . . 16.33 ft/s < 39.37 ft/s
  - Lateral (not required) . . . . . 10.32 ft/s
- Vehicle Damage . . . . . Extensive
  - TAD<sup>31</sup> . . . . . 11-FFQ-3, L&T-4
  - SAE<sup>32</sup> . . . . . 11LFEW3, 00TDDO6
- Vehicle Stopping Distance . . . . . 88 ft downstream
  - 5 ft laterally behind
- Barrier Damage . . . . . Extensive
- Maximum Deflections
  - Permanent Set . . . . . NA
  - Dynamic . . . . . NA
- Working Width . . . . . NA

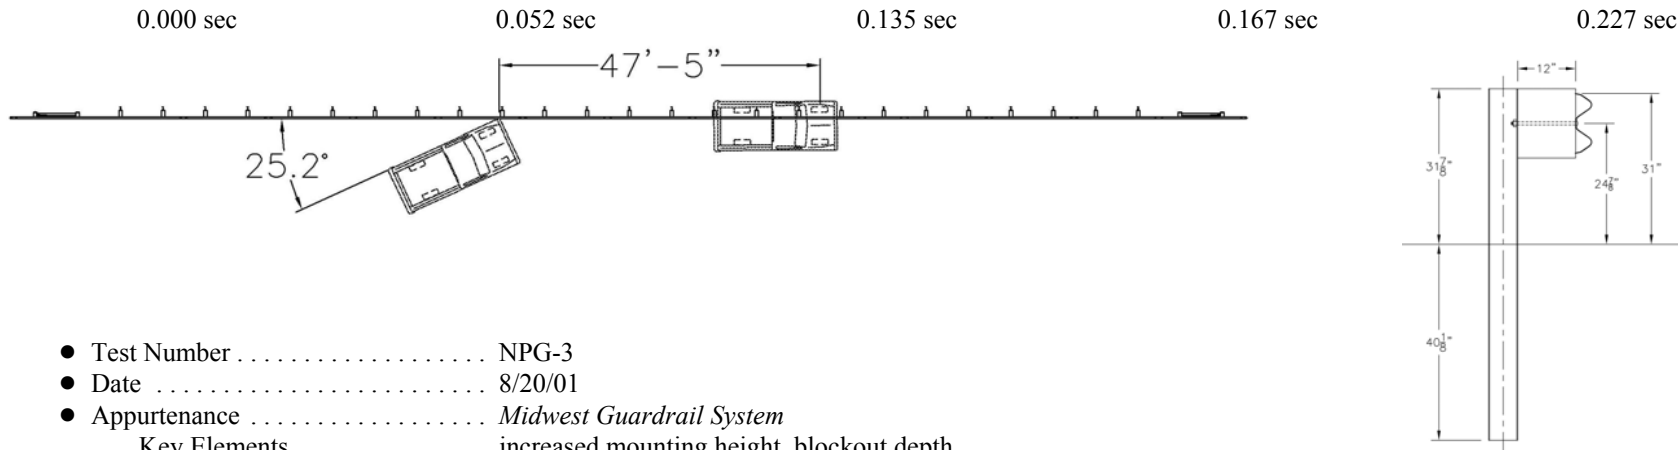
Figure A-3. Summary of Test Results and Sequential Photographs (English), Test NPG-3

- Test Number . . . . . NPG-3
- Date . . . . . 8/20/01
- Appurtenance . . . . . *Midwest Guardrail System*
  - Key Elements . . . . . increased mounting height, blockout depth, and bolt slot length, mid-span splices

- Lateral (not required) . . . . . 11.97 ft/s
- Vehicle Damage . . . . . Minimal
  - TAD<sup>31</sup> . . . . . 11-LFQ-4, 11-FL-3
  - SAE<sup>32</sup> . . . . . 11LFEW4

- Vehicle Stopping Distance . . . . . 47 ft-5 in. downstream
  - 0 m lateral
- Barrier Damage . . . . . Moderate
- Maximum Deflections
  - Permanent Set . . . . . NA

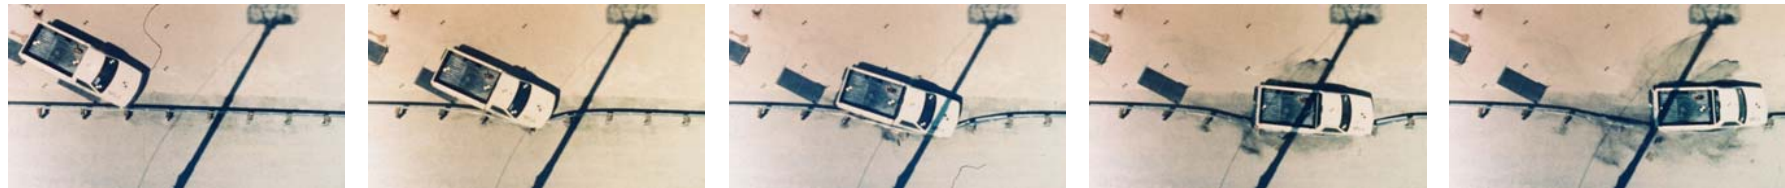
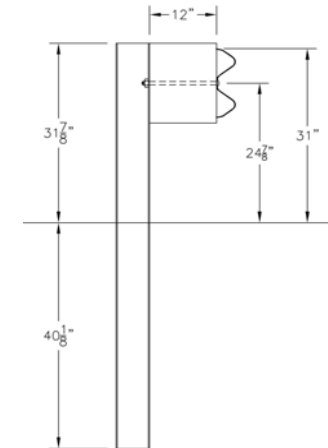
Figure A-4. Summary of Test Results and Sequential Photographs (English), Test NPG-4

- Test Number . . . . . NPG-4
- Date . . . . . 6/14/02
- Appurtenance . . . . . *Midwest Guardrail System*
  - Key Elements . . . . . increased mounting height, blockout depth and foundation tube length, mid-span splices

- Occupant Impact Velocity
  - Longitudinal . . . . . 18.32 ft/s < 39.37 ft/s
  - Lateral (not required) . . . . . 12.78 ft/s
- Vehicle Damage . . . . . Minimal

- Barrier Damage . . . . . Moderate
- Maximum Deflections
  - Permanent Set . . . . . 26 in.
  - Dynamic . . . . . 43 in.
- Working Width . . . . . 49 5/8 in.
