JRC2011-56132

CRASHWORTHINESS ANALYSIS OF THE JANUARY 26, 2005 GLENDALE, CALIFORNIA RAIL COLLISION

Daniel Parent
David Tyrell
Karina Jacobsen
Kristine Severson
Volpe National Transportation Systems Center
United States Department of Transportation
Cambridge, Massachusetts, USA

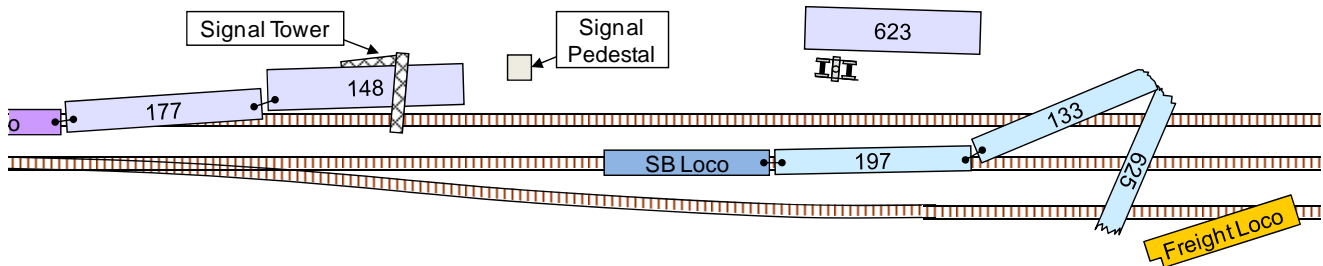
As with car 148, the penetration into the side sill stops at the body bolster of car 623, suggesting that the car was pushed off of the track at this point. Car 623 then rotated completely onto its side and slid down the right-of-way. In the process, its lead truck detached and landed upright. The final resting position of the rail vehicles is shown in schematic in Fig. 6.

Fig. 6. FINAL RESTING POSITION OF THE EQUIPMENT IN THE GLENDALE, CA RAIL COLLISION

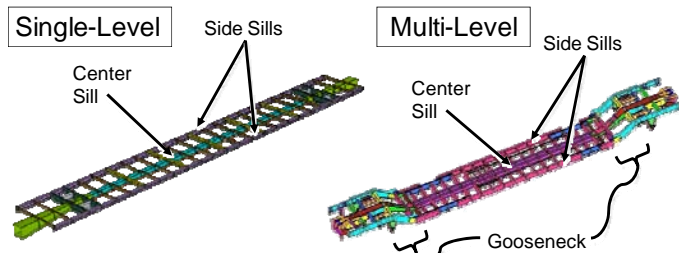
The location that experienced the greatest amount of structural deformation was the front end of the cab car (625) of the southbound train. Unlike typical single-level passenger cars which have a continuous horizontal center sill that spans the entire length of the vehicle, the center sill of the multi-level cars in the METROLINK fleet is raised at either end and lowered inboard of the body bolsters (Fig. 8). The transition area between the two levels is referred to as the gooseneck. When loaded in compression, the offset nature of the distal ends of the structure creates a moment at the gooseneck, thus a plastic hinge can form at one of these transition areas and can result in gross structural deformation. Such deformation has occurred in previous collisions, such as the Placentia, California rail collision that occurred in April 2002 [3, 7].

Fig. 8. COMPARISON OF SINGLE-LEVEL AND MULTI-LEVEL CAR BODY STRUCTURES

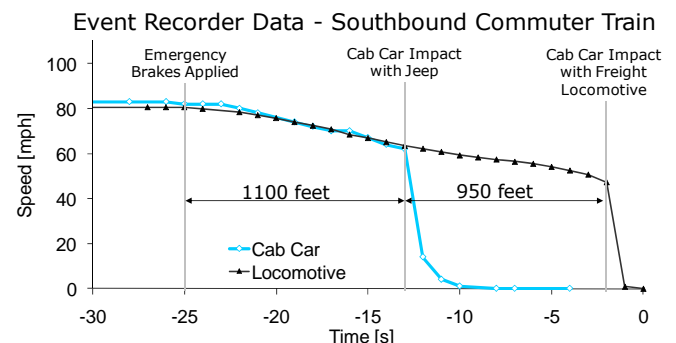
Fig. 14 shows a velocity-time history of the cab car and locomotive in the southbound passenger train. The train was traveling just above 80 miles per hour when the conductor spotted the SUV on the track, at which point the emergency brakes were applied. During the impact with the SUV, it appears that the lead axle of the cab car (the typical location of velocity measurement) stopped spinning, as the velocity drops abruptly. According to the event recorder data, the locomotive then continued at a mostly constant deceleration of 1.5 miles per hour per second until the cab car impacted the freight locomotive. At this point, the speed reported by the southbound locomotive dropped from 47.3 miles per hour to 0.9 miles per hour in one second, which would have required a deceleration of 2.1 times the acceleration due to gravity. However, it is possible that this change in speed occurred over a smaller time interval than the one second sample time of the event recorder, thus the deceleration of 2.1g is a lower bound on the severity of the occupant environment. As a point of comparison, an 8g peak deceleration pulse is used in the standard for the development of seats for commuter rail service.

Fig. 14. SPEED-TIME HISTORY OF THE LEAD CAB CAR AND TRAILING LOCOMOTIVE IN THE SOUTHBOUND PASSENGER CONSIST

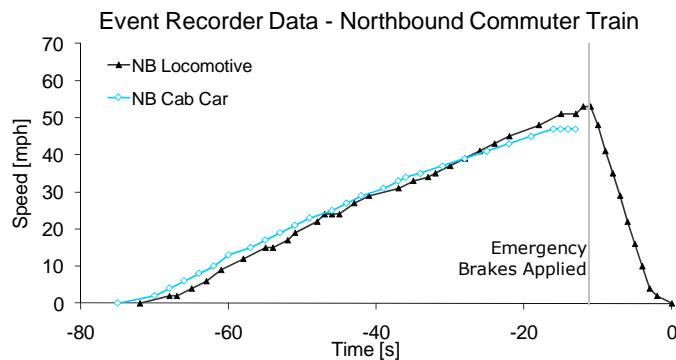
In the northbound passenger train, the longitudinal acceleration pulse was less severe than in the southbound train. According to the event recorder in the northbound locomotive (Fig. 15), the forward cars in the consist that remained coupled stopped from around 53 miles per hour in roughly 11 seconds, an average deceleration of 5 miles per hour per second or about one quarter of the acceleration due to gravity. This level of deceleration is slightly more severe than emergency braking

The trailing cab car in the northbound commuter train, which decoupled during the interaction with the southbound train, stopped more abruptly than the cars that remained coupled. Unfortunately, data from the event recorder are unavailable after the time of impact. The coupled cars continued two car lengths, or about 160 feet, farther than the trailing cab car. This accounts for roughly one half of the distance traveled by the northbound train after the impact. Therefore, the deceleration of the trailing cab car is likely to have been twice as high as that of the cars that remained coupled to the locomotive, which is still relatively low compared to the acceleration due to gravity.

Fig. 15. SPEED-TIME HISTORY OF THE LEAD LOCOMOTIVE AND TRAILING CAB CAR OF THE NORTHBOUND PASSENGER TRAIN
