**JRC2011-56077**

## **FUEL TANK CRASHWORTHINESS: LOADING SCENARIOS**

Volpe National Transportation Systems Center  
US Department of Transportation  
Cambridge, MA 02142  
[www.volpe.dot.gov](http://www.volpe.dot.gov)

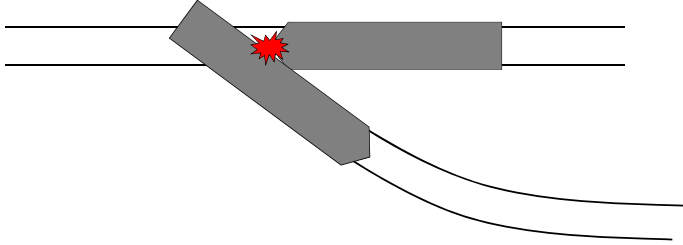
**Figure 8. Schematic drawing, oblique impact between two rail vehicles.**

Fuel tanks are typically attached to the underframe of a locomotive or DMU and span nearly the full width of the car to optimize space. This presents a situation in which the side of the tank is exposed in oblique collisions. An oblique collision between two trains or rail vehicles can challenge fuel tanks with a blunt impact and/or raking impact. Figure 8 shows a schematic illustration of rail equipment on intersecting tracks.

The schematic illustrates how the orientation of the equipment may create a raking collision between equipment. The following example collisions in Fullerton, California and Silver Spring, Maryland, highlight this scenario and consequences of fuel tank rupture.

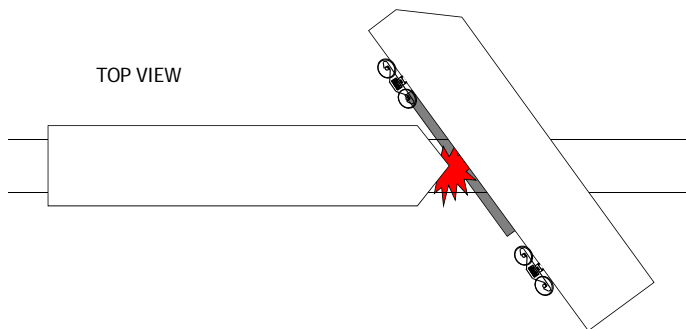
**Figure 11. Schematic drawing, car-to-car impact, with one car overturned**

Under severe collision conditions, train dynamics behavior may include large amplitude zigzag-pattern buckling of the trainset and rollover of individual cars. As a lateral buckle progresses through a trainset, individual cars may become decoupled, potentially overturning and beginning to pile up, and impacting into the sides of each other. If rollover of individual cars occurs, the underside of the car, and as such, the bottom of fuel tanks, is exposed to impacts from adjacent cars. Figure 11 shows a schematic illustration of an overturned car being struck by another rail vehicle. In these types of impacts, the fuel tank is subject to an impact by a coupler or similarly blunt component of the impacting piece of equipment. Numerous accidents can be identified and three are described in this paper, in which one or multiple trainsets have demonstrated this collision mode and fuel tanks have been challenged and compromised. In these cases, which fuel spills, and cars piled up in close proximity, the risk of fire may pose a higher threat to passengers and crew. The passengers are at greater risk, particularly when cars are overturned and emergency egress a more complex and lengthy process.

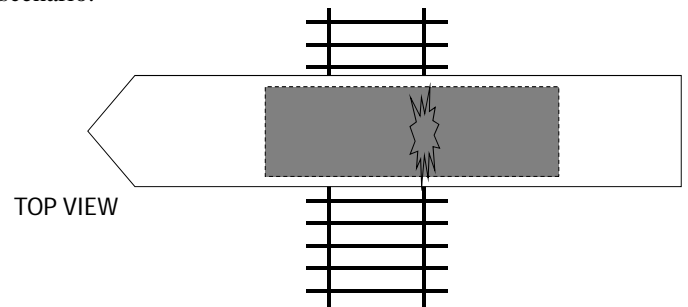
Figure 18. Schematic drawing showing a piece of equipment straddling the rails with the weight of the vehicle supported by the fuel tank.

In the event of a derailment or collision event in which the equipment leaves the tracks, it is possible for the equipment to come to rest with the underside of the equipment resting on one or both rails. Figure 18 shows a schematic illustration of a piece of equipment resting perpendicular to the original direction of travel, straddling the tracks. Because the rails and tie structure is typically raised off of the ground, the piece of equipment would be suspended off of the ground and resting entirely on the rail or rails. The following example collision in Bradford, Illinois shows a conventional freight locomotive that may have sustained a rupture from this type of loading scenario.
