**Federal Railroad  
Administration**

## **Collision of Amtrak Passenger Train and Norfolk Southern Freight Train—November 30, 2007, Chicago, Illinois**

| 1. AGENCY USE ONLY (Leave blank) | | 2. REPORT DATE<br>October 2013 | | 3. REPORT TYPE AND DATES COVERED<br>Final Report |
| 6. AUTHOR(S)<br>Patricia G. Llana, David Tyrell, Karina Jacobsen | | | | |

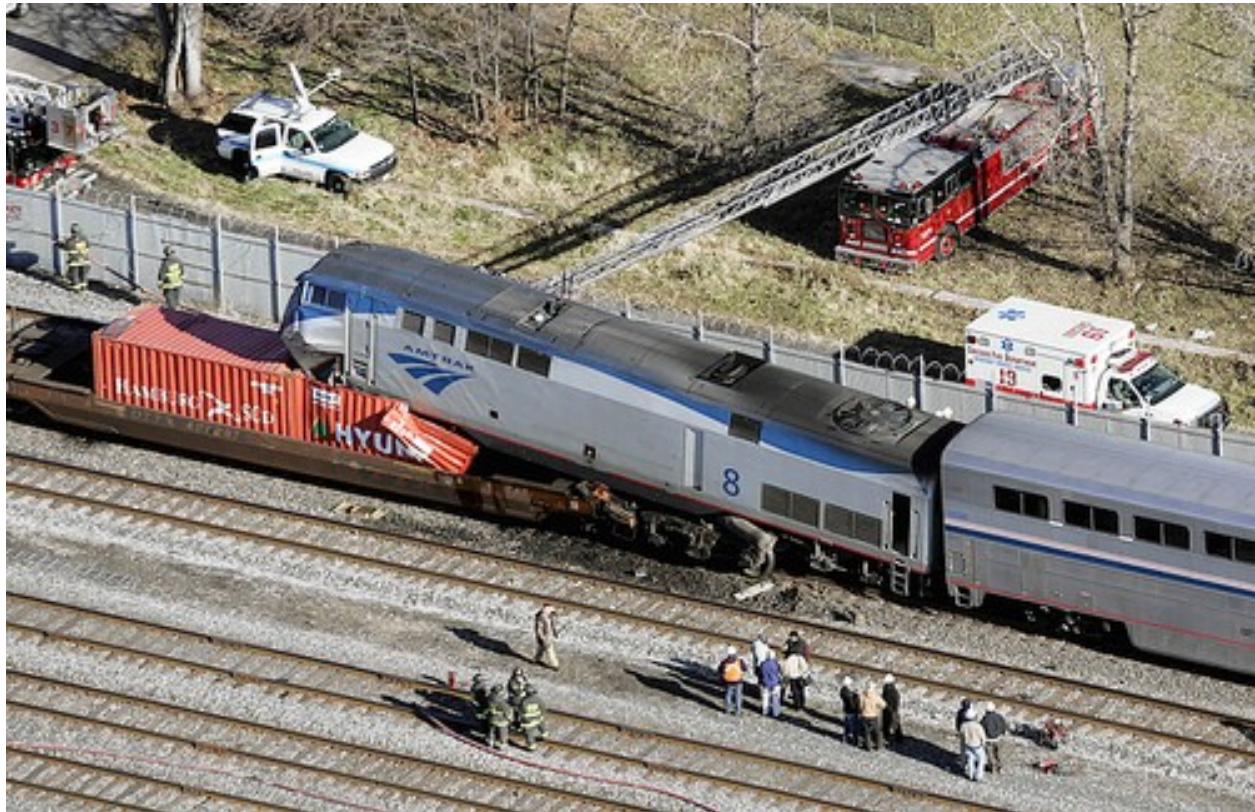
**Figure 3. Aerial photograph of accident [4].**

Figure 3 is an aerial photograph of the accident shortly after it occurred. On the left side, the photograph shows the end unit of the three-unit articulated car. Approximately half the length of the rear intermodal container is crushed. The passenger locomotive is resting on top of the intermodal container and the well car. The lead truck of the locomotive is detached from the body of the locomotive, derailed, and adjacent to the trailing truck. The end of the first passenger car can be seen on the right side of the photograph, with no visible structural damage.

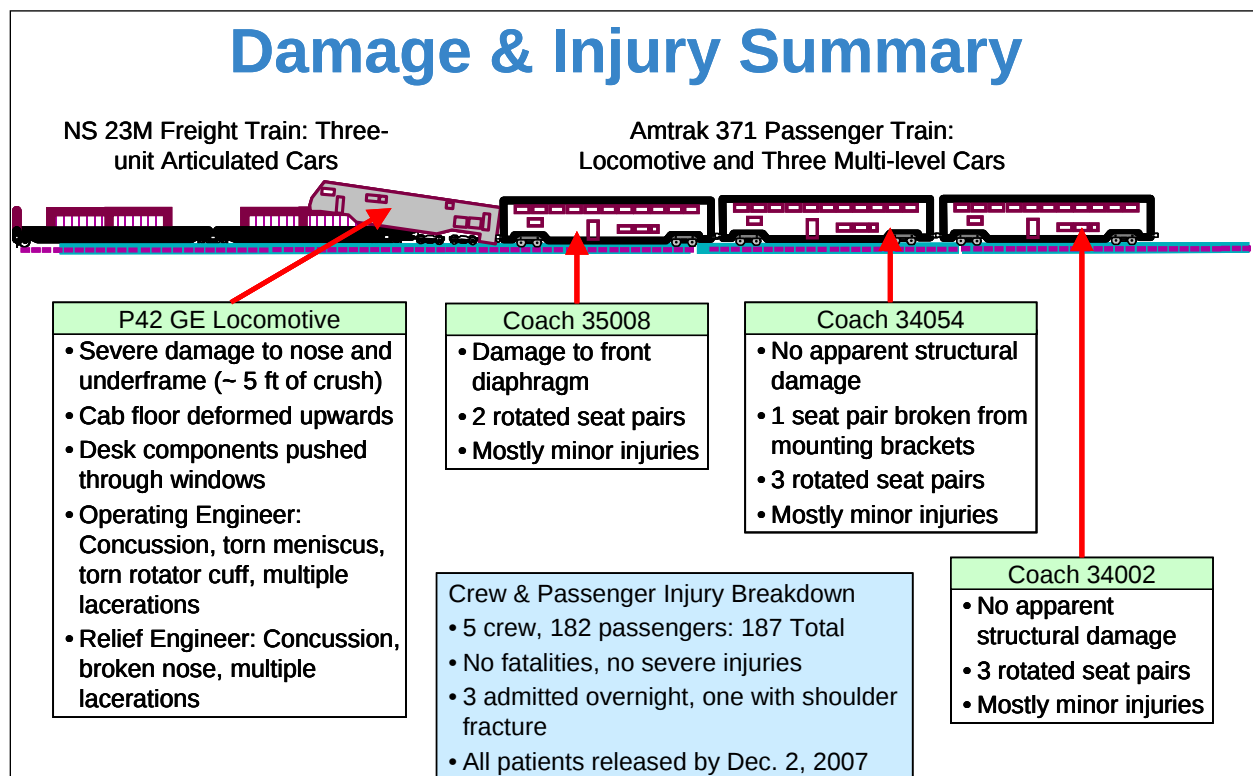
**Figure 4. Damage and injury summary.**

Figure 4 shows a sketch of the post-accident layout of the two trains and provides a summary of the damage and injuries for each of the cars in the passenger train and the last freight car. There were no fatalities caused by the accident and only minor injuries were incurred by the passengers and crew. However, the engineers located in the operator's cab at the time of impact sustained more severe injuries than the passengers and crew located in the coach cars. This was a result of the locomotive sustaining most of the exterior and interior structural damage and bearing the brunt of the impact, creating an almost life-threatening situation within the cab. In addition, the damage incurred by the locomotive cab was such that the crew could not exit and had to be helped out by emergency responders. The crew of the freight train in the accident that occurred on September 12, 2008, [5] in Chatsworth, California, found themselves in similarly situated; they could not exit their cab without help from the emergency responders.

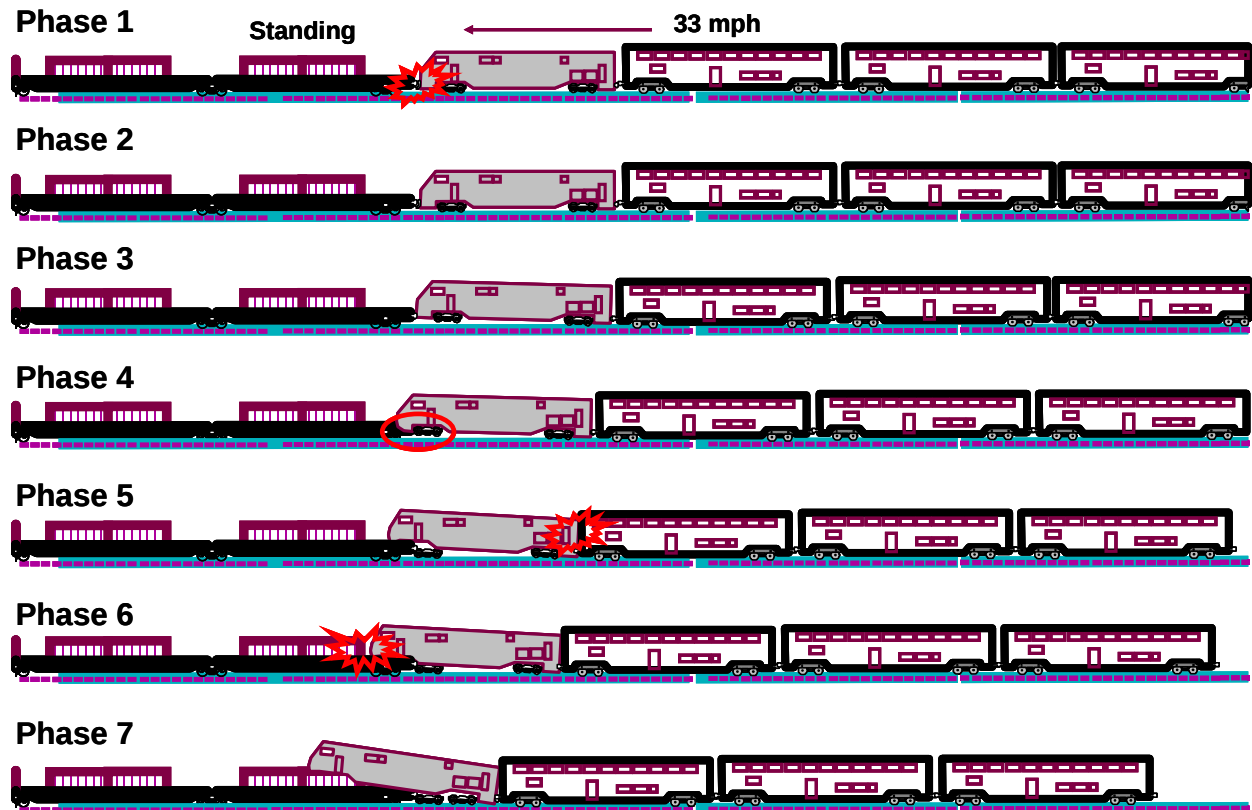
**Figure 5. Phases of the collision.**

- Phase 1: Contact of the couplers;
- Phase 2: Locomotive and freight car couplers moved back, both draft gears bottomed out;
- Phase 3: Locomotive coupler carrier failed, locomotive began to climb rear of freight car;
- Phase 4: Locomotive draft gear housing pushed back and up, locomotive lead truck engaged freight car;
- Phase 5: Locomotive striker engaged freight car bolster, locomotive lead truck sheared off, rear roof of locomotive engaged lead passenger car collision posts;
- Phase 6: Locomotive striker engaged the rear container, locomotive wheel cut fuel tank, locomotive lead truck pushed under locomotive;
- Phase 7: Locomotive crushed two containers and passenger train came to a stop.

As a result of the accident, the passenger locomotive overrode the freight car. The end of the locomotive, including the engineer's cab, was significantly crushed. There remained just enough space for the two locomotive engineers to ride out the collision. What typically occurs in train collisions is lateral buckling of one or both of the colliding trains. However, in this accident, the passenger train overrode the freight train, with no lateral buckling of either consist. Considering that there were trains on adjacent tracks on both sides of the collision, the absence of lateral buckling prevented the accident from involving additional trains, which may have caused more severe injuries or fatalities in all of the trains involved.

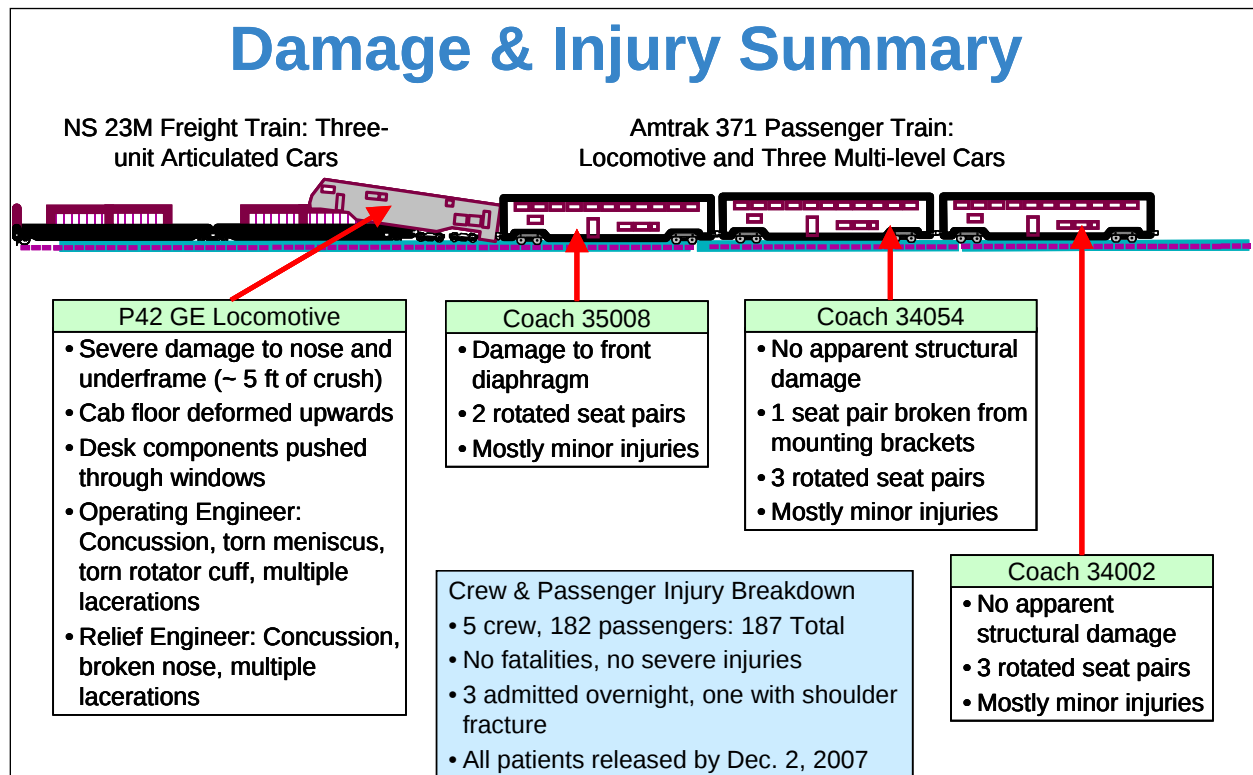
**Figure A-3. Final positions of passenger train and freight train with damage and injury summary.**

In the last phase of the impact, the passenger train came to a stop with the locomotive resting on top of the last freight car. Figure A-3 provides a sketch of the post-accident layout of the two trains, as well as a summary of the damage and injuries sustained..

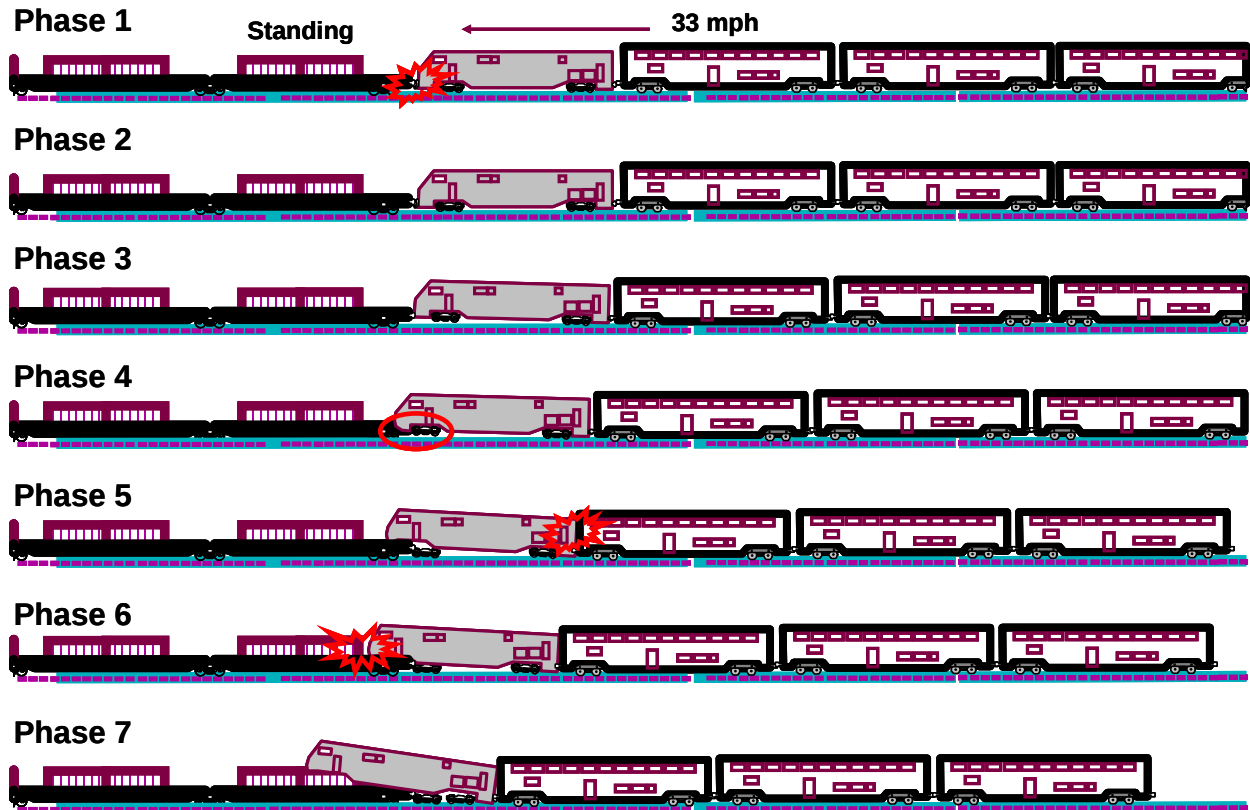
Figure A-4. Phases of the collision.

The final position of the equipment, the structural damage to the equipment, the wayside evidence, and the occupant interviews were interpreted in order to synthesize the following impact sequence of events, broken down into a series of seven phases in Figure A-4 and described in detail in the following sections.

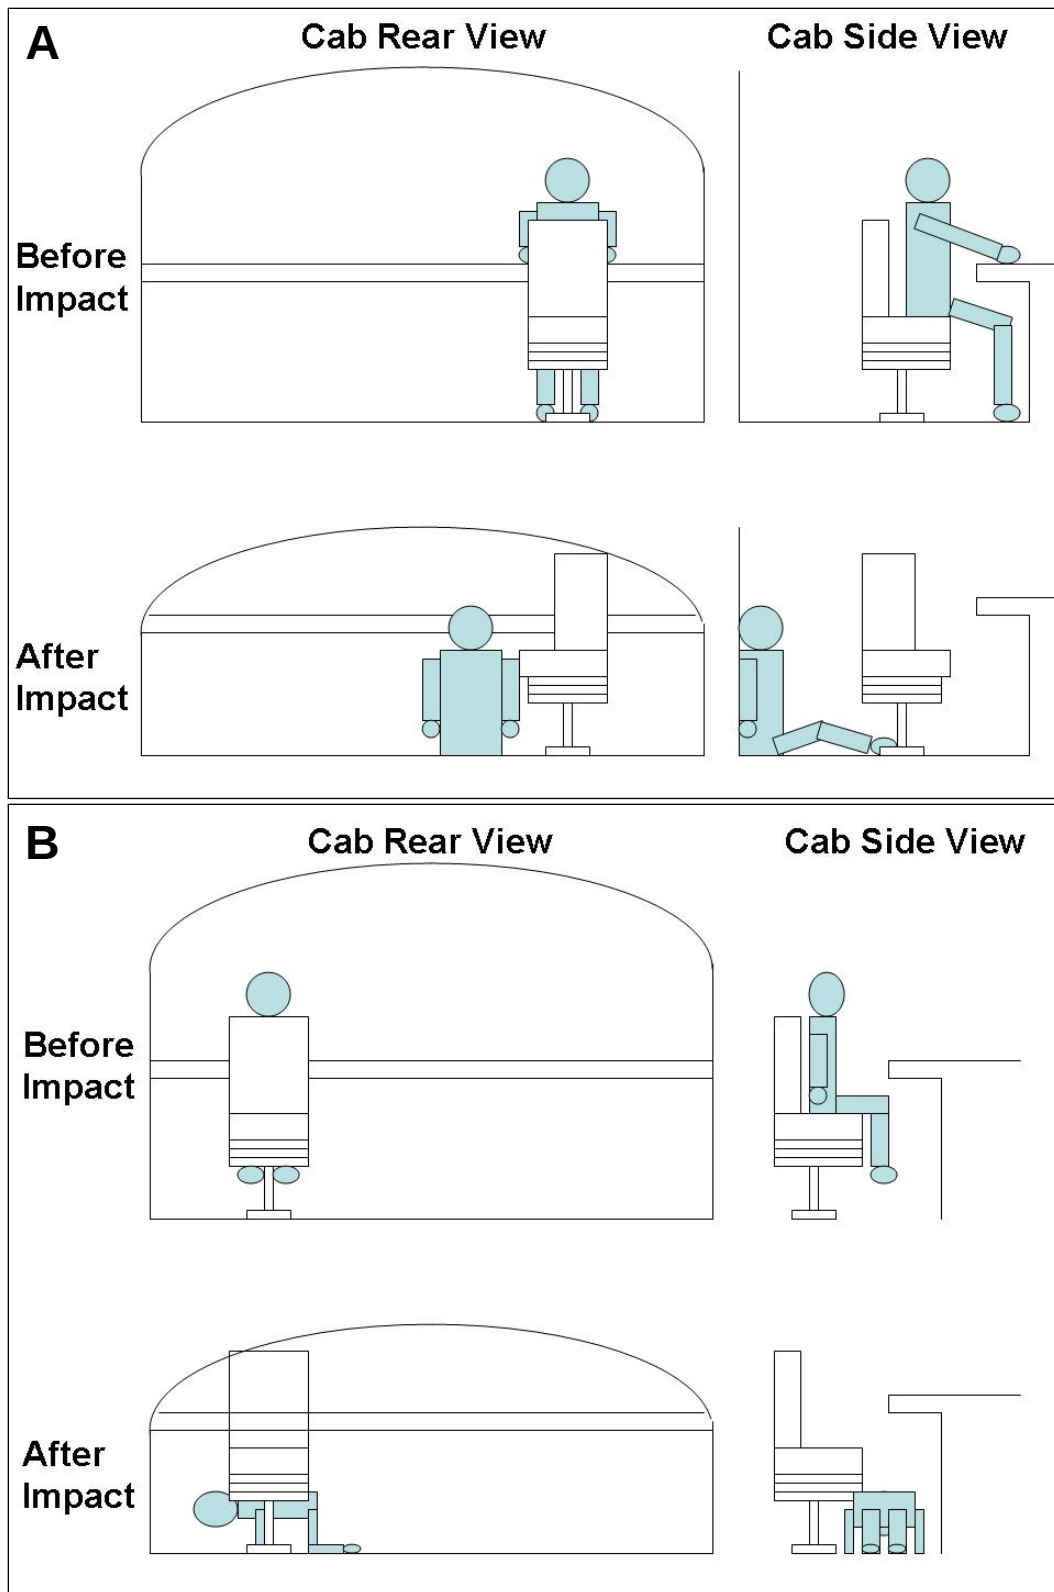
**Figure A-26. Operating engineer (A) and relief engineer (B) locations within the cab before and after impact.**

The relief engineer was a 43-year-old woman, 5'4" tall, and 125 lb. Figure A-26B shows the relief engineer's location before and after impact. Prior to impact, she indicated that her seat was in the midway position. She was fully seated and either looking forward or looking to the right at the operating engineer. She does not remember whether or not she extended her arms out to brace against the impact. She thinks that the impact caused her to slide off her seat and underneath the desk, which can be seen in Figure A-18. She came to rest on her hands and knees facing to the left. She sustained a severely broken nose, a head concussion, bruises on her left side, and multiple head lacerations on the left side of her head. She thinks that the head lacerations were caused by the heavy metal structure of her seat pedestal, shown in Figure A-18. Note that there is very little space left within the cab after the impact and the relief engineer's seat has been pushed into the ceiling of the cab. Had she remained in her seat, the relief engineer might have sustained severe head, neck, and spinal injuries from being pushed into the ceiling by her seat. After the accident, the relief engineer climbed out the right-side cab window, went down the emergency ladder, and walked away under her own power. Figure A-19 shows the broken right-side cab window through which she climbed to exit the cab.

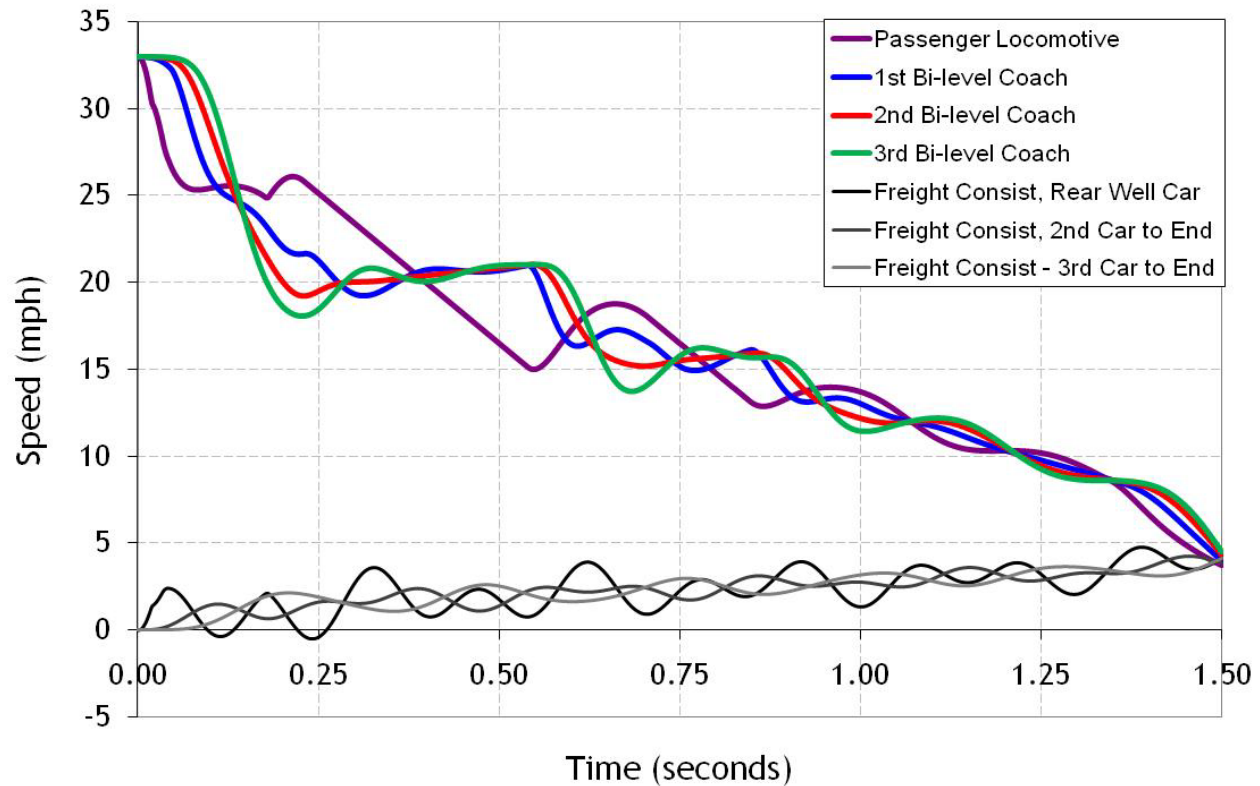
**Figure A-29. Velocity-time histories for each vehicle starting at the time of impact.**

Figure A-29 shows the velocity-time history of the passenger train and the last three cars of the freight train. The passenger train was travelling at approximately 33 mph when it impacted the standing freight train. The passenger locomotive slows to approximately 25 mph in the first 0.05 seconds after the impact. There is a 0.05-second delay before the following passenger cars begin to decelerate. The passenger train tries to rebound, as indicated by the increase in speed of the passenger train at 0.25 seconds. By 0.7 seconds all the vehicles in the passenger train are moving at about the same speed and decelerating at a constant rate and by 1½ seconds both trains have reached the same speed.

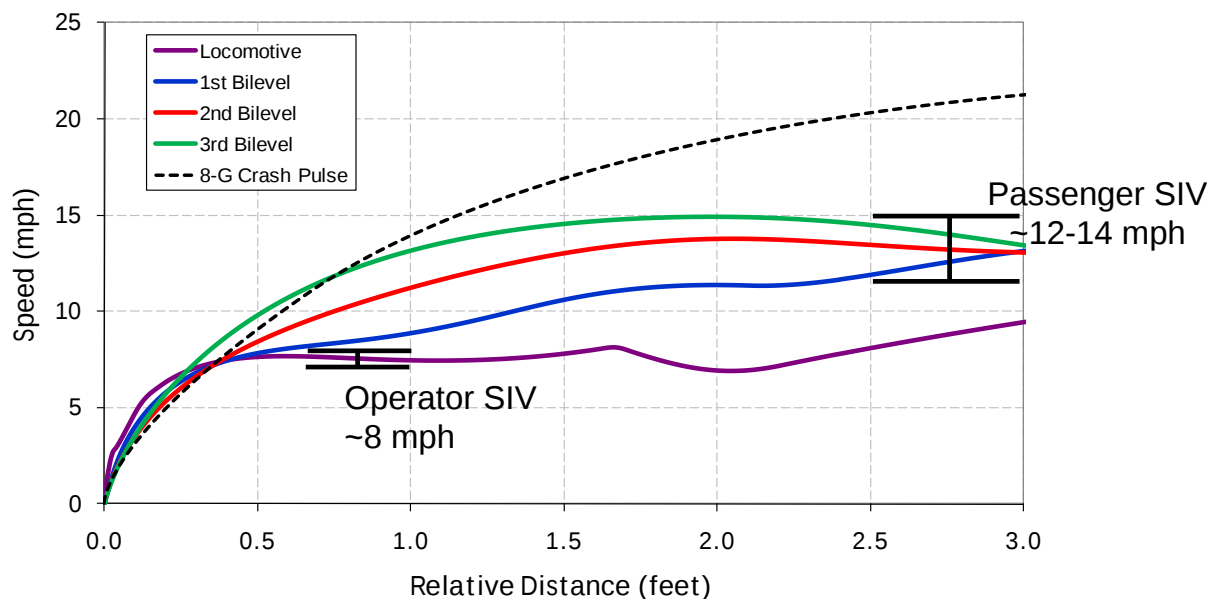
**Figure A-30. Secondary impact velocities for each occupied vehicle.**

Figure A-30 shows the secondary impact velocities (SIVs) for the passenger train. Secondary impact velocities provide an estimate of the severity of the collision as the occupants make contact with the interior structures. In the locomotive, the operators are seated at the console and have a possible travel distance of 8–12 inches. The results show that the operators impact the interior of the cab at approximately 8 mph. These results show that the longitudinal component of the impact is the most significant in the accident collision dynamics. It is worth noting that, as described in Appendix B.1.1, the cab floor was pushed upward as the locomotive underframe crippled, which added a vertical component to the cab environment. This component is not estimated in these model results.

For passengers in forward-facing seats in the trailing coaches, the SIVs range from 12 to 14 mph. The results show that the decelerations are progressively higher in each of the successive cars over this initial 0.23 seconds of the collision. The trailing coach experiences a higher overall deceleration over this timeframe, leading to a more severe interior environment. These results correlate with the evidence of interior damage described in Appendix B.1.2.
