RTDF2008-74020

A DYNAMIC TEST OF A COLLISION POST OF A STATE-OF-THE-ART END FRAME DESIGN

US Department of Transportation
Volpe Center
Cambridge, MA

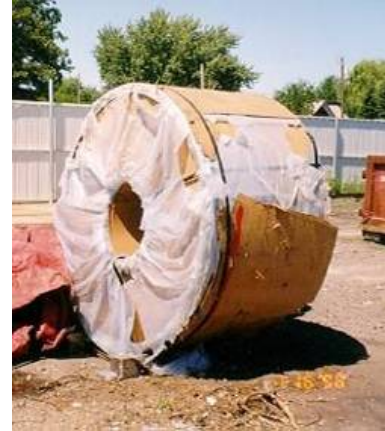
Figure 2. Steel coil involved in the grade crossing collision in Portage, Indiana

Figure 1 shows the exterior and the interior of the cab car after the collision. The picture on the right shows the interior of the car. The collision post had been severed and pushed back into the car. Figure 2 shows the 6-foot diameter, 19-ton steel coil. This grade crossing collision is significant because the coil loaded the superstructure of the car, not the underframe.

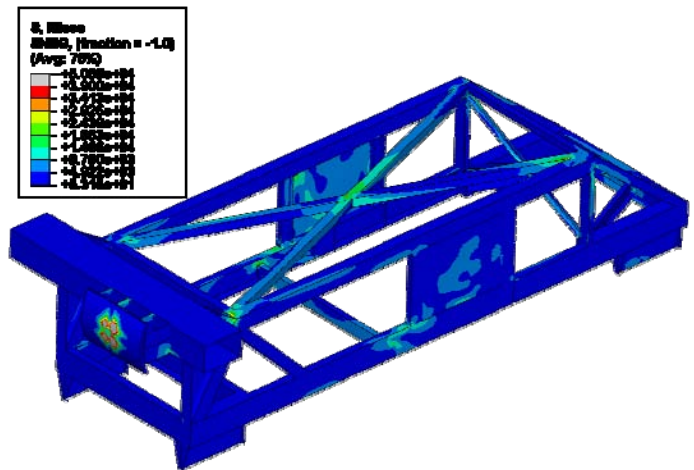
Figure 7: Von Mises Stresses of the Cart

The cart impacted with the rigid collision post body at a speed of 21 mph, travelled approximately 8 inches, and then rebounded backwards with a yaw of the rear of the vehicle of less than 2°. Figure 7 shows the stresses in the cart after impact. As shown in the figure, the maximum stresses found in the coil shape are just at their 50-ksi yield strength, and these maximum stresses are only at the location of contact with the rigid body. The stresses in the rest of the cart are well below their 39-ksi yield strength.

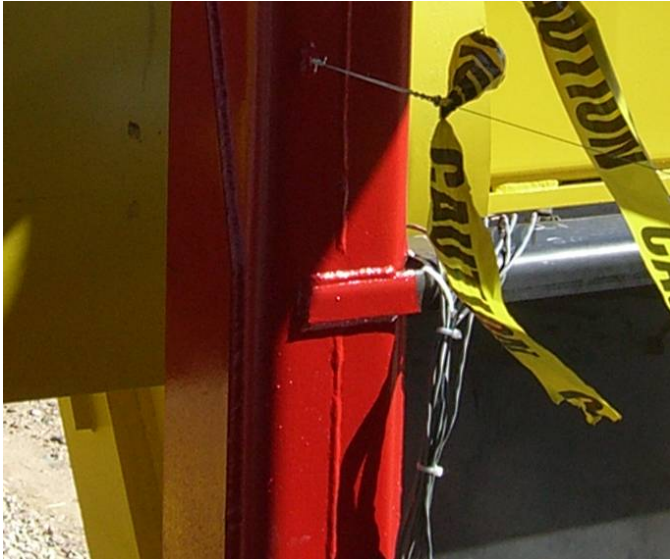
Figure 13. The back of the collision post, at the connection to the shelf, pre-test

Figure 13 shows the back of the collision post and the connection to the shelf before the test. The tab extends from the shelf and is welded to the back of the collision post. There is a gap between the side of the post and the shelf. The post is a box cross section formed by two U-sections welded together at the front and back of the post. There are several internal gussets in the horizontal plane.

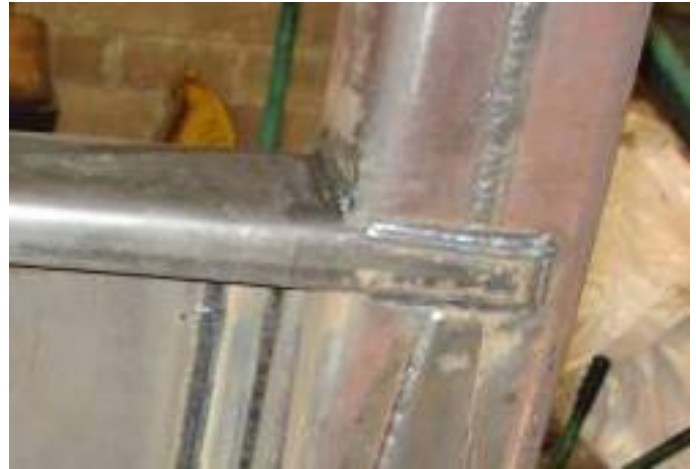
Figure 15. The shelf connection to the corner post, pre-test

Figure 15 shows the connection of the shelf to the back of the corner post before the test. This connection is similar to the connection between the shelf and the collision post. There is a gap between the shelf and the corner of the corner post.

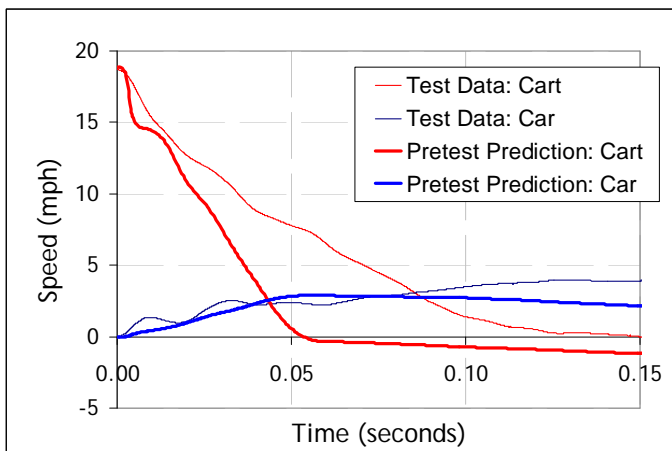
Figure 18. Accelerometer data, velocity vs. time for the cart and cab car

Gross Motions Figure 18 shows the velocity time history for the cab car and the cart. The test data time histories are calculated from accelerometers mounted on both the cab car and the cart. The pretest predictions come from the collision dynamics model. The cab car is initially standing and travels at approximately 3 mph after the impact. This matches the pretest collision dynamics prediction. The cart impacts the car at 18.7 mph, rebounds off of the passenger car, derails, and stops. The pretest prediction estimated that it would take 0.05 second for the cart to nearly stop. The test data shows that the cart takes 0.12 second to stop. The energy absorbed by the end frame during the test was 138,000 ft-lb.
