**Wheelchair Lifts on Transit Buses  
Summary of U.S. Experience**

**(U.S.) Transportation Systems Center  
Cambridge, MA**

**Urban Mass Transportation Administration  
Washington, DC**

**Jan 83**

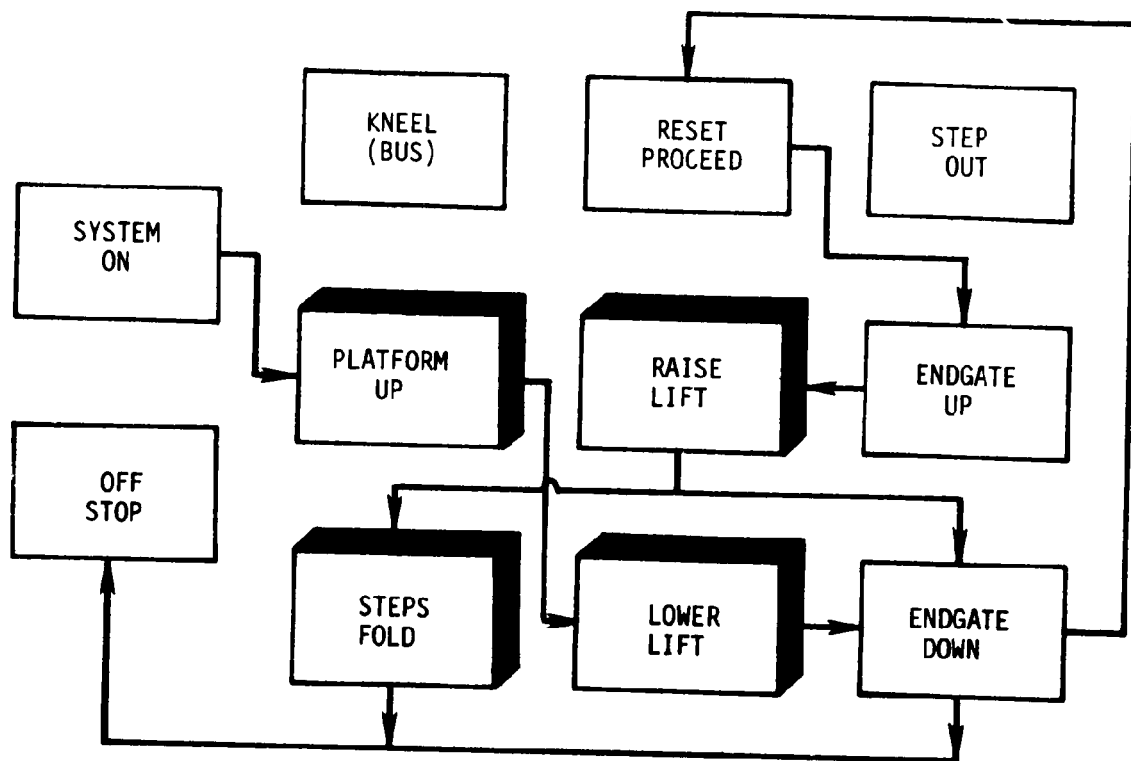
FIGURE 3.7-3: TRAVELIFT CONTROL LAYOUT AND SEQUENCE

Six microswitches are used within the lift mechanism to sense the position of various elements and control the lift motions so that they can occur only in the proper sequence. The first microswitches used by Vapor proved to be very susceptible to dirt accumulation and especially corrosion, particularly with the use of salt directly on the steps of the buses. The microswitch design was improved by increasing the ice scraper around the plunger, providing an integral boot on the plunger, and by changing the anodizing. These modifications solved the local step switch problems, but operators experience shows that the end gate switches can now suffer bent plungers if not installed and adjusted correctly. Although a service bulletin was issued by Vapor prohibiting the use of salt on the steps of the lift, Milwaukee was unable to comply with it. Ice will form on the steps in their winter climate from snow tracked into the bus unless positive measures are taken to prevent ice formation. Because of the repeated opening of the front door, the bus heating system with the lift installed cannot keep the melted snow on the steps from refreezing.

The push buttons on the control panels have also been susceptible to dirt ingress. Later versions of the control panel have the buttons sealed under a plastic cover and some operators of early models have fabricated their own covers.

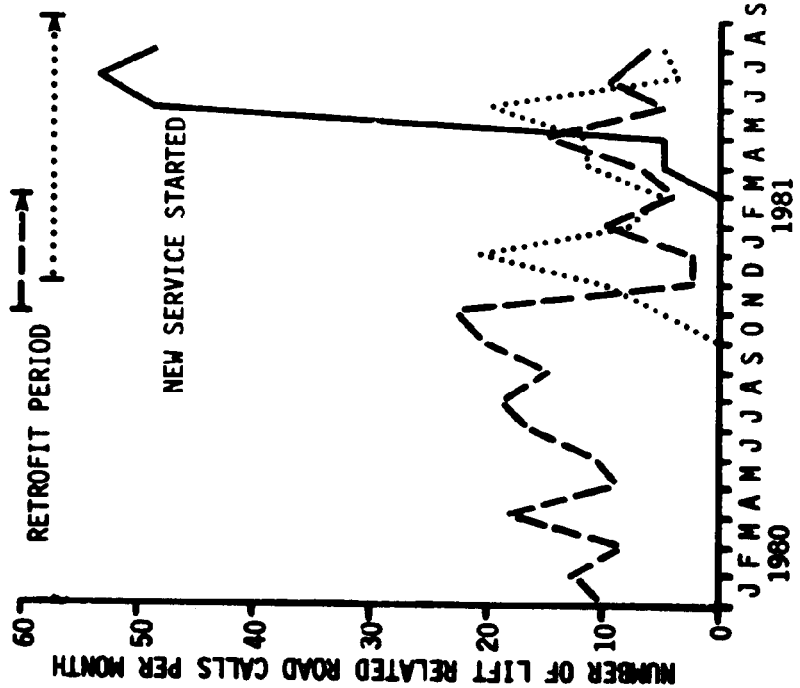
FIGURE 4.3-1: ROAD CALL PERFORMANCE OF ALL THREE LIFT BUS FLEETS AT RTD, DENVER

**4.3.2.1 Ridership** - Using data for the week's commencing June 7 through August 23 the on-the-road performance for the first three months of service has been estimated as shown in Table 4.3-1. Ridership was still increasing and road calls were averaging about one for every ten wheelchair trips. This appears to be on a par with the experience of operators using other EEC lift models. Figure 4.3-1 shows the history of road calls for all three of the bus groups. Because of the change in service structure in June of 1981 the prior period cannot be directly compared to the later period. It would appear, however, that the retrofitted 140 installation in the GMC's did not prove to be significantly superior to the previous lift model. The absolute number of road calls dropped a little, but this may reflect the change in service patterns. The percentage of road calls attributed to lift problems did not change appreciably. The data for the AMG buses indicate that some low level of lift-related road calls may be expected even when the lifts are not in accessible service.

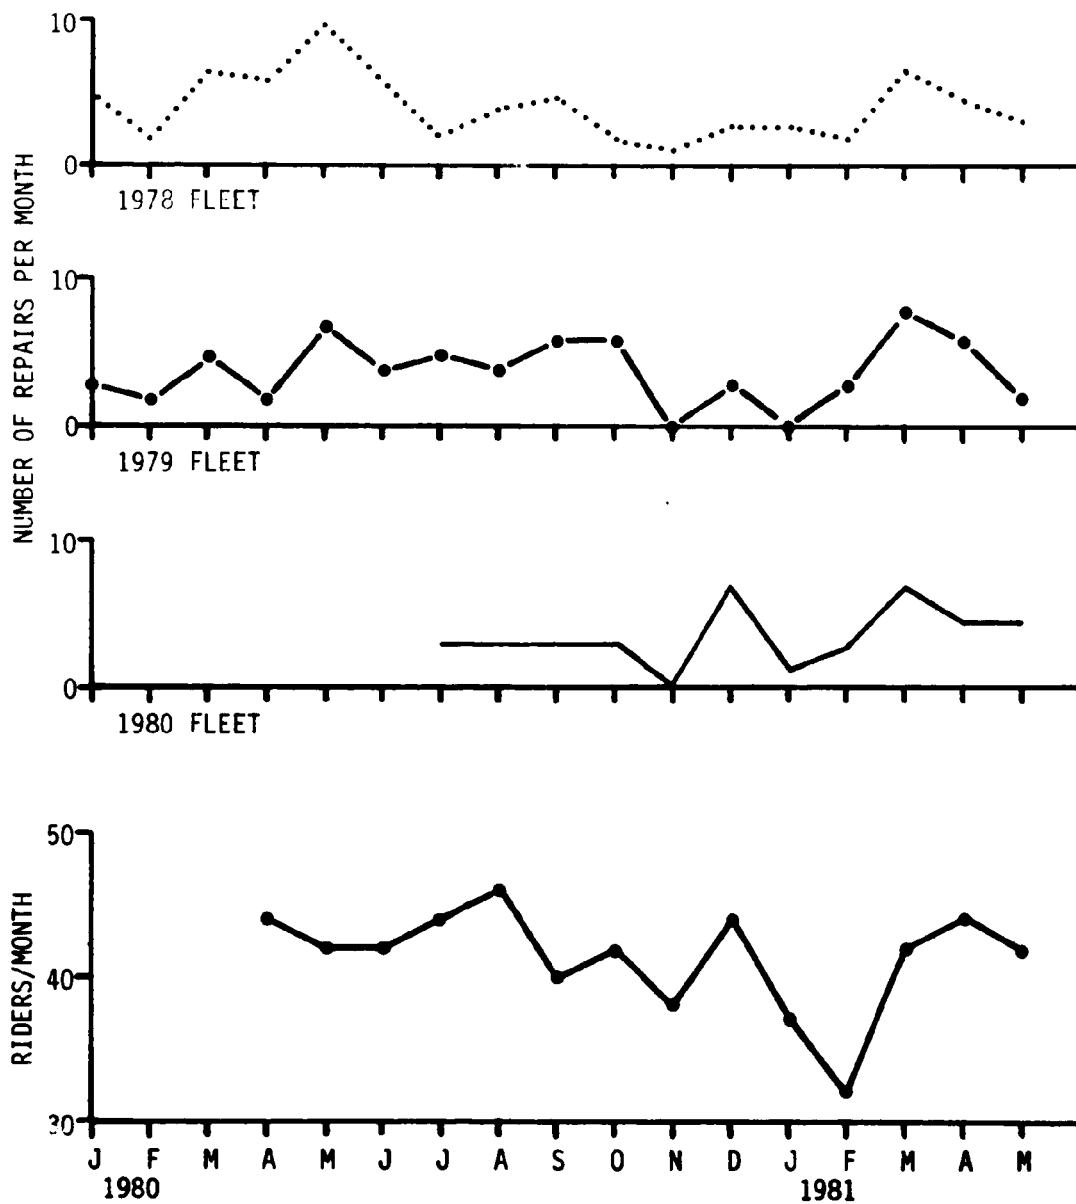
FIGURE 4.5-1: NUMBER OF REPAIRS BY BUS FLEET AND RIDERSHIP AT SENTA-MACOMB

(Figure 4.5-1) demonstrated a variable level of monthly repairs, which seemed to reflect the overall ridership reported. The cumulative records show a steady rate of repairs for the whole fleet which averages ten repairs a month (Figure 4.5-2). A review of the figures for the different year models shows that the 1979 and 1980 buses had 20-30% fewer repairs per bus than the 1978 vehicles although the difference narrowed in 1981 (Figure 4.5-3). Initially, the 1979 buses seemed to have had a higher repair rate than the 1980 models, but the first five months of 1981 shows no difference between the 1979 and 1980 model coaches.

It must be cautioned that many of the repairs were corrective actions rather than repairs of failed components, therefore, the records required a fair degree of interpretation. For instance, many of the lift failures were related to the step locks failing to disengage. These were variously reported by different mechanics as "frozen," "stuck," and a need to "free-up." Where it appeared that the primary needs were just for lubrication, then such incidents were not counted as repairs. Similarly, in some instances the simple notation of "repaired lift" was used with no other diagnostic information or evidence of parts use. These instances were also not counted since it was felt that the probability was that the primary effort needed was lubrication. The net result was an overall repair rate of ten per month, but with fluctuations from a high of over 20 to a low of one repair per month.

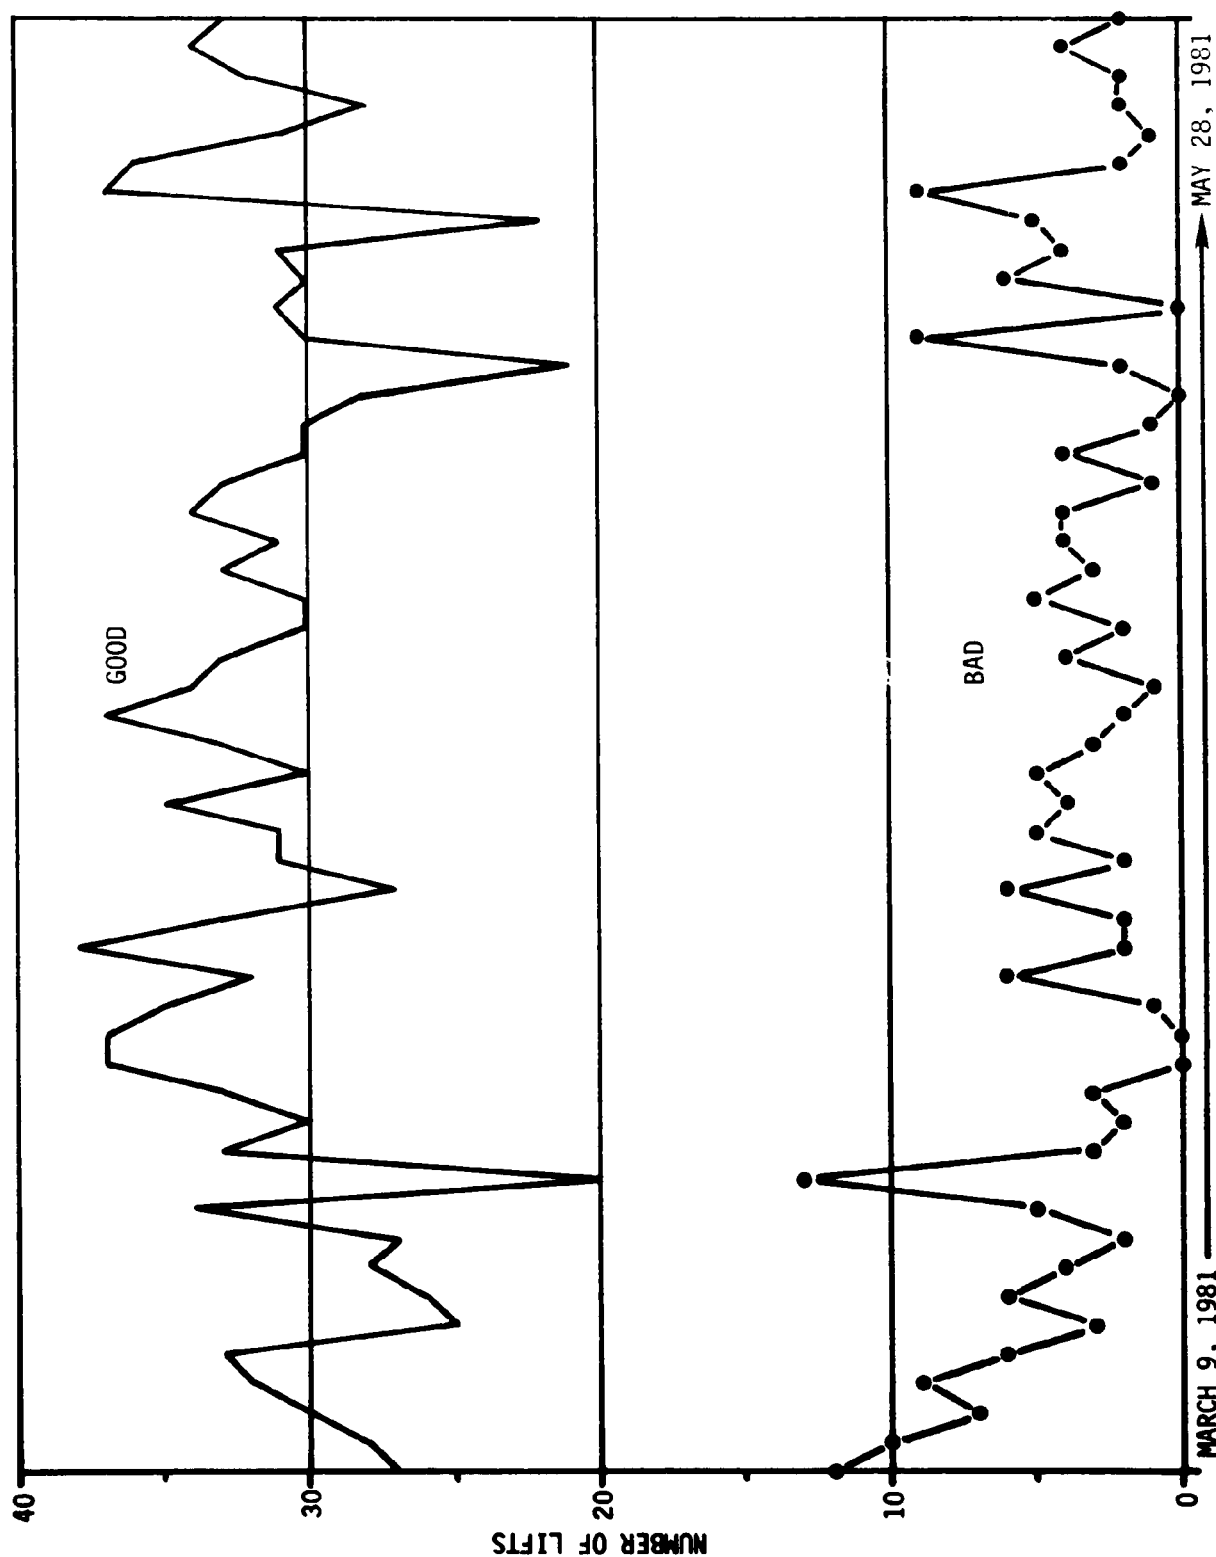
FIGURE 4.5-5: DAILY VARIATION OF "GOOD" AND "BAD" LIFTS AT SENTA-MACOMBS

Figure 4.5-5 illustrates daily fluctuations in the number of known working (OK) and bad (BAD) lift categories many lift repairs were minor and were corrected during the next day's work shift.

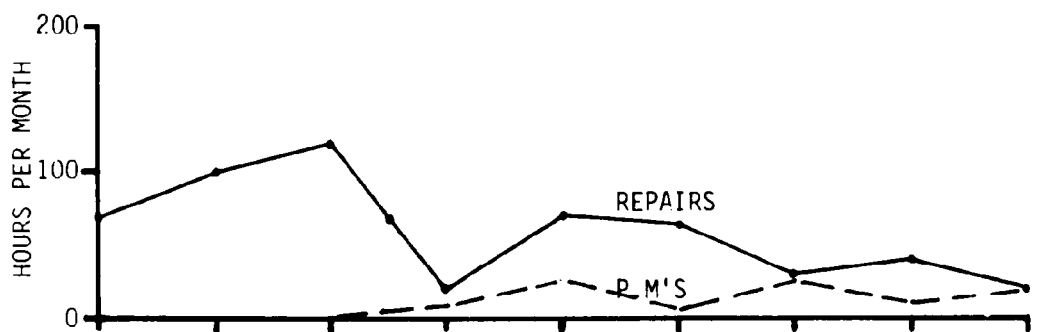
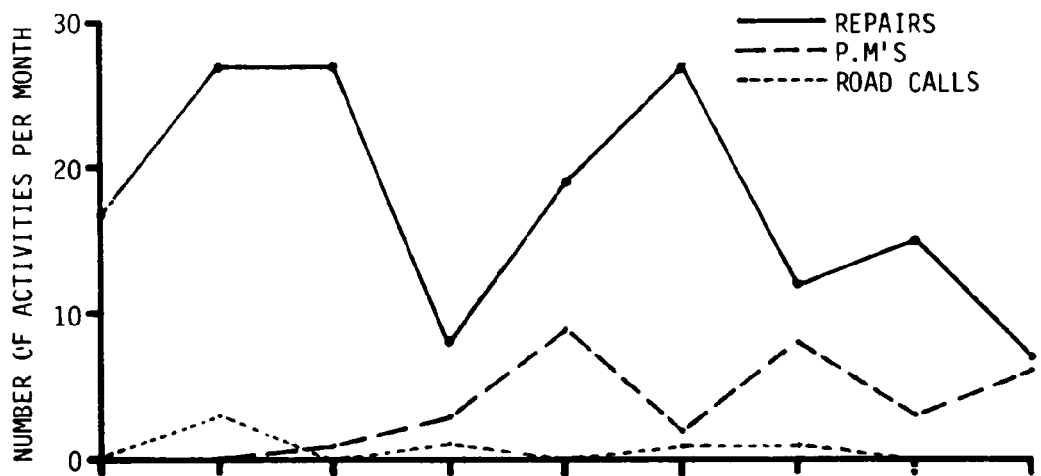
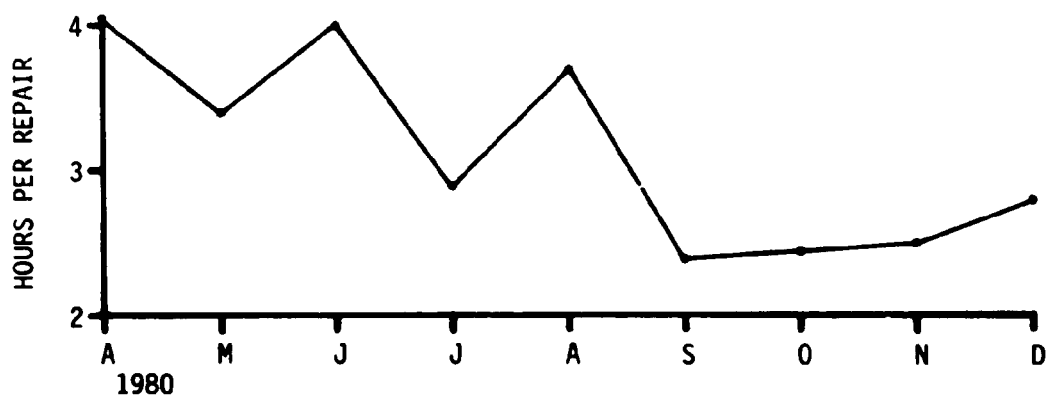
FIGURE 4.7-1: LIFT REPAIR AND MAINTENANCE TRENDS AT GRATA

Figure 4.7-1 shows the trends in repair hours, preventive maintenance hours, the number of repairs and road calls, and the hours per repair during the period of accessible service. The favorable trends undoubtedly reflect the overall learning process and the establishment of the maintenance program. The major problems encountered by GRATA may be summarized as:

- 7) Excessive pressure in the power steering pump circuits leading to hose failure.
- 8) Some faulty relays and hydraulic valves.

GRATA added a warning to the manually operated emergency system to remind operators that the manual control must be returned to neutral after use, or the system will spill hydraulic fluid the next time it is activated. Also as a result of experience, GRATA is using ATF in the system and not the SAE 10/40 weight oil specified by Flexible for the power steering system. They believe the oil degrades under the temperatures and pressures of the power system causing deposits which affect the hydraulic operation. They also indicate that the ATF provides better (faster, smoother) operation in cold weather.

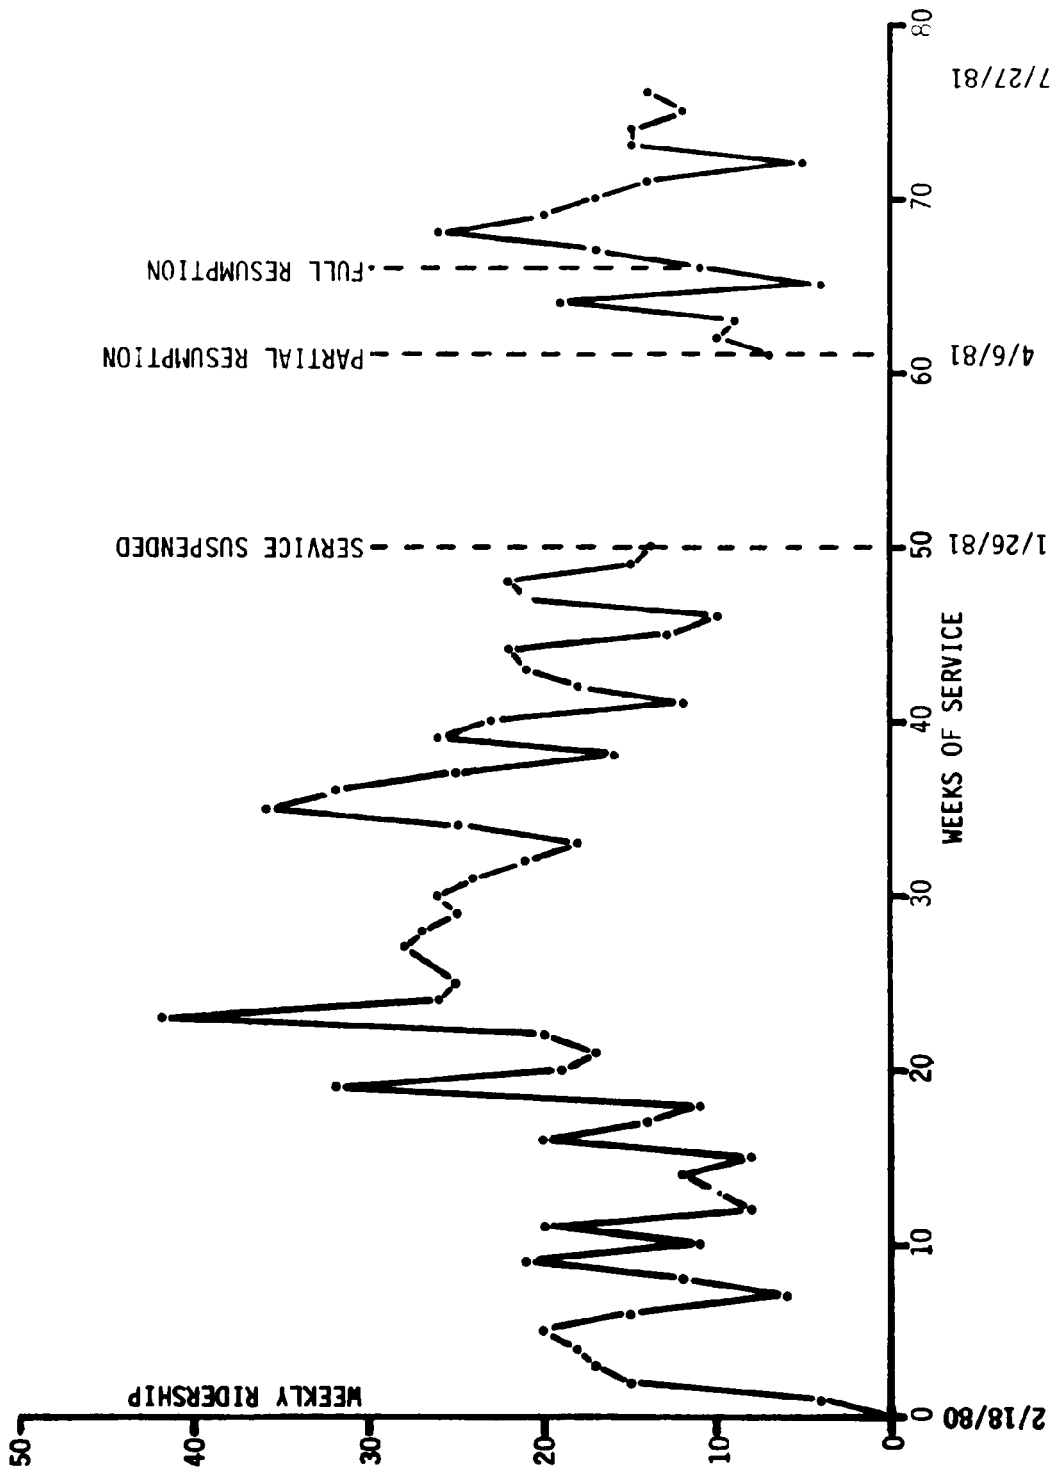
FIGURE 4.10-1: RIDERSHIP HISTORY ON SCRTD'S AMG/TDT BUS ROUTES SHOWING THE EFFECT OF SERVICE INTERRUPTION

4.10.1.2 Ridership - Ridership on the original 21 routes operated with the 200 AMG/TDT buses was relatively stable, but at a low level as shown in Figure 4.10-1. The figure also illustrates the effect of the suspension of service while major repairs were made on lift installations. Based upon later telephone conversations, the initial deployment of the RTS buses which increased the number of accessible routes from 21 to 53 also increased the ridership from 15-20 to about 40 per week.

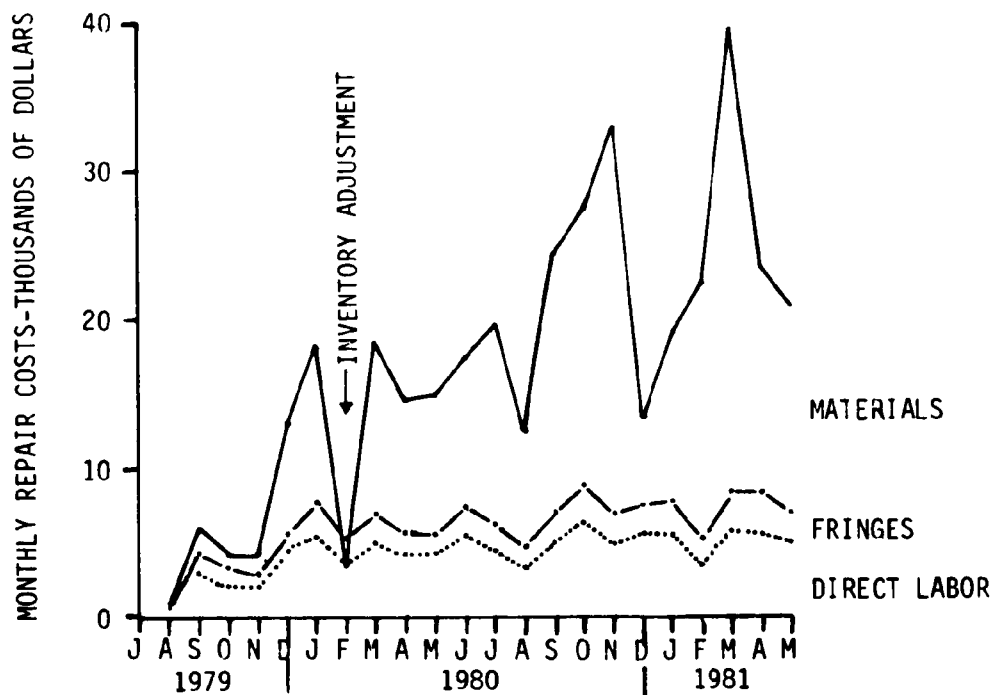
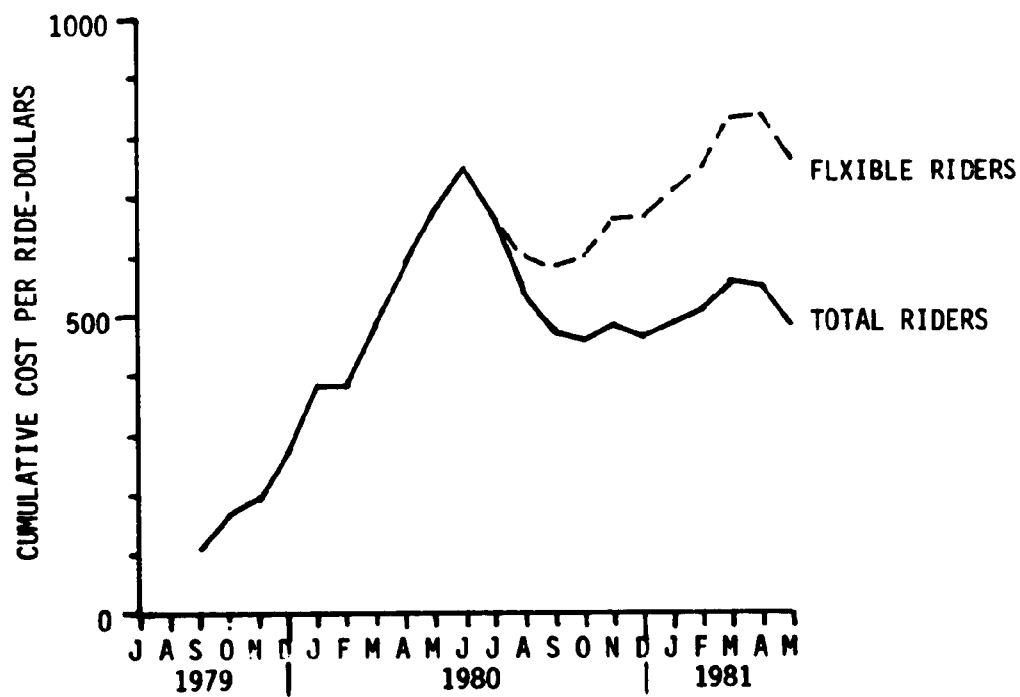
FIGURE 4.12-1: MONTHLY REPAIR AND RIDERSHIP TRENDS AT MCTS

The MCTS records on the cost of lift repairs, maintenance, and inspection consisted of labor cost and parts cost summaries. The only repair records available were the personal (and sometimes cryptic) records of two mechanics at the main shop. The cost of lift maintenance and repair was accumulated separately since August of 1979. The monthly figures through May of 1981 are presented in Figure 4.12-1. Until March of 1981, the accumulated costs represented only the Vapor/Flexible installation, but at that time the GM RTS-2 buses began to come out of warranty, consequently the MCTS cost figures would begin to reflect some GM lift costs. MCTS reported that there had been no major GM lift repairs in the three months of combined costs, and the figures provided do not show any sudden significant increase. Figure 4.12-1 also shows the cumulative cost per ride. The cumulative figures are presented because the monthly fluctuations in cost and the seasonal nature of the ridership produced large variations. Two trends are shown, for the Flexible ridership only, and for the total system.
