**JRC2012-74154**

## **COMPARISON OF INTERIOR CRASHWORTHINESS OBSERVED IN PASSENGER TRAIN ACCIDENTS AND 8G DYNAMIC SEAT SLED TESTS**

**Kristine Severson**

**Volpe National Transportation Systems Center  
Cambridge, MA, USA**

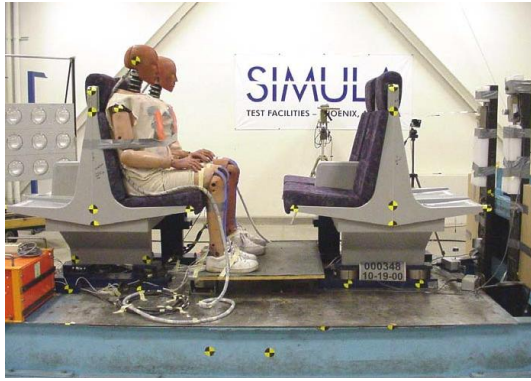
**FIGURE 6. PHOTO OF TEST SET-UP**

Four tests were conducted using a facing-seat configuration. Two ATDs were positioned in forward-facing seats, impacting the opposing seat pair during the test. Three of these tests were conducted with an 8G triangular crash pulse, while one test used a 9G crash pulse, based on results of parametric modeling analyses [8]. One of the 8G sled tests also incorporated a workstation table between the facing seat pairs. Three out of four tests used two instrumented 50<sup>th</sup> percentile male ATDs, while one test used a 95<sup>th</sup> percentile male and a 5<sup>th</sup> percentile female ATD. The seat pitch between facing seats was 65 inches, which is the same seat pitch used between facing seats in the Metrolink cars. See Figure 6 for a photo of the test configuration.

The sled tests demonstrated that the seats did not meet the injury criteria or compartmentalization requirements specified in the Seat Standard. In two of the three tests without a table, the aisle-side head rest completely separated from the seat back. In the test with the 5<sup>th</sup>- and 95<sup>th</sup> percentile ATDs, the window-side head rest of the facing seat failed completely due to the impact from the larger ATD. In some tests, the grab handles on the head rest cracked, but the head rest did not detach from the seat back. These types of seat damage were also prevalent in the Chatsworth accident.

In the single test with a table between the facing seats, the two 50<sup>th</sup> percentile ATDs impacted the table, causing it to shear off at the wall attachment, which led to a failure at the floor attachment as well.

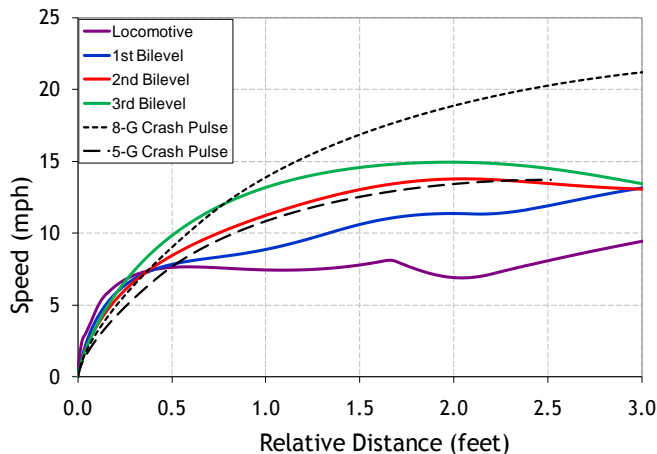
**FIGURE 9. PLOTS OF SECONDARY IMPACT VELOCITY (SIV) FOR CHICAGO**

Following the accident, a lumped-mass collision dynamics model was developed to estimate the gross motions of the cars in the passenger train. The acceleration time history for each car was integrated to produce a plot of relative velocity vs. relative displacement. The resulting curves are shown below in Figure 9, along with the corresponding curves for 5 G and 8 G, 250 ms crash pulses.

The curves in Figure 9 indicate that the engineers had lower SIVs than passengers in trailing coach cars; however, they had more severe injuries. This observation highlights the point that SIV is only one factor in estimating the severity of secondary impacts. Additionally, the SIV curves presented in this paper only account for longitudinal train acceleration and do not address lateral or vertical accelerations. Longitudinal acceleration usually dominates the train motion, but lateral and vertical accelerations may be more significant factors in the event of derailment, override, and car rollover.

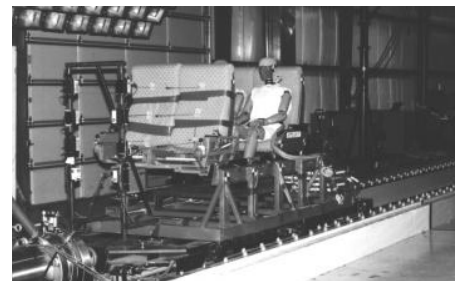
**FIGURE 10. PHOTO OF TEST SET-UP**

In 1995, seven sled tests were conducted on Amtrak's traditional coach seat at MGA Research Corporation in Burlington, WI [11]. The Amtrak seat tests were the first tests conducted by the Volpe Center, to evaluate the performance of seats under dynamic loading conditions. Although the APTA Seat Standard did not exist at that time, the tests were conducted in a manner consistent with the eventual Seat Standard. Two rows of two-person seats were fastened to the sled at the floor and the wall via standard seat tracks that are used in Amtrak cars, at a 52-inch seat pitch. Two ATDs were positioned in the rear seat pair; only the wall-side ATD was instrumented. See Figure 10 for photo of test set-up.

The first three tests were conducted to evaluate the influence of crash pulse on the seat performance. The test sled was accelerated using a 250 ms triangular crash pulse with a peak amplitude of 5, 10, and 8 Gs, respectively. The remaining tests were conducted with an 8 G pulse to evaluate the influence of initial ATD position, i.e., placement of seat back and leg rest position.

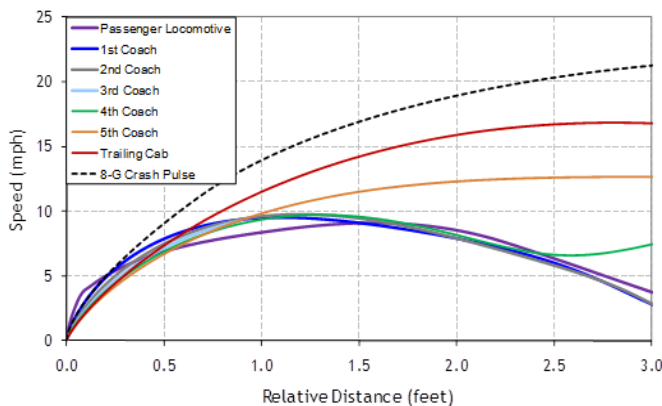
FIGURE 13. SIV PLOTS FROM CANTON ACCIDENT

On March 25, 2008, a runaway CSX freight car impacted a stationary, locomotive-led MBTA commuter train at about 23 mph (see Figure 12). The locomotive engaged the freight car, causing dents in the front of the locomotive and one to two feet of deformation on each vehicle. The impact caused the train and the freight car to roll about 50-70 feet before coming to a stop, with the impacted vehicles still attached. The graph in Figure 13 plots the SIV curves corresponding to each car, based on results from a collision dynamics model of the accident.
