Repair of Distortion-Induced Fatigue Damage in Bridge No. 135-87 (043SB and 044NB) Using Newly-Developed Strengthening Schemes

1 Report No. KS-16-06	2 Government Accession No.	3 Recipient Catalog No.	
4 Title and Subtitle Repair of Distortion-Induced Fatigue Damage in Bridge No. 135-87 (043SB and 044NB) Using Newly-Developed Strengthening Schemes		5 Report Date August 2016	
		6 Performing Organization Code	
7 Author(s) Kathleen S. McElrath, Adolfo Matamoros, Ph.D., P.E., Caroline Bennett, Ph.D., P.E., Jian Li, Ph.D., Stan Rolfe, Ph.D., P.E.		7 Performing Organization Report No.	
9 Performing Organization Name and Address The University of Kansas Department of Civil, Environmental and Architectural Engineering 1530 West 15th St Lawrence, Kansas 66045-7609		10 Work Unit No. (TRAIS)	
		11 Contract or Grant No. C1916	
12 Sponsoring Agency Name and Address Kansas Department of Transportation Bureau of Research 2300 SW Van Buren Topeka, Kansas 66611-1195		13 Type of Report and Period Covered Final Report November 2011–August 2015

Final Report

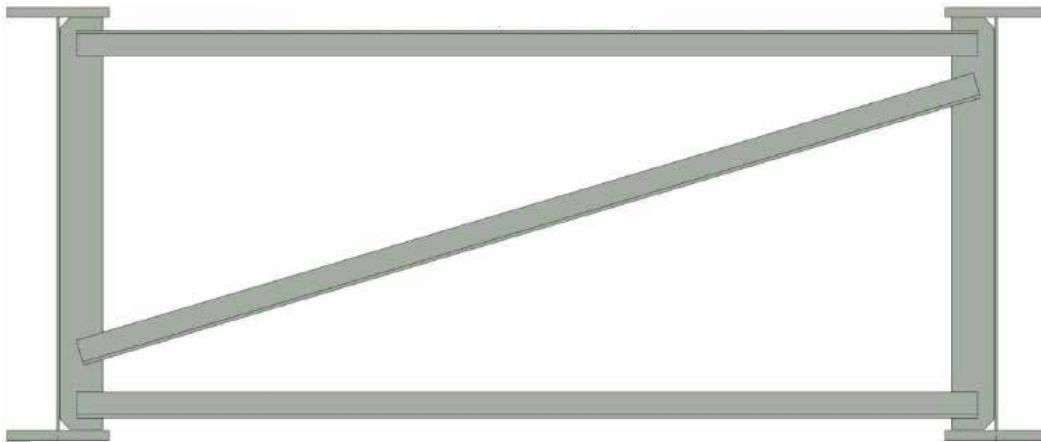
Figure 2.6: Cross-Frame Geometry of Kansas Bridge 135-87(043/044)
Source: Richardson (2012)

Also, Kansas Bridge 135-87 (043/044) has cross frames with two horizontal cross-frame members framing directly into the connection stiffener at the top and bottom web gaps, as shown in Figure 2.6.

In bridges with cross-frame geometry such as this, application of the existing retrofit technique would first require removal of at least the horizontal cross-frame members. Similarly, the KDOT-proposed retrofit technique of applying angles at each corner of the cross frame would also require cross-frame members to be first removed before application (Richardson, 2012).

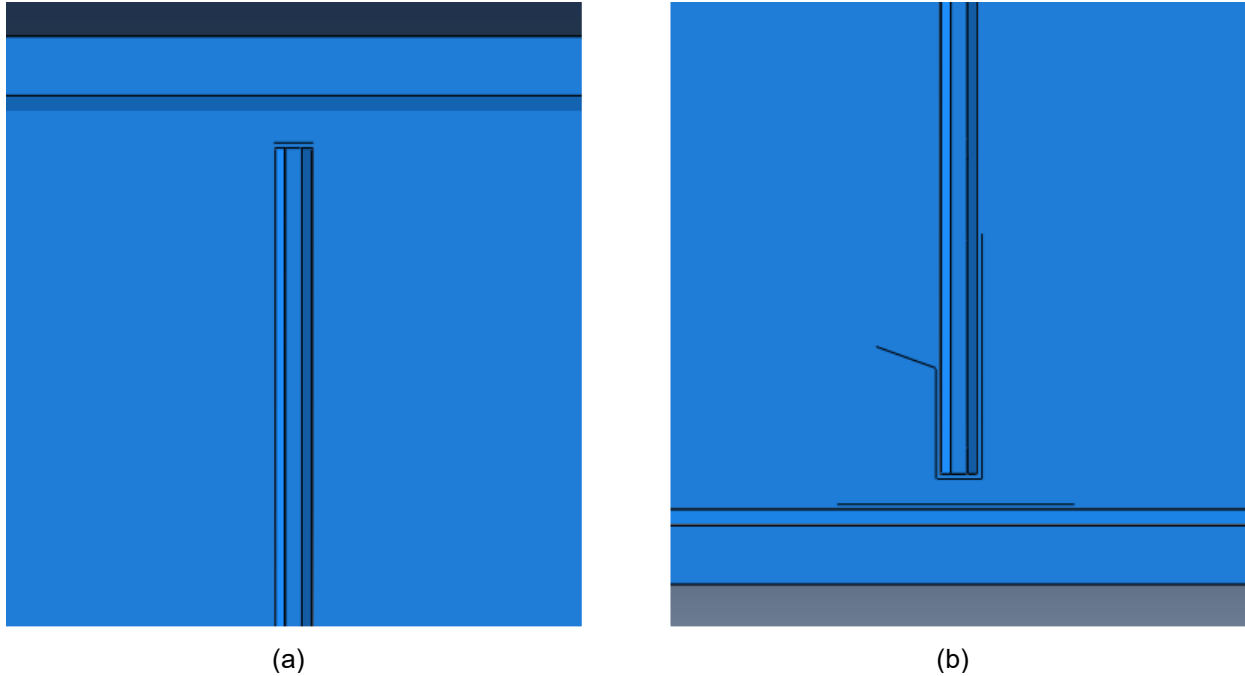
Figure 4.2: Crack Patterns Modeled at (a) Top Web Gap (b) Bottom Web Gap

Cracks were modeled using the Abaqus Extended Finite Element Method (XFEM), which allows cracks to be modeled at any location in an element. Cracks were modeled as three-dimensional extruded shell elements and given depths equal to the girder web thickness. The lengths of the cracks were modeled as closely as possible to those observed in the field at the testing location, as shown in Figure 4.2. The crack pattern in the bottom web gap included a 116-mm ($4\frac{9}{16}$ -in.) Type D crack, a 117-mm ($4\frac{5}{8}$ -in.) Type B crack on the north side of the connection plate, and a 51-mm (2-in.) Type B crack that spidered out into a 33-mm ($1\frac{5}{16}$ -in.) Type C crack on the south side of the connection plate. The crack pattern in the top web gap included a 19-mm ($\frac{3}{4}$ -in.) Type A crack.

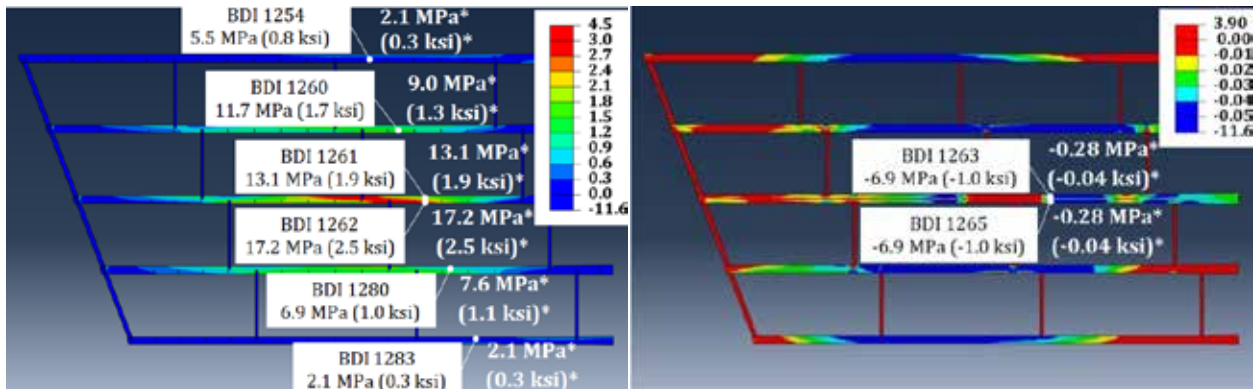
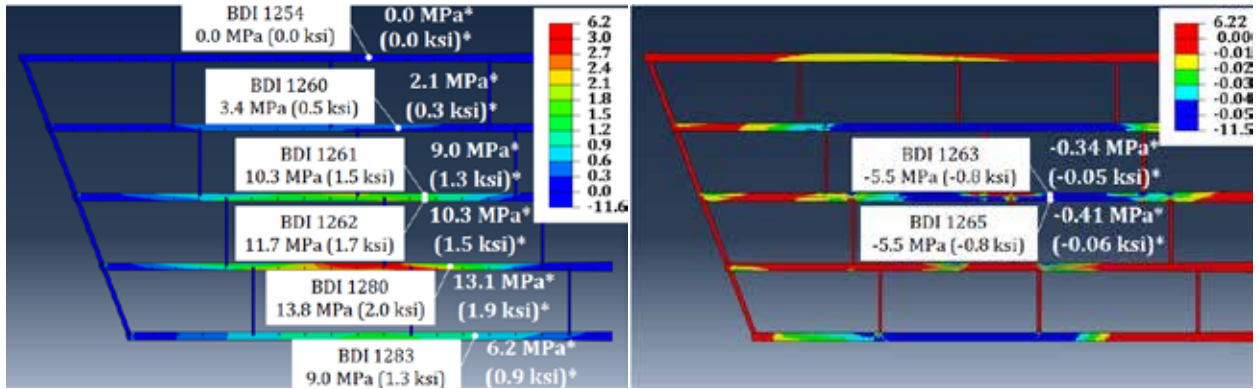
Figures 6.1 and 6.2 show the maximum stresses for the BDI strain transducers for the west lane, east lane, and center truck loadings for the second field test. As previously mentioned, electrical noise and connection grounding issues prevented the BDI strain transducers from producing viable data during the first field test. In these figures, the field test data overlays the FE analyses results; field test values are presented with callout boxes to indicate instrument location. The stress values shown in Figures 6.1 and 6.2 show that maximum stresses in the girders and cross frames coincided with the respective truck position. For instance, as the truck traveled over the west lane, the highest stress was recorded for the BDI strain transducers located on the girders under that lane. This was the same relationship for each truck loading location and corresponding girder BDI. The BDI strain transducers placed on the cross frame show that the bridge center and east lane loadings had the most effect on the cross-frame members. Center loading produced the highest tensile stress in the diagonal cross-frame member, while the east lane loading produced the highest tensile stresses in the top and bottom horizontal cross-frame members. The BDI instrument results made sense intuitively and corresponded to the expected global behavior of the bridge girders. Additionally, the values from the field test corresponded to those from the FE analyses, indicating that the FE models provided a good comparison to the actual bridge and its behavior.

Figure 6.1: Girder Flange BDI Results from Field Tests and FE Analyses for (a) West Truck Load Placement (b) Center Truck Load Placement (c) East Truck Load Placement

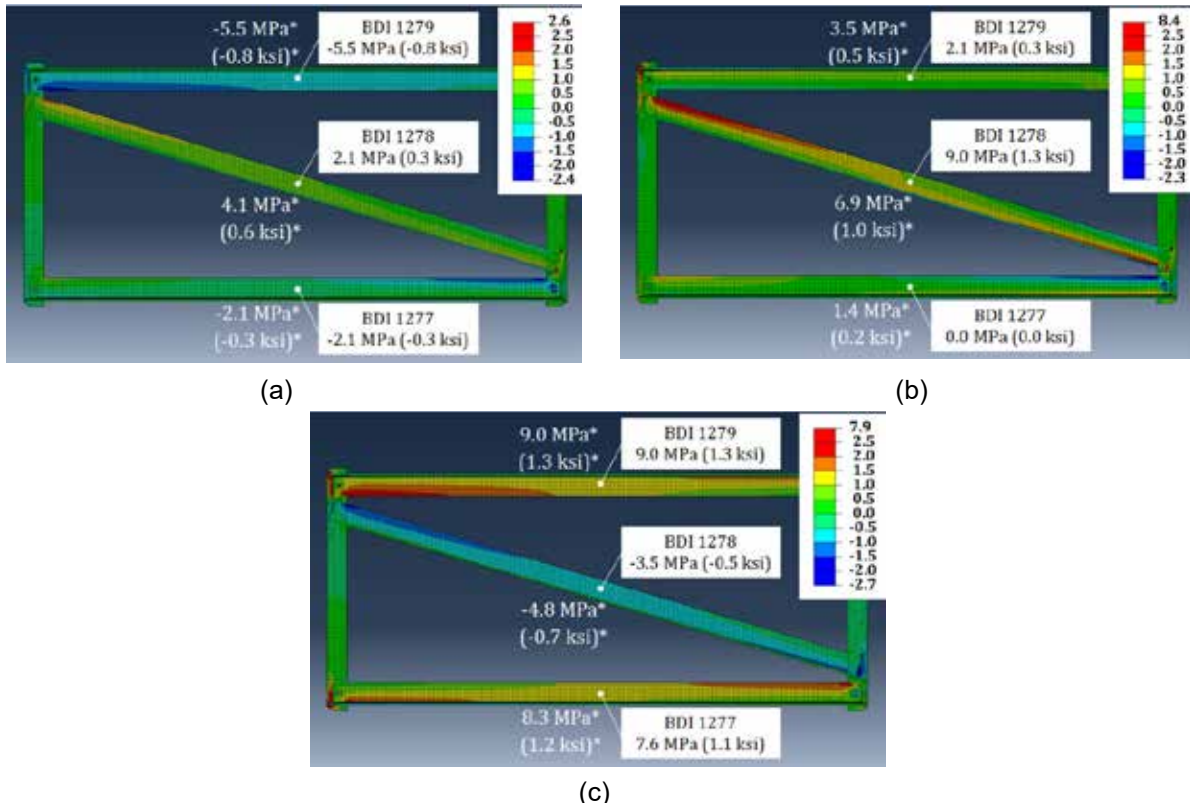
Figure 6.2: Cross Frame BDI Results from Field Tests and FE Analyses for (a) West Truck Load Placement (b) Center Truck Load Placement (c) East Truck Load Placement

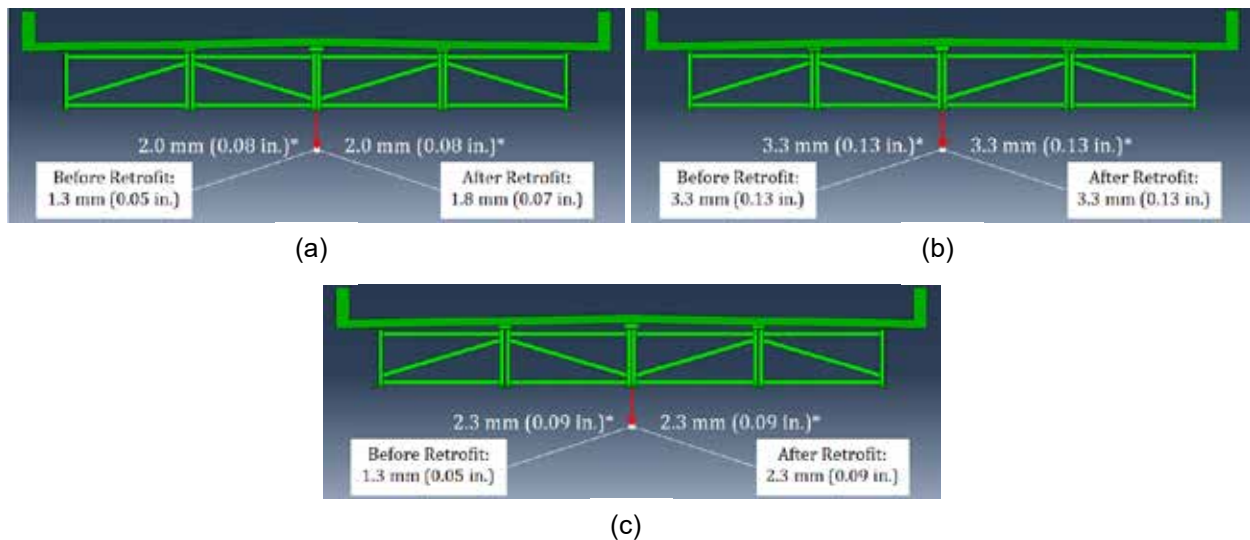
Figure 6.3: String Potentiometer Results from Field Tests and FE Analyses for (a) West Truck Load Placement (b) Center Truck Load Placement (c) East Truck Load Placement

The string potentiometer results for west lane, east lane, and bridge center truck loadings are shown in Figure 6.3. Maximum vertical deflection of Girder C at the connection plate occurred when the truck traveled over the center of the bridge. There was no change in deflection between the first test and the second test, indicating that application of the retrofit did not have an impact on vertical deflection, which was the expected result. As with the BDI results, the values from the field test corresponded to those of the FE analyses, indicating that the FE models provided a good comparison to the actual bridge and its behavior.

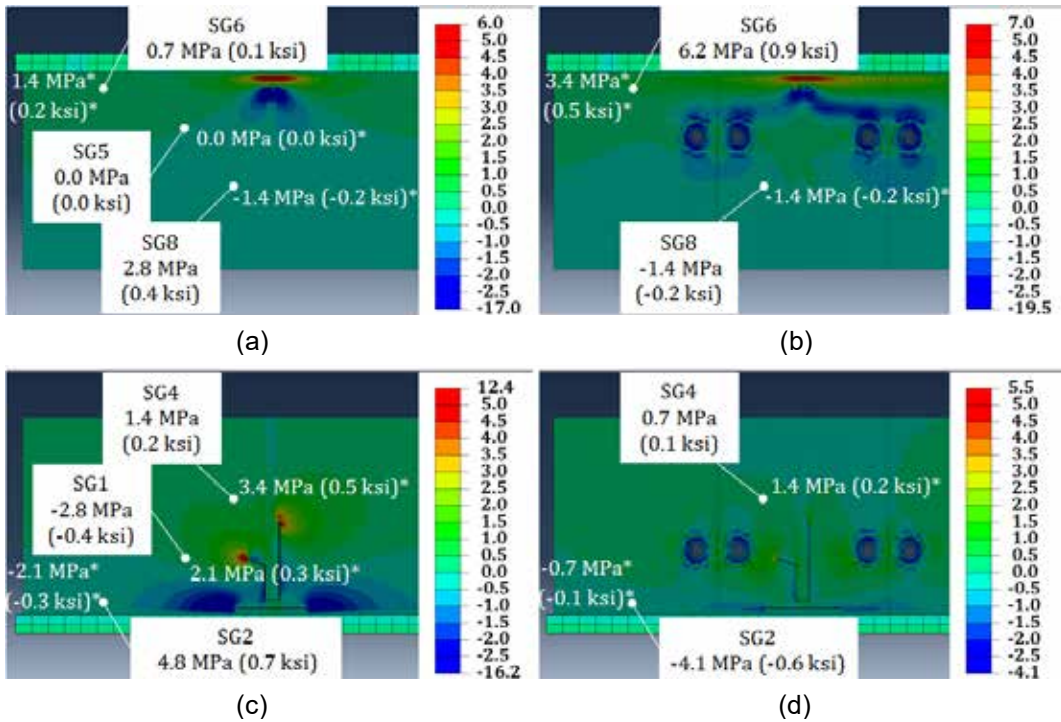
For stresses nearest the top flange, peak stresses showed favorable reduction and behavior after application of the angles-with-plate retrofit for the center truck loading test. However, for the east and west lane truck loadings, low levels of stress decrease, and in a few cases, stress increase, in the top web-gap region were observed. Although the top web-gap region was found to experience lower stress demands before the retrofit than the bottom web gap, this is still a result that warranted further investigation. For this reason, an additional analytical investigation was performed that focused on the top web-gap region of the bridge.

Figure 6.7: Directional Stresses for West Load Truck Placement at (a) Top Web Gap, Before Retrofit (b) Top Web Gap, After Retrofit (c) Bottom Web Gap, Before Retrofit (d) Bottom Web Gap, After Retrofit

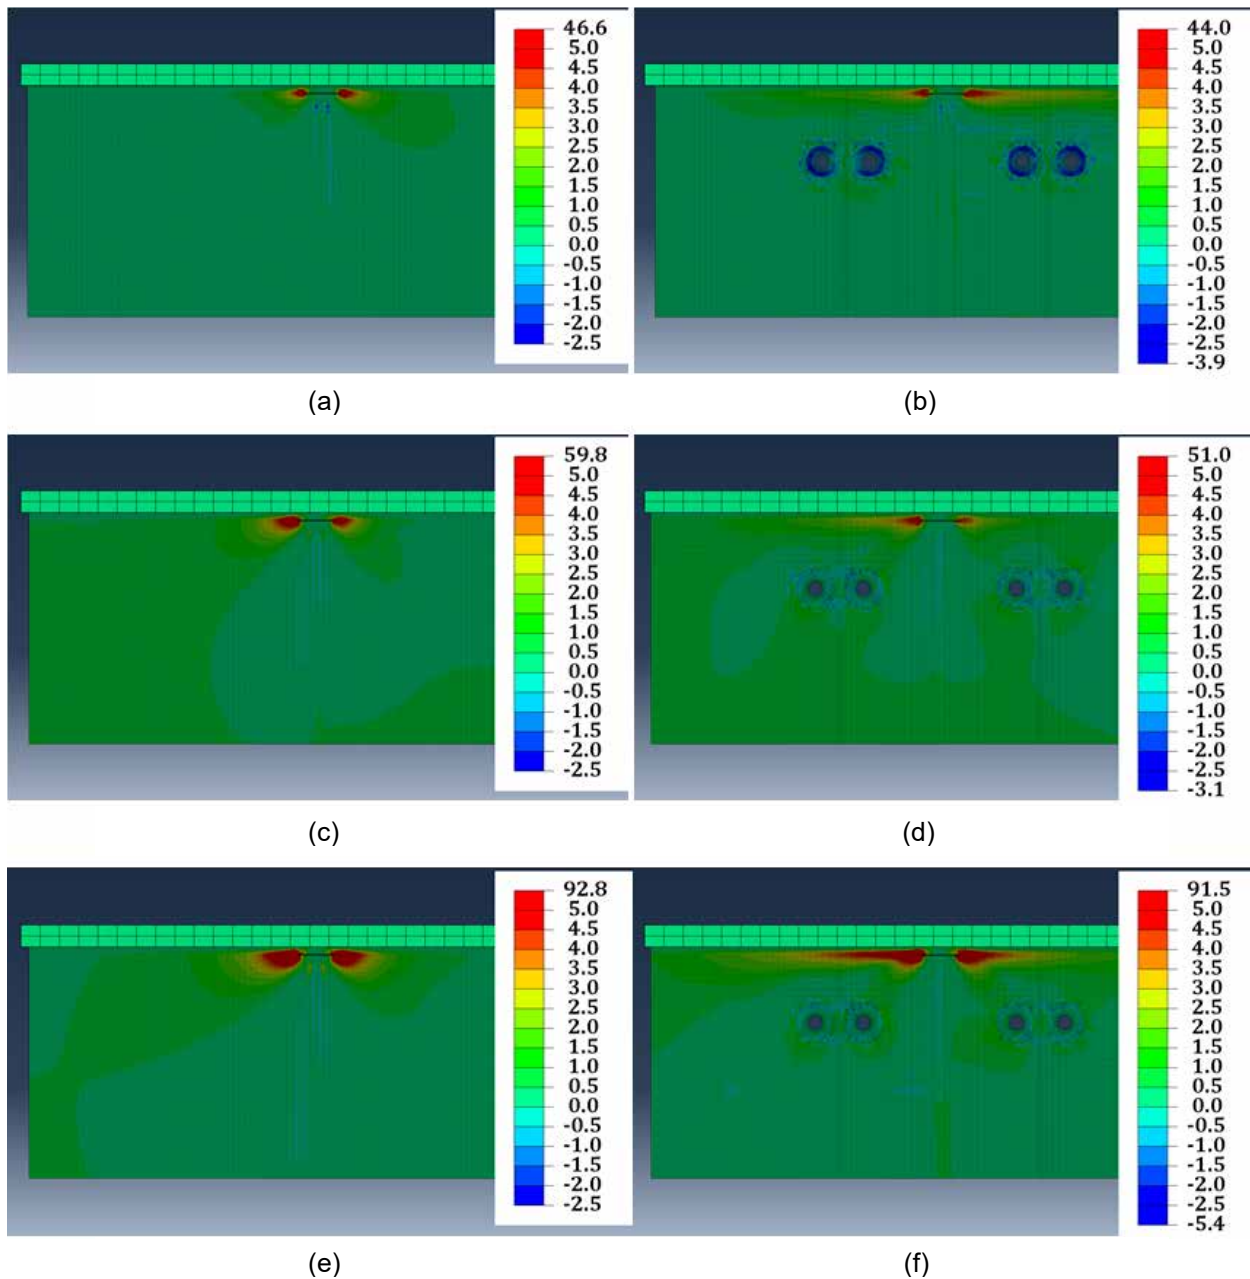
Figure 6.12: Maximum Principal Stresses at Top Web Gap when Only Flange-to-Web Weld Crack is Present for (a) West Load Truck Placement, Before Retrofit (b) West Load Truck Placement, After Retrofit (c) Center Load Truck Placement, Before Retrofit (d) Center Load Truck Placement, After Retrofit (e) East Load Truck Placement, Before Retrofit (f) East Load Truck Placement, After Retrofit

In all cases, stress demands were reduced in the top web-gap region by application of the retrofit. Although stresses were reduced much less when just the flange-to-web weld crack was present, the stress patterns shown in Figure 6.12 indicate that when the flange-to-web weld crack is present, the stresses in the connection plate-to-web weld crack region are also high and are likely to produce the connection plate-to-web weld crack. The same is true for the case with just the connection plate-to-web weld crack with respect to the stress patterns in the flange-to-web weld crack region, as shown in Figure 6.11. These are favorable results in that the appearance of both the connection plate-to-web weld and flange-to-web weld cracks only improves the performance of the angles-with-plate retrofit.
