This appendix describes the interactions of the equipment, starting from the interaction of the colliding locomotives. The interactions of the coupled passenger equipment are described in detail, and an overview is presented of the interactions of the coupled freight equipment.

## Appendix A.2.1: Additional Detail on Structural Damage to Passenger Locomotive and Cars

## Appendix A.2.2: Additional Detail on Structural Damage to Freight Locomotives and Cars

## Appendix A.3: Fuel Tank Damage

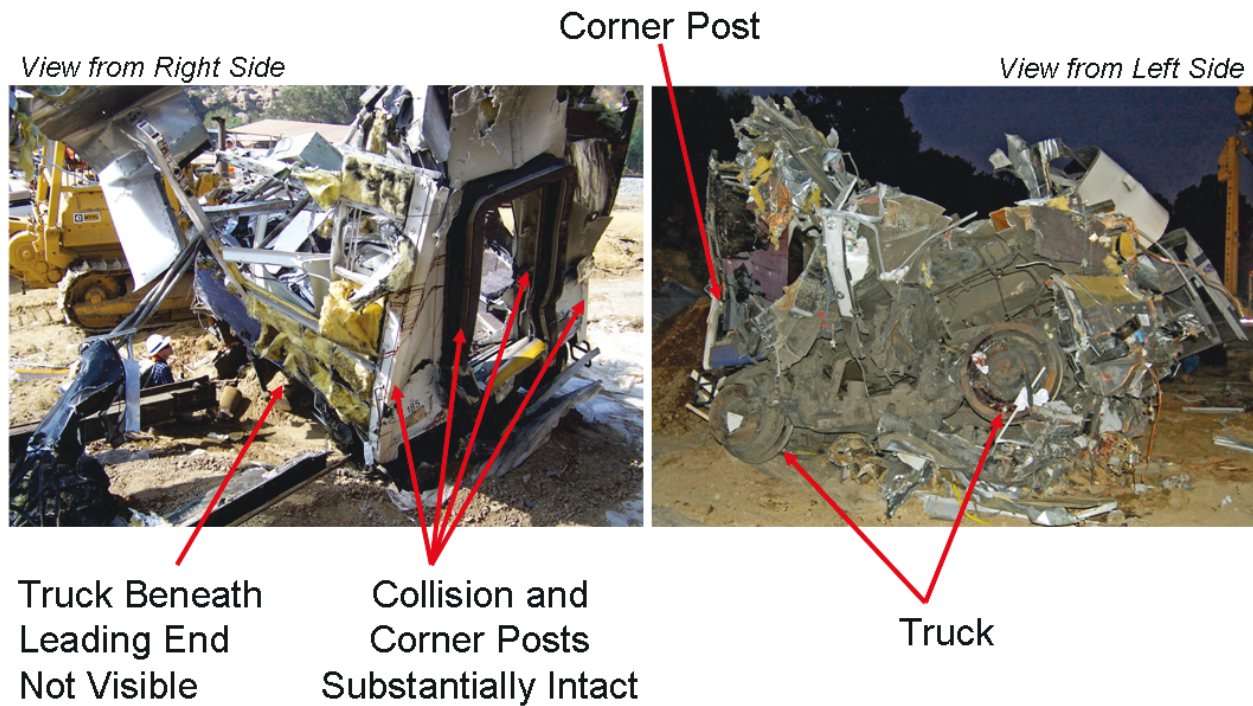
**Figure A.2.1-6. Remains of First Passenger Car Lead End Mezzanine Level**

Figure A.2.1-6 shows the remains of the lead end structure of the first passenger car, including the lead truck. The end frame, including both corner posts and both collision posts, is essentially intact. There is a significant amount of debris compacted onto the remains. The center and side sills of this single-level portion appear to be largely intact. The relatively light roof and sidewall structures have been stripped off, and likely contributed to the compacted debris.

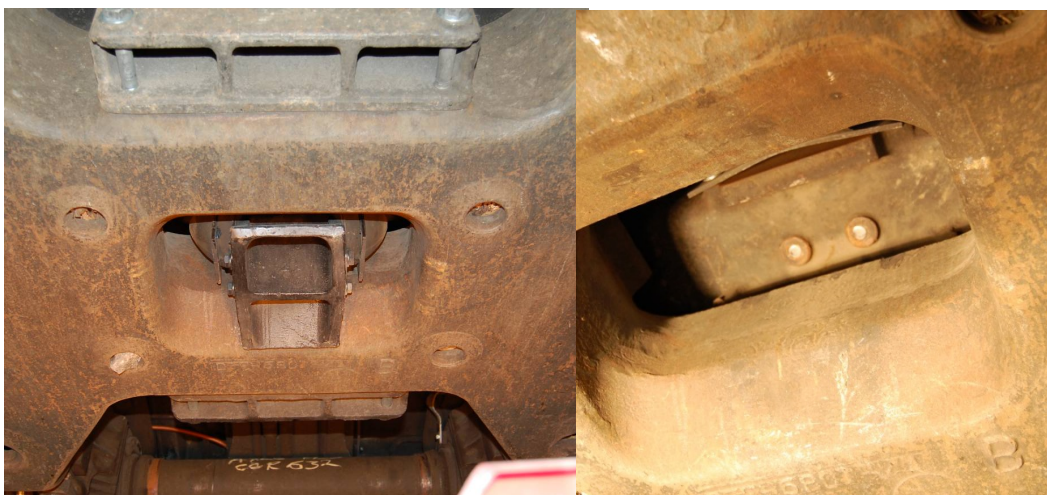
**Figure A.2.1-15. Intact Truck Retention Mechanism**

For perspective, Figure A.2.1-15 provides visual comparisons showing on the left, the intact truck retention mechanism, and on the right, the bolts after an impact in which the truck retention mechanism failed.

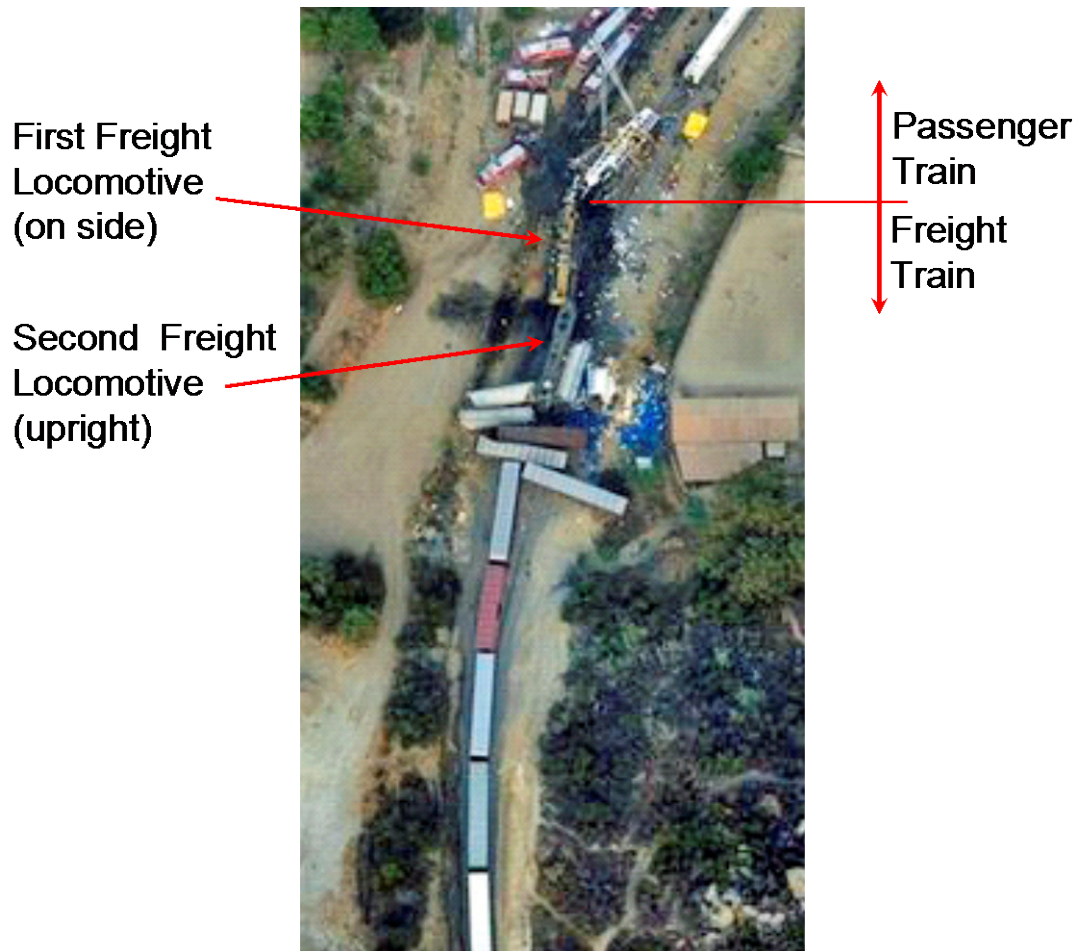
**Figure A.2.2-1. Aerial View of Freight and Passenger Equipment**

The underframes of the freight equipment all remained essentially intact. The principal damage to the lead locomotive affected the ancillary structures on the front end—the draft gear housing, the plow, the breast plate, and the short hood. In the second locomotive, a portion of the roof peeled back, likely caused by an impact with an empty covered hopper car. Seven trailing freight cars stacked up sideways against the trailing end of the trailing freight locomotive, and consequently received damage to their superstructures. Behind the sideways freight equipment, three freight cars derailed but remained upright. These cars received fairly minor damage. The trailing seven freight cars remained upright and on the track, and did not appear to be damaged. Table A.2.2-1 summarizes the structural damage to the freight locomotives and cars.

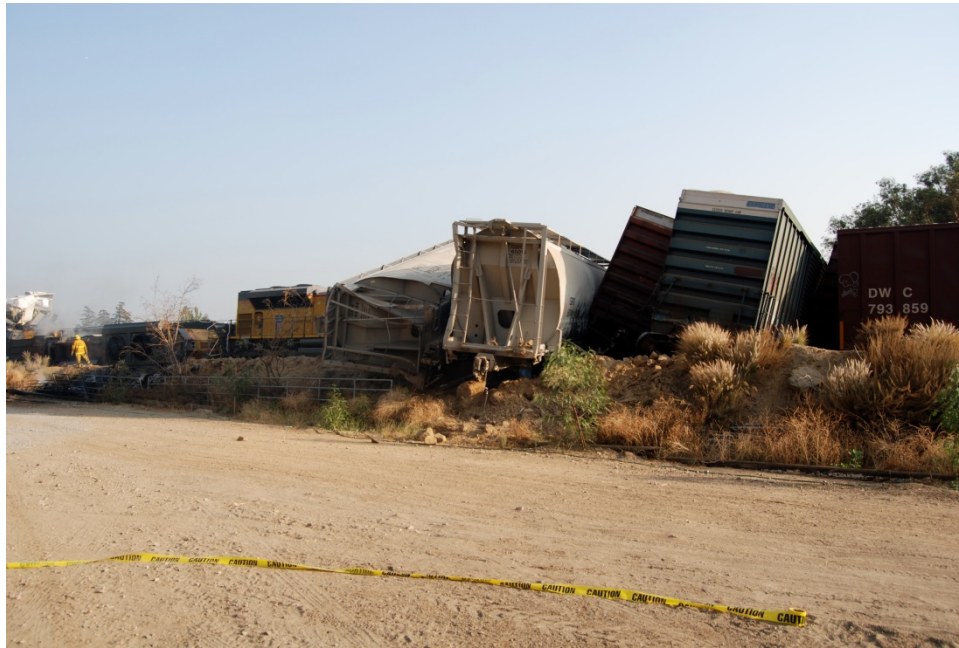
**Figure A.2.2-7. Derailed Freight Cars**

Figures A.2.2-6 through A.2.2-8 show the trailing freight equipment. The second freight locomotive and its damaged roof can be seen in the upper-right portion of the photograph above. The end of the covered hopper car resting on the short hood can also be seen. The end of a second covered hopper car can be seen on the left side of the photograph. Three box cars are then stacked up perpendicular to the track. The next three box cars are upright and derailed. A rail can be seen near the two-people walking up to the middle upright and derailed freight car. The three freight cars near the bottom of the photograph are upright and on the track, as well as the remaining four trailing freight cars, which are not visible in the photograph.

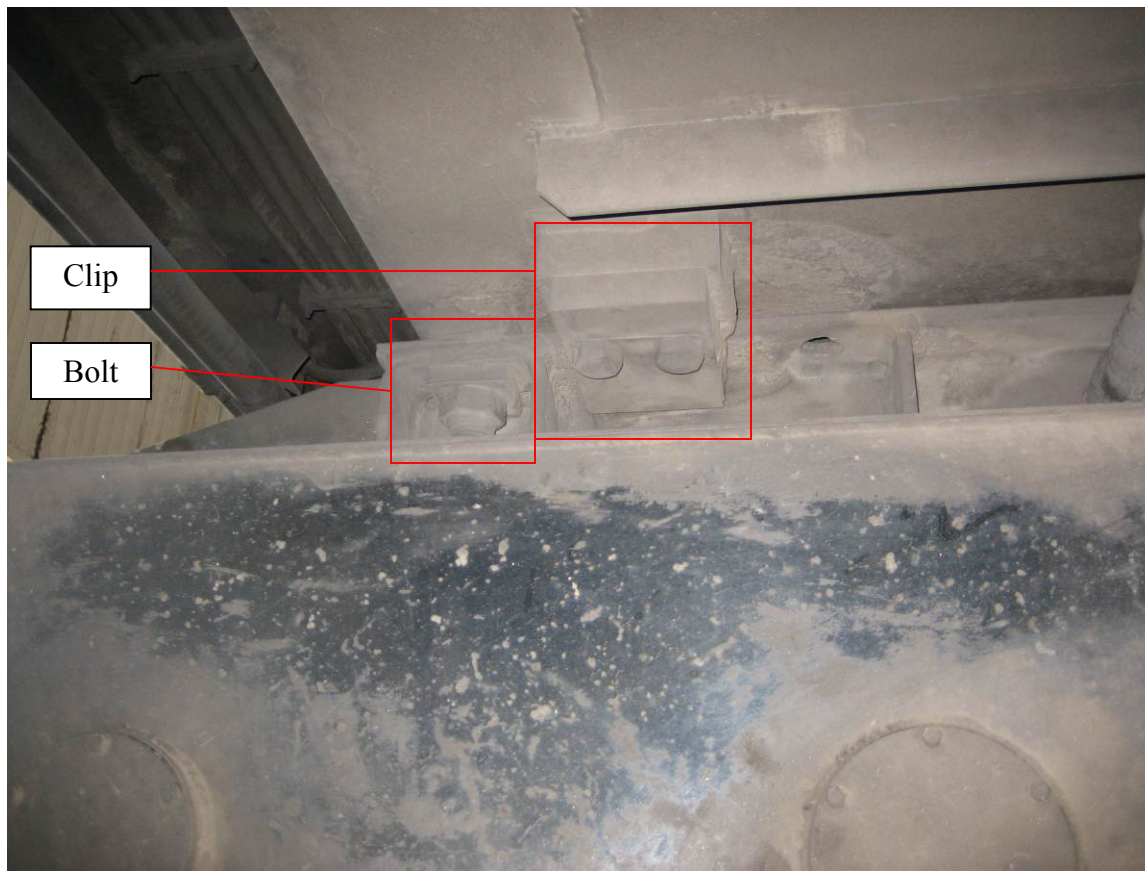
**Figure A.3-2. Fuel Tank Attachment to Underframe**

The fuel tank on this type of locomotive is suspended from the underframe of the locomotive, attached to the locomotive by bolts and clips, as shown in Figure A.3-2. This arrangement is found at the four corners of the fuel tank. The particular location shown in Figure A.3-2 is at the rear of the fuel tank, on the locomotive's left-hand side.

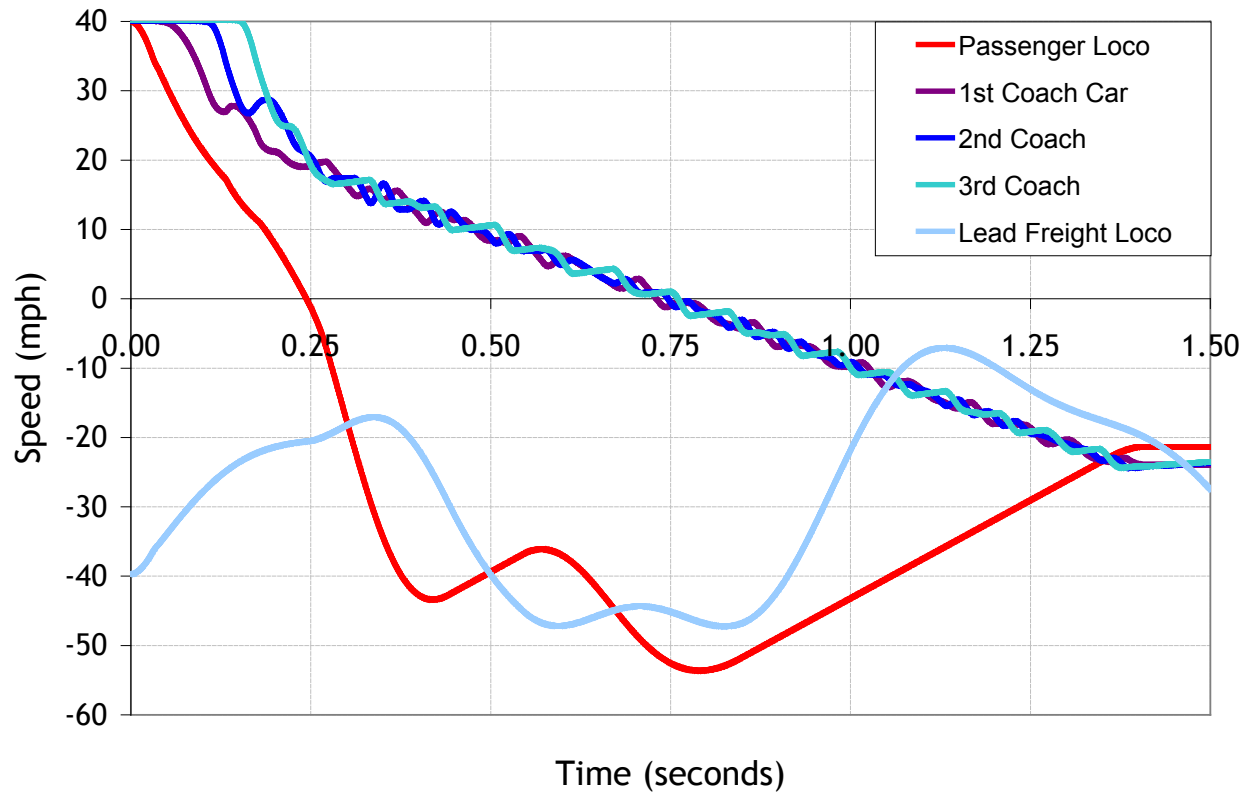
**Figure A.4-4. Velocity-Time Histories for Each Vehicle Starting at the Time of Impact**

Figure A.4-4 shows the velocity-time history of the passenger train and the first locomotive in the freight train. The two trains were traveling toward each other, with a closing speed<sup>3</sup> of about 80 mph. In the first 0.05 seconds after the impact, the passenger locomotive slowed to about 30 mph, a rate of approximately 7.3 gs.<sup>4</sup> There is about a 0.05-second delay before the following passenger cars begin to decelerate. The passenger train then decelerates at a rate of about 1.8 gs. The approximate timing of the simulation collision event correlates to timing estimated from reviewing the onboard locomotive cameras, as described in Appendix A.5.

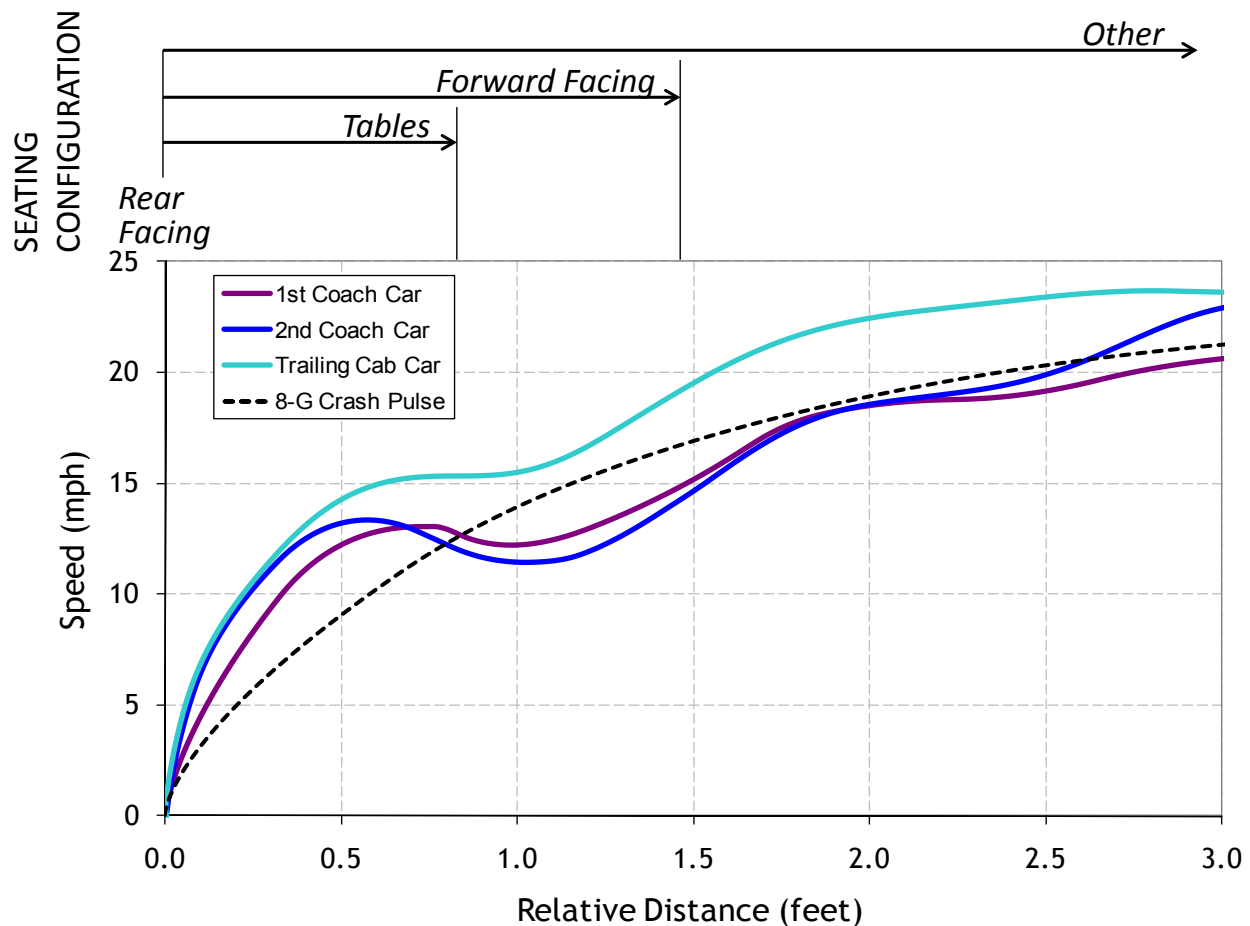
**Figure A.4-5. Secondary Impact Velocities for Each Occupied Vehicle**

Figure A.4-5 shows the SIVs for the passenger train. The horizontal axis at the bottom of the plot represents the distance travelled for an occupant in free flight with respect to the carbody (which varies with seating configuration as shown at the top of the plot). The vertical axis represents the velocity of an occupant in free flight, also with respect to the carbody. The first 0.3 seconds of the gross motions in Figure A.4-4 are used to plot the relevant SIV data for this accident. For comparison, the SIV plot associated with the 8-g crash pulse (used for passenger seat crashworthiness testing) is also plotted in the graph.
