EVALUATION REPORT

FIBER-REINFORCED POLYMER (FRP) PULTRUDED DECKING MATERIAL AND HELICAL ANCHORING SYSTEM FOR USE IN SNOW FENCE APPLICATIONS

Location: Livingston, Montana. Interstate 90, MP-332, Park County

Project No.: IM90-7(63)331

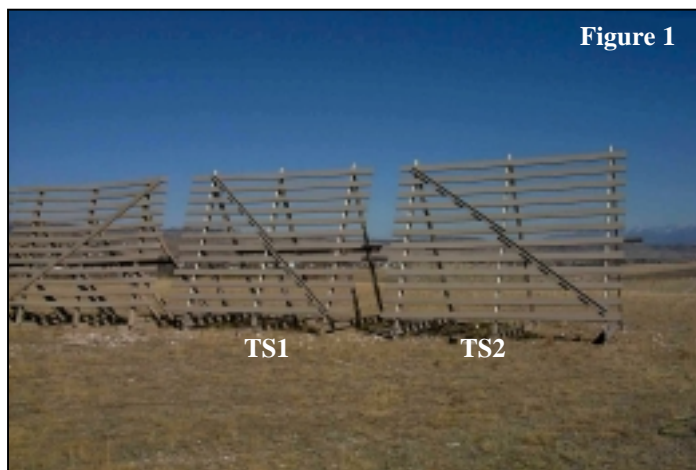
The purpose of this study is to evaluate the feasibility of using a fiber-reinforced polymer (FRP) material in the construction of snow fences. FRP is a process where continuous glass-fiber strands are pulled through a thermosetting polyester resin to form a composite. The main purpose of testing the FRP product is to determine its structural integrity based on MDT's current snow fence design specifications (TS1), especially with the harsh climate these structures are subjected to in the state of Montana. In addition, to compare this material in determining its design function as a possible alternative for MDT current specifications for the construction of snow fences (TS1 vs. TS2). The final purpose was to test the Helical Anchoring System as a reliable ground attachment for snow fences (used in TS2). Inspections are held in early spring and late fall to document the environmental effects of seasonal extremes of the FRP material as well as stability of design. Figure 1 shows section TS1 & TS2.
