# **NATIONAL TRANSPORTATION SAFETY BOARD**

## **RAILROAD ACCIDENT REPORT**

**DERAILMENT OF AMTRAK TRAIN NO. 6  
ON THE BURLINGTON NORTHERN RAILROAD  
BATAVIA, IOWA  
APRIL 23, 1990**

**Abstract:** This report explains the derailment of Amtrak Train No. 6 on the Burlington Northern Railroad at Batavia, Iowa, on April 23, 1990. The safety issues discussed in this report are the lack of consistency, continuity, and comprehensiveness in Burlington Northern's Maintenance of Way Standard Practice Circulars, the efficacy of the rail expansion and contraction tables in Burlington Northern's Maintenance of Way Rules for in-track electric flash butt-welding operations, the propriety of conducting in-track electric flash butt-welding operations and out of face maintenance operations in cold weather, the effectiveness of Burlington Northern's track buckling prevention seminar for the in-track electric flash butt-welding operation, the adequacy of Burlington Northern's supervision of in-track electric flash butt-welding operations and implementation of maintenance of way standards; the ambiguity of Burlington Northern's rail temperature record form, and the lack of temperature quality contro

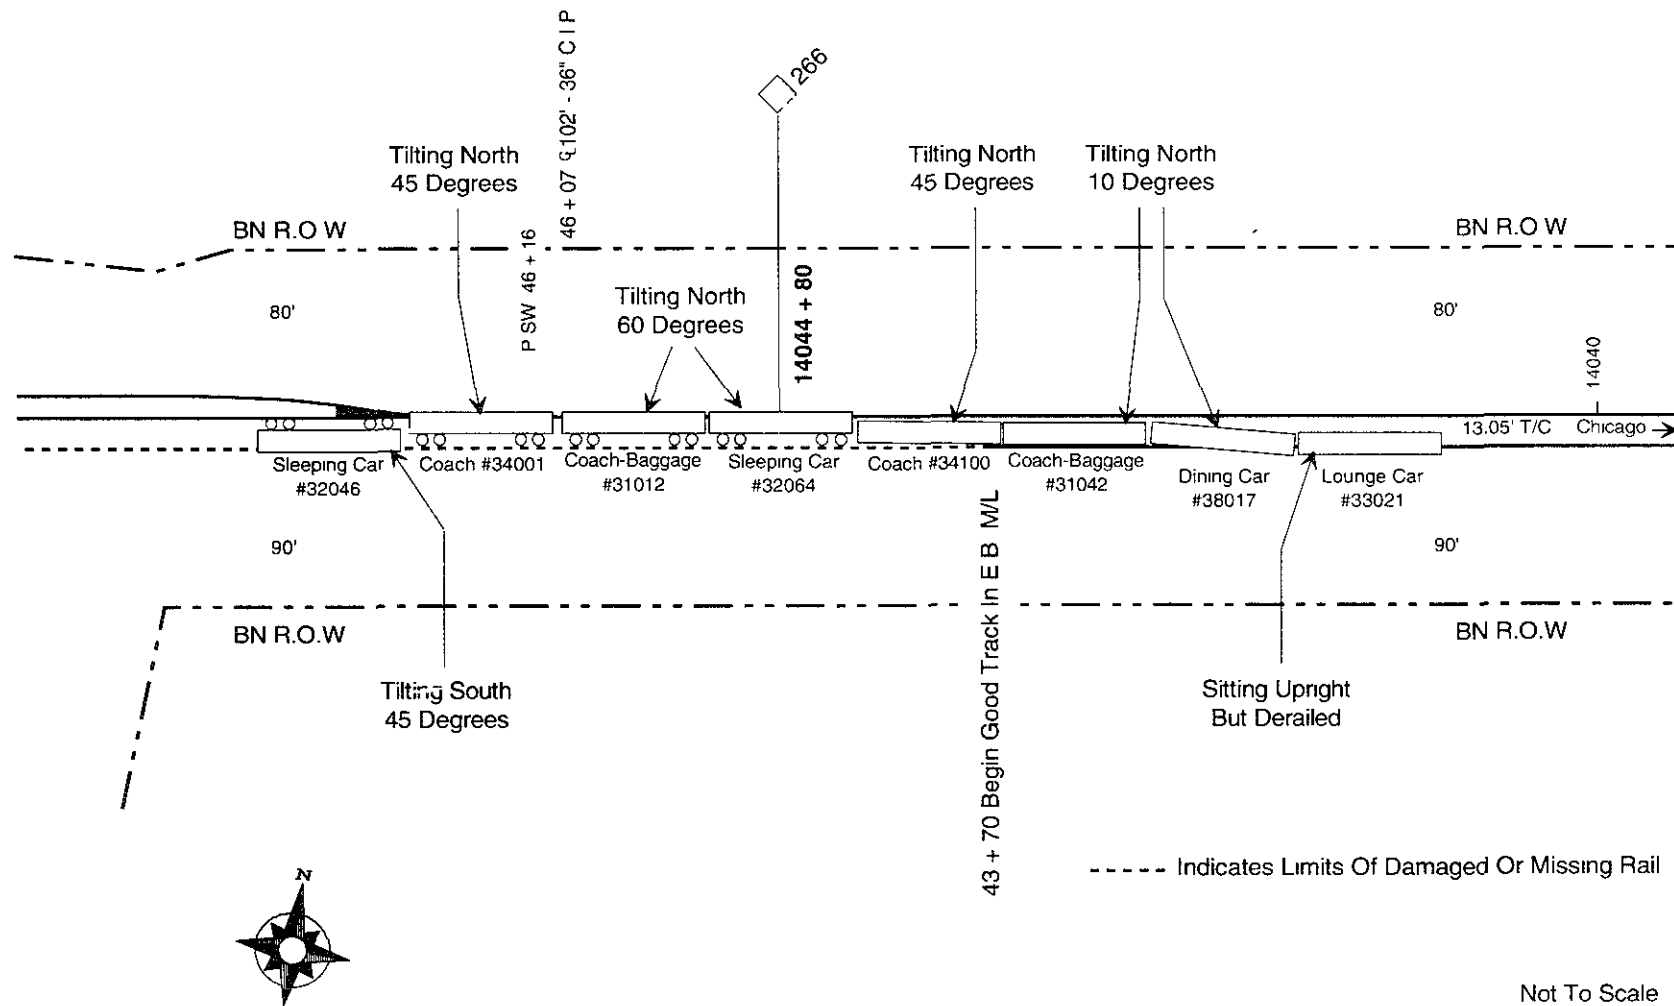
Figure 2.--Accident site diagram

About 1:26 p.m., the last eight cars of train No. 6 derailed on the BN mainline track near MP 266 at Batavia, Iowa. The first derailed car, lounge car No. 33021, remained upright. The other cars, except the last one, came to rest leaning to the north at various angles, the last car leaned toward the south. The eight cars came to rest in a very shallow arc. The lead derailed car was almost centered on the eastbound track and the last car was just south of the eastbound track. The last four derailed cars had struck and sideswiped a gondola<sup>6</sup> car parked on an adjacent siding. None of the derailed cars rolled over on their side, although several leaned severely. The train remained coupled throughout the derailment. (See figures 2 and 3.)

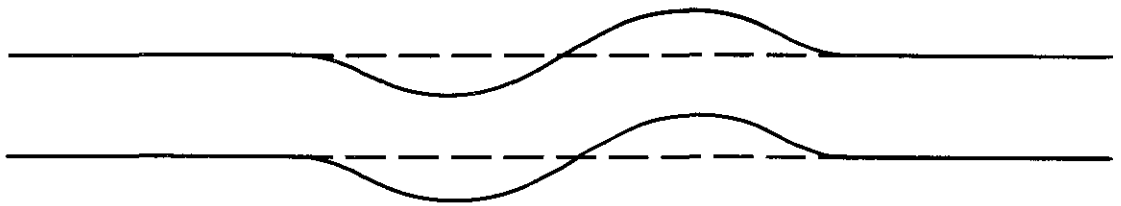
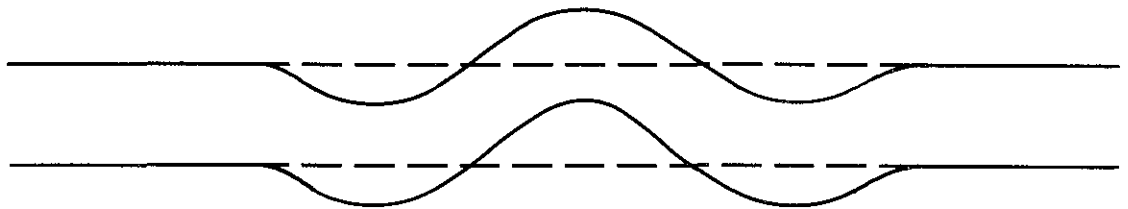
Figure 7 --Types of track buckles

Track buckling is also referred to as a "sun kink," and usually takes two forms or shapes in straight track--an "S" shape with symmetrical lobes on each side of the track centerline or a "longhorns" shape that has a small lobe on each end of the buckle on one side and a large center lobe on the other. (See figure 7.)

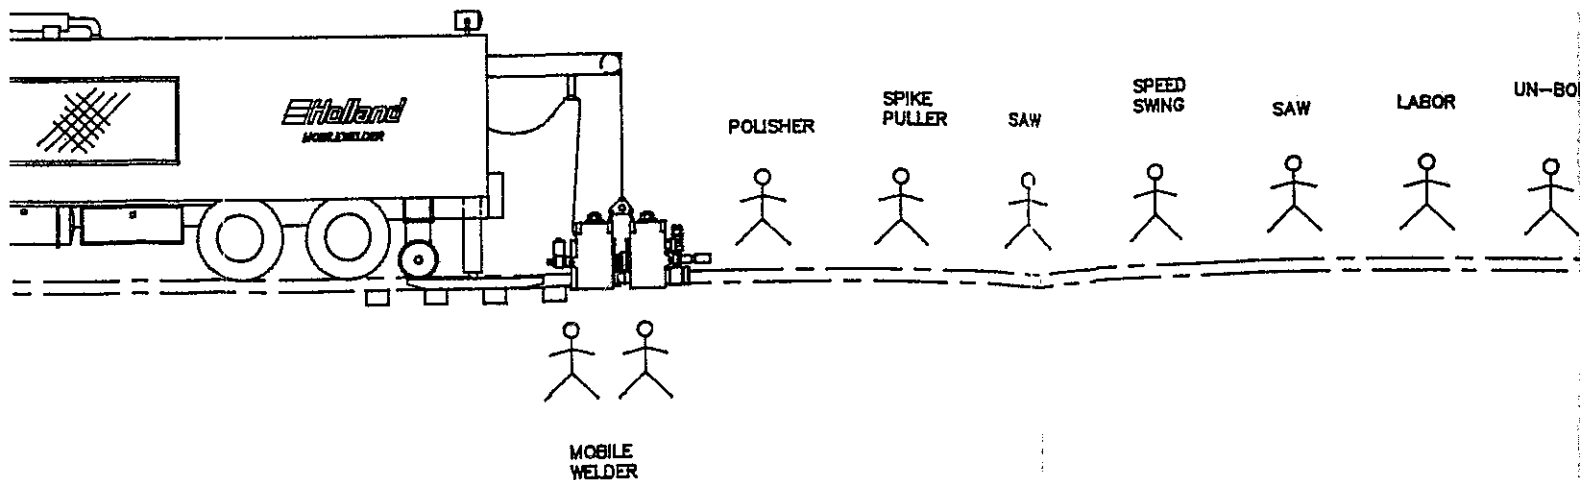
Figure 12. -- Holland welding gang.

**Welding Gang No. 41** --A Holland welding gang had performed much of the rail welding in the Batavia area. The BN has one welding gang that performs in-field production welding of rail or creates CWR on-site. All other CWR installations on BN are done by "steel gangs" who only install or "lay" 1/4-mile lengths of rail. The Holland welding gang comprises a general foreman, two assistants (foremen), and 56 machine operators and laborers, who operate two Holland welding trucks and miscellaneous support machines. The gang is split into two duplicate groups that work simultaneously about 1/4 mile apart on each of the track rails. (See figure 12.)
