REPORT NO. 3523

CHICAGO, MILWAUKEE, ST. PAUL AND PACIFIC  
RAILROAD COMPANY

IN RE ACCIDENT

NEAR SUPERIOR, MONT., CN

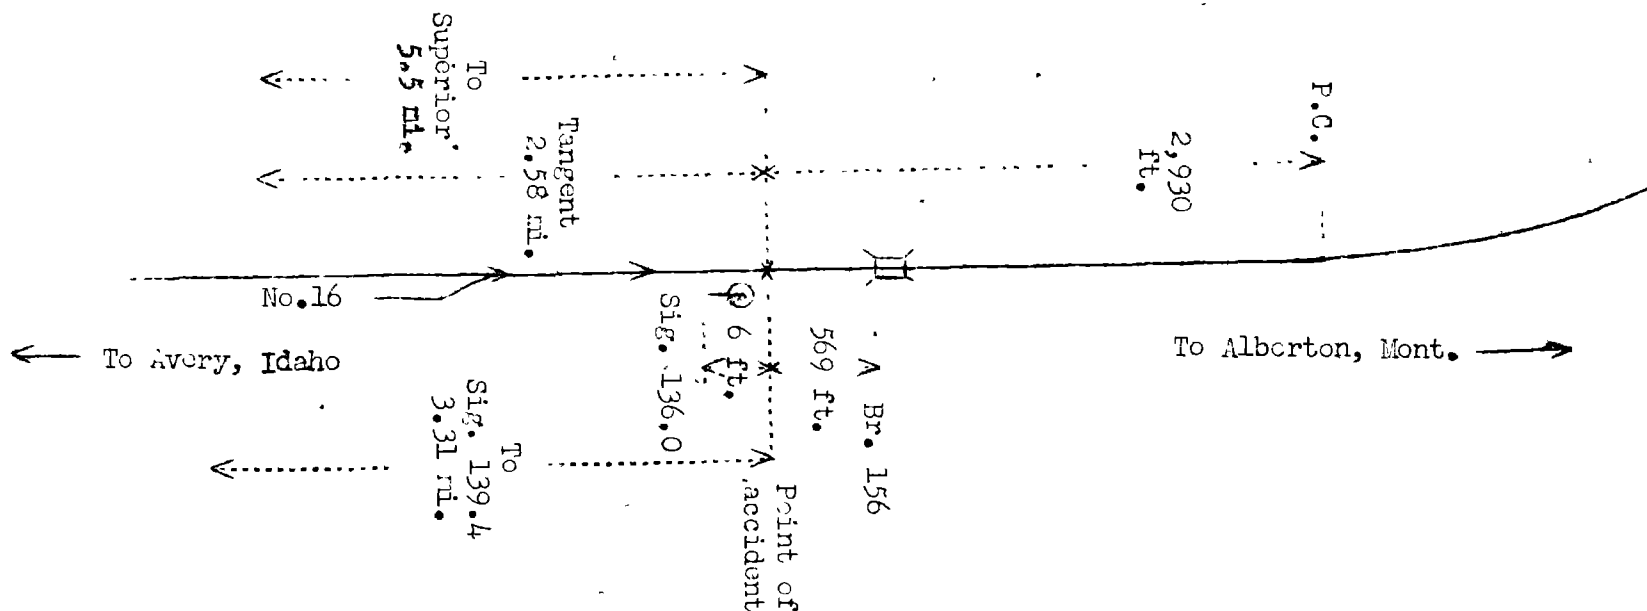
Sketch showing broken rail-south side of track

After the accident occurred two adjoining rails in the south side of the track were found to be broken. The west rail was broken over a tie at a point 17 inches west of the leaving end of the rail. The east rail was broken at a point 13-3/4 inches east of the receiving end of the rail. Both breaks were square. Batter on the head on each side of the break in the west rail indicated that movements in each direction had passed over the rail after the break occurred. The tie under this break was plate-cut and somewhat deteriorated under the tie plate. The next tie to the east, which was directly under the joint between the rails, was sound and firmly tamped. Apparently when the wheels of the locomotive of No. 16 struck and depressed the broken end of the west rail, the east rail was broken beyond the tie under the joint. The bolts and joint bars remained in place, but after the east rail was broken the 30-3/4-inch section of rail between the breaks was displaced from the track. The rail in which the initial break occurred was manufactured by the Inland Steel Company in July 1925. It bore heat number 4, 16767 G. The surfaces of the fracture were battered and worn to the extent that it was impossible to ascertain whether a fissure existed. From the examination which could be made, it appeared that the rail was free from defects.

The joint between the broken rails was insulated. In territory on this line over which trains are propelled by electric current, three bond wires are used on each side of each insulated joint. These wires are attached to the rail by channel pins inserted in 3/8-inch holes through the web. The rail in which the initial break occurred was broken through the middle hole. The bond wire west of the break remained in place, and as a result the operation of the automatic block-signal system was not affected.
