Office of Research, Development and Technology Washington, DC 20590 Ground Penetrating Radar (GPR) Technology Evaluation and Implementation: Appendices A Through F

DOT/FRA/ORD-20/18

Final Report May 2020

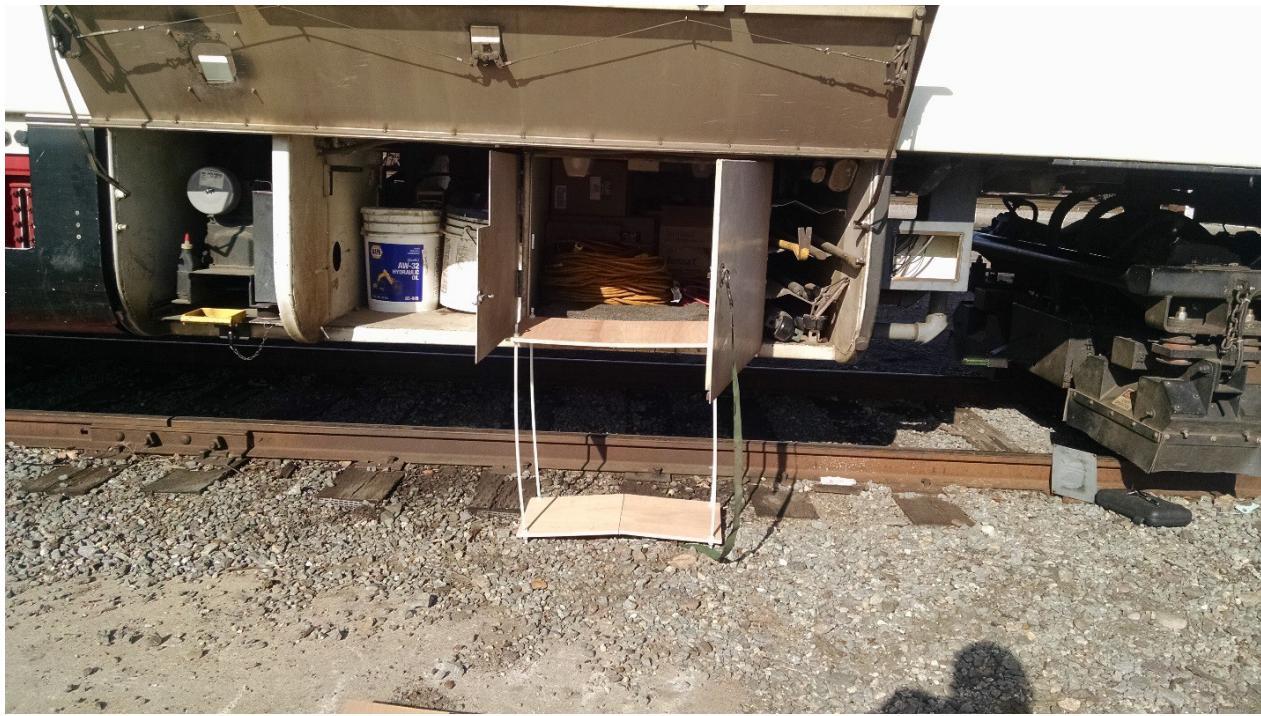
Figure A 1. DOTX220 storage compartment with plywood mockup of 2 GHz antenna

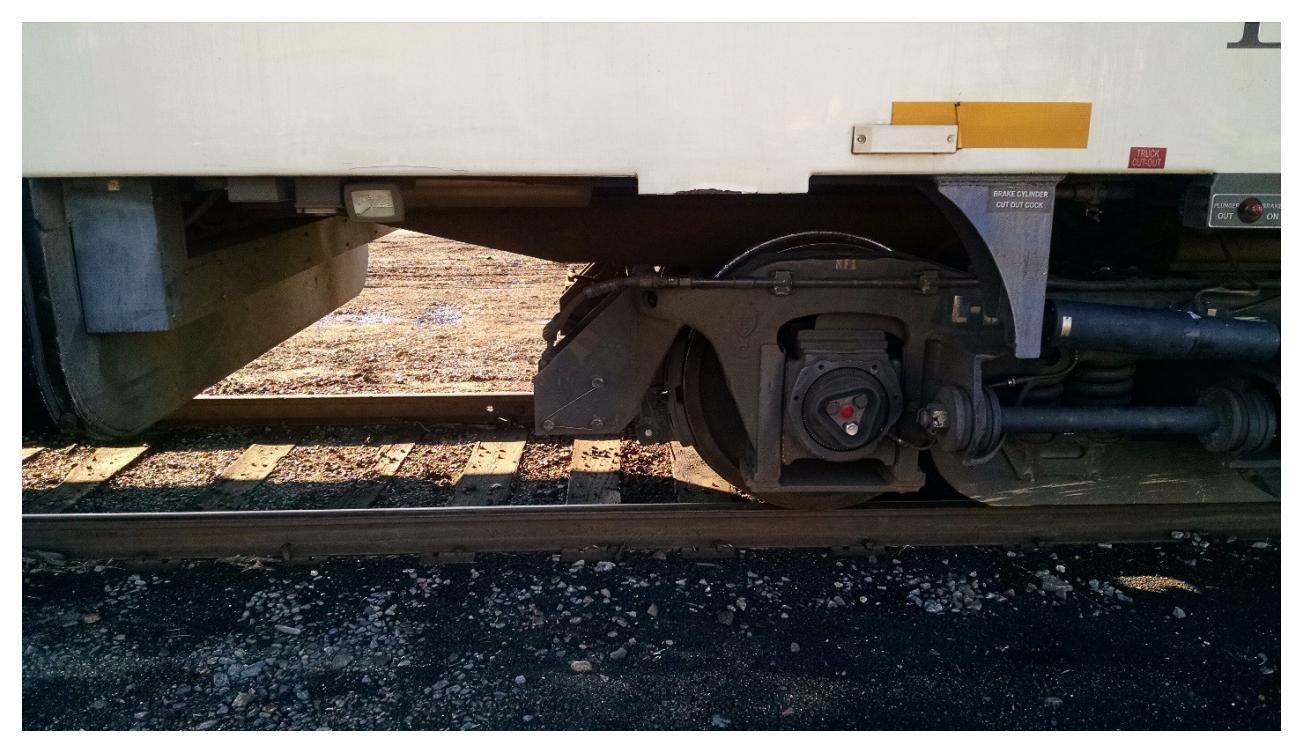
Figure A 2. DOTX220 available space between tank and rear truck

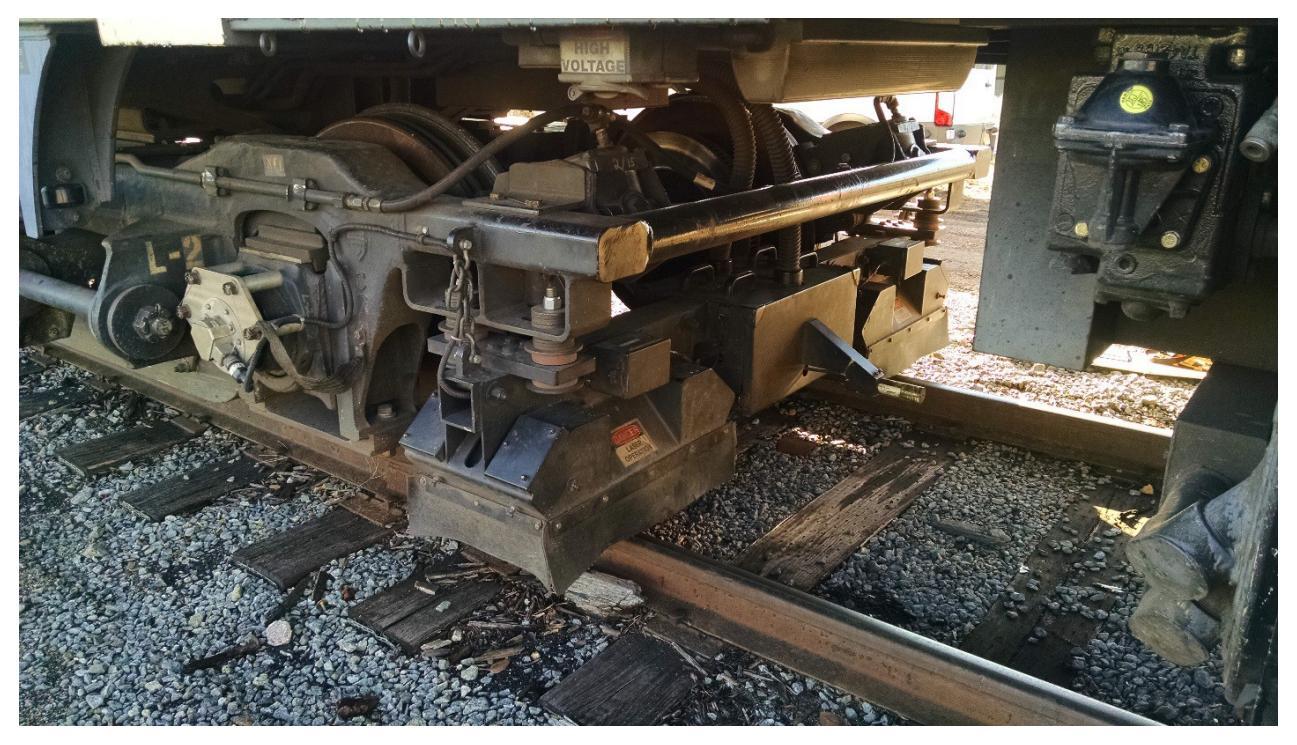
Figure A 3. DOTX220 TG measurement system with ALD detector

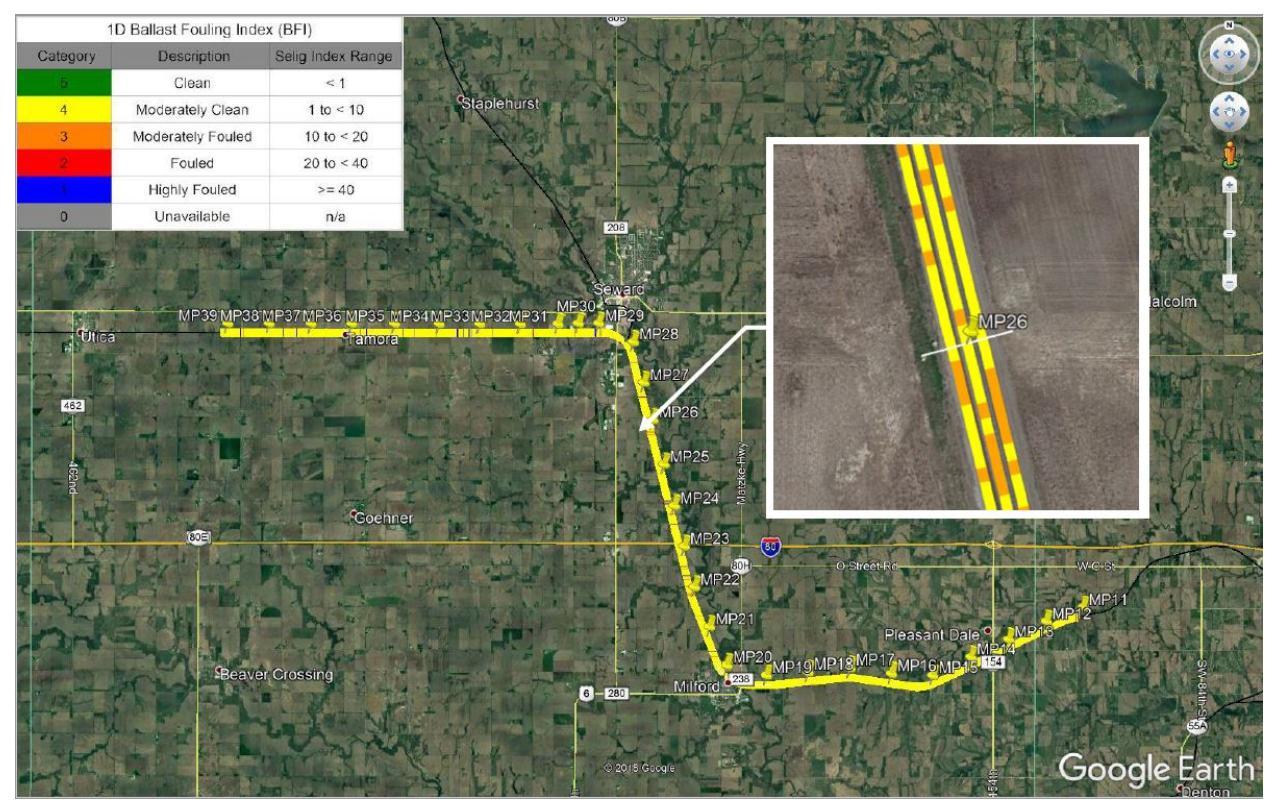
Figure B 1. BFI with train insert

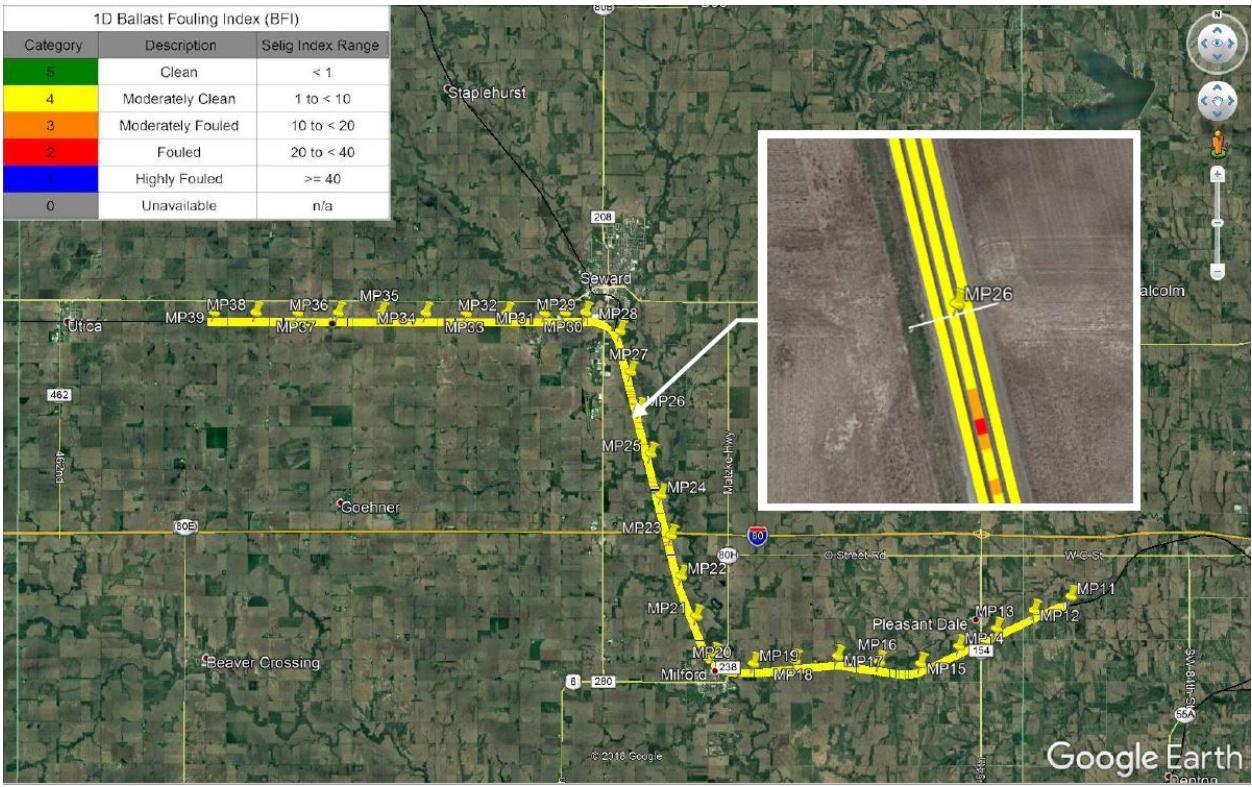
Figure B 2. BFI truck with insert

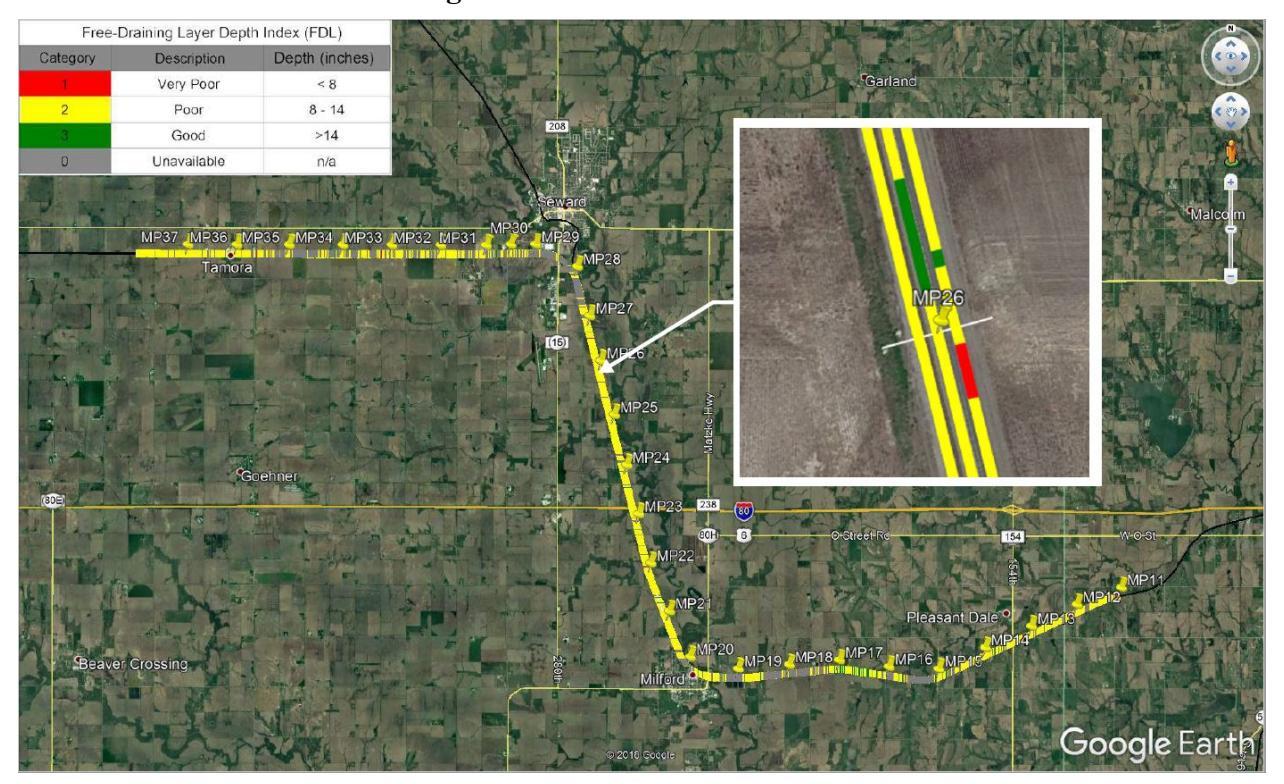
Figure B 3. FDL train with insert

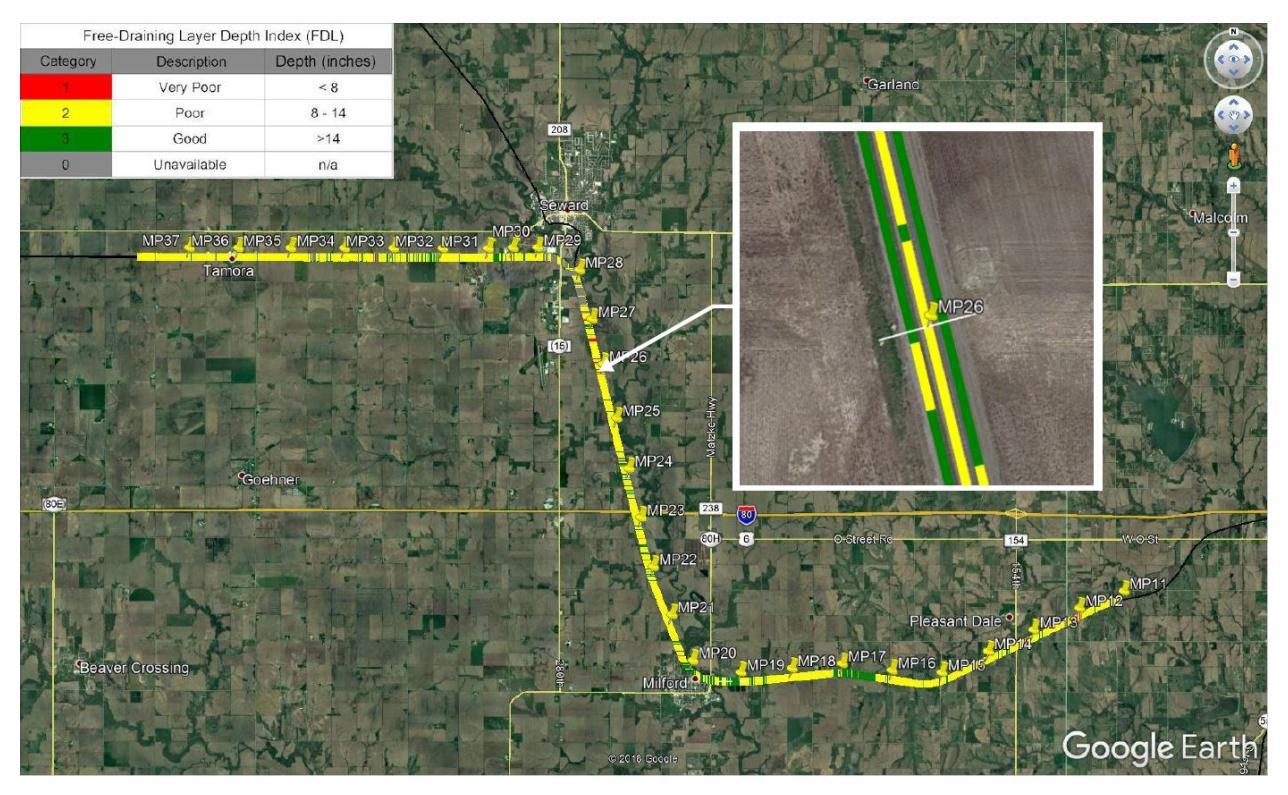
Figure B 4. FDL truck with insert

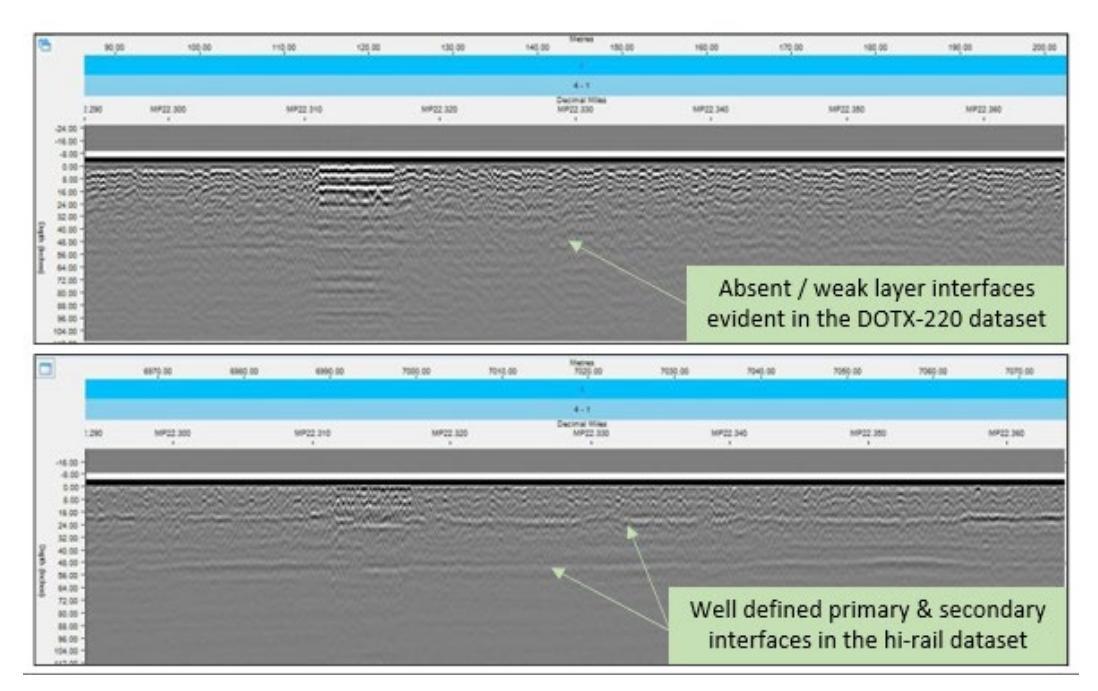
Figure E 13. (Top) DOTX220, (bottom) hi-rail

- Comparison of center 400 MHz data from hi-rail at the bottom and DOTX220 at the top over section of concrete ties on Main 1 around MP 22.330
- The primary and secondary layer interfaces evident in the hi-rail data are less apparent in the DOTX220 data, which also suffers from increased interference in the near-surface (~0–12").

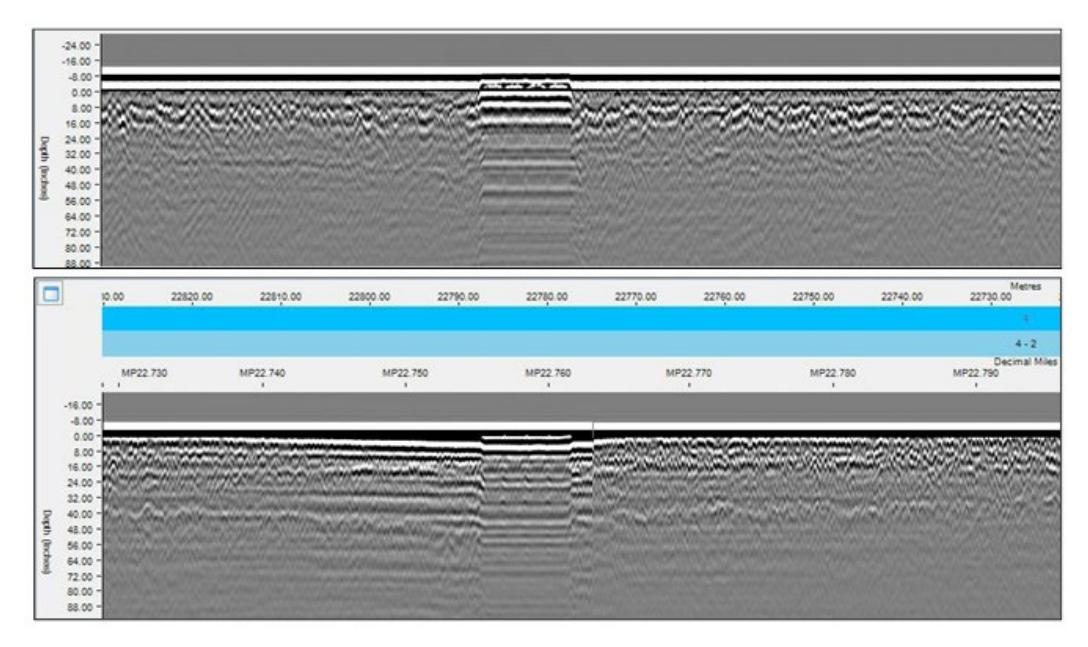
Figure E 14. (Top) DOTX220, (bottom) hi-rail

• The 400 MHz data from DOTX220 at the bottom acquired over wood ties on Main 2 is similarly of reduced quality in terms of definition of subsurface layer interfaces when compared to the hi-rail dataset.

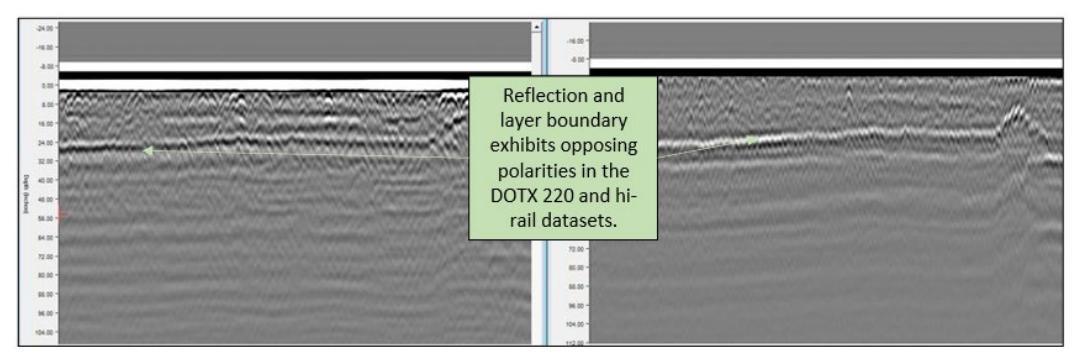
Figure E 15. (Left) DOTX220, (right) hi-rail

- Where layer reflections are observed in the DOTX220 400 MHz dataset the polarity of the reflection is reversed compared to the same reflection in the hi-rail data.
- This points to a potential problem with the 400 MHz antenna on DOTX220 during the Ravenna survey.

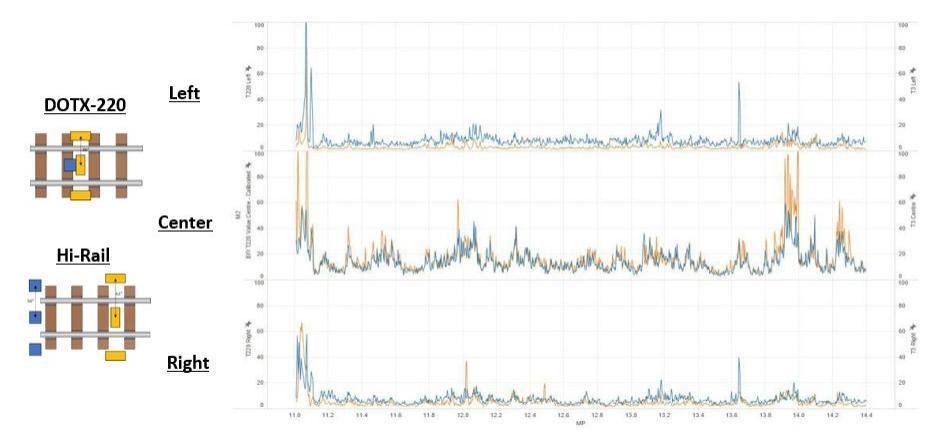
Figure E 18. Comparison of the BFI results for all three channels

• Comparison of the BFI results for all three channels from the truck (orange) and the DOTX220 (blue) in areas of wood ties indicates the

shoulders are generally slightly more fouled, particularly on the left shoulder. Results below are from Main 2 between ~MP 11.0 and MP 14.4.

• This is attributed to the closer proximity to the more fouled rail seat of the shoulder antennas on the train.

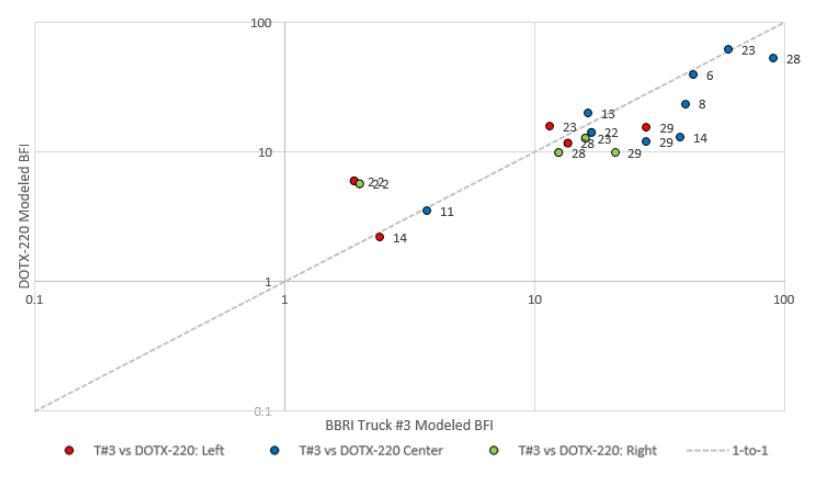
Figure E 20. A comparison of the modeled BFI obtained on the hi-rail truck and DOTX220

- The plot below presents a comparison of the modeled BFI obtained on the hi-rail truck and DOTX220 for all center samples acquired over wood and concrete ties together with the shoulder samples over wood ties on Main 2.
- Except for the shoulder data from Location #22, the match is considered to be good.

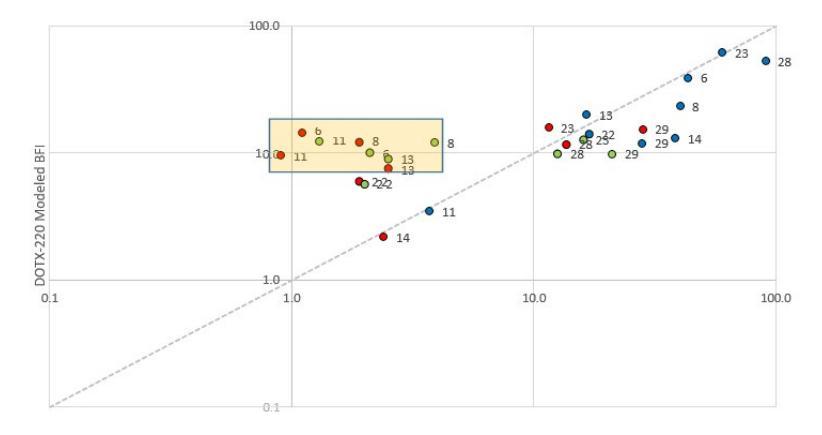
Figure E 21. Residual interference attributed to shoulder antennas on the two vehicles

- Samples acquired on the ballast shoulders over concrete ties—exclusively Main 1—sit above the 1- to-1 line, indicating a discrepancy between the train and hi-rail results.
- Whilst this discrepancy may be partly due to the different positions of the shoulder antennas on the two vehicles it is also attributed to residual interference observed within the DOTX220 dataset.

- To address the issues identified with the DOTX220 datasets the following recommendations are made: Consider moving the shoulder 2 GHz antennas up by ~50 mm to take advantage of the increased width of the Plate C clearance envelope at 360 mm above top of rail. This is illustrated in the figure below.

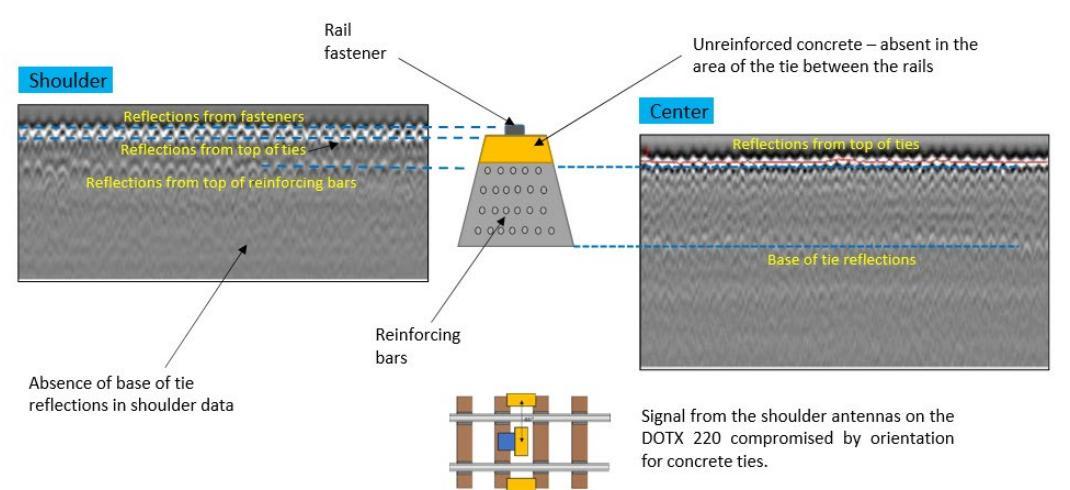
Figure E 24. Interprets provenance of each reflection interface identified within the shoulder and center datasets from DOTX220

• The diagram in Figure E 24 further illustrates the interpreted provenance of each of the reflection interfaces identified within the shoulder and center datasets from DOTX220 that are attributed to the ties:

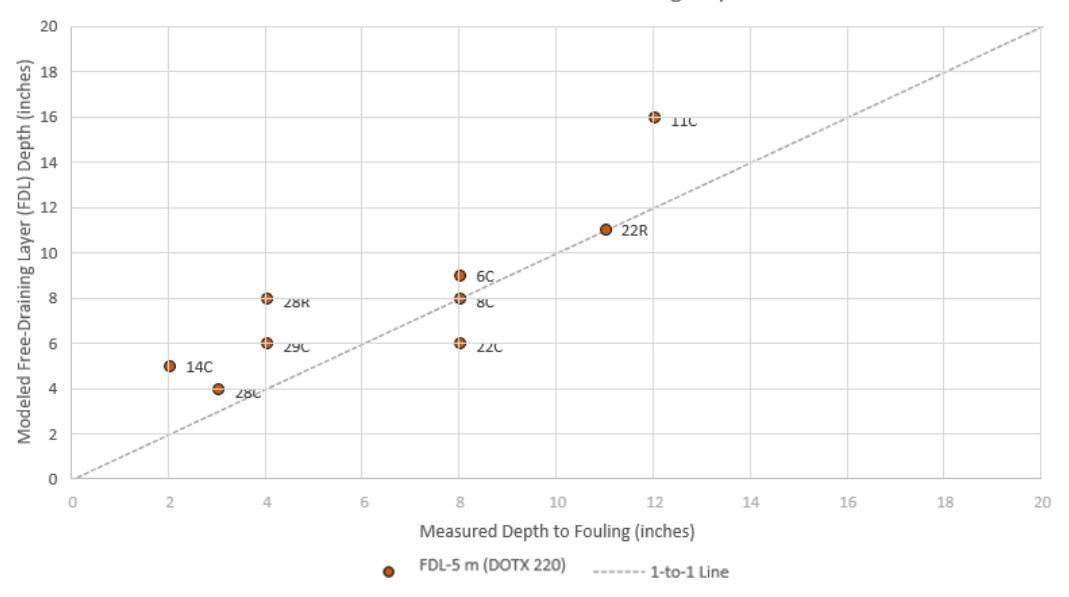
Figure E 27. Modeled FDL vs. measured fouling depth

- The modeled FDL generally shows good correlation with the measured . fouling depth.
- The R2 value for a linear best fit through results acquired in the center • over both wood and concrete ties and over wood on the shoulders is \sim 0.77.

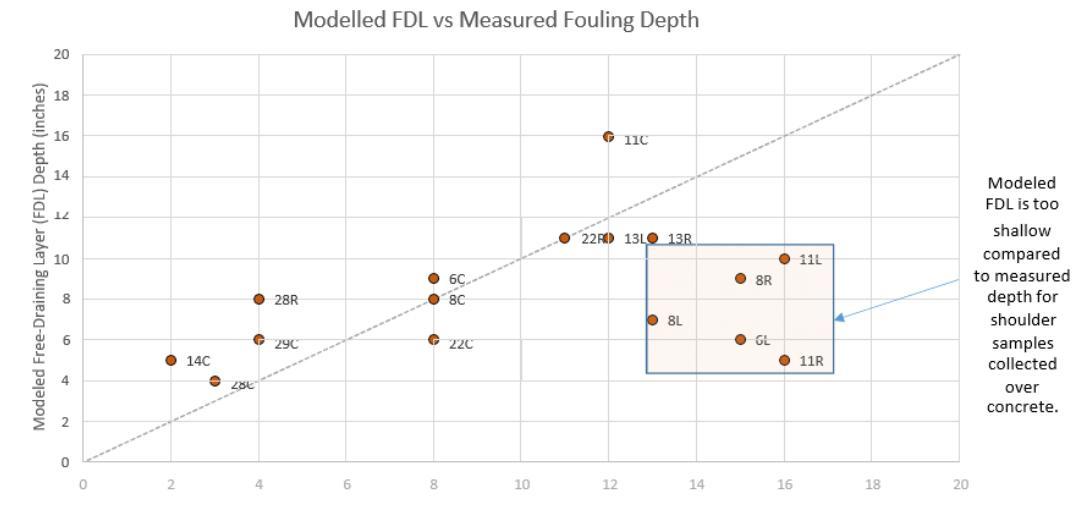
Figure E 28. Modeled FDL vs. measured fouling depth samples from Main 1

Samples acquired on the ballast shoulders over concrete ties, exclusively • Main 1, are also affected by the residual tie interference previously discussed, with the points lying below the 1-to-1 line.

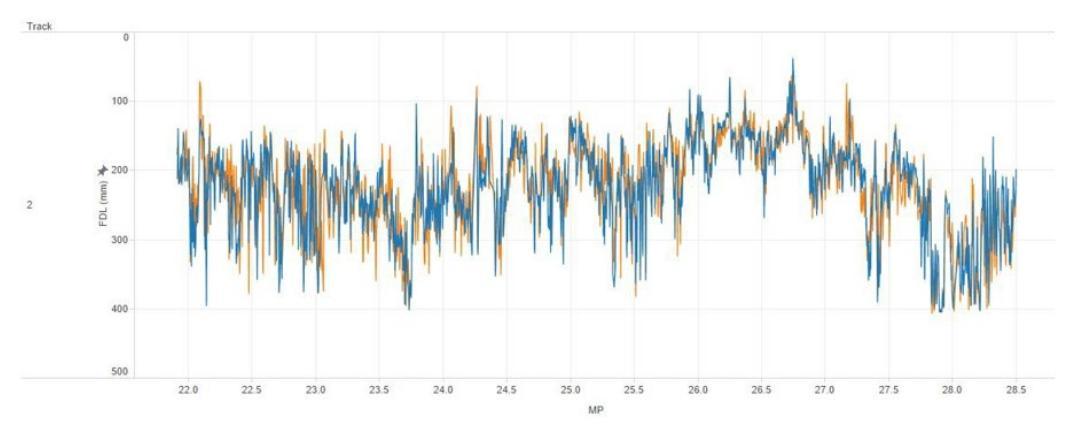
Figure E 29. Modeled track center FDL from DOTX220 (blue) and the hirail GPR truck (orange)

Modeled track center FDL from DOTX220 (blue) and the hi-rail GPR • truck (orange) for the main sampling area on Main 2. The agreement is excellent.

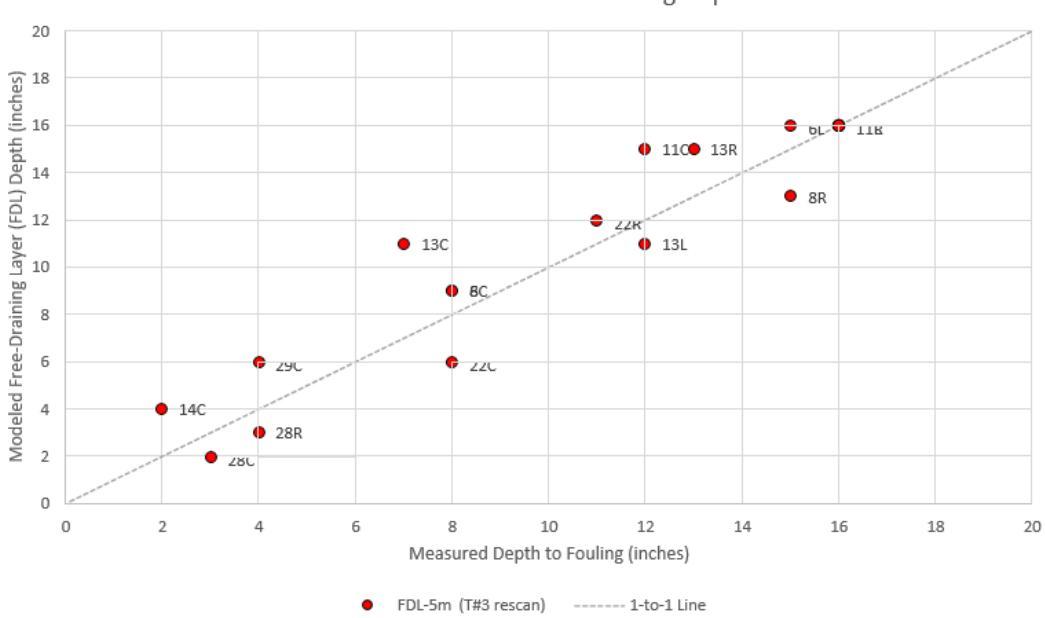
Figure E 30. Modeled FDL vs. measured fouling depth R2 value

Modeled FDL derived from the hi-rail truck datasets show improved . correlation to measured fouling depth compared to the DOTX220 data. The R2 value for the linear best fit line through all the data points is \sim 0.88. Shoulder data unaffected by interference over concrete ties.

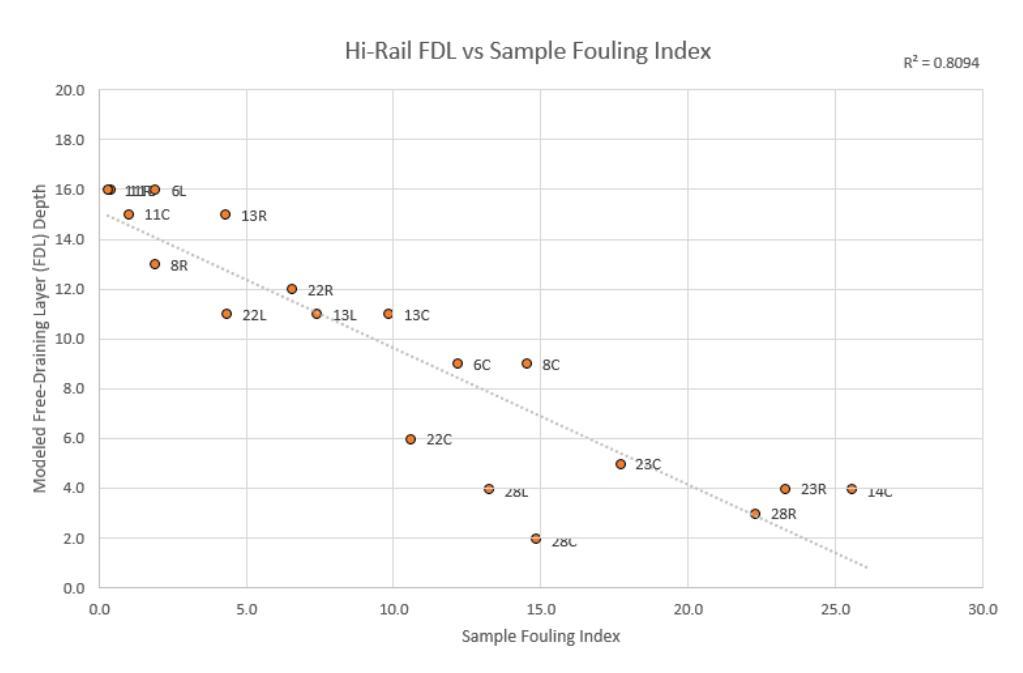
Figure E 31. Hi-rail FDL vs. sample fouling index

• Plotting modeled FDL against sample fouling index for the hi-rail data indicates a better correlation than is observed with modeled BFI vs sample fouling index.

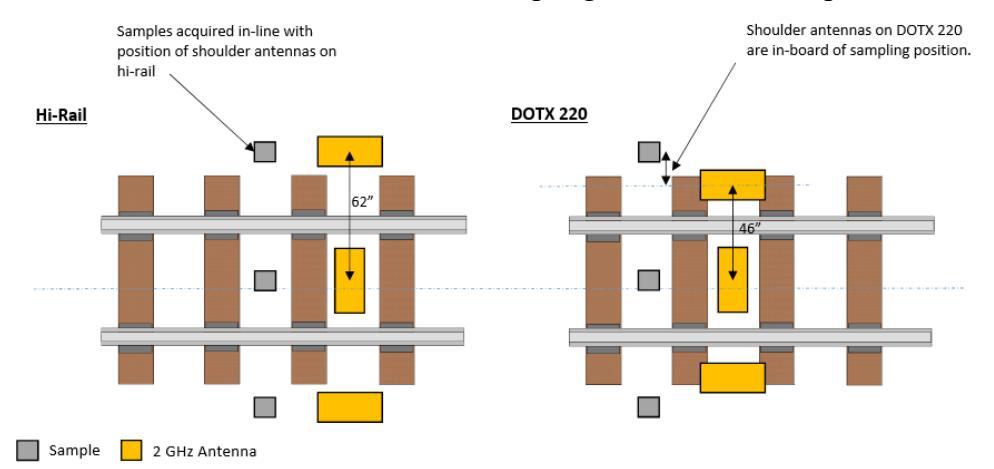
Figure E 33. Relative positions of the 2 GHz shoulder antennas and the sampling tubes on the two platforms

• As discussed, the improved correlation between the hi-rail FDL results and the measured fouling depth, compared to the equivalent with the DOTX220 results is likely to be in part due to the relative positions of the 2 GHz shoulder antennas and the sampling tubes on the two platforms:

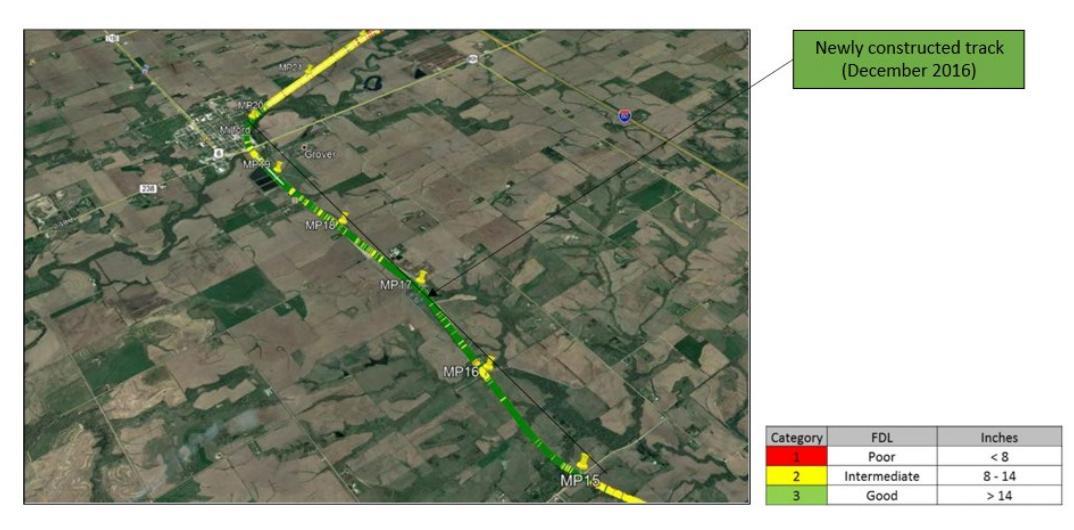
Figure E 34. Google Earth image of modeled FDL from DOTX220 on Main 1

- Google Earth image of the modeled FDL from DOTX220 on Main 1 through the section of new track between Milford and Pleasant Dale illustrating good depth to the base of clean ballast.
- The average FDL on all three data channels exceeds 14 inches.

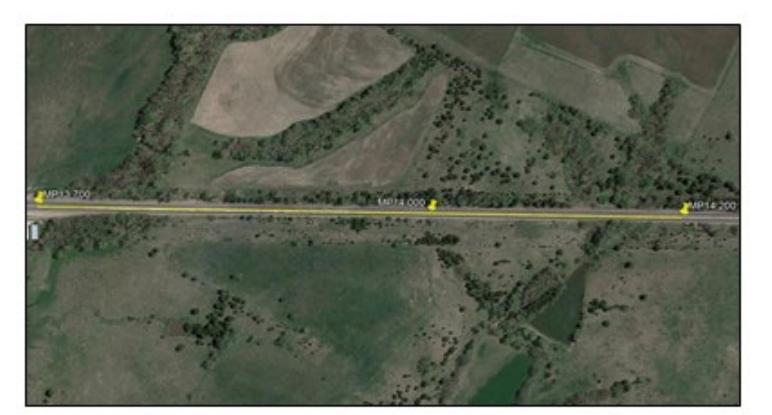
Table F 1. Trackbed inspection report summary

Trackbed Condition Summary	The general condition of the trackbed within this 1/2 mile is classified by the Combined Trackbed Quality Index (CTQI) as Good, with relatively low levels of ballast fouling (predominantly CAT 4 - Moderately Clean) on all three data channels (left & right shoulders and track center) and a Good to Poor free-draining layer depth of between 8 to +16 inches. Short sections of Moderate to Poor quality trackbed are associated with localized defects (see below). Increases in track geometry Profile and Twist have been identified at a number of locations within this section but all lie within exception limits for the posted track speed / class.
Trackbed Layer Summary	A well-defined Primary layer interface interpreted as the base of clean ballast, has been identified in the track center for the majority of the 1/2 mile and less continuously on the ballast shoulders. With the axception of a number of identified ballast defects, the modeled depth to the interface is generally at or close to design depth, lying at between 16 - 20 inches from surface. Through much of this section, local increases in reflection strength on the primary interface and attenuation of the GPR signal in the underlying materials suggest that the sub-grade is likely to comprise relatively moist, cohesive materials. On the right shoulder, the Primary interface is generally absent and is instead replaced by a more uniform Secondary interface lying at modeled depths of between 24 - 28 inches. This interface is interpreted as the base of sub-grade. Between ~MP13.700 and MP13.780 it is additionally evident within the track center and on the right shoulder.

Trackbed Defects Summary	MP13.774 - MP13.785, MP13.840 - MP13.852, MP13.855 - MP13.879, MP14.060 - MP14.018, MP14.149 - MP14.158 - Ballast pockets: These are characterized by localized increases in the depth to the Primary layer interface of between 4 - 8 inches indicative of possible locally soft subgrade / soil conditions. They are predominantly observed within the track center. The three anomalies between MP13.774 and MP13.879, are associated with an apparent cross-cutting drainage feature and may be associated with an unidentified cross-track culvert or pipe. A similar pocket has been identified at the same location in the GPR data acquired on Main 2 (see TBIR# ZR0345_2017_0002). MP13.080 - MP13.801 - MP13.801 - MP14.019, MP14.091 - MP14.115 - Subgrade pumping / failure, mud spot development: These defects are characterized by localized reductions in the modeled depth to the Primary layer interface, indicates that a slight deterioration in track geometry Wall.399. MP13.999. MP14.080 - MP14.069 - MP14.115 - Subgrade pumping / failure, mud spot development: These defects are characterized by localized by localized with an apparent cross-cutting drainage for the site and may be associated with an and the GPR data acquired on Main 2 (see TBIR# ZR0345_2017_0002). MP13.091. MP13.001. MP13.001

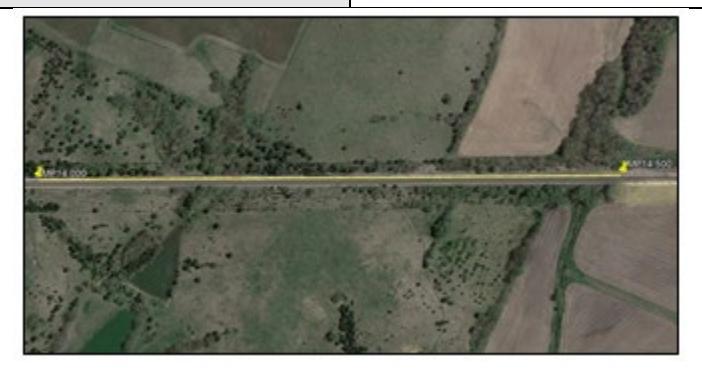
Table F 2. Trackbed inspection report summary (continued)

Trackbed Condition Summary	The condition of the trackbed within this 1/2 mile is classified as generally. Moderate to Good within areas outside of the identified trackbed defects. The condition on the ballast shoulders is typically slightly better than that of the track center, primarily as a result of improved ballast quality. Areas of Poor quality trackbed are characterized by modeled ballast fouling ranging from Moderately Fouled to Fouled, a shallow [<8 inches] modeled free-draining layer (FDL) depth, particularly in the track center, and an irregular ballast profile.
Trackbed Layer Summary	A well-defined continuous Primary layer interface has been identified over the majority of the 1/2 mile on all three data channels (left & right shoulders and track center) at modeled depths of between <4 inches and 24 inches. The interface is variably interpreted as representing the boundary between clean ballast and fouled material, and clean ballast and sub-grade. There is no evidence of a deeper, secondary, interface within the 2GHz datasets indicating that the base of the trackbed lies below ~3 feet through this section. No 400MHz data was available from the DOTX- 220 survey.

Trackbed Defects	MP14.000 - MP14.012 - Ballast pocket: Characterized by a localized increase in the modeled depth to the Primary layer interface from ~10 - 16 inches to over 20 inches on both the left and right shoulders attributed to soft sub-grade conditions. Attenuation of the GPR signal below the interface is proteinally indicative of increased % moisture within the underlying materials. MP14.019 - MP14.012 - Insufficient Clean ballast thickness, mud spot development and surface mud: This section of track is characterized by a shallow Primary layer interface (< 8 inches in center] and correspondingly shallow FDL together with evidence of both active (surface) and developing (sub-surface) mud spots in the center and on the right shoulder. Coincident with this defect is a well- defined negative (Dip) left and right profile deviation of ~1 inch in the track geometry data, potentially indicating locally soft trackbed conditions. The deviation does not constitute a track geometry exception for the posted track speed/dass.

Summary	MP14.135 - MP14.153 - Ballast pocket: This feature comprises a relatively broad low in the ballast profile that extends to a modeled depth of ~28 inches. It is coincident with a cross-track drainage feature viable in aerial imagery of the site and may be associated with an unidentified culvert/pipe. A similar anomaly is identified here in the GPR data acquired on Main 1. MP14.214 - MP14.300 - Developing and active mud spots, insufficient clean ballast thickness, elevated % moisture: This defect is characterized by an irregular and very shallow (<4 inches) Primary layer interface and correspondingly shallow FDL. The elevated reflection amplitude of the Primary interface and attenuation of the signal in the underlying materials is potentially indicative of elevated moisture levels within the near-surface materials. Various TG surface parameters are slightly elevated within this section but lie within exception limits. MP14.236 - MP14.404 - Ballast pocket (center only), MP14.485 - MP14.495 - Active mud spot (center only): Weil-defined "30-ft wide anomaly. No significant track geometry response.
