MPC REPORT NO. 00-112

Composite Repair of Timber Structures

June 2000

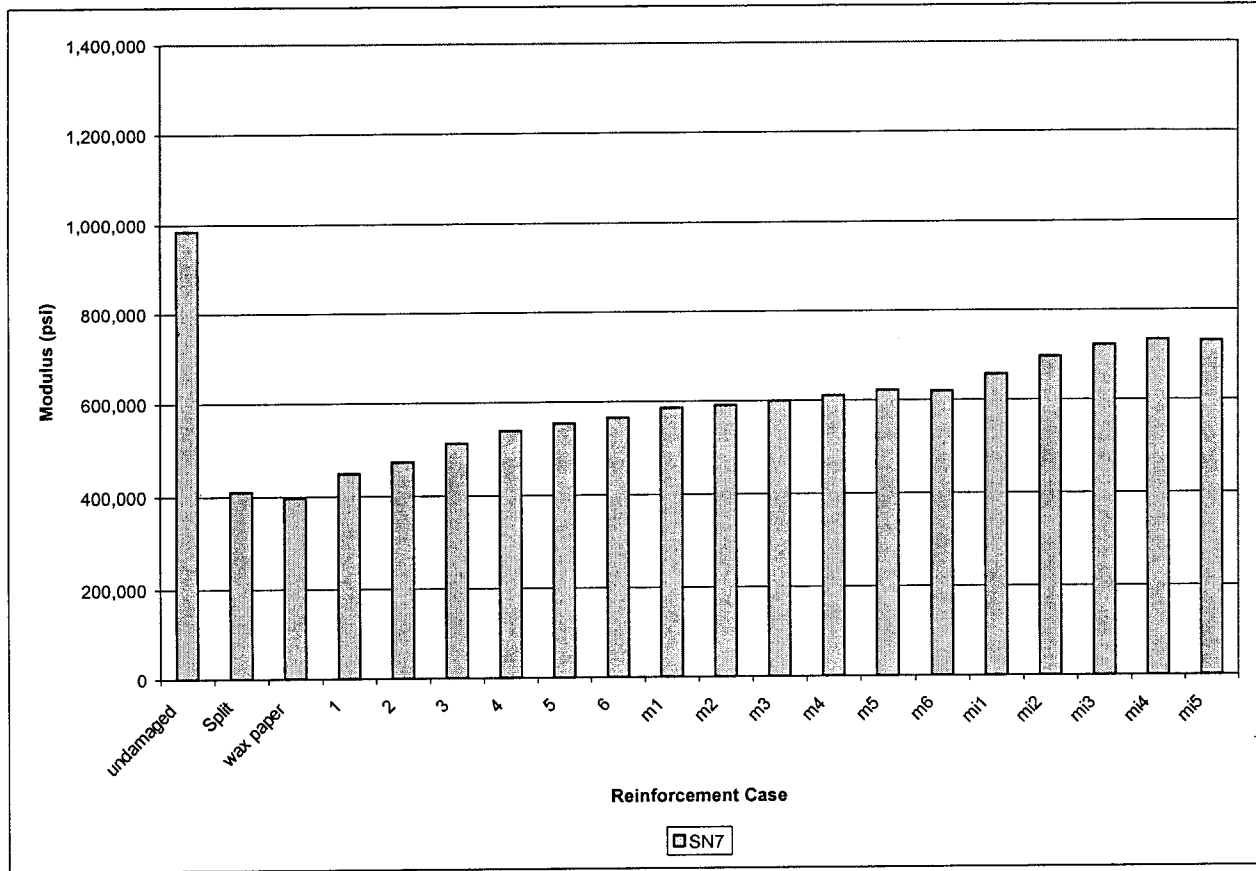
The results of stiffness testing of this modified beam, shown in Figure 5.16, indicate that the additional shear spikes do enhance the modulus of the specimen. The addition of the third pultruded rod in each row has only a limited effect, with the greatest gain (m5) being approximately 10 percent more than the final set of paired spikes. The additional intermediate rows of spikes showed a somewhat greater gain, with the final modulus showing an increase of approximately 25 percent more than the final paired shear spike case (6).

Figure 5.16 Stiffness Related to Additional Reinforcement in 2x4 Specimens (Mid, then Intermediate)

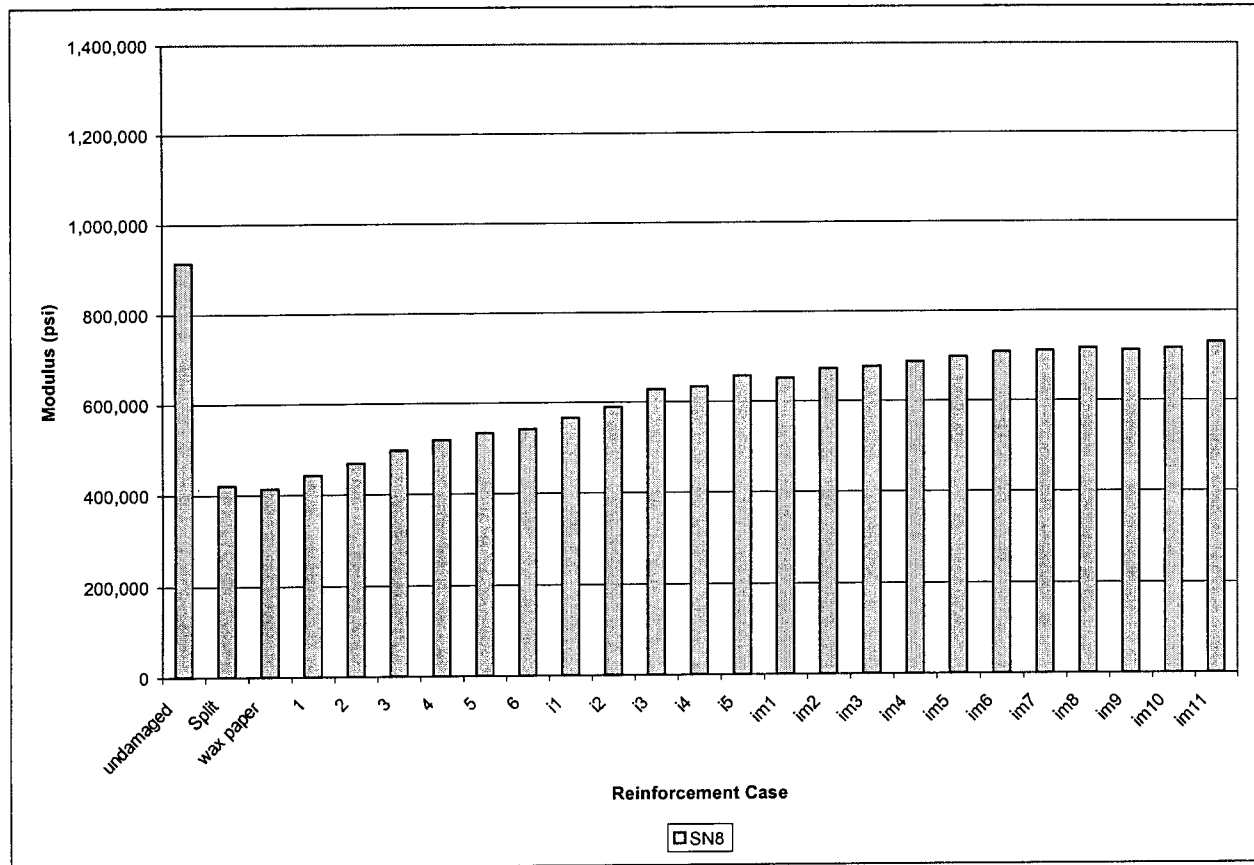
The results of stiffness testing of this modified beam (SN8), shown in Figure 5.18, indicate that the additional shear spikes do enhance modulus of the specimen. Again, the addition of the intermediate pairs of rods seems to have a somewhat greater overall effect. The additional intermediate rods (i5) yield an approximate gain in modulus of 20 percent more than the final paired shear spike case (6), while the added middle rods only generate an additional 10 percent increase. The final modulus increase is similar to the previous specimen (SN7), having an approximate gain of 30 percent over the final paired shear spike case (6).

Figure 5.18 Stiffness Related to Additional Reinforcement in 2x4 Specimens (Intermediate, then Mid)

The overall effect of these additional shear spikes is an appreciable gain in stiffness; however, neither specimen (SN7 or SN8) reaches the same level of modulus, upon completion of repair, as the undamaged 2x4 initially showed. The expected modulus gain for the actual repair case would be greater due to the additional epoxy rejuvenation, and should approach the level of improvement noted in the preliminary set of tests. In addition, it is possible that the density of shear spikes must be increased for optimal stiffening effect, plus, it may be necessary to optimize the distribution with respect to position along the beam. This could result in a non-uniform spacing of the reinforcing rods along a damaged region depending on the location in the beam.
