PB99-916401  
NTSB/MAR-99/01  
DCA98MM028

# NATIONAL TRANSPORTATION SAFETY BOARD

## MARINE ACCIDENT REPORT

SINKING OF THE RECREATIONAL SAILING VESSEL  
*MORNING DEW* AT THE ENTRANCE TO THE HARBOR  
OF CHARLESTON, SOUTH CAROLINA  
DECEMBER 29, 1997

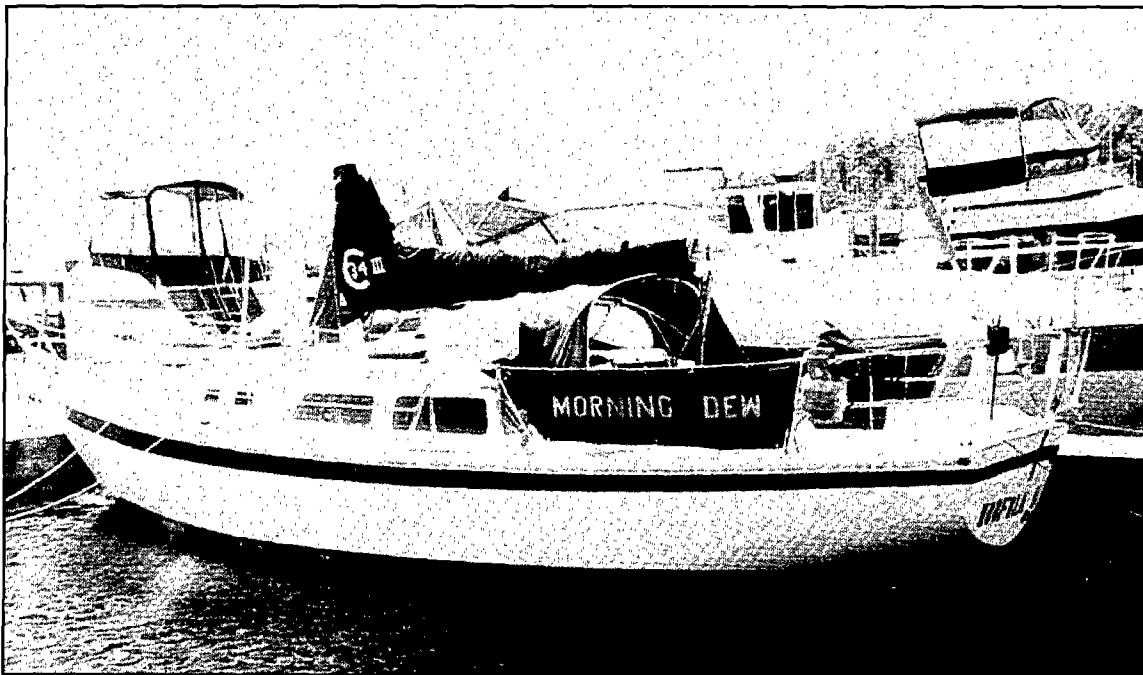
**Figure 1.** Sailing vessel *Morning Dew* before it was acquired by the accident owner

In December 1997, a 49-year-old recreational boater planned to sail his newly purchased 34-foot sailboat, *Morning Dew* (figure 1), from its berth in a marina at Little River (near North Myrtle Beach, South Carolina) to Jacksonville, Florida. (See figure 2.) According to family members, he was to be accompanied on the trip by his brother, his two sons, ages 16 and 13, and his 14-year-old nephew. Although the boat was equipped with sails, the owner (hereinafter referred to as the “operator”) planned to make the trip under power using the vessel’s auxiliary diesel engine.
