# **Refurbishment of Railroad Crossties - A Technical and Economic Analysis**

| 4. Title and Subtitle<br>REFURBISHMENT OF RAILROAD CROSSTIES<br>A Technical and Economic Analysis | 5. Report Date<br>December 1977 | 6. Performing Organization Code |
| 7. Author(s)<br>A.V. Loomis and T. Anyos | 8. Performing Organization Report No.<br>DOT-TSC-FRA-77-29 | 10. Work Unit No. (TRAIS)<br>RR819/R8306 |

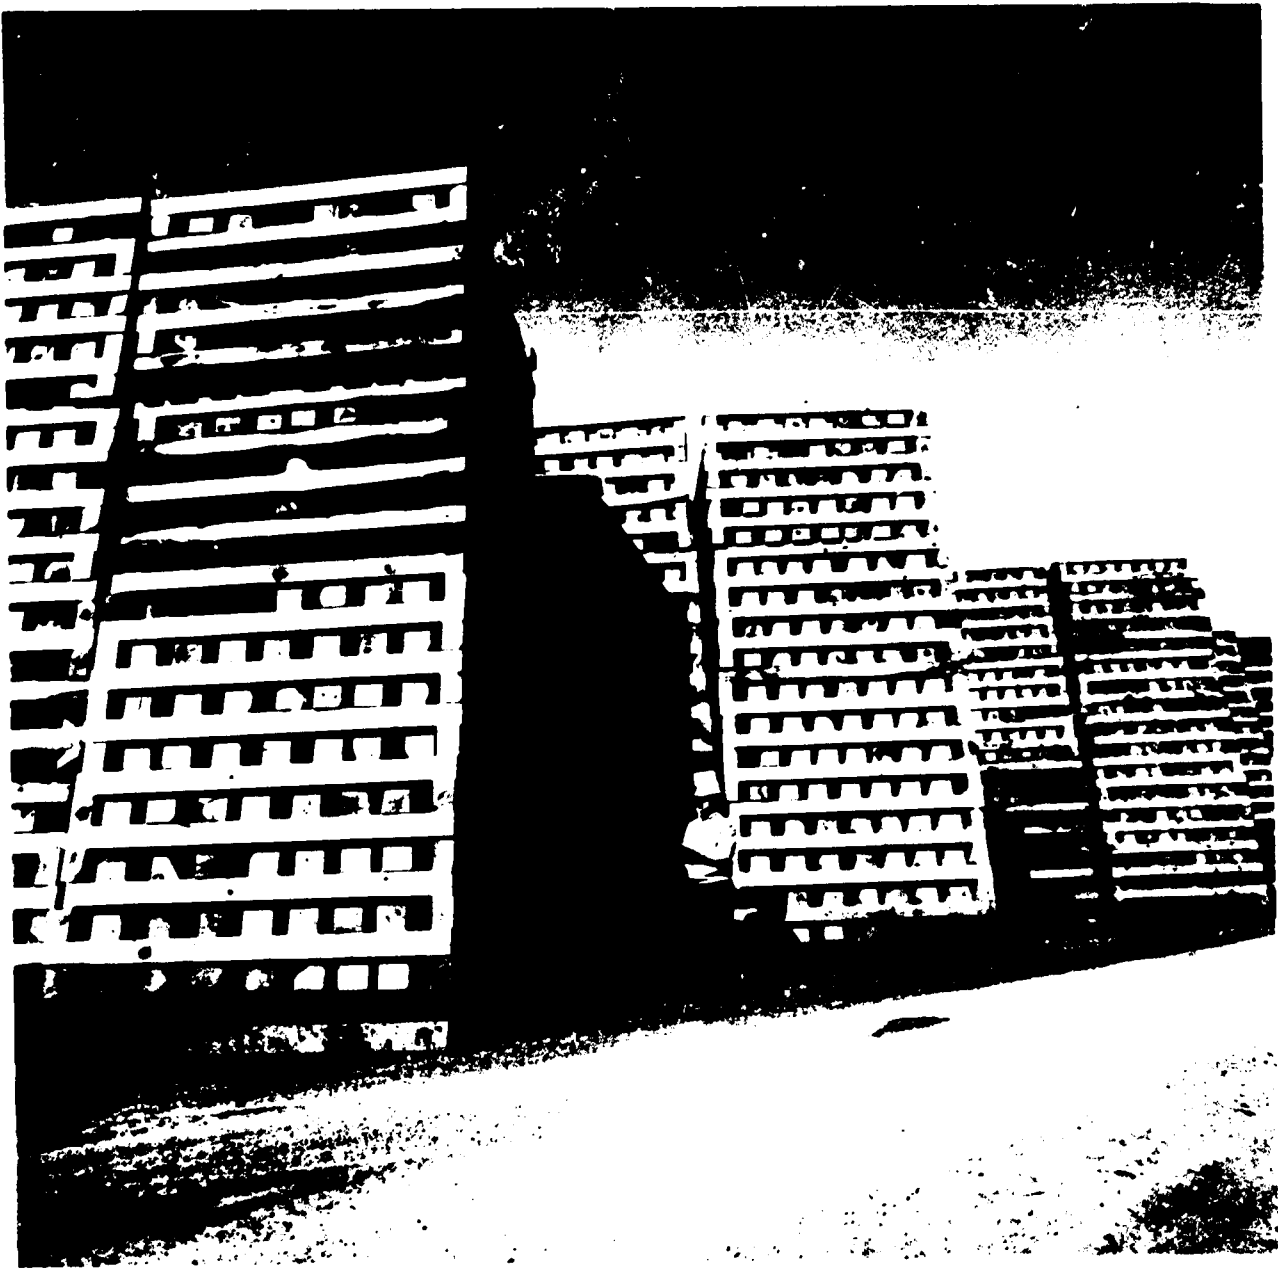
SA-3670-60

FIGURE 3.2 STOCKPILE OF HARDWOOD LUMBER FOR CROSSTIE USE

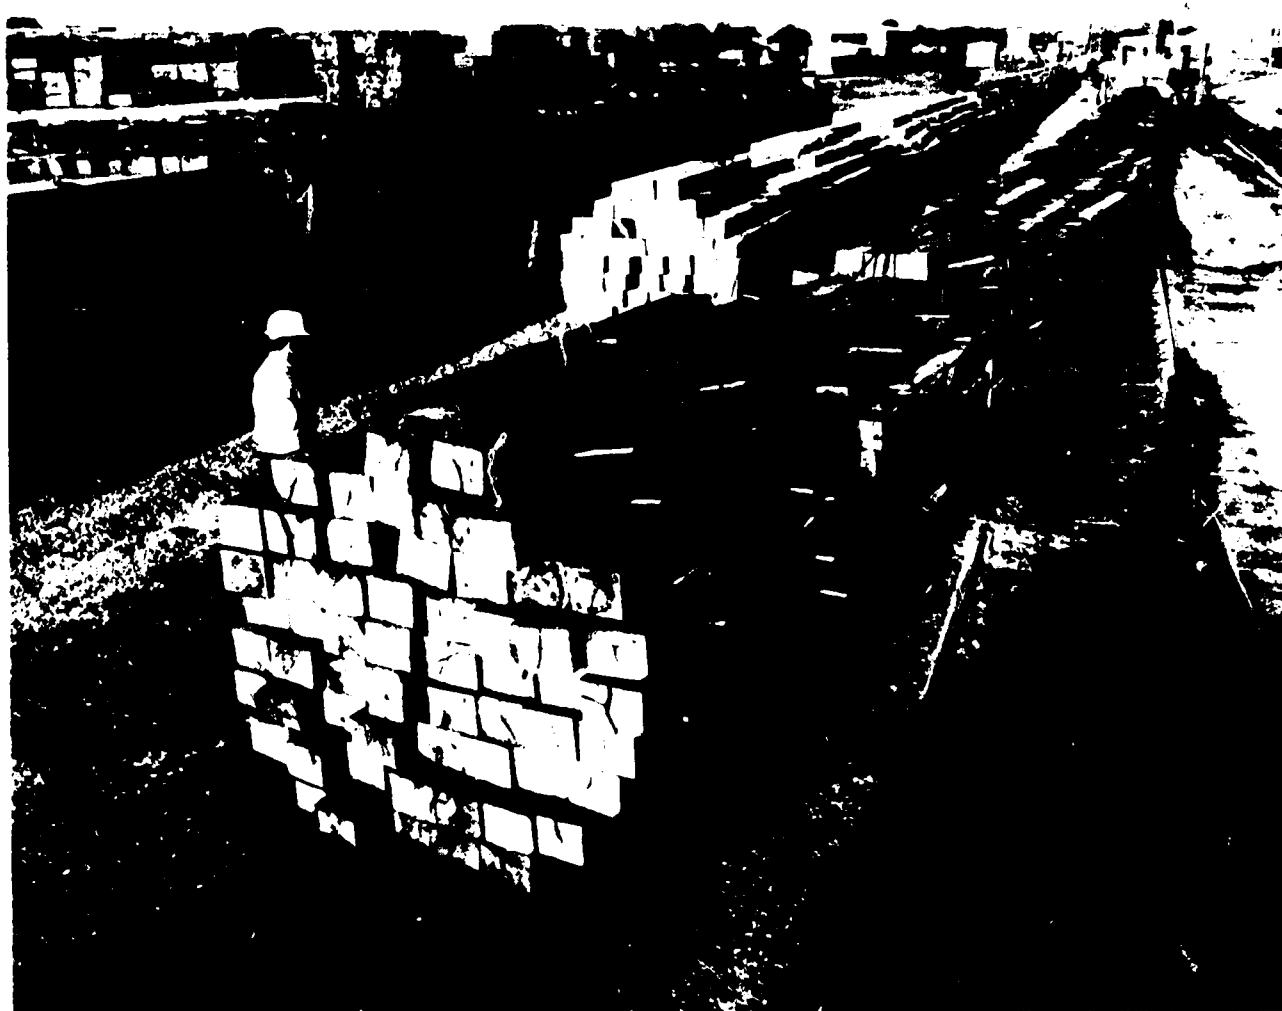
SA-3670-63

FIGURE 3.5 TIES AWAITING DRYING AND CREOSOTE TREATMENT  
SOURCE: The Koppers Company

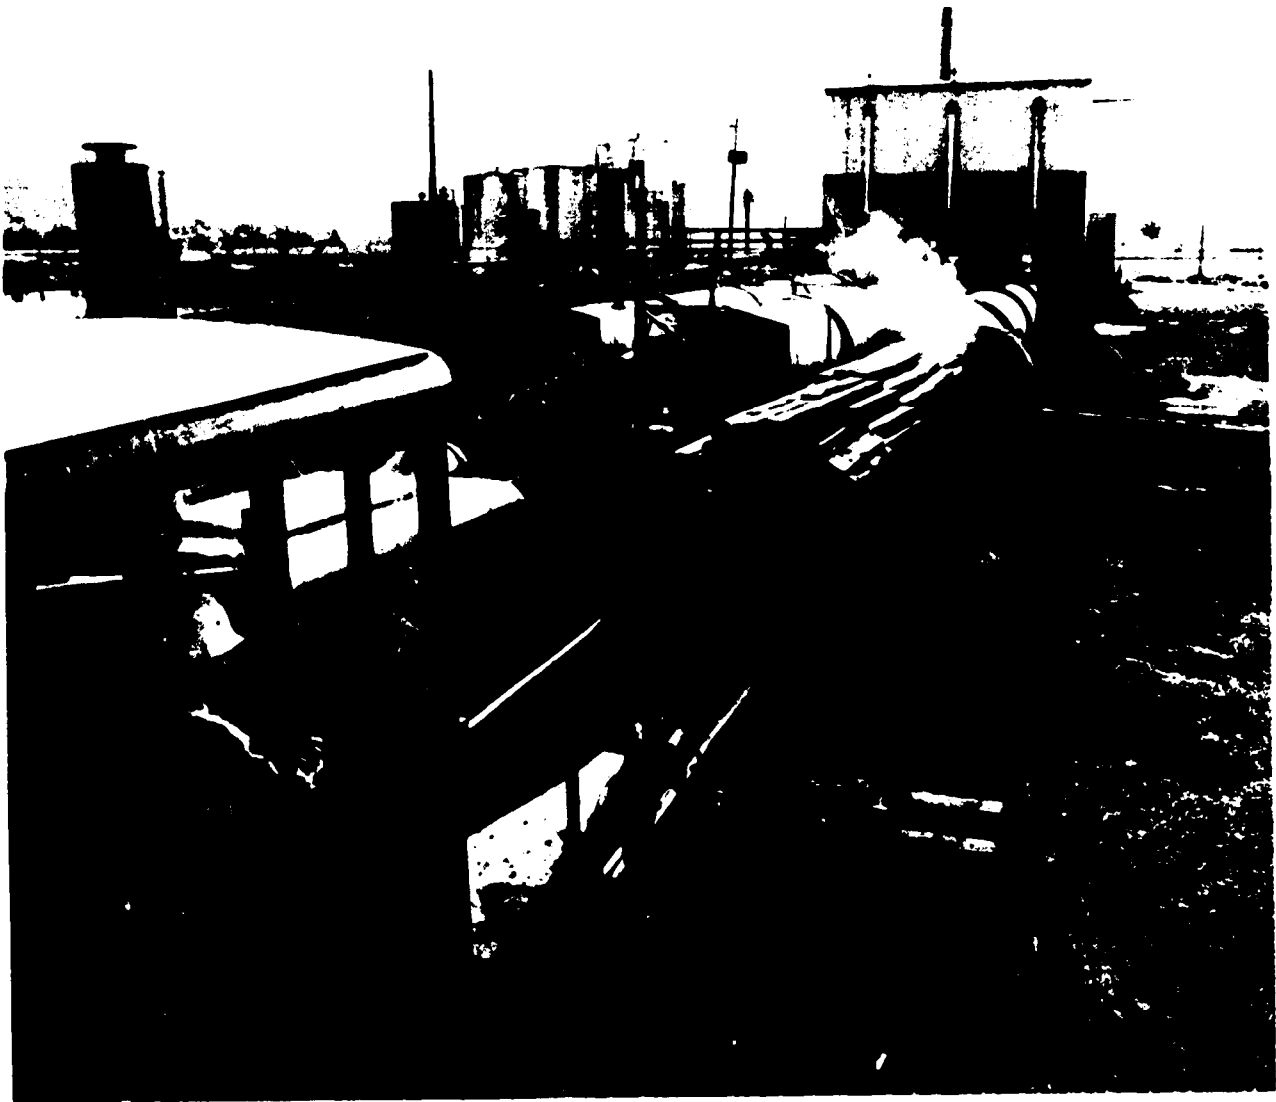
SA-3670-64

FIGURE 3.6 PRESSURE-CREOSOTED TIES BEING REMOVED FROM THE TREATING CYLINDER  
SOURCE: The Koppers Company

proved so effective that all crossties are now treated before use. Figure 3.6 shows pressure-croosoted ties being removed from the treating cylinder. After removal from the treatment area, treated ties are loaded onto tie-carrier cars for shipment to track construction and maintenance projects (Figure 3.7).

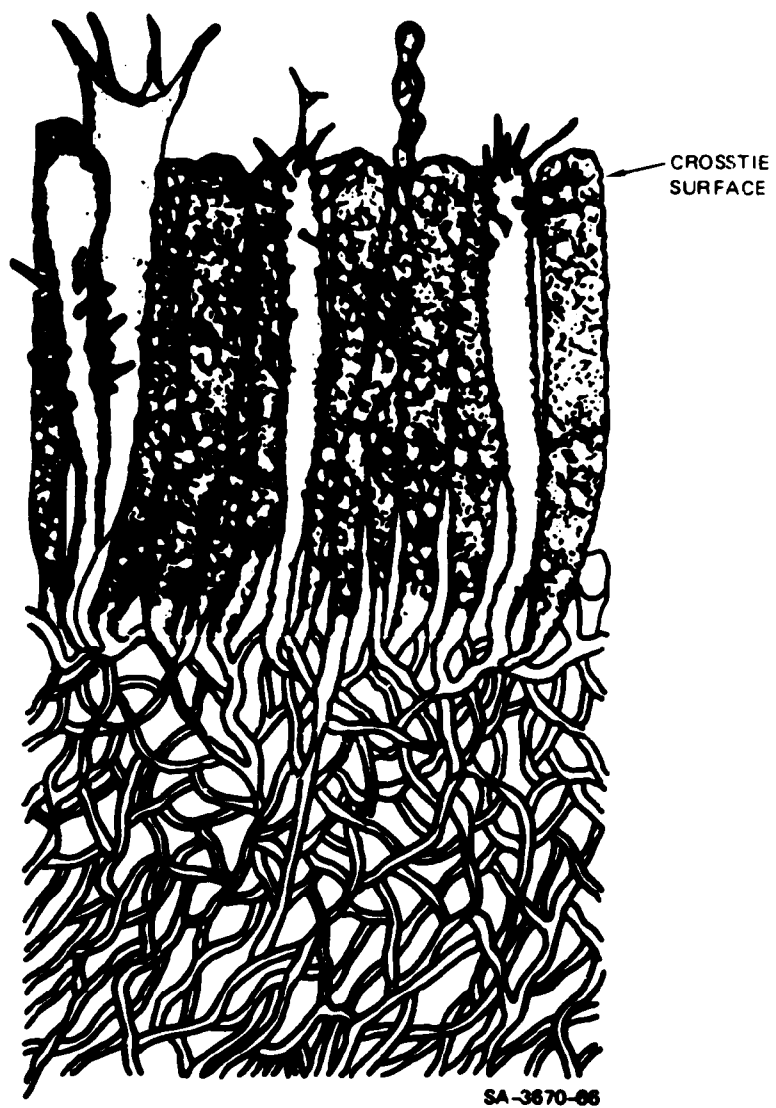
FIGURE 4.1 CROSS-SECTION VIEW OF DECAY FUNGI ATTACK

A spore is so small that it could support very little subsequent growth. Therefore, on germination the delicate mycelial filaments must grow quickly into the wood (Figure 4.1). They penetrate into and through wood cells by dissolving the cell walls and using the substances thus obtained for further growth and expansion. The penetrating hyphae use certain parts of the cell walls and continue to multiply and concentrate action of growth until much of the content of the cell walls are broken down and the wood weakened and largely destroyed. This is the process called decay. Some species of fungi dissolve and utilize mainly the cellulose and much of the lignin (white stringy rots). There are many other fungi (molds) which will grow in sapwood and utilize the cell contents but cause no reduction in wood strength. Such fungi render the sapwood more permeable so it will absorb water or liquid preservatives more readily.

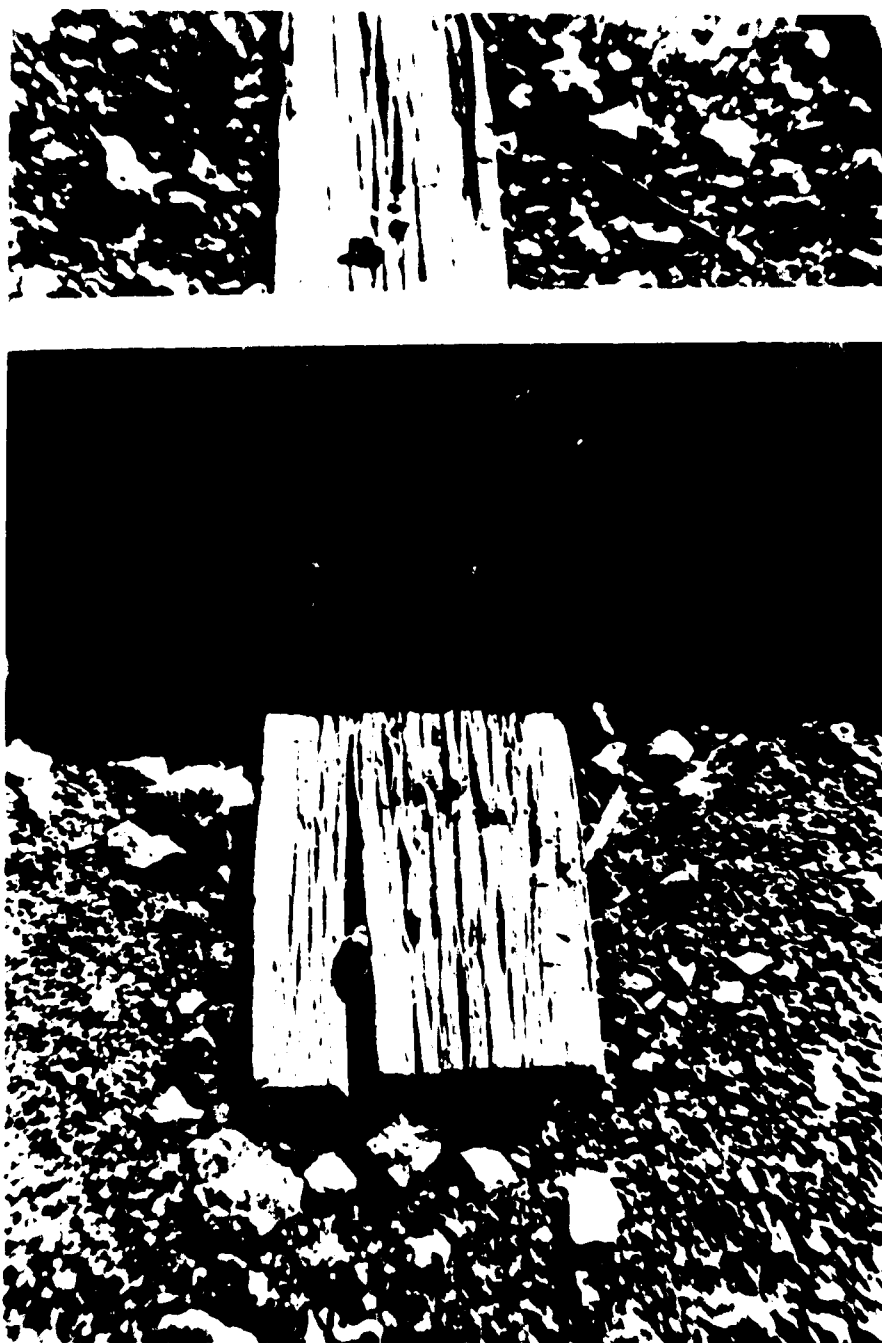
SA-3670-69

FIGURE 4.5 AN IN-SERVICE TIE EXHIBITING CHECKING AND SPLITTING

This deterioration mode has already been described in Section 2.0. Although checking is not normally a cause for crosstie replacement, it is critical to tie decay because it exposes internal portions of the tie and allows biological attack of untreated wood. Checks may also create large splits when the presence of ballast in a check continually enlarges the check under the movement or vibration of passing trains (see Figure 4.5). The entry of water and the freeze and thaw cycle of the winter will also expand checks or splits, allowing entry of decay fungi, ballast, and other foreign materials.

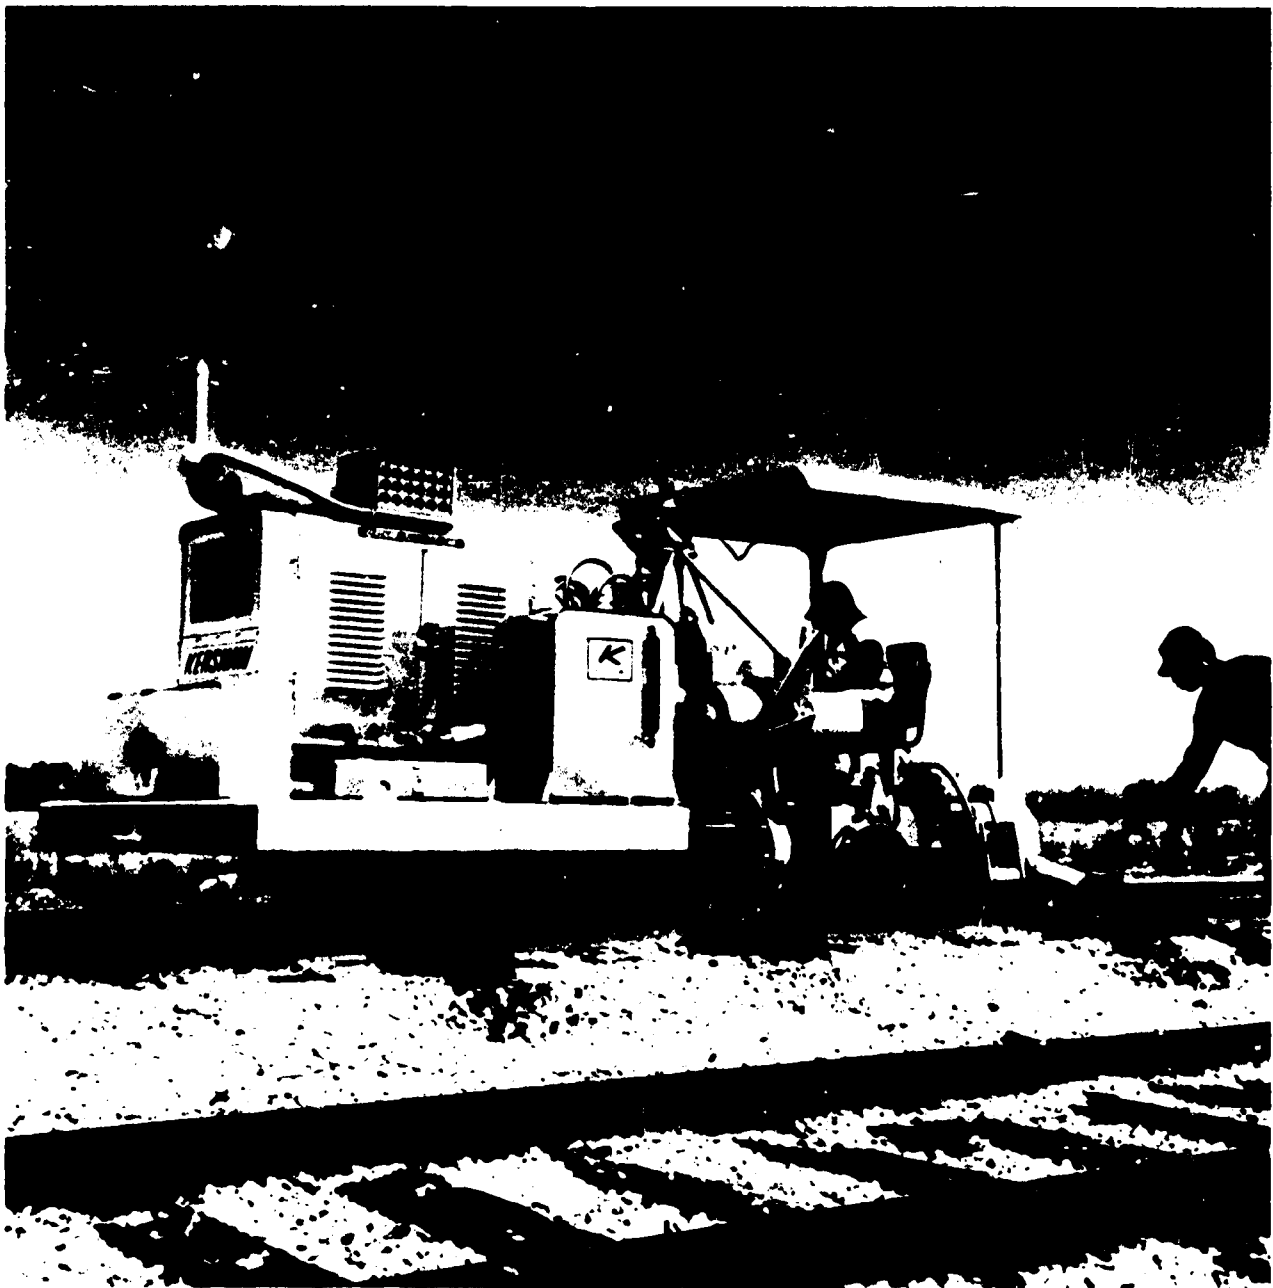
SA-3670-72

FIGURE 5.1 A DUAL TIE SAW REMOVING OLD TIES  
SOURCE: The Kershaw Company

After the defective ties have been marked, replacement ties are brought up and distributed along the right-of-way. When the tie gang arrives, procedures similar to that outlined below are followed. Obviously these vary from railroad to railroad, but generally speaking the procedure entails: (1) removing the rail anchors and pulling the spikes, (2) lifting the rail and removing the tie plates either prior to or after tie removal, (3) removing the tie intact or in some cases cutting the tie into three segments to avoid disturbing the track line and surface (Figure 5.1) (4) scarifying the surface if needed (Figure 5.2) (5) installing

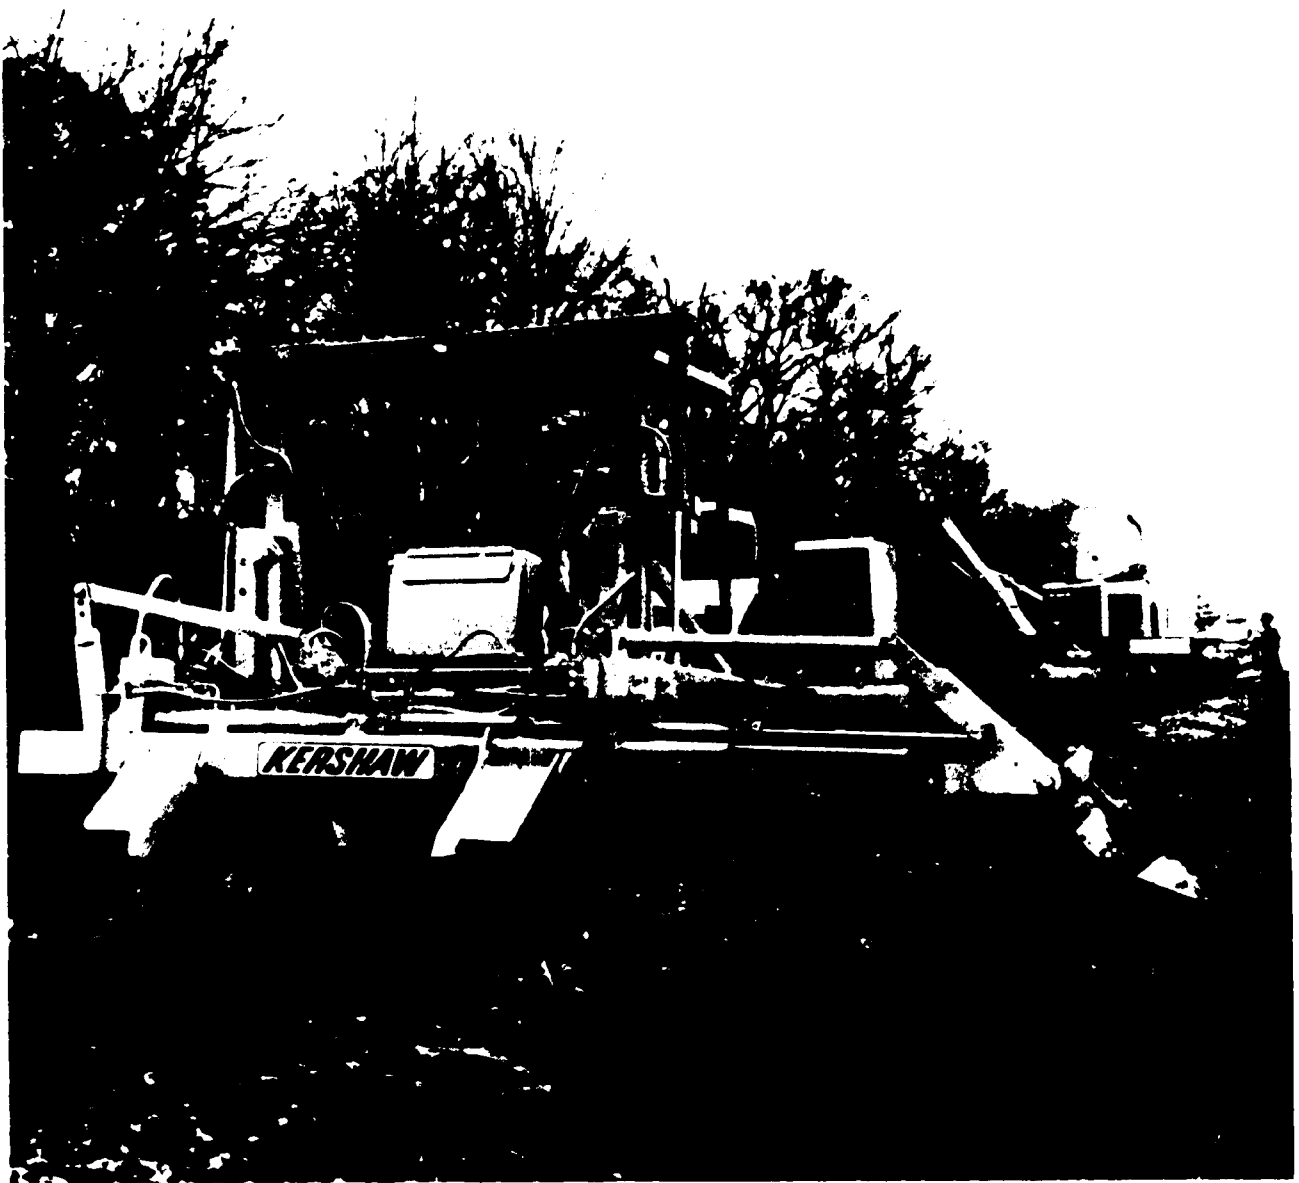
SA-3670-73

FIGURE 5.2 SCARIFYING THE ROAD SURFACE PRIOR TO NEW TIE INSERTION
