IMECE2018-87700

SIDE STRUCTURE INTEGRITY RESEARCH FOR PASSENGER RAIL EQUIPMENT

Volpe National Transportation Systems Center
U.S. Department of Transportation
Cambridge, MA, USA

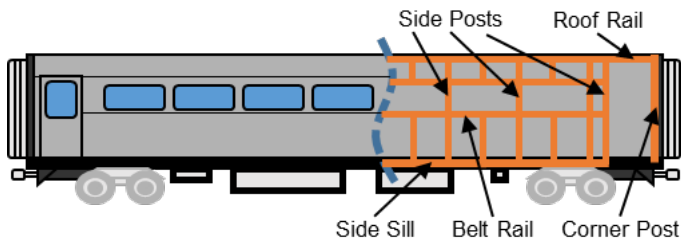
Conventional U.S. passenger railcar designs typically feature a sidewall constructed of discrete vertical and longitudinal members with an exterior metal sheathing. In general, the vertical members of the sidewall are referred to as posts, with the most structurally-substantial sidewall post located at each corner of the occupied volume. The longitudinal member at the intersection of the sidewall and the underframe is referred to as the side sill, and can be considered a part of both the sidewall and underframe structures. In typical single-level car designs, the longitudinal members are prismatic in cross-section. The longitudinal member at the top of the sidewall is referred to as the roof rail. The sidewall also features a longitudinal member referred to as a belt rail, typically located just below the windows. A schematic of a representative single-level passenger railcar, with a cutaway indicating major structural members, is shown in Figure 1.

Figure 1. Generalized Sidewall Members, Single-level Conventional Railcar

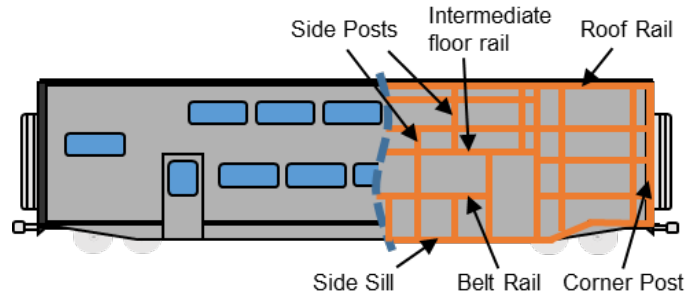
Additionally, a multi-level passenger car will typically feature longitudinal structure in the sidewall to support the upper level. Depending on the design of the multi-level car, the upper level may only extend over the region of the car where the underframe has transitioned downward, or may extend for the full-length of the car. A schematic illustration of a generalized multi-level conventional railcar is shown in Figure 2.

Figure 2. Generalized Sidewall Members, Multi-level Conventional Railcar

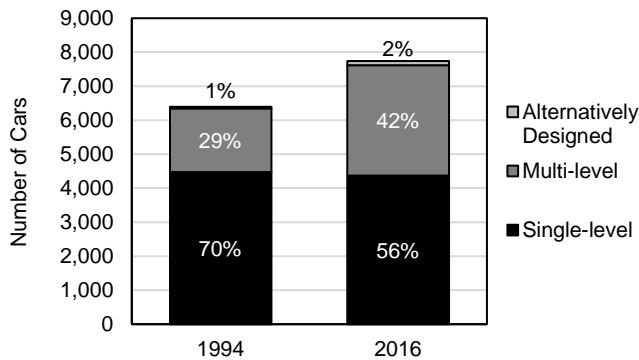
Railcar Type	Count in 1994	Count in 2016
Single-level	4,472	4,367
Multi-level	1,875	3,254
Alternatively-designed	45	122
Total	6,392	7,743

Figure 3. Estimated Passenger Railcar Fleet in the U.S.

These results indicate that since 1994 the passenger car fleet has grown by approximately 1,350 cars or 21%. While the majority of the passenger fleet is still made up of single-level cars, the number of multi-level cars has nearly doubled since 1994 and now comprise approximately 42% of the passenger fleet. The increase in the number of multi-level cars indicates a need to ensure that current standards and regulations, some of which are based on longstanding design practice, remain relevant to the entire fleet. Thus, any new or modified criteria or evaluation procedures for side structure integrity should be relevant to both types of equipment. Additionally, because of the inherent structural differences between single- and multi-level passenger railcars, it is also important to consider whether a side impact presents the same hazard to each design.

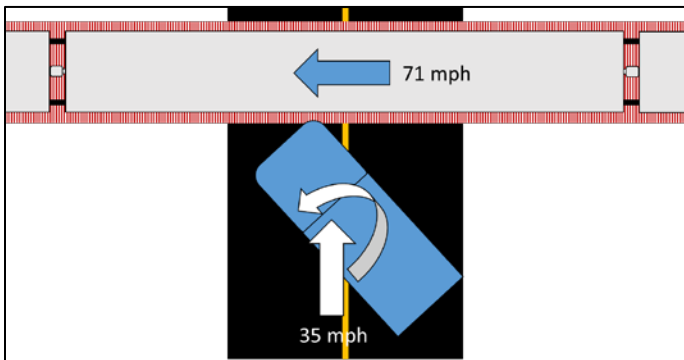
In 1975, a highway dump truck traveling at approximately 35 mph (while braking) struck the side of an Amtrak Turboliner train traveling at approximately 71 mph in Elwood, IL [7]. The dump truck skidded and overturned during the impact event. A combination of the impact force and debris from the dump truck caused 4 out of 5 single-level coach cars to derail leading to injuries of 45 passengers but no fatalities. The collision is illustrated schematically in Figure 4.

Figure 4. Schematic Illustration of Elwood, IL Highway-Rail Accident

[i]mpact damage to the second car was restricted to the left rear side of the car... The damaged area was 24 feet 6 inches long, about 6 feet high, and about 8 inches deep at its deepest point. Two double-pane windows were shattered completely and a third had only its outer pane shattered. In the area of impact, the floor was deformed slightly, a pair of seats had rotated partially, and a folding tray was deformed to the right. The floor and seats were littered with broken window glass. There were no signs of side or roof panel buckling or deformation of the overhead baggage racks.

The third car was damaged at its left front corner. At that point, the lower-outside paneling had been crinkled and had been marked with horizontal striations, and the window was broken. The left front corner of the car was crushed beginning about 8 feet above the top of rail and extending upward for 21 feet. Some additional deformation occurred just above that crushed area. [7]

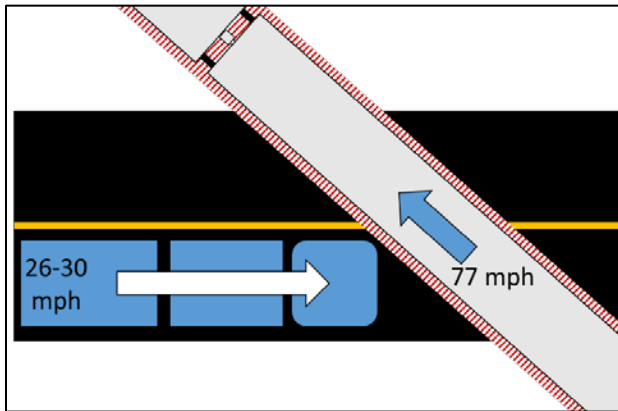
In a similar accident in 2011, the sidewalls of two Amtrak Superliner multi-level railcars were breached in a highway-railroad grade crossing collision in Miriam, NV [2]. A semi-trailer truck pulling two unloaded side-dump trailers traveling at an estimated speed of 26-30 mph (while braking) impacted the side of the train which was traveling at 77 mph. The impact is illustrated schematically in Figure 5.

Figure 5. Schematic Illustration of Miriam, NV Highway-Rail Accident

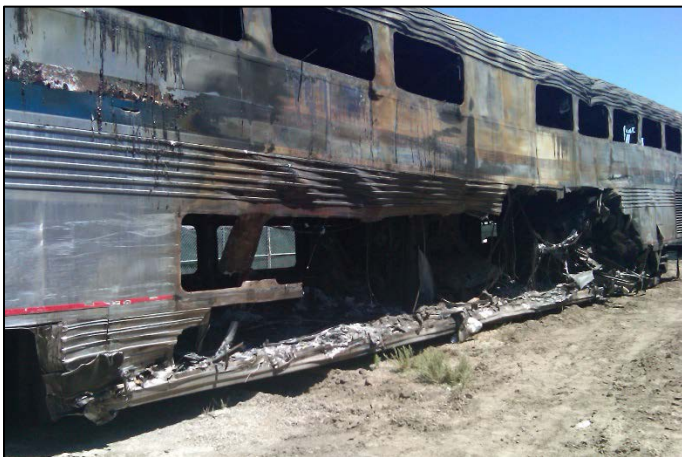
The highway vehicle impacted Amtrak Superliner Crew Sleeper Car 39013 at its lower level, and struck Coach Car 34033 on its upper level. The accident killed the driver of the semi-trailer truck, the train conductor, and four train passengers; additionally, 15 train passengers and one train crewmember were injured. The two damaged sleeper cars are shown in Figure 6 and Figure 7.

Figure 6. Sleeper Cars 39013 from Miriam, NV Accident Showing Damage from Highway Tractor Unit

In the NTSB's report on this accident [2] there is clear evidence that the engine compartment of the tractor unit overrode the side sill of car 39013, compromising the survival space of the passenger compartment. As the highway vehicle continued moving, the first side-dump trailer impacted the rear of the tractor unit and "ramped over" it. The trailer then collided and raked the upper level of the following railcar, car 34033. This led to a loss of survival space on the upper level of Car 34033, as seen in Figure 7. The passenger train did not derail in the Miriam accident and the multi-level railcars suffered a large loss of occupant survival space leading to cases of fatal blunt force trauma. Passengers outside of these impact zones suffered only minor injuries. In the Elwood accident, the train did derail without a large loss in occupant survival space; however, there was a larger number of non-life-threatening passenger injuries.

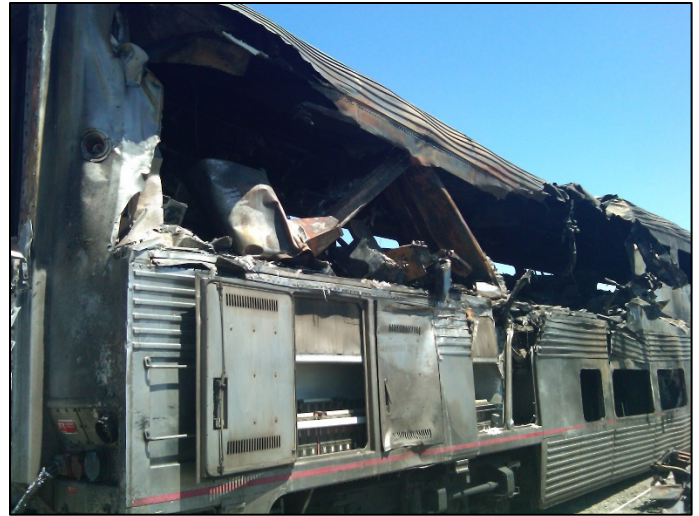
Figure 7. Coach Car 34033 from Miriam, NV Accident Showing Damage from Highway Trailer
