U.S. Department  
of Transportation  
**Federal Railroad  
Administration**

RR 20-04 | May 2020

## **FIRE RESISTANCE TESTS OF REDUCED SCALE RAIL CAR FLOOR ASSEMBLIES**

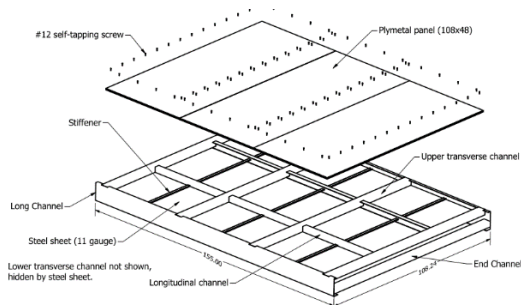
**Figure 1: Full scale Assembly Design 1, Tests 1 and 2**

The assemblies were fabricated using carbon steel, fiberglass insulation, and plymetal or phenolic composite floor panels. The frame was made of welded carbon steel channels. Fiberglass insulation bats were inserted within the frame. Tests 1, 2, and 3a specimens used a plymetal panel to cover the insulation and frame. The plymetal was made of two 16-gauge facesheets and 3/4-in plywood. Test 3b specimen was covered with a phenolic floor panel.

Fire resistance tests of full-scale and reduced-scale rail car floor assemblies were coordinated by JH and conducted at the SwRI, a certified test facility for performing fire resistance tests. The floor designs are based on exemplar floors from surveying various rail cars and discussions with industry. Figure 1 through Figure 3 show design drawings of the floor assemblies.

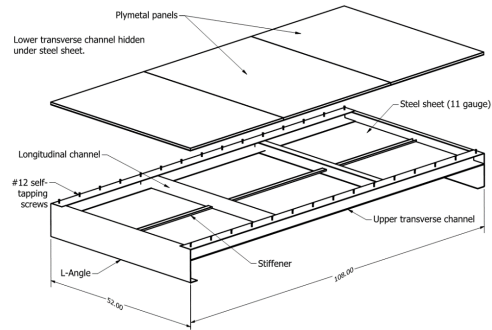
**Figure 2: Reduced scale assembly Design 1, Test 3a**

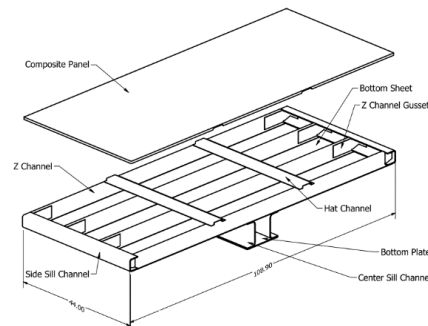
**Figure 3: Reduced scale Assembly Design 2, Test 3b**

Temperature rise on unexposed surface for Test 3b was significantly higher than the rise for Test 3a. This may be contributed to Test 3b specimen having a phenolic-faced composite panel—instead of plymetal—and being constructed of thinner gauge steel than Test 3a. Test 3b specimen phenolic floor panel delaminated, which may have resulted in the steep rise in deflection at 31 minutes in Figure 7. The response of Test 2 and Test 3a was expected to be same based on the computer simulation. The temperature rise for these tests was similar. The scaling methodology did not alter the thickness of individual members of the

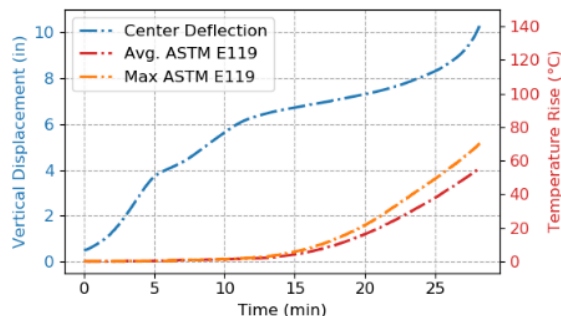
Figure 4: Test 1 deflection and temperature rise

The results for Tests 1–3b are shown in Figure 4 through Figure 7. The Test 1 data in Figure 4 include the measured center deflection and unexposed side temperature rise. Test 1 failed due to excessive structural deflection at 28 minutes, indicating the test assembly could not support the load. The peak and average temperature rise on the unexposed side was less than 80 °C (144 °F). Test 2 supported the load up until 45 minutes, when it failed due to exponential increase in structural deflection. Figure 5 contains the center deflection and unexposed side average and maximum temperatures were similar, and the rise was approximately 125 °C (225 °F) at termination. The average unexposed temperature rise for Test 2 at 28 minutes was approximately 60 °C (108 °F) which was similar to Test 1 as both assemblies had the same design with identical structural members.

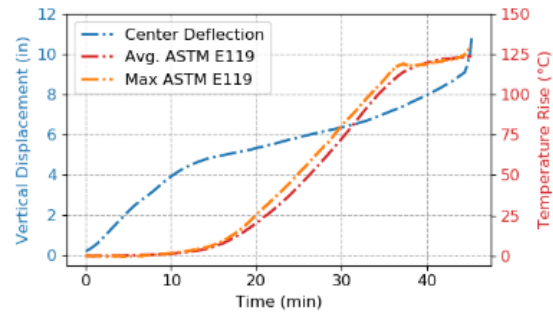
Figure 5: Test 2 deflection and temperature rise

assembly, resulting in an identical thermal resistance for both scaled specimens. Both tests were expected to have similar deflection, but there was more deflection in Test 2 than Test 3a, see [Figure 5](#) and [Figure 6](#). While the structural design and distributed load of these were the same, the edges of the assemblies were partially shielded from the furnace exposure with the thermal blanket to prevent hot gasses from escaping. This may be more pronounced in Test 3a since this may have partially shielded the transverse beams on the edges in the assembly.

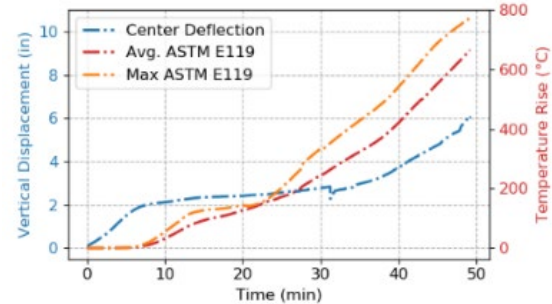
Figure 7: Test 3b deflection and temperature rise

Tests 3a and 3b were conducted simultaneously. Temperature rise and deflection measurements for Tests 3a and 3b are shown in Figure 6 and Figure 7, respectively. Test 3a supported the load for the test duration but failed the average temperature rise requirement at 57 minutes. The test was terminated at 62 minutes due to flaming ignition on the unexposed surface. Test 3b failed due to exceedance of the average temperature rise criterion at 20 minutes and exhibited structural failure due to exponential increase in deflection at 49 minutes.
