**DEMONSTRATION OF AUTOMATED ENFORCEMENT SYSTEMS  
AT SELECTED HIGHWAY-RAILROAD  
GRADE CROSSINGS IN TEXAS**

Research Report 2987-2F  
Research Study Number 7-2987  
Research Study Title: Evaluation of Automated Highway-Railroad  
Grade Crossing Enforcement System

Sponsored by the  
Texas Department of Transportation

October 1997

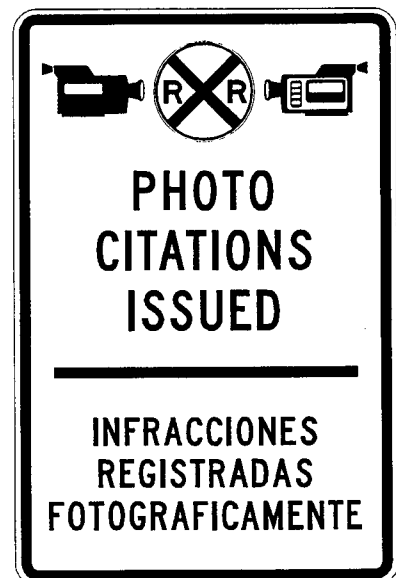
**Figure 2-3. Bilingual Photo Enforcement Sign Used in Los Angeles.**

Citation issuance was preceded by a major media campaign which included press conferences, public service announcements, distribution of handbills and posters within the communities, and installation of photo enforcement signs at the target grade crossings (see Figure 2-3).

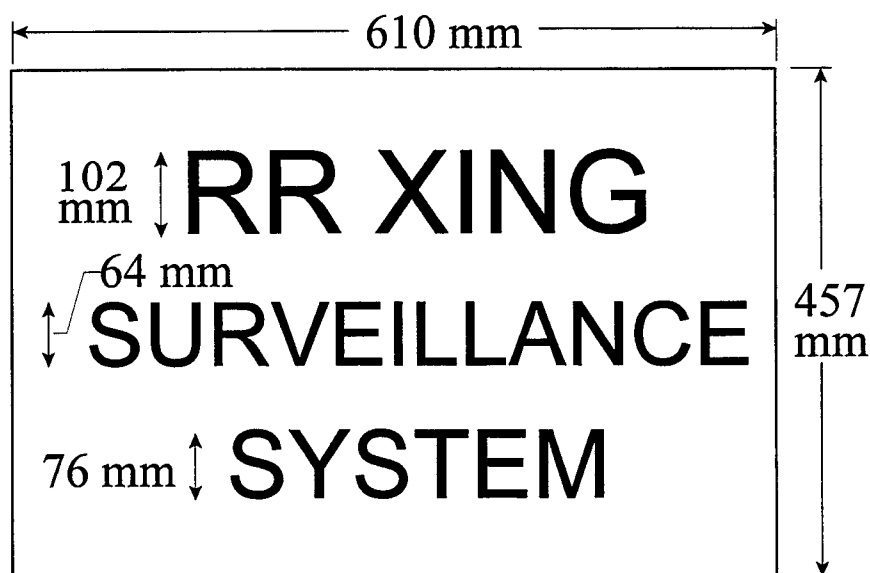
**Figure 2-4. Enforcement Sign Used in Ames.**

A public information campaign was initiated at the end of 1995. The system has been featured in the local news media, both on TV and in the newspaper. It is believed that the violation rate has already decreased due to public education. Signs are installed prior to the crossing. Figure 2-4 shows the dimensions of the sign.

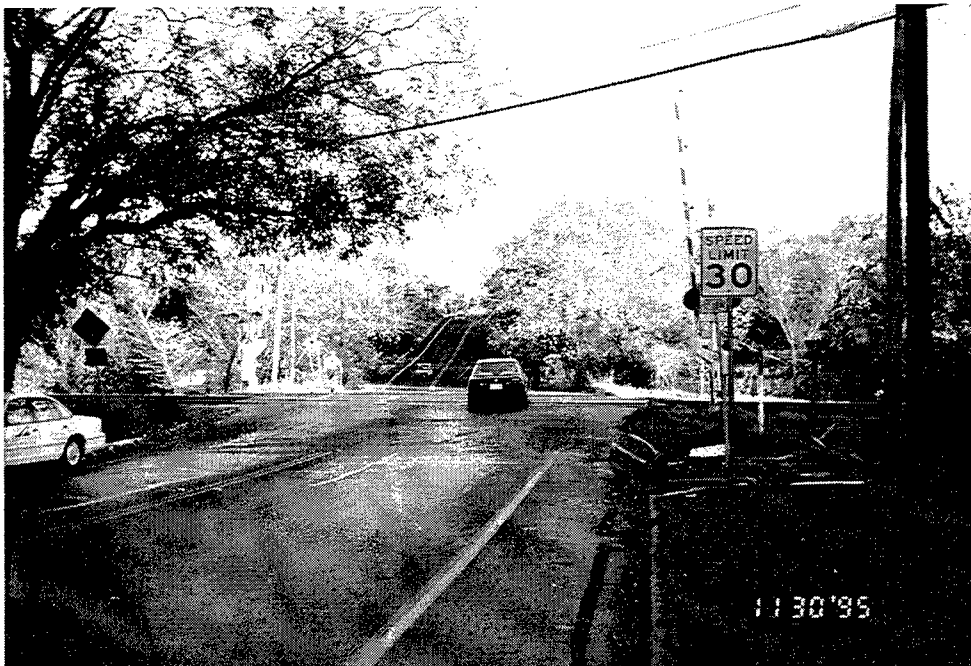
**Figure 6-1. Photograph of West Mary Site.**

Two sites were selected in Austin. The West Mary site is a two-lane roadway with 4.3 m lanes and 2 m shoulders. The roadway is a residential collector street with approximately 7500 vehicles per day and a speed limit of 48 km/h. In the area near the crossing, the roadway is in hilly terrain. The crossing has one track and approximately 17 trains per day. Figure 6-1 illustrates the crossing.

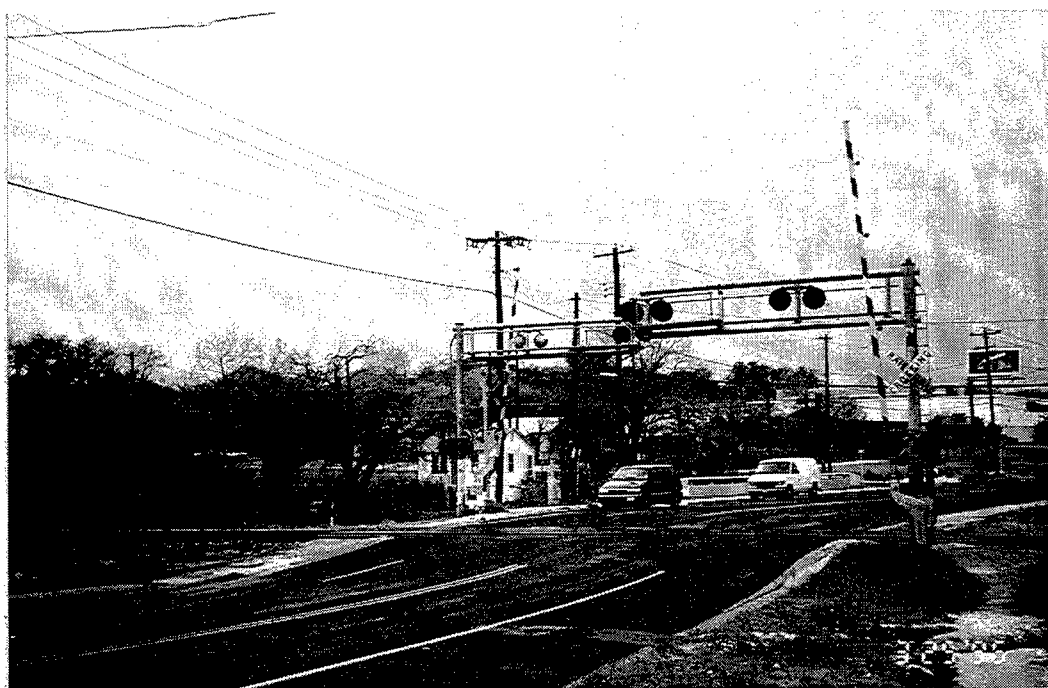
**Figure 6-2. Photograph of Oltorf Site.**

The Oltorf site is a four-lane roadway located approximately 1 km from the West Mary crossing. It has 3.7 m lanes, curb and gutter, and a 56 km/h speed limit. The roadway is an arterial street with average traffic of approximately 16,600 vehicles per day. The crossing has one track and approximately 17 trains per day. Figures 6-2 illustrates the crossing.

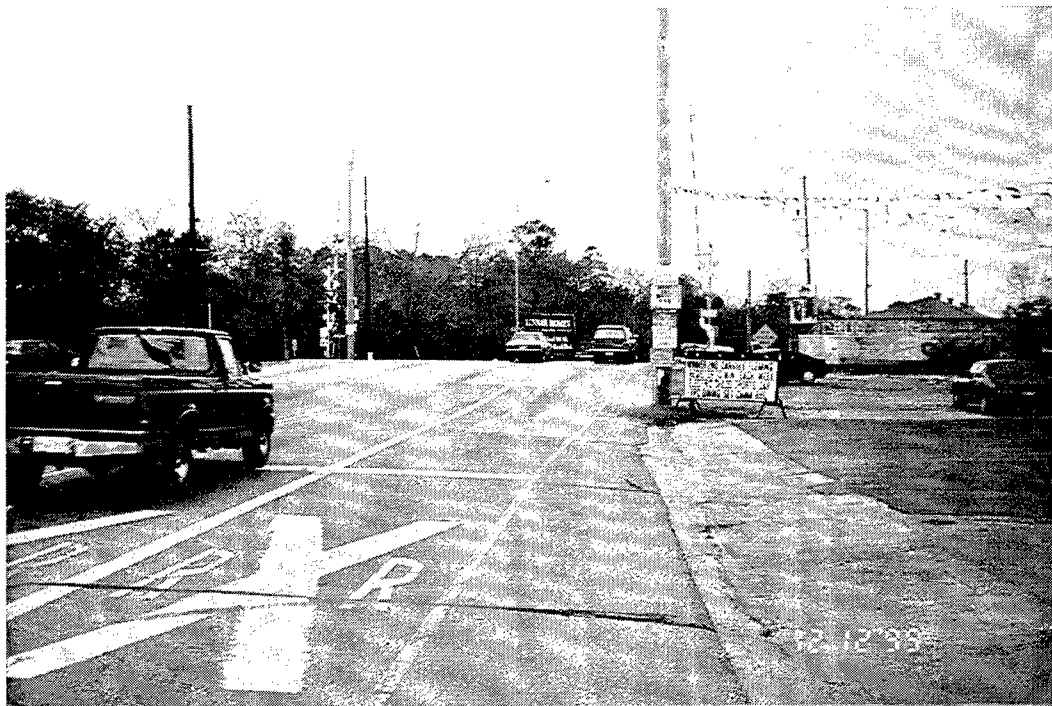
**Figure 6-11. Photograph of FM 2100 Site.**

A single vendor was contracted by the state to install, operate, and maintain the automated enforcement system at FM 2100. The automated enforcement system was installed during February and March 1997. Operation of the system was delayed when the local law enforcement agency stated they had serious concerns with sending an "educational letter" rather than citations to suspected violators. Because of their concerns, other solutions were investigated

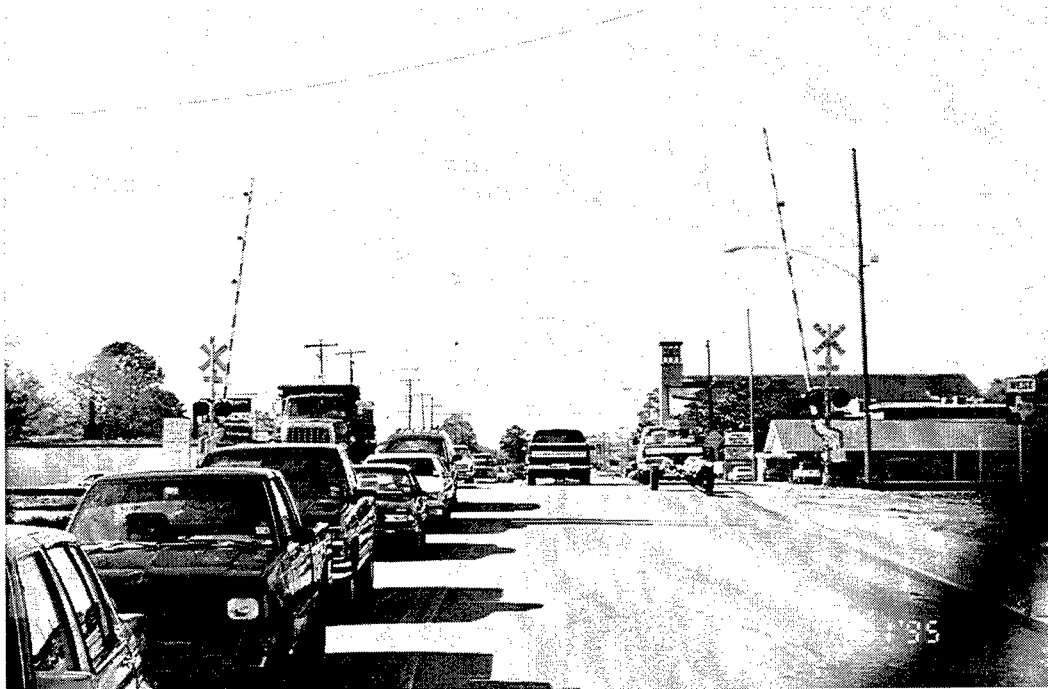
**Figure 6-16. Photograph of Broadway Street.**

Broadway Street has two tracks crossing a four-lane state highway in Pearland, Texas. The crossing has an estimated 34 trains per day. The roadway is a major arterial for the city with an average daily traffic of 19,500. Each lane is 3.7 m wide. Figure 6-16 illustrates the crossing.

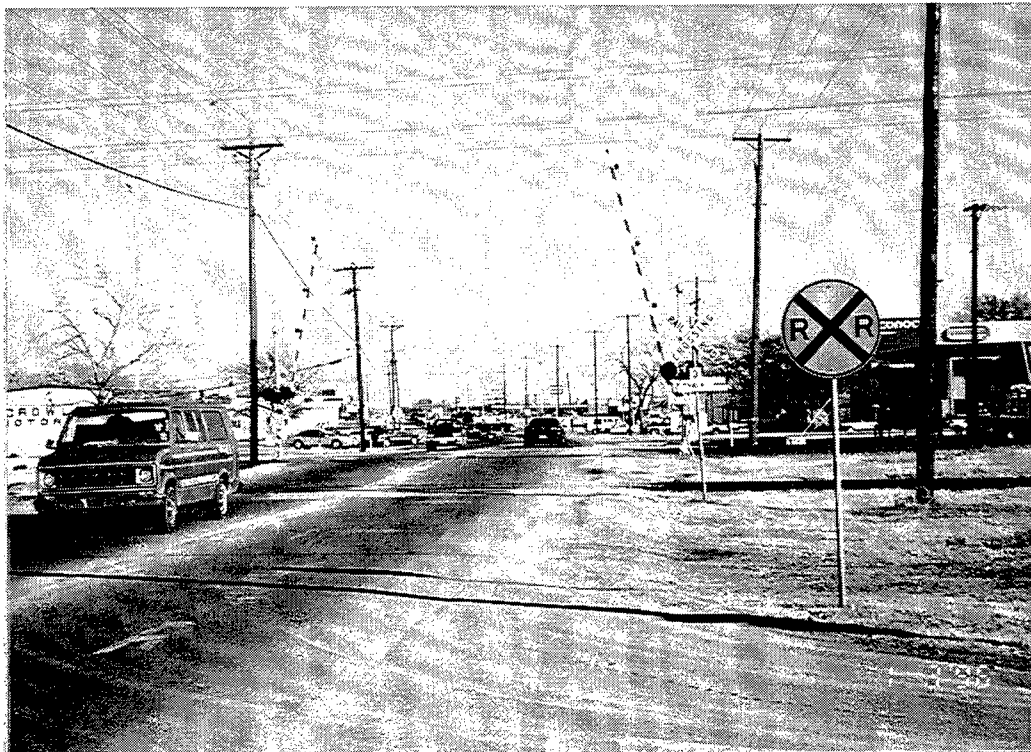
**Figure 6-17. Photograph of Main Street.**

Main Street has three tracks crossing a two-lane state highway in Crowley, Texas. The roadway is a major arterial for the city with an average daily traffic of 13,600. The site is in a developed area with several driveways near the crossing. Each lane is 4.6 m wide, and the roadway has no marked shoulders. Thirty trains use the crossing each day. Figures 6-17 illustrates the crossing.
