Report No. FHWA-RD-73-22

**DIAGRAMMATIC GUIDE SIGNS FOR USE ON
CONTROLLED ACCESS HIGHWAYS
Vol. II. Laboratory, Instrumented Vehicle, and
State Traffic Studies of Diagrammatic Guide Signs**

**December 1972
Final Report**

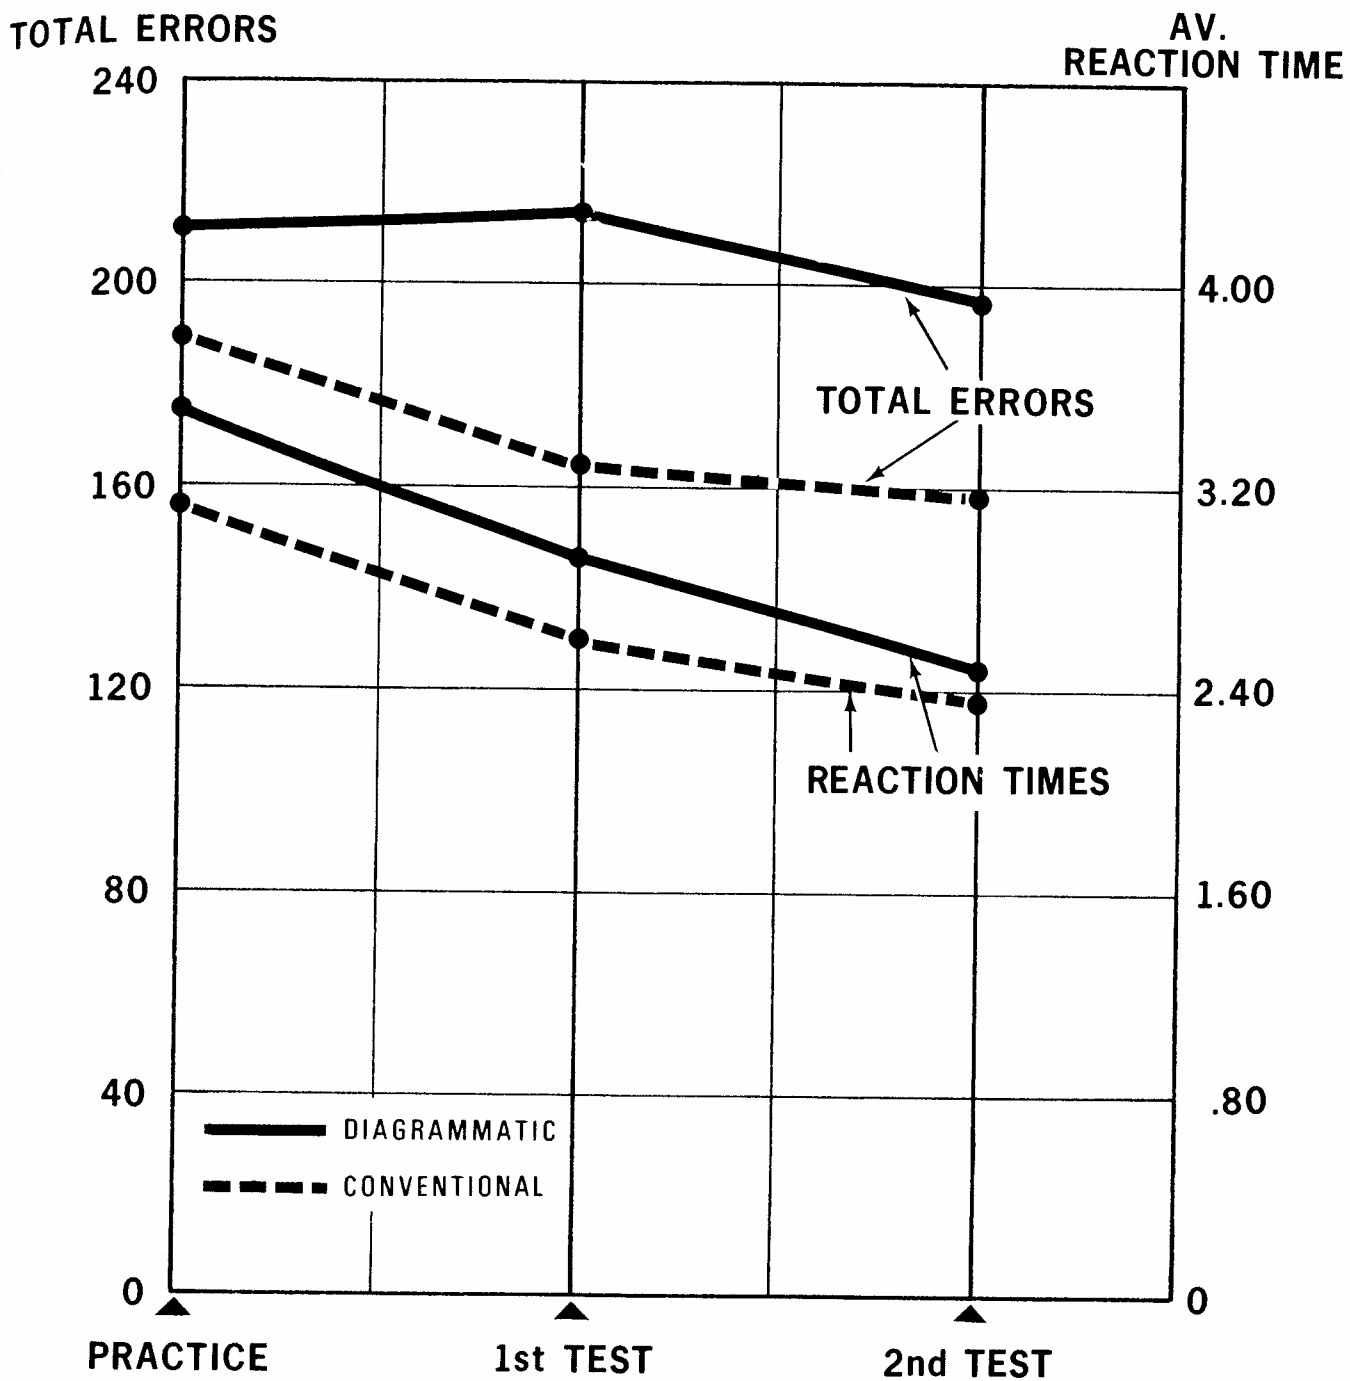
Figure 3-7. Improvement in subjects' performance with practice.

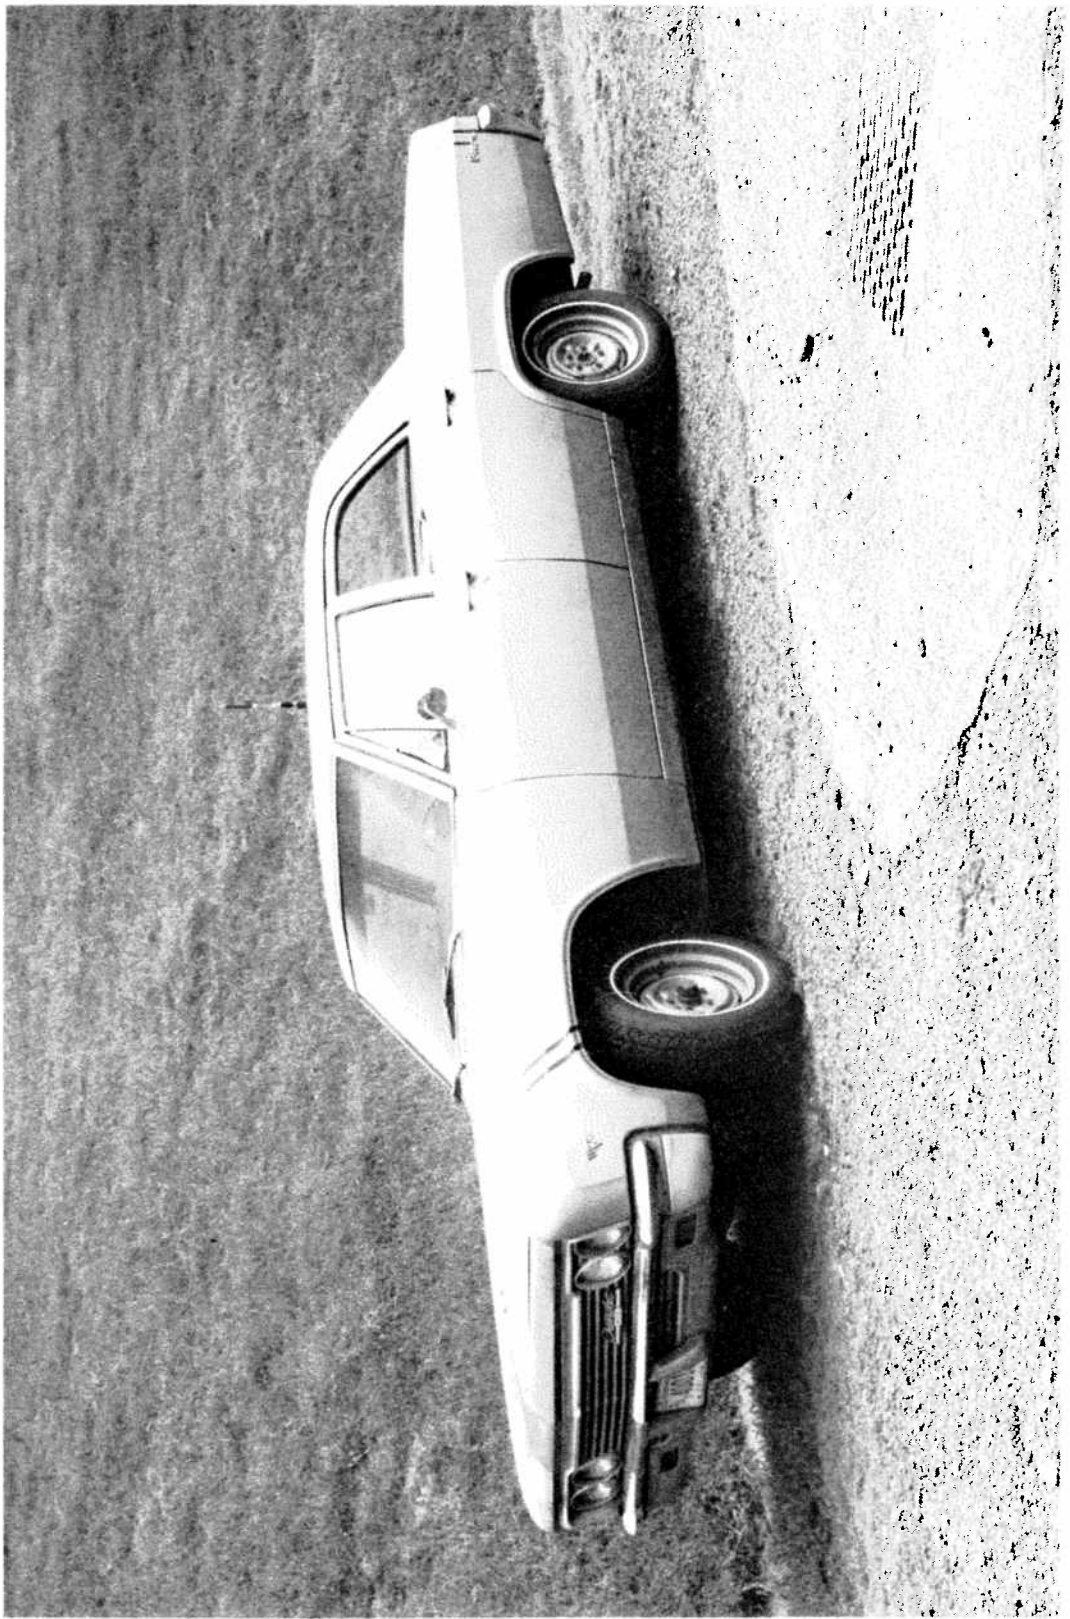
Figure 4-3. Picture of instrumented test vehicle.

The vehicle used for the driver tests was a 1966, 8 cylinder Chevrolet. A picture of the vehicle is presented in Figure 4-3. It was a four door Biscayne sedan equipped with power steering, automatic transmission, air conditioning and power brakes. The tires were new steel belted, 4-ply radials. In order to accommodate part of the instrumentation package, the back seat of the vehicle was removed and special mountings were installed. The instrumentation package was comprised of an inverter, recorder, and velocity/distance measuring device. Instrumentation components were mounted in both the back seat area and on the dashboard of the test vehicle. The component mounted on the dashboard was located on the passenger's side. The inverter and recorder were positioned in the back seat area. The inverter was manufactured by Carter Company and provided 115 volts at 60 cycles per second. It was the source of power for the recorder and velocity/distance measuring equipment. The recorder was a ten channel, digital printer manufactured by Systron-Donner, Inc. It is pictured along with the inverter in Figure 4-4. The velocity/distance measuring equipment was manufactured by Zeronics Engineering Company and was mounted on the dashboard. It measured the velocity of the test vehicle in tenths of a mile per hour and the distance traversed in one hundredths of a mile or to the nearest 52.8 feet. This was accomplished by means of a photo-electric sensor attached to the speedometer cable. A picture of the Zeronics velocity/distance device is presented in Figure 4-5.

A 1966, 8-cylinder Chevrolet was instrumented and used in the investigation. A picture of this vehicle was presented in Chapter IV in Figure 4-3. The vehicle was equipped with steel belted 4-ply radial tires, power steering, automatic transmission, air conditioning, and power brakes. Instrumentation components were mounted in both the back and front seat area of the vehicle. Mounted on the dash board on the passenger side was a velocity/distance measuring device manufactured by Zeronic Engineering Company (Figure 5-1). It measured the velocity of the test vehicle in 1/10ths of a mile per hour and the distance traversed to the nearest 1/100ths of a mile. An experimenter's control box was positioned on the front seat between the test driver and the experimenter (Figure 5-1). Buttons on the control box were used to present experimental test signs to the driver as well as to record the subject's response latencies or information interpretation times (IIT). A digital readout of subject IIT times was displayed to the experimenter on the front of the control box panel. Also mounted in the front seat area of the vehicle was a small 3.5 x 8 inch screen which was positioned along the upper edge of the front windshield next to the rear view mirror (Figure 5-1). This screen was used for the projection of sign stimuli to the driver. The image of a diagrammatic sign can be seen on the screen in Figure 5-1.

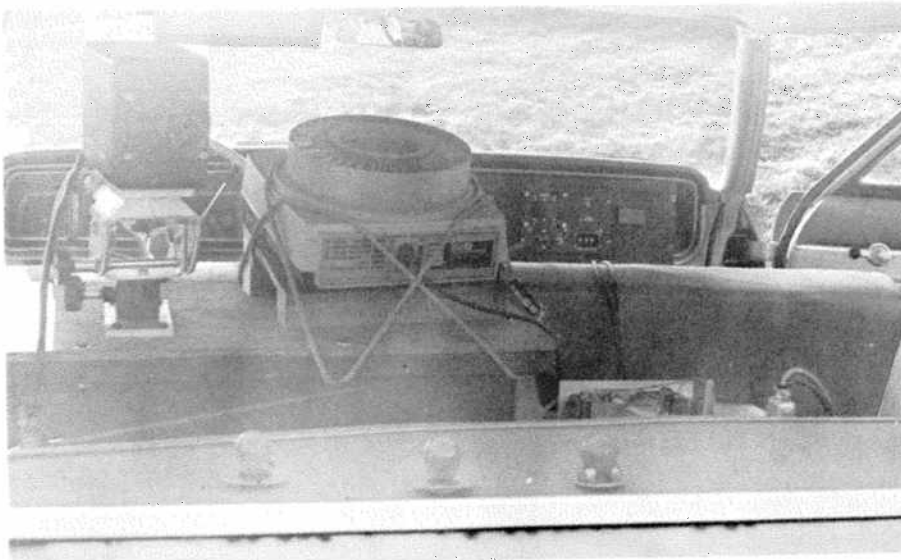
Figure 6-4. View of projector, camera, and stimulus response lamps.

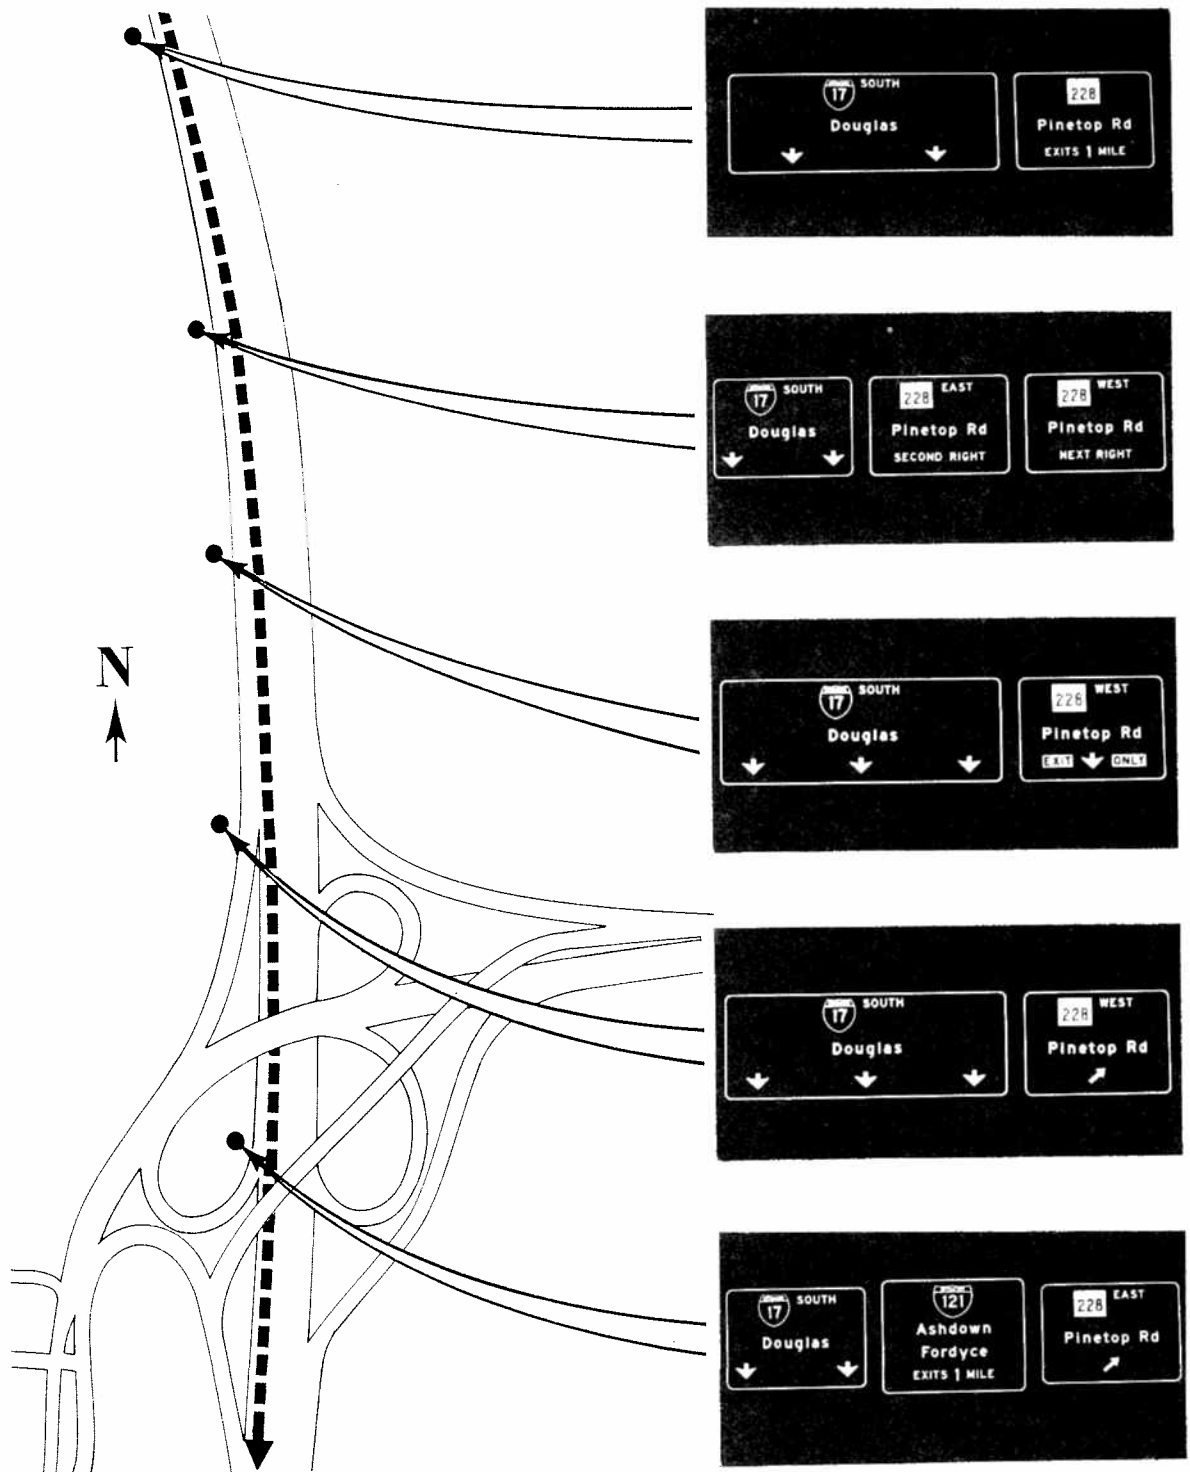
Figure 6-22. Southbound approach to Interchange B (conventional signing).

Figure 6-23. Southbound approach to Interchange B (Diagrammatic I signing).

Figure 6-24. Southbound approach to Interchange B (Diagrammatic II signing).

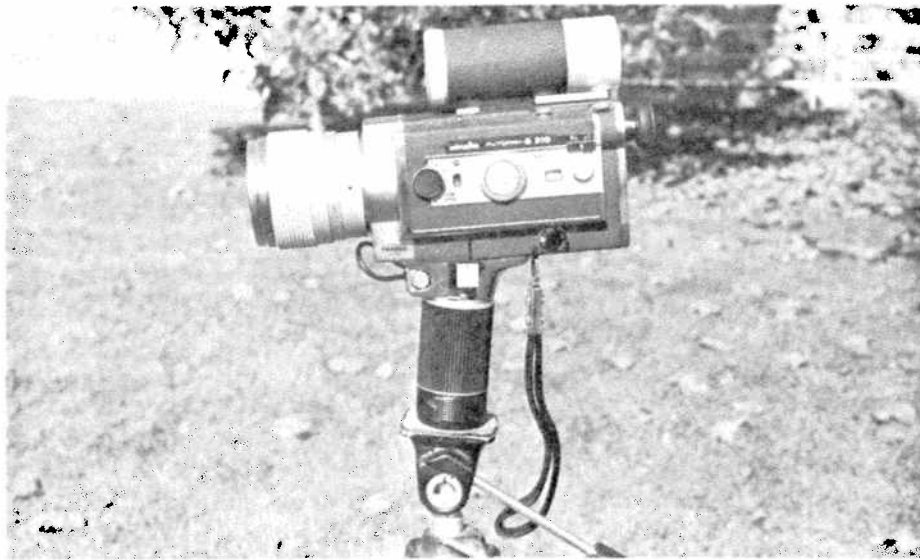
Figure 7-1. Picture of Minolta Super 8 time lapse camera.

Four cameras were positioned on tripods near the locations of the advance signs and Germantown exit gore area of the test interchange. The cameras were camouflaged so that they could not be seen by motorists on the highway. Presented in Figure 7-2 is a 35 mm picture taken from camera position four with the lens settings adjusted to approximate the time lapse cameras' fields of view. Two of the cameras recorded traffic behavior in the vicinity of the 1 mile advance sign. The principle purpose of the first camera, numbering camera positions from the advance sign to the interchange, was to record the number, type, and origin of vehicles

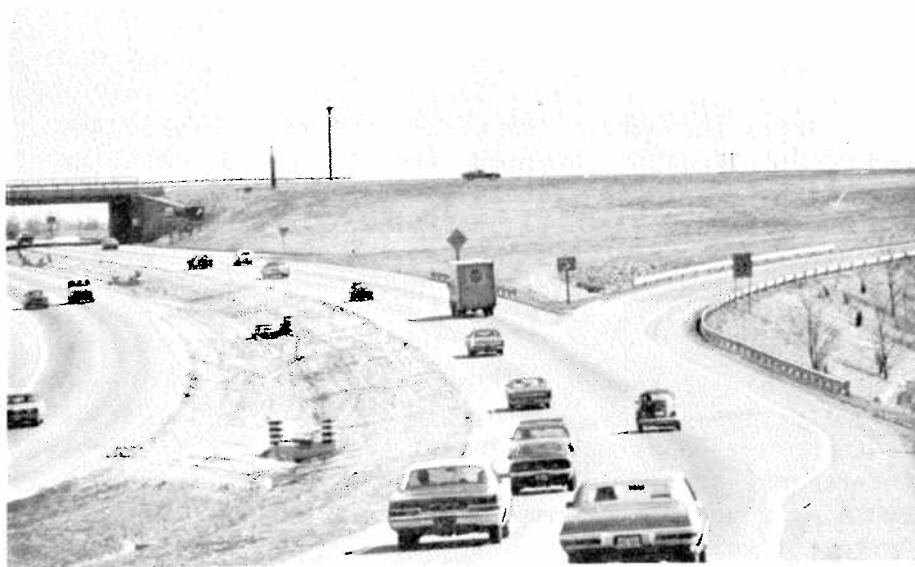
Figure 7-2. Picture taken from camera Position 4 showing the camera's approximate field of view.

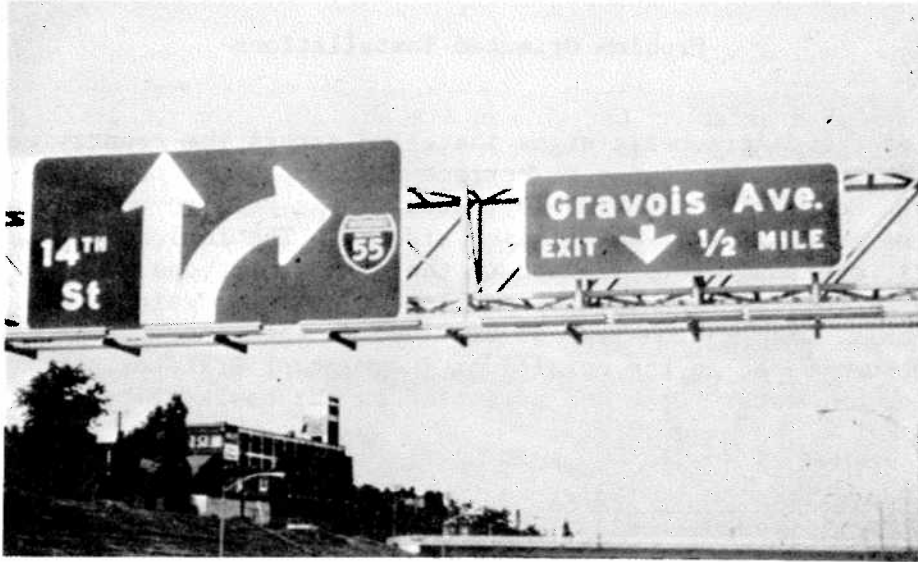
Figure 8-7. Diagrammatic sign in St. Louis, Missouri.

St. Louis, Missouri. In St. Louis Missouri, there is a major fork that functions as a two-lane left exit, tangential off-ramp. The two-lane left exit is complete and awaiting the finish of the interstate; in the interim it is merely an exit to a main city street. In the future these lanes will carry traffic for U.S. 66 and I-44. This sign (Figure 8-7) has a very large diagram.
